1 The vulnerability of buildings to a large-scale debris flow and outburst 2 flood hazard chain that occurred on 30 August 2020 in Ganluo, 3 Southwest China

11 **Abstract:** In mountainous areas, damage caused by debris flows is often aggravated by
12 subsequent dam-burst floods within the main river confluence zone. On 30 August 2020, a
13 catastrophic disaster chain occurred at the confluence of the Heixiluo Gully and Niri River in
14 Ganluo County, Southwest China, that consisted of a debris flow, the formation of a barrier lake
15 and subsequent dam breach that flooded the community. This study provides a comprehensive
16 analysis of the damage to buildings resulting from the sequential occurrence of debris flow and
17 dam-burst flood. The peak discharge of the debris flow in the gully mouth reached 1937 m³/s, and
18 the change in the main river channel resulting from the dam-burst flood, which had a peak
19 discharge of 2273 m³/s, resulted in a fourfold increase in the extent of flood inundation compared
20 to an ordinary flood. Three hazard zones were established based on the building damage patterns:

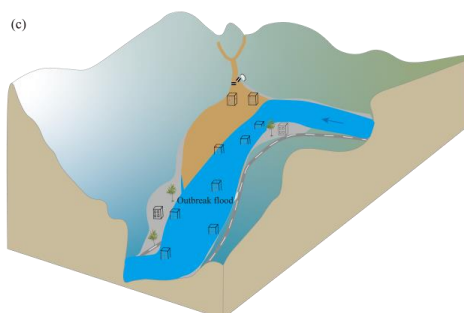
160 **Figure 3** Illustration of the multi-hazard chain: (a) river flow before the occurrence of debris flow; (b)
161 debris flow blocks the river and forms a dammed lake that destroys the railway, roads and buildings; (c) the
162 bursting of the dammed lake and buildings and road were damaged or inundated by the flood.

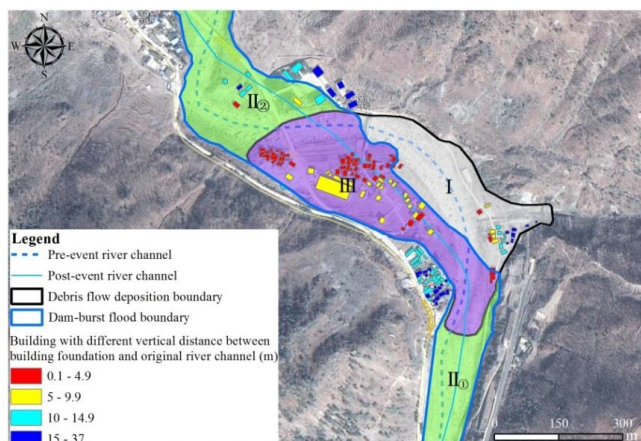
317 Three hazard zones are identified based on the boundary of the debris flow and dam-burst
318 flood, as shown in Fig. 8 and Fig. 9. The damage patterns of buildings in the different hazard
319 zones can be classified into three categories, namely, (I) buildings only buried by debris flow; (II)
320 buildings only inundated by dam-burst flood; and (III) buildings sequentially buried by debris
321 flow and inundated by dam-burst flood. Zone (I) is situated near the Heixiluo gully mouth, where
322 the debris flow transported a large volume of sediment and seriously eroded the sidewall and bed
323 of the channel, expanding the channel’s width from 10 m to 40 m. All buildings were inundated
324 by sediment to a depth of over 6 m.

348
349 **Figure 8** Inundation boundary of debris flow and dam-burst flood and spatial division of the hazard zone
350 based on building damage patterns: (I) buried by debris flow; (II) inundated by dam-burst flood; (III)
351 buried by debris flow and the inundated by dam-burst flood.

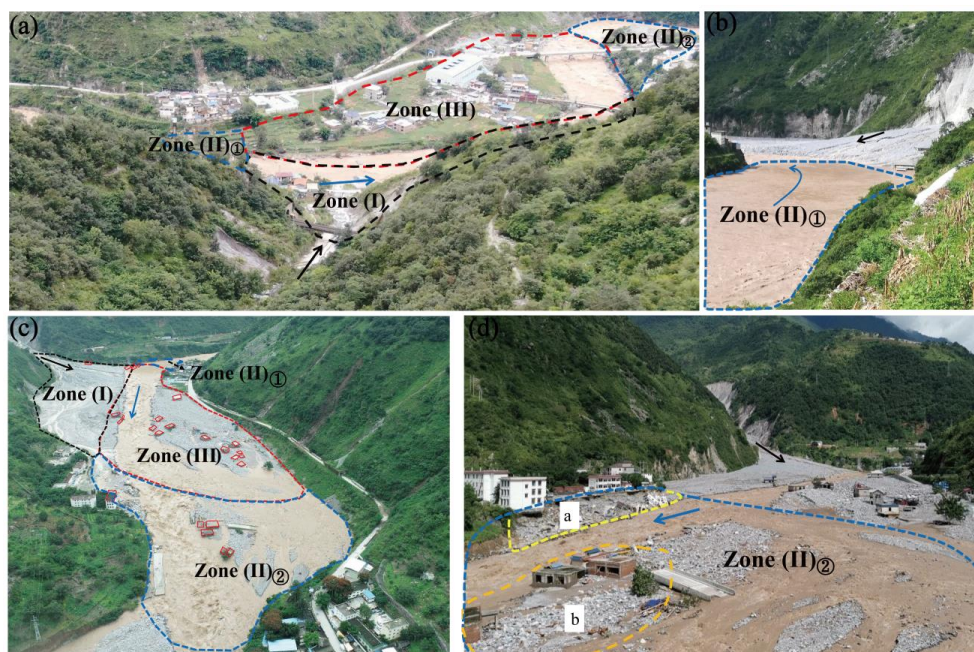
352 A total of 110 buildings in the village were impacted by the multi-hazards, accounting for
353 69.62% of the total buildings. Among them, 75 buildings located in Zone (III) were impacted by
354 the debris flow and flood in succession, which accounted for 47.47% of the total buildings. In
355 contrast, buildings destroyed by the debris flow in Zone (I) and dam-burst flood in Zone (II)
356 accounted for only 16.46% and 5.70% of the total buildings, respectively (Table 3). Overall, the
357 number of buildings within the debris flow deposition boundary and flood inundation boundary is
358 101 and 84, respectively, accounting for 63.92% and 53.16% of the total buildings in the village.
359

Figure 9 Spatial distribution of the three hazard zones before and after the disaster: (a) before the disaster; (b) (c) (d) after the disaster.

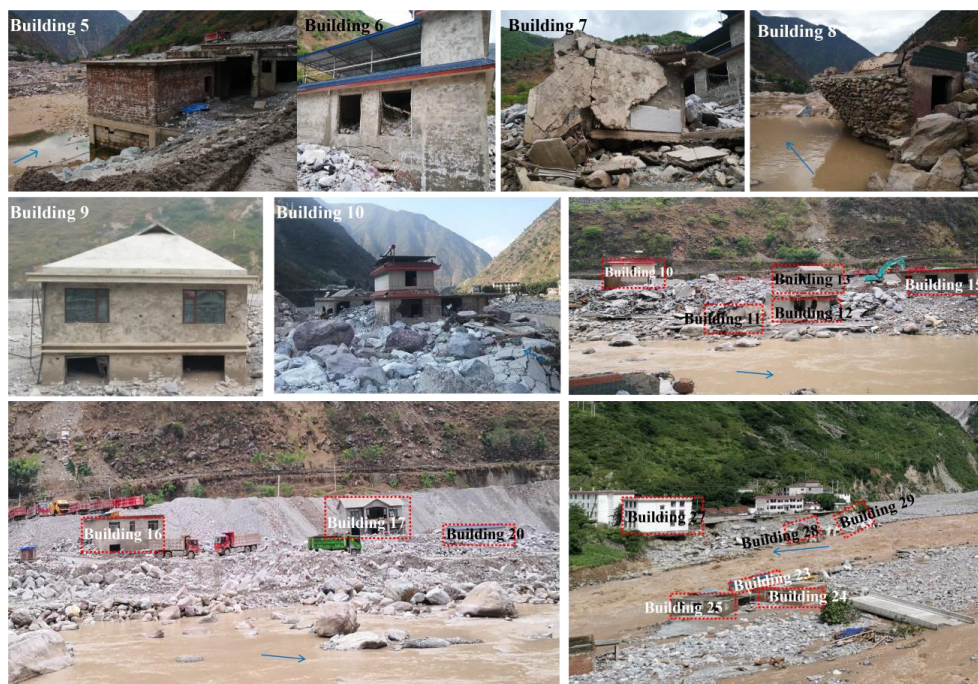
384 The building characteristics and hazard intensity are presented in Table 5. The two buildings
385 in Zone (I) were buried by debris flow with a thickness greater than 5 m. In Zone (III), buildings
386 located near the debris flow dam (such as buildings 3, 4, and 5) were first buried by the debris
387 flow and then inundated by water from the dammed lake for 30 minutes. These buildings were
388 then impacted by the dam-burst flood. Additionally, buildings near the new river channel suffered
389 greater impact pressure than other buildings. For example, the residual broken structures of
390 buildings 7 and 8 were heavily damaged by the direct impact of the flood in the vertical direction.
391 The walls of the two buildings were severely abraded by impact pressures of 75.7 kPa and 71.1
392 kPa, respectively. Additionally, the foundations of the two buildings were partially scoured by
393 floods with high shear stresses of 562 Pa and 553 Pa, respectively.

394 Buildings located in Zone (II) were only severely impacted by the dam-burst flood. For instance,
395 the foundation of the three-story school building (building 27) was severely eroded by the flood
396 to a scour depth of 1 m, and the floors on the right were collapsed. There was no evidence on the
397 walls of the building that the debris flow had abraded the structure. The velocity and shear stress
398 of the flood in this location were 5.3 m/s and 463 Pa, respectively. Buildings 23-27, which were
399 close to the new river channel, were thoroughly buried by the sediment transported by the flood
400 and inundated by floodwater.

Figure 10 Buildings with the different degree of damages within three hazard zones.

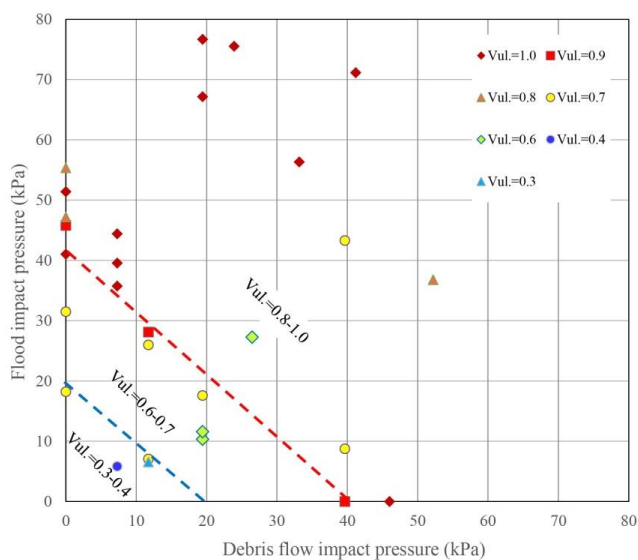
442 impacted by the sequentially occurring hazards in Zone (III) and damage caused by a single
443 hazard in Zone (I) and Zone (II). Damage is divided into three categories based on the threshold
444 impact pressure: slight damage (0.3-0.4), moderate damage (0.6-0.7), and heavy and complete
445 damage (0.8-1.0). Heavy damage occurs at impact pressures greater than 40 kPa, while slight
446 damage occurs below 20 kPa. Moderate damage occurs at impact pressures between 20 kPa and
447 40 kPa. The threshold impact pressure is compared with that proposed by [Hu et al. \(2012\)](#) and
448 [Zanchetta et al. \(2004\)](#), which were derived from a single debris flow disaster in China and Italy,
449 respectively. Although the detailed definition of the damage scales differs, the threshold of the
450 impact pressure for buildings at the slight, heavy, and complete damage scales is generally larger
451 than that for the brick-concrete structures presented in [Hu et al. \(2012\)](#) and smaller than that for

452 the reinforced concrete frames also presented in [Hu et al. \(2012\)](#) and the masonry structures with
453 basements presented in [Zanchetta et al. \(2004\)](#). A similar trend for the threshold of the impact
454 pressure for buildings with a moderate damage scale can be observed.

455
456 **Figure 15** Accumulation of building damage due to debris flow and dam-burst flood. The damage
457 distribution is based on the debris flow and flood impact pressure (Vul. refers to vulnerability).
