Nat. Hazards Earth Syst. Sci., 14, 545–556, 2014 www.nat-hazards-earth-syst-sci.net/14/545/2014/ doi:10.5194/nhess-14-545-2014 © Author(s) 2014. CC Attribution 3.0 License.

# Landslide and slope stability evaluation in the historical town of Kruja, Albania

### Y. Muceku and O. Korini

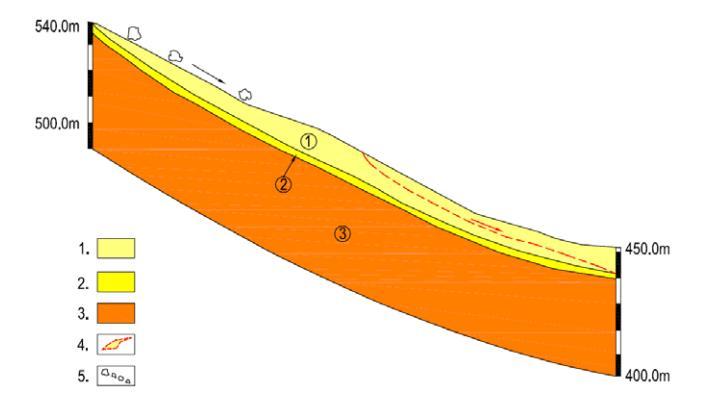
In the central and southeastern parts of Kruja have occurred two earthslides. The larger one was 500.0–550.0 m long, 200.0–320.0 m wide and 4.0–8.5 m thick (Figs. 3 and 5). It occurred in 1990. During heavy rain periods some sites in the upper part of the landslide move slowly downwards on hill slopes. Over this slide are built the Kasmaj, Perlataj and Berberaj squares of Kruja, where about 12, 2–3 storey buildings were demolished and about 47 others affected by joint failure and cracks. This certainly constitutes a serious threat to human life for the people who live in this area. Besides, this mass movement has affected transportation corridors and

**Fig. 3.** Lithological profile of engineering geology site no.  $II_1$ . (1) inorganic silts and clays with fine sands, (2) weathering crust of flysch rocks, (3) flysch rocks, (4) earthslide body, (5) breccia and limestone blocks.

The engineering geology site no.  $II_1$ . It is built by three geotechnical layers, which are nos. 4, 5 and 6 (Fig. 3). The geotechnical layer no. 4 consists of inorganic clays of low to medium plasticity, 1.9-4.2 m up to 6.5-8.2 m thick. These soils are included in the CL soil group (Samtani and Nowatzki, 2006). The geotechnical layer no. 5 represents the weathering crust of flysch rocks (FL), which are very weak rocks (Romana, 1996), 1.8-2.5 m thick. It is characterized by the same physical-mechanical properties in the whole engineering geology zone. The geotechnical layer no. 6 is comprised of flysch rocks (FL), and is mainly built of claystones-siltstones with interbedding of sandstones layers that are weak rocks (Romana, 1996). It is found in the entire engineering geology zone with the same geotechnical properties.

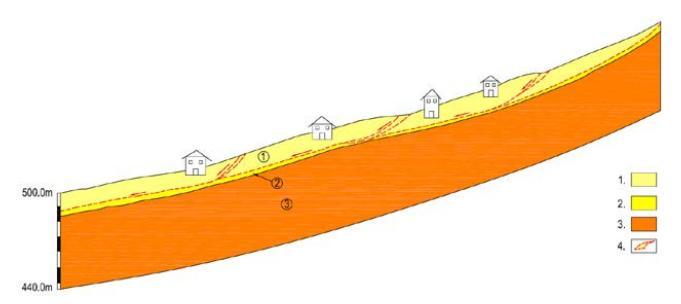
**Fig. 5.** Lithological profile of engineering geology site no.  $II_4$ . (1) inorganic silts and clays with fine sands, (2) weathering crust of flysch rocks, (3) flysch rocks, (4) earthslide body.

- (c) *The engineering geology site no. II*<sub>4</sub>. The geotechnical layer no. 9 consists of inorganic clays of low to medium plasticity included in the CL soil group (Samtani and Nowatzki, 2006). It ranges from 3.2–5.0 m up to 7.5–8.7 m thick.

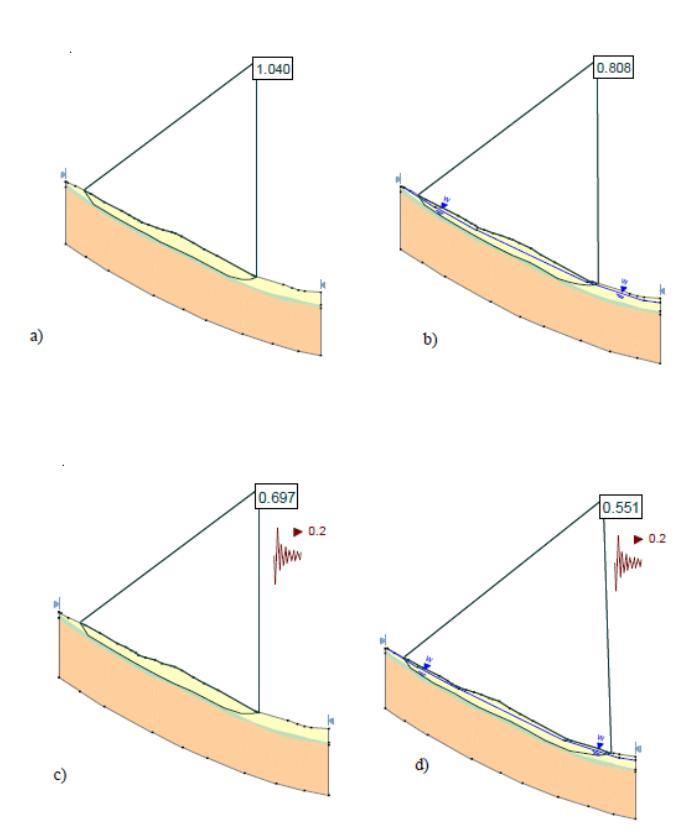
**Fig. 9.** Model of safety factor computed by limit equilibrium at engineering geology site no. II<sub>1</sub> in the case of (**a**) arid, (**b**) wet, (**c**) PGA and (**d**) wet and PGA.

The computed safety factor in this case is  $S_F \le 0.82$  (Figs. 9, 10, 11, 12, 13 and 14), indicating that the engineering geology sites (hill slopes) for these conditions (earthquake after heavy rainfall) are unstable and very susceptible to landslide occurrences (Fig. 18).

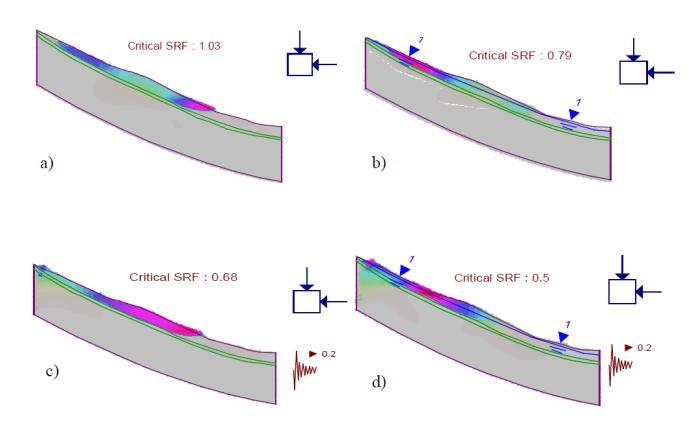
**Fig. 10.** Model of safety factor computed by finite element at engineering geology site no. II<sub>1</sub> in the case of (**a**) arid, (**b**) wet, (**c**) PGA and (**d**) wet and PGA.

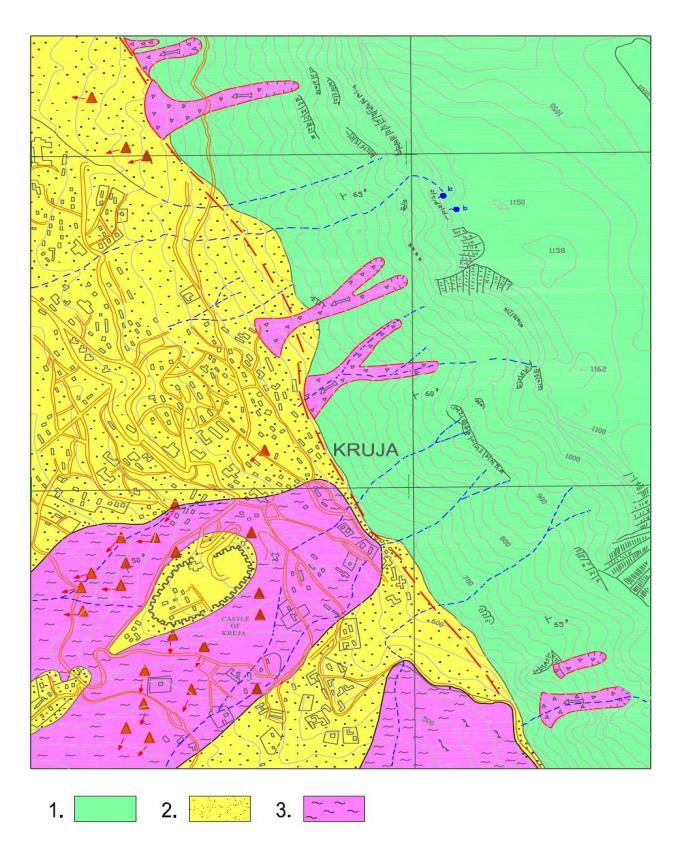
The slope stability evaluation concludes that a considerable area in the southern and eastern parts of Kruja, in the case of saturated conditions (rainy days) and seismic activity, is in an unstable state. This means that these slopes are characterized by a landslide occurrence, in terms of earthslide, rocks rolling and debris flow types. This category includes the engineering geology site nos. I<sub>1</sub> and II<sub>1</sub> (Fig. 16, saturated conditions), engineering geology site nos. I<sub>1</sub>, II<sub>1</sub>, II<sub>4</sub> and II<sub>5</sub> (Fig. 17, seismic activity) and engineering geology site nos. I<sub>1</sub>, II<sub>1</sub>, II<sub>2</sub>, II<sub>3</sub>, II<sub>4</sub> and II<sub>5</sub> (Fig. 18, saturated and seismic conditions).

**Fig. 18.** Slope stability zonation map of Kruja in the case of earthquake and rainfall occurrence at the same time, scale 1 : 5000. (1) engineering geology zone with a basement of limestone rocks, stable, (2) engineering geology zone with a basement of breccia rocks, stable, (3) engineering geology site in an unstable state.

The conditions of the unstable areas need to be improved in order to prevent loss of life and economic or cultural heritage damages. To protect the urban area against rock block rolling, it is necessary to remove them. For protection against debris flow phenomena, engineering measures such as benches and concrete walls should be used. To protect Kasmaj, Perlataj and Berberaj squares against earthslide phenomena, engineering measures such as piles and drainage systems should be used.

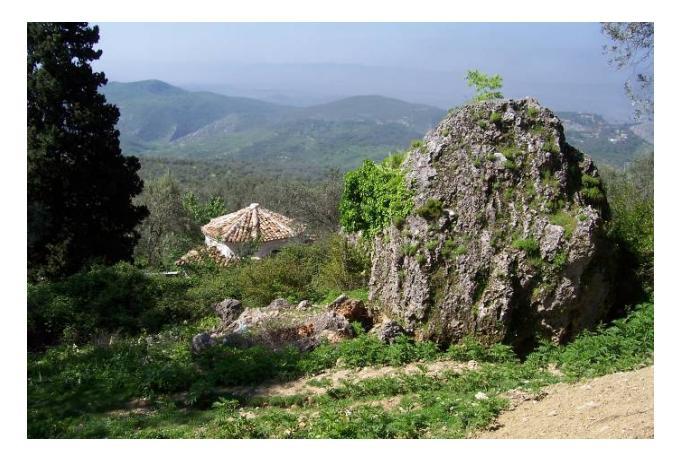
inclination angle of  $16-27^{\circ}$ . They are situated on the urban area slope with an inclination angle of  $16-27^{\circ}$ . Most of them rest in unstable state conditions that occur often times due to landslide and erosion activities (Figs. 19 and 20). From this process some large blocks during heavy rain events do roll down, damaging roads, green landscape and buildings. So, this phenomenon is a real risk to life and engineering objects such as buildings, roads, etc. (Figs. 19 and 20).

Fig. 19. A breccia block in unstable state condition.

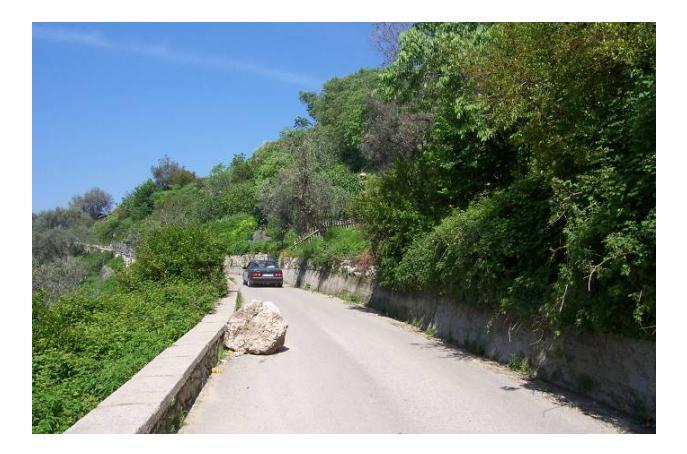
**Fig. 20.** A limestone block fell on the Kruja urban area during heavy rain in 2010.
