# The catastrophic landfill flowslide at Hongao dumpsite on 20 December 2015 in Shenzhen, China

Abstract. A catastrophic flowslide occurred at the Hongao dumpsite on 20 December 2015 in the Guangming New District of Shenzhen, China. The flowslide caused 77 causalities and damaged 33 buildings. In the absence of extreme weather conditions and seismic activity, the causes of the failure were analyzed on the basis of multi-temporal remote-sensing images, site investigation, in situ tests, laboratory tests, and numerical analyses. Site investigations showed that the volume of the displaced material was  $2.32 \times 10^6$  m<sup>3</sup> and the volume of the pre-failure waste filling was  $6.27 \times 10^6 \text{ m}^3$ . The flowslide was characterized by high travel velocity and long runout distance. The displaced material was primarily a mixture of silty soil and construction and demolition waste with water content of 17.3-42.4 %. The primary causes of the failure were concluded to be the following: (1) groundwater flow had stagnated in the dumpsite due to drainage system failure and the underlying impermeable granite stratum; (2) the accumulation rate and total volume of the waste

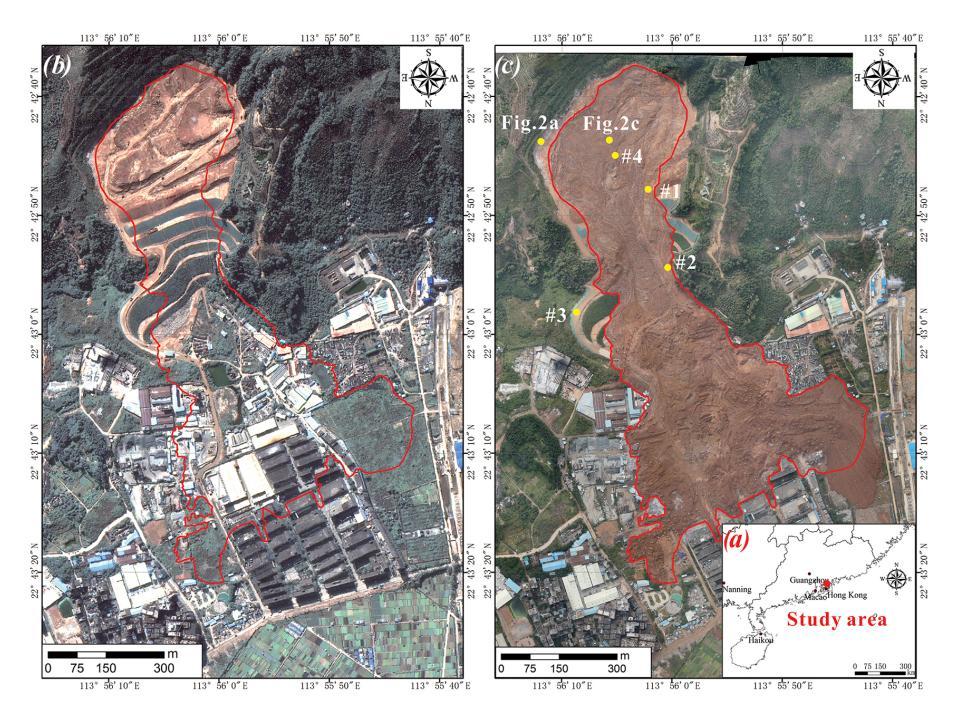
Figure 1. Location of the study site and images of the pre-/post-failure dumpsite. The boundary of the flowslide is indicated in red. (a) Location of the study area; (b) Pléiades satellite image (18 December 2015); (c) aerial photo with DEM of the flowslide with locations of samples for laboratory tests (23 December 2015).

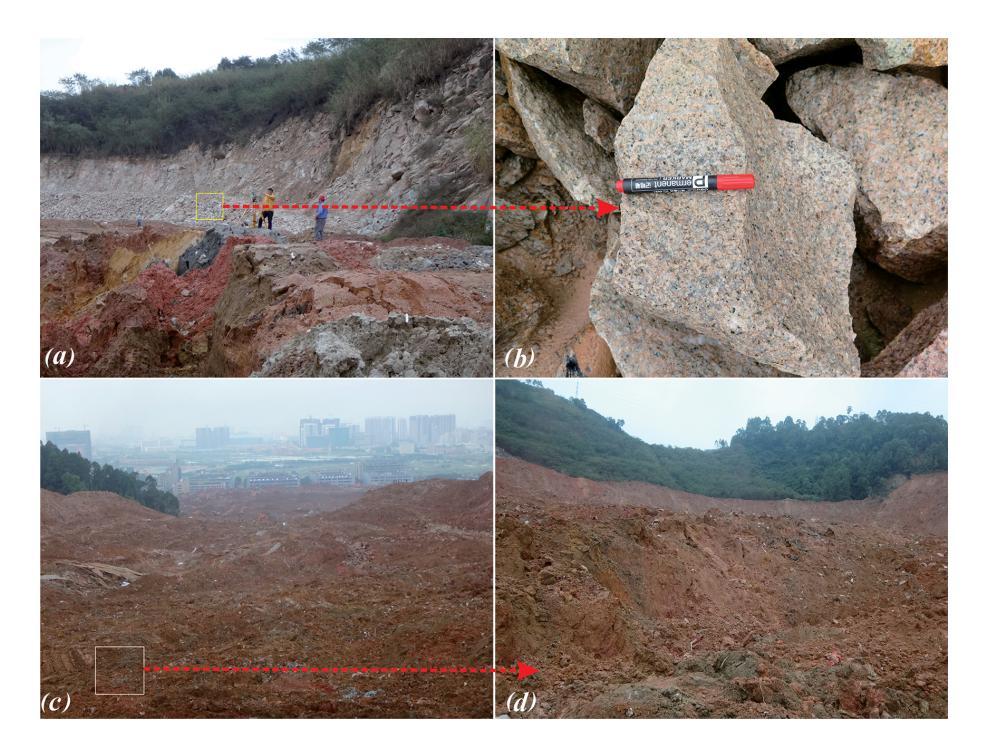
Figure 2. Photos of the rock and soil specimen collected from the displaced material. (a) Exposed granite rock near the flowslide scarp; (b) close view of the granite rocks; (c) displaced material in the zone of depletion; (d) materials in the flowslide source area.

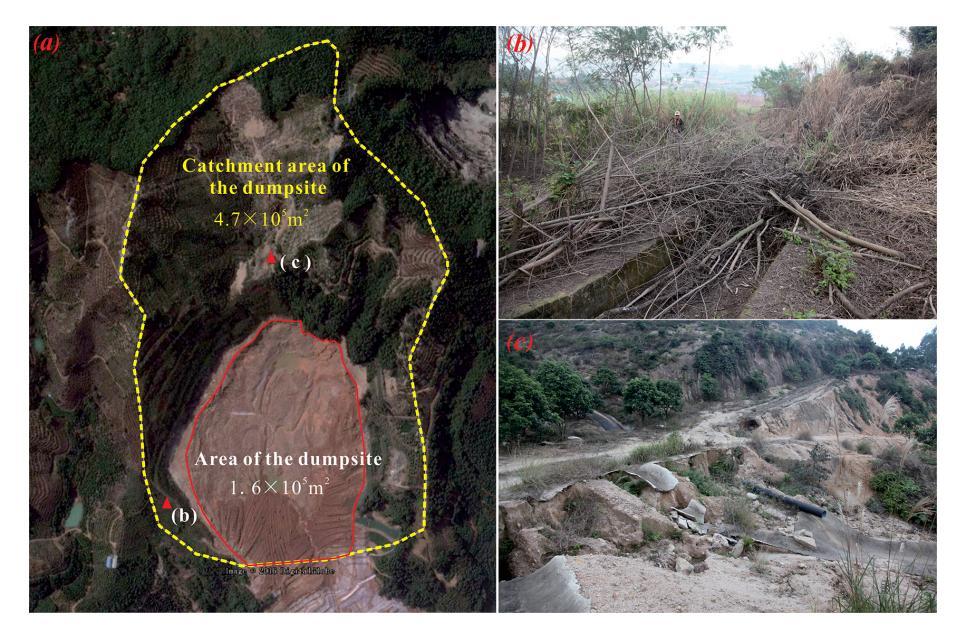
Figure 5. (a) Overview of the catchment area (Google Earth image); (b) the surrounding peripheral drainage channel of the dumpsite was abandoned; (c) damaged drainage pipes were not repaired and failed to divert surface runoff into the peripheral drainage channel. Surface runoff concentrated in the waste filling.

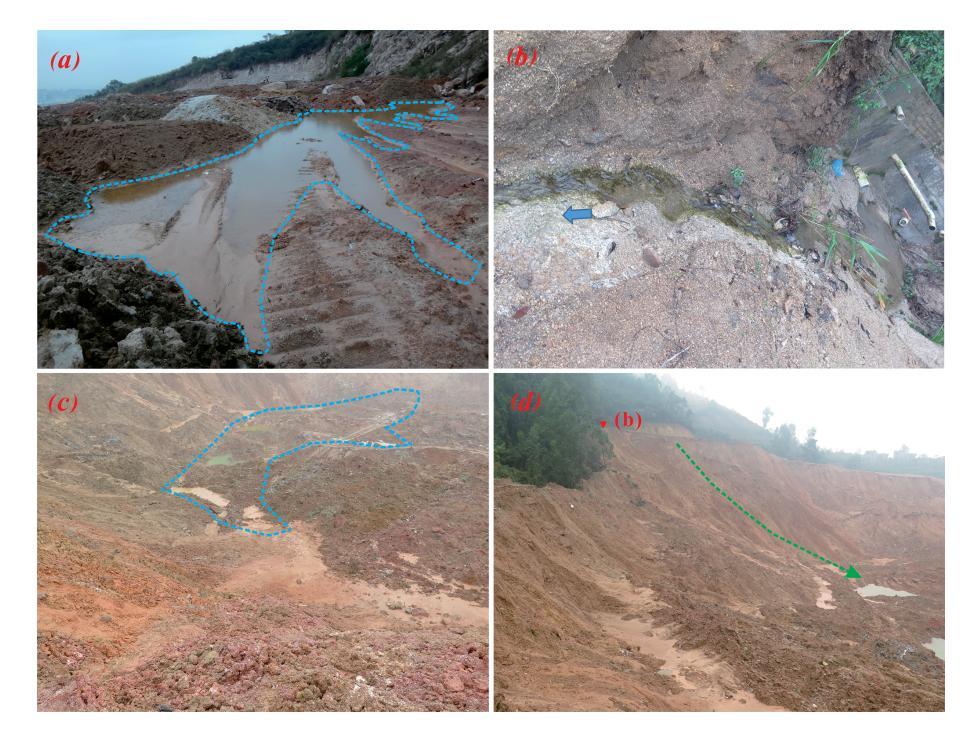
mitted (Fig. 6c), in addition to the concentration of surface runoff and groundwater into the dumpsite. The infiltration rate of the waste filling was estimated as  $5.26 \times 10^{-6}$  cm s<sup>-1</sup> by using a field double-ring infiltrometer. Low permeability and inadequate drainage resulted in high water content and high pore-water pressure in the dumpsite. The groundwater in the study area was mainly bedrock fissure water and Quaternary pore water (Fig. 6).

Figure 6. (a) Groundwater overflow in the rock fissures near the flowslide crown; (b) water accumulation in the flowslide crown; (c) water accumulation in the source area; (d) surface runoff and infiltration contributed to groundwater seepage.

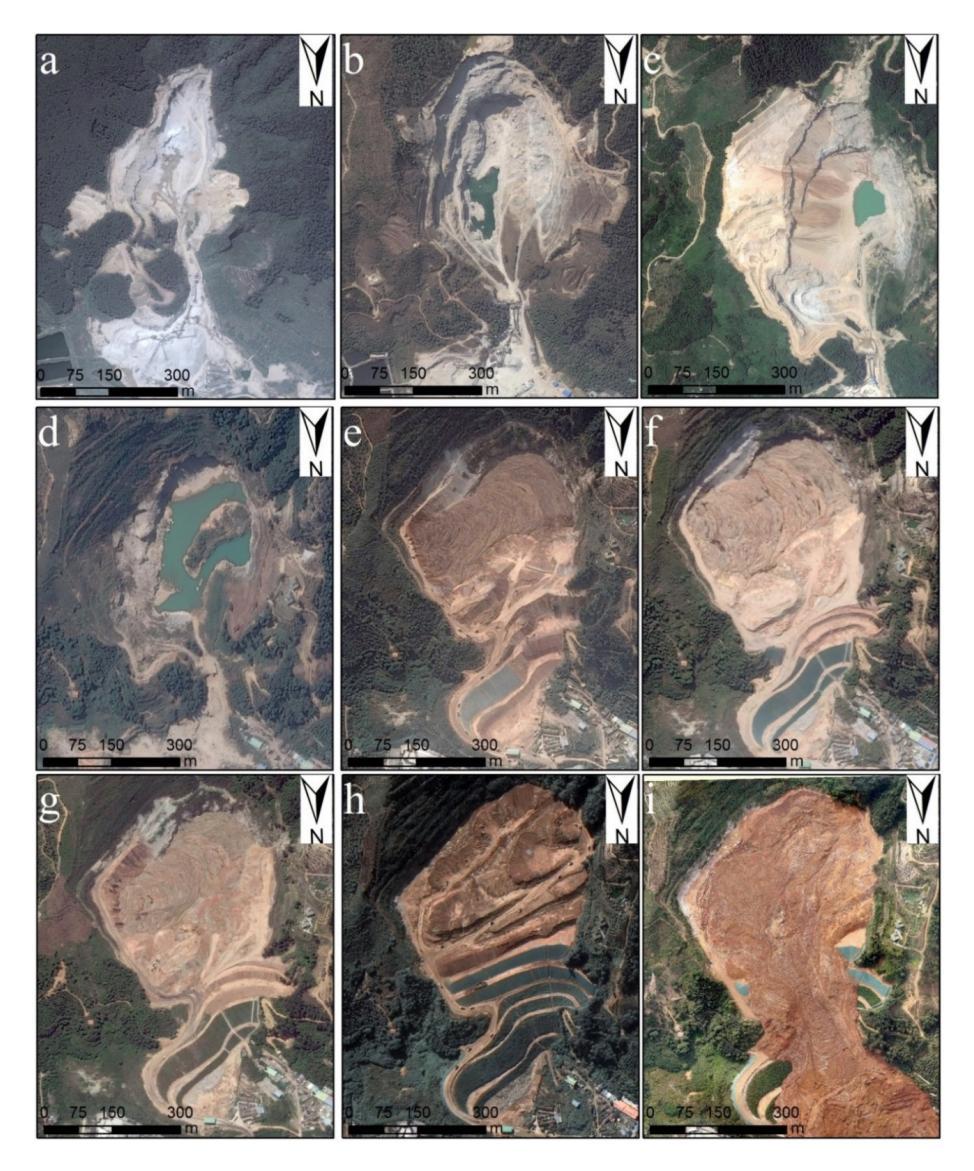
The development of dumpsite and landform changes is presented by a series of remote-sensing images taken between 2002 and 2016 (Fig. 7). It is postulated that the quarry was active between 2002 and 2008, during which time formation of ponds of various sizes at different spatial and temporal locations in the quarry indicated low permeability and the lack of a drainage network (Fig. 7b, c, and d). The quarry was abandoned in or before 2008 as shown in Fig. 7c (20 February 2008) with a small amount of waste filling in the pit. A large-scale pond was subsequently formed by rainfall and groundwater (Fig. 7d). The depth of the pit was over 100 m before routine disposal activities. A service road was excavated between two rock hills exiting the quarry and formed a small-scale gully across the pit longitudinally (Fig. 7a, b, c, and d). Additionally, a small-scale platform (office area of the abandoned quarry) was excavated immediately downstream of the quarry exit. The gully was later covered by a multibenched retaining slope, with a gradient of 15–18°, between the rock hills, and waste disposal continued throughout the process (Fig. 7e). Disposal activity started possibly in 2014 (Fig. 7e and f), and the accumulation rate of the waste filling was considerably fast (Zou, 2016).

**Figure 7.** Multi-temporal remote-sensing images of the study area. (a) 31 August 2002; (b) 20 February 2008; (c) 30 August 2010; (d) 25 November 2013; (e) 17 November 2014; (f) 23 January2015; (g) 14 April 2015; (h) Pléiades (18 December 2015); (f) aerial (23 December 2015). Panels (a) to (g) were obtained from Google Earth. A service road was excavated at the exit of the quarry with a width of nearly 70 m (see panels a, b, c, and d).

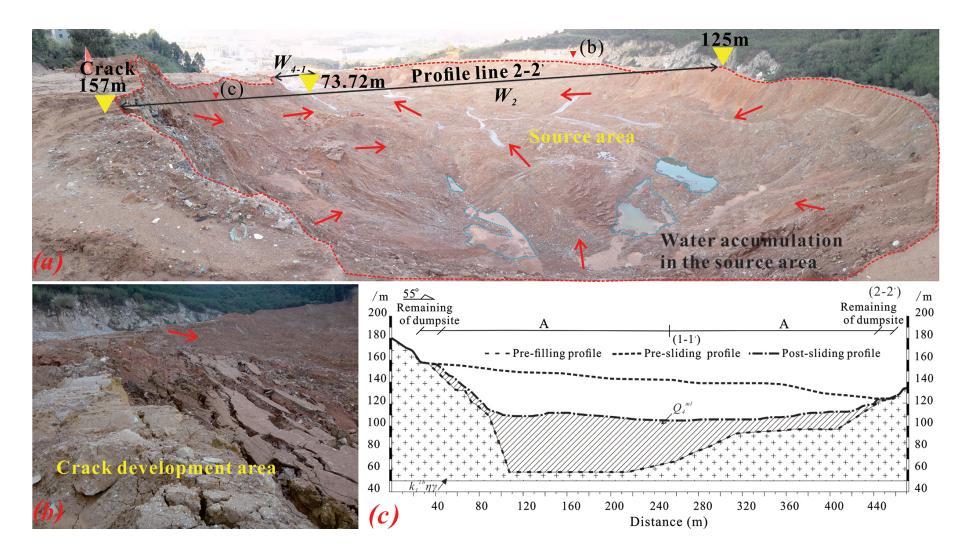
Pore-water pressure increases as rainwater and groundwater infiltrate the dumpsite. The lack of drainage resulted in waste filling saturation in the basal zone of the dumpsite, which appeared as the sliding surface of the flowslide (Fig. 12a). A large amount of silty soil was observed in the source area. The water content of the remaining materials in the source area is 17.3–42.4 % (six sampling locations). The materials on both sides of the source area were mobilized due to a debuttressing effect as the waste filling in the lower portion of the dumpsite slid and, in consequence, caused the collapse of the dumpsite. A step-like steep scarp was formed on the west side of main scarp, with tensile cracks having developed on the rear edge as well as on both sides of the scarp.

**Figure 12.** (a) An overview of the source area (image taken at the flowslide crown facing north). A large opening  $(W_{4-1})$  formed due to the failure of the retaining slope (the exit of the original quarry pit), which provided passage for the flowslide and permitted rapid release of kinematic energy. (b) Surface cracks developed due to unloading near the crest and the flanks of the flowslide. (c) The geological cross section (profile line 2-2') of the source area.

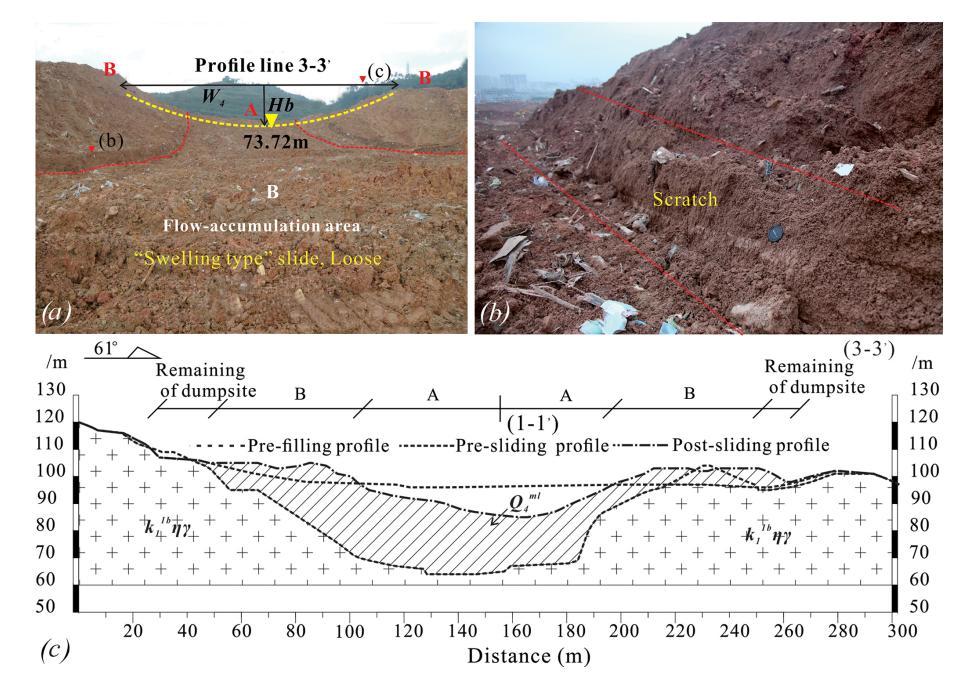
The presence of the aforementioned rock ridges formed unfavorable topography for the retaining slope stability, as it promoted a narrow gully for groundwater flow and concentration (Figs. 7c and 9). As a result of the retaining slope failure, a large opening was formed at the elevation of 73.7 m (between the front edge of the steep scarp and the rear edge of the flow-accumulation area) as shown in Figs. 9, 10, and 12a. The displaced material was stratified in the middle part of the flow-accumulation area during the high-speed sliding. The shape of the failed retaining slope was half-elliptic-like with a width ( $W_{4-1}$ ) of 217.7 m and a height ( $H_b$ ) of 27.5 m (Fig. 13a and c).

**Figure 13. (a)** The half-elliptic-like opening of the failed retaining slope; **(b)** details on the scratch caused by mass movement; **(c)** geological cross section (profile line 3-3') of the failed retaining slope located at the original quarry pit between the two rock ridges.

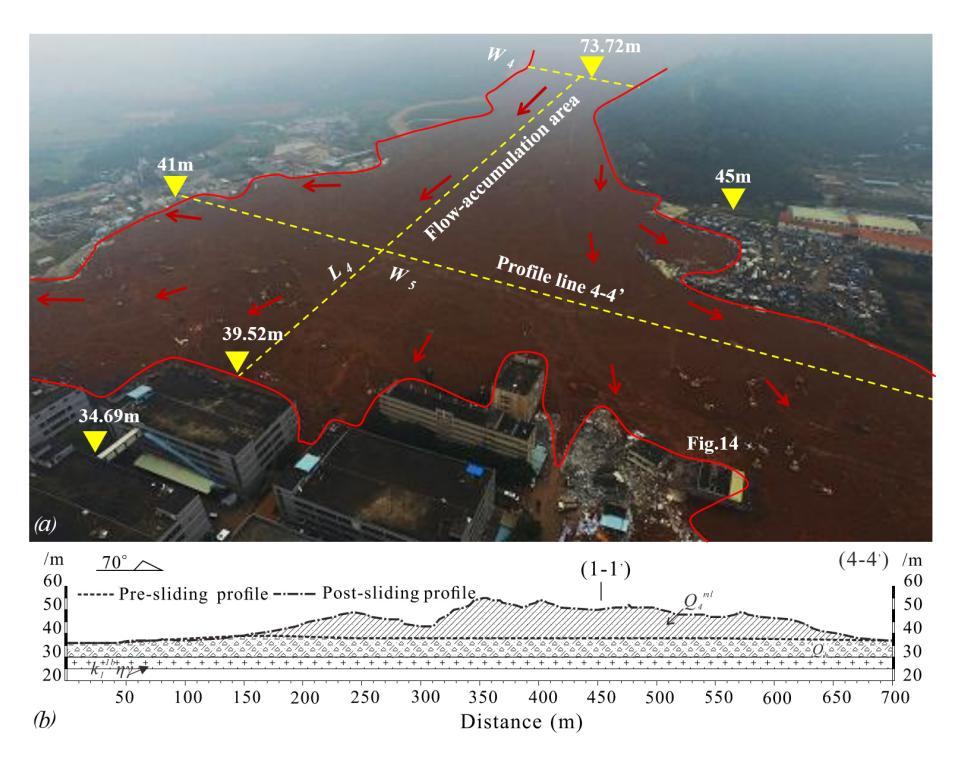
**Figure 14.** (a) Overview of the flow-accumulation area with elevations (China News Agency); (b) geological cross section (profile line 4-4') of the flow-accumulation area. The length  $(L_4)$  was 664.4 m, and the width  $(W_3)$  was 218.3 m, with the width of the front edge  $(W_5)$  being 592.3 m. The area was  $28.51 \times 10^4$  m<sup>2</sup>, and the elevation difference  $(H_4)$  was 35.7 m with an apparent dip  $(\Phi_6)$  of  $3.08^\circ$ . The average thickness was 8.21 m with the maximum thickness of 18.82 m (Fig. 12c, Table 1, and Table 3).

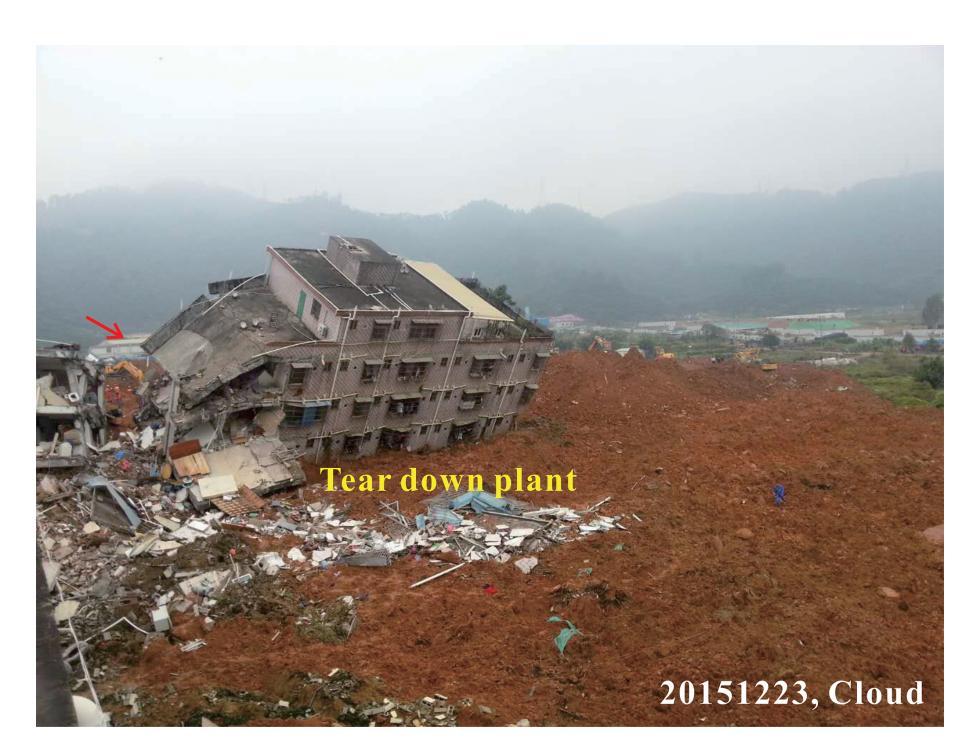
as shown in Fig. 1. Most of the industrial structures were located on the east, west, and north sides of the pond (Figs. 1 and 9), which created an ideal flow path for the flowslide without obstructions. The failure of the retaining slope resulted in an opening for the mass movement, which subsequently destroyed downstream buildings (Figs. 14 and 15).

Figure 15. The damage of buildings in the industrial park.

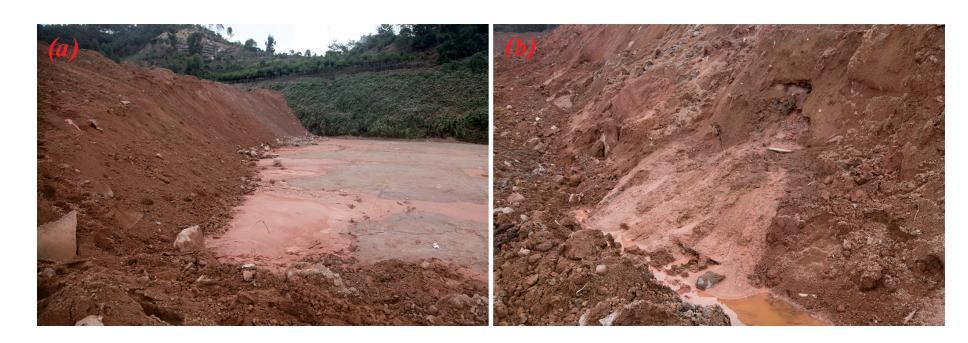
The high sliding velocity and long runout distance of the flowslide may be related to a more diffuse failure due to liquefaction near the base of the slope. Evidence of localized liquefaction can be found at several locations (Fig. 16). Empirical correlation was used to back-calculate the flowslide travel velocity with its geometrical characteristics. Laboratory tests and back analyses were performed to better understand the failure process.

Figure 16. Evidence of liquefaction near the opening of the failed slope.
