Nat. Hazards Earth Syst. Sci., 18, 921–934, 2018 https://doi.org/10.5194/nhess-18-921-2018 © Author(s) 2018. This work is distributed under the Creative Commons Attribution 4.0 License.

# Damage during the 6–24 February 2017 Ayvacık (Çanakkale) earthquake swarm

Ramazan Livaoğlu<sup>1</sup>, Mehmet Ömer Timurağaoğlu<sup>1</sup>, Cavit Serhatoğlu<sup>1</sup>, and Mahmud Sami Döven<sup>2</sup>

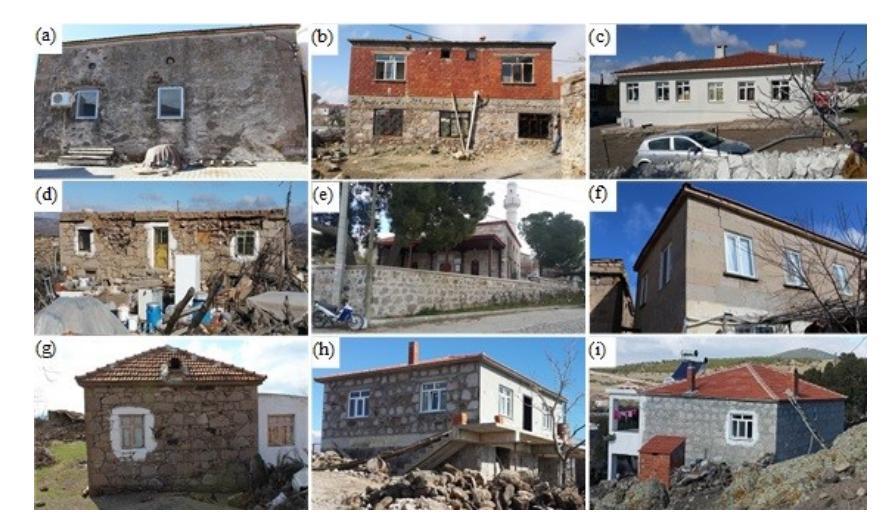
In the reconnaissance area, observations showed that construction materials and skills were extremely deficient. Modern materials and techniques were only used in a small portion of the observed region. Moreover, cement mortar between stones was not used in almost 50 % of the walls. There were a few buildings in which reinforced concrete elements were partly or fully used. Curing of concrete is still not practiced as an integral part of the concreting process. The concrete blocks are of poor quality because of the lack of compaction and very little or no curing. The existing building types in the area are shown in Fig. 4.

Figure 4. Existing building types in reconnaissance area: (a) *hattl* dwelling (b) stone and brick with cement mortar, (c) engineered RC building (d) *hattl* building with heavy roof, (e) historical masonry with cut stone, (f) cut stone without mortar, (g) stone without mortar, and (h, i) stone with cement mortar and reinforced concrete.

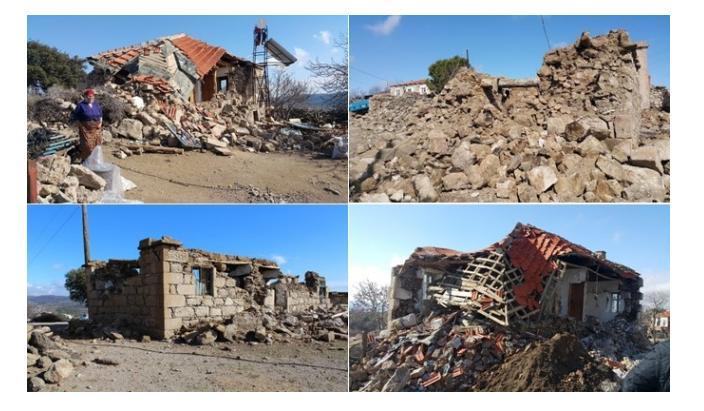
sonry structures (Fig. 16). This type of construction is among the most vulnerable type of building during an earthquake. Even under moderate lateral forces, such a masonry structure can be damaged or collapse due to lack of shear strength, improper interlocking mechanisms and/or poor stone–stone or stone–mortar bonding. In this case, shear failure is unavoidable in the planes forming diagonal cracks along the wall due to workmanship defects. Furthermore, when the wall is not designed with any engineering in mind, catastrophic and rapid collapse occurs in out-of-plane bending mode.

**Figure 16.** Examples of totally collapsed structures from Ayvacık (Çanakkale) 2017 earthquake swarm.

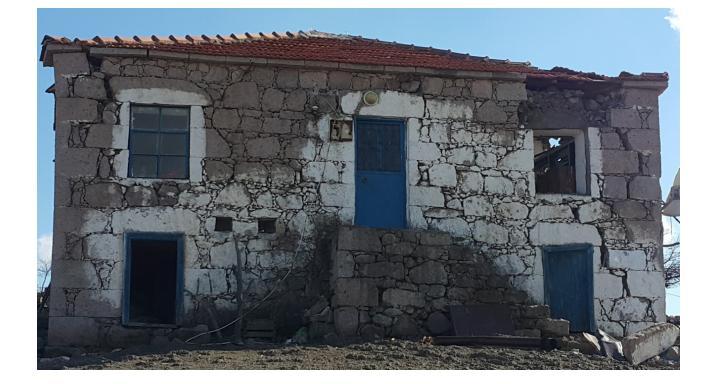
Figure 17. An example of a damaged dwelling due to inadequate interlocking.

tar or mud was not used as binding agent between stone or masonry units in almost all damaged houses. Figure 17 is a striking example of heavy damage during earthquakes due to lack of mortar among stones. After a few mild earthquakes this masonry dwelling became unstable.

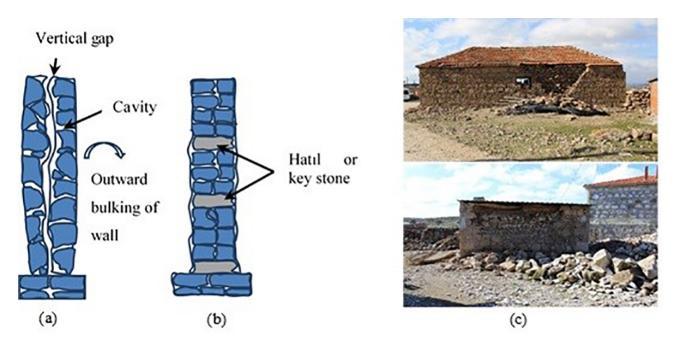
Another damage type observed in the region is outward bulking of walls, which is caused by interlocking deficiency. The reason of this deficiency is the vertical gap between stones creating wall thickness as shown in Fig. 18. In order to prevent this damage, horizontal elements such as *hattl* or key stone, which provide integrity to masonry walls, can be vertically used in specific intervals. The key stones or *hattl* can provide limited resistance to lateral seismic loads, and thus probably prevent the out-of-plan failure in some parts of masonry walls.

**Figure 18.** Schematics of (**a**) conventional wall section without through stone, (**b**) wall section with key stones (Sharma, 2016), (**c**) damage observed in the region.

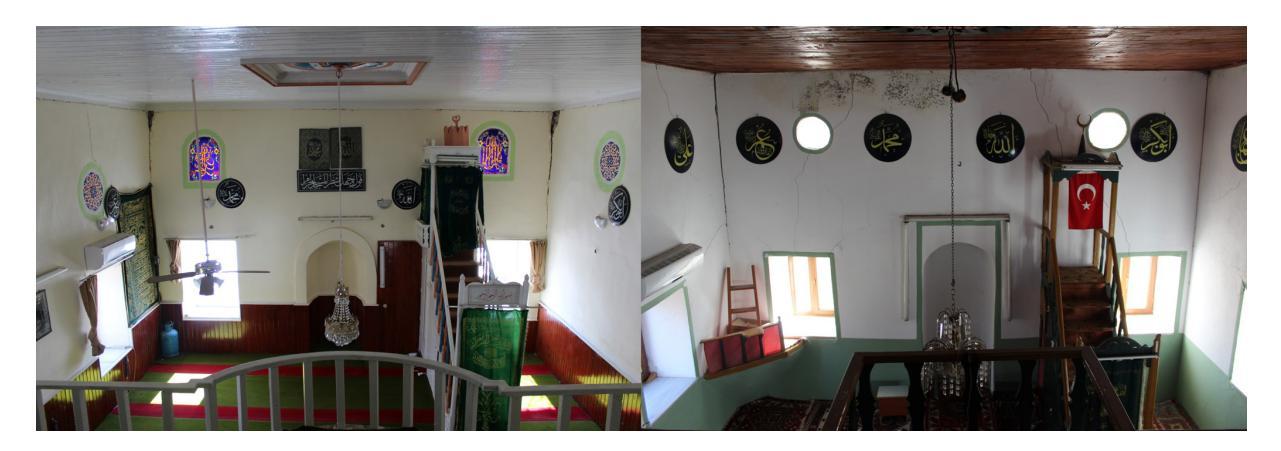
Another interlocking damage type is observed at the intersection of perpendicular walls (Fig. 19). One of the walls acts out of plane while the other remains very stiff in plane, inevitably resulting in cracks. This type of damage can either result in gaps developing between the in-plane and out-ofplane wall or vertical cracks may occur in the out-of-plane wall (Tolles et al., 1996). Further stages of this damage may result in out-of-plane failure of the gable end wall. To avoid

Figure 19. Observed damage at intersection of perpendicular walls.

intersection damage, the interlocking of the corners between perpendicular walls should be properly designed against lateral earthquake forces.

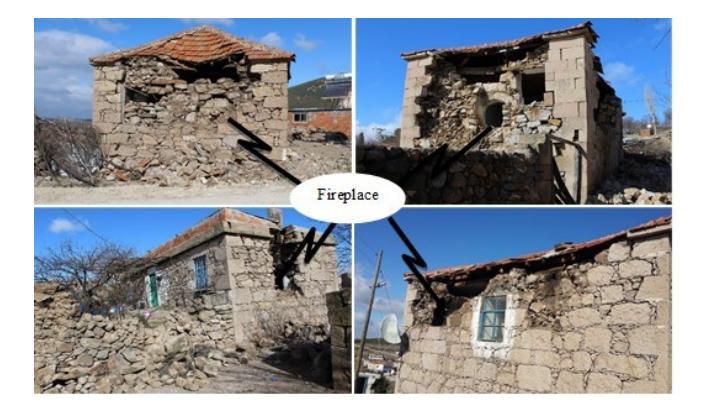
The design process of masonry buildings needs more regularity compared to other supporting systems, because resisting system must have continuity and regularity in order to take the stress of the shear from an earthquake. In rural areas, however, traditional fireplaces have been used in buildings, and they are built within the wall by decreasing the wall thickness or curving the wall outward. In such cases, irreversible damage is inflicted on the wall because of decreasing shear resistance (Fig. 20). This damage type was observed in different masonry, stone with plaster and stone without mortar can be seen in Fig. 20. The common damage type is most likely caused by the lack of craftsmanship or retention of traditional habits.

Figure 20. Examples of out-of-plane collapse due to wall cavity.

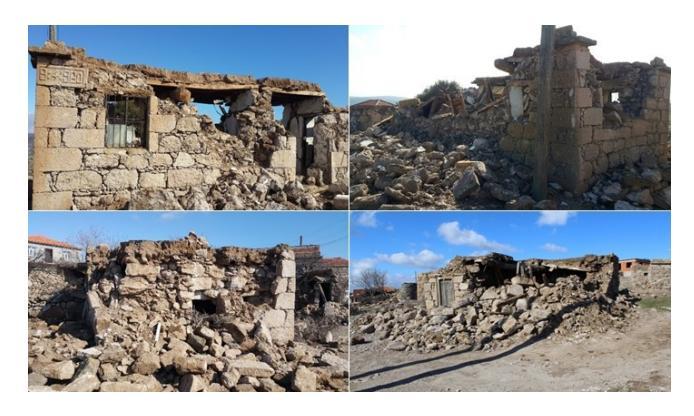
Another important cause of damage is the roofs made from a thick and heavy layer of mud spread over wooden logs (Fig. 21). This technique is widely used in certain parts of Anatolia where timber is increasingly scarce. These heavy earth roofs are generally hardened by spreading soil with a cylindrical stone. The roof must be thickened more and more over the years to make it more durable against water leakage. Consequently, heavier roofs exert larger shear forces during an earthquake. In the investigated area, the roofs were either supported by beams and indirectly by walls or beams of the inner structure, and the columns were round or sub-round in cross section and the trunks were without bark. This made it virtually impossible to make strong connections and bearing surfaces between the beams. Such beams were prone to rolling over during motions induced by earthquakes. Moreover, the round ends of the beams exerted loads (to an ex-

Figure 21. Examples of collapse due to heavy earth roof.

cessive degree) on the supporting walls beneath them, and resulted in the collapse of the earth roof or walls.

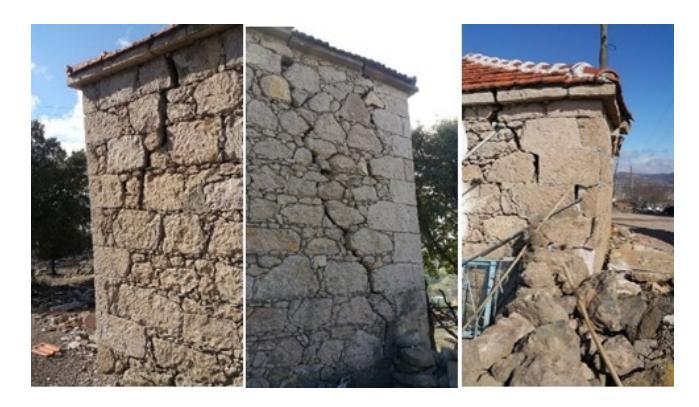
Many weak masonry walls without mortar had diagonal or inclined shear cracking as a result of cyclic shear forces exerted during the earthquakes (Fig. 23). But this diagonal shear cracking does not necessarily lead to total collapse. However, collapse may be inevitable if the triangular wall blocks on each side of a full diagonal crack become unstable by substantially losing their interlock or friction resistance along the cracks (Fig. 24). Similar failures have previously been reported around the world (Ural et al., 2012; Klingner, 2006).

Figure 23. Examples of diagonal shear cracking.

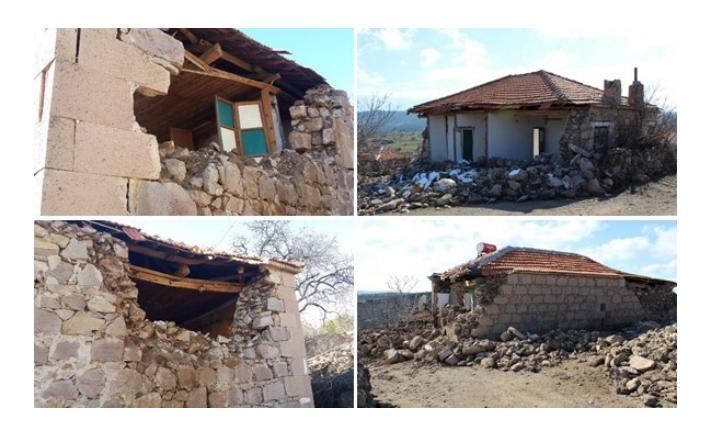
Figure 24. Out-of-plane failures due to improper wall thickness and/or height–length ratio.
