The 27 May 1937 catastrophic flow failure of gold tailings at Tlalpujahua, Michoacán, México

J. L. Macías¹, P. Corona-Chávez², J. M. Sánchez-Núñez³, M. Martínez-Medina^{4,5}, V. H. Garduño-Monroy², F. García-Tenorio¹, and G. Cisneros-Máximo¹

Received: 16 June 2014 – Accepted: 6 July 2014 – Published: 20 August 2014

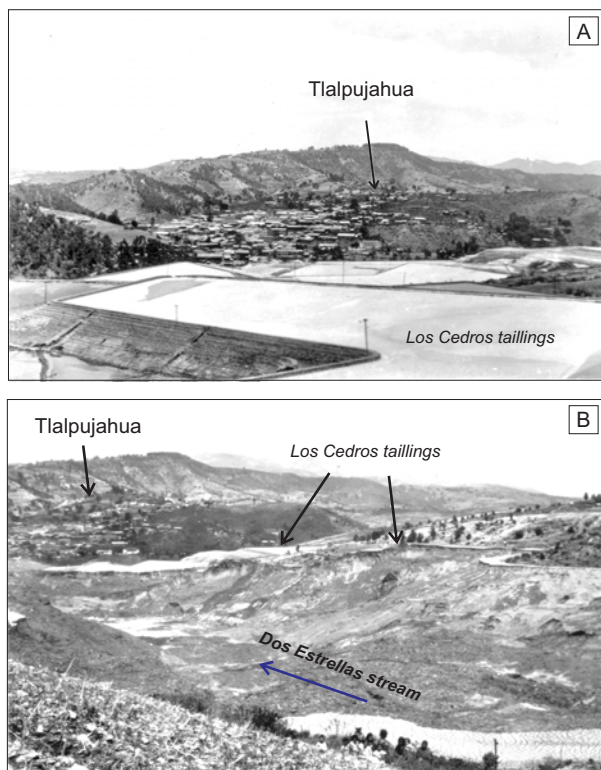
performed. The thickness of the tailings increased rapidly (ca. 35 m thick) to an approximated elevation up to 2875 m and acquired a platform-like form (Fig. 4). From 1908 to 1936, the dam had an approximated volume of 14.7 million t of mine waste (Uribe Salas, 2009; Corona Chávez et al., 2010; Table 1). In 1934, the mine had its largest production (820 603 t, ~ 2 thousand t day⁻¹). By 1935, the mining company was projecting the construction of a new dam, suggesting that Los Cedros dam was already at or near its capacity. However, this new project of the company never materialized.

Figure 4. Panoramic views in 1937 from the southeast that show **(A)** Los Cedros tailings dam with a platform-like form prior to the collapse; and **(B)** the tailings and the Dos Estrellas Stream scoured by the flood after the collapse. See people standing on the hill in the foreground.

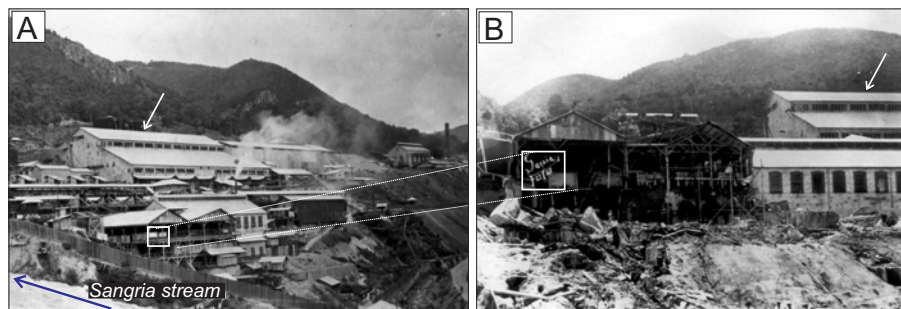
Los Cedros metallurgical plant (Fig. 5a and b) and then the Trigueros hill. Inhabitants felt the ground shaking caused by the flood impact.

Figure 5. Panoramic view of Los Cedros metallurgical plant of “Las Dos Estrellas” mining company at the Sangria stream, **(A)** before and **(B)** after the collapse. The white squares show the same location in both images, and an undisturbed roof of the Metallurgical plant (white arrows).

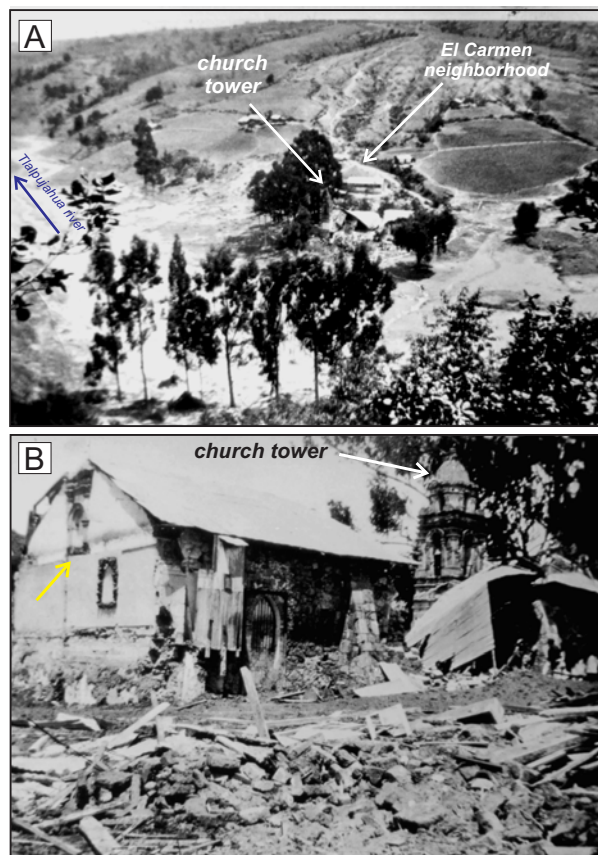
Figure 7. Different views of El Carmen Church after the 1937 flood and extent of the deposit along the Tlalpujahua river (a), and rubble and high-mud marks (yellow arrow) (b).

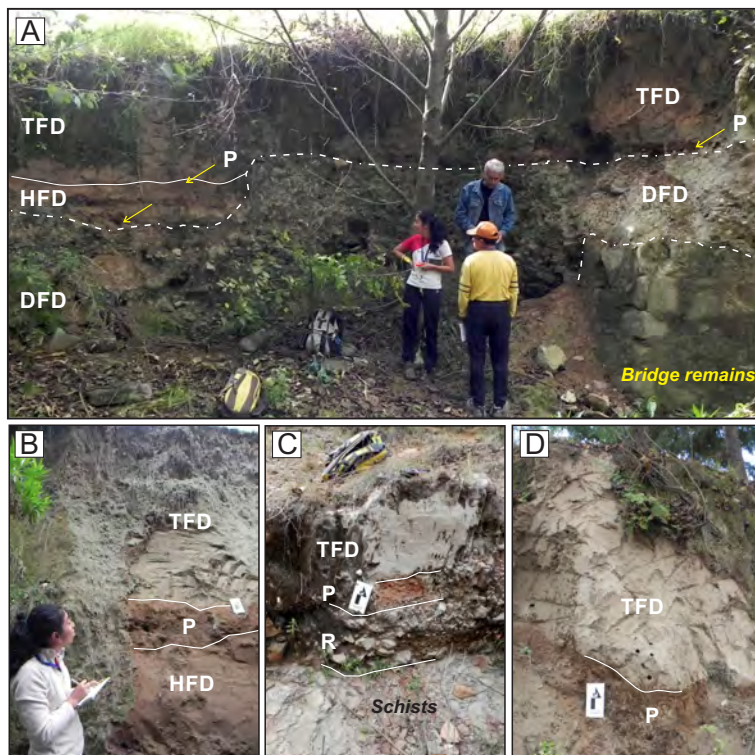
Figure 10. Aspects of the Tailings Flood Deposit (TFD) at three different sections. **(A)** At section TL-14, the TDF rests over a paleosol, a thin hyperconcentrated flood deposit (HFD), another paleosol, and a basal debris flood deposit (DFD) that contains pieces of bottle glass. The DFD forms a paleo-channel that stands against the remains of an old stone bridge. **(B)** View of the TFD at Sect. 17 overlying a paleosol and the lower brown hyperconcentrated flood deposit (HFD) rich in sand-size particles. **(C)** At section TL-18 the TFD overlies a poorly developed paleosol, a reworked bed with gravel-sized fragments and schists from the local basement. **(D)** At section TL-19 the deposits rests directly on top of a thicker paleosol.

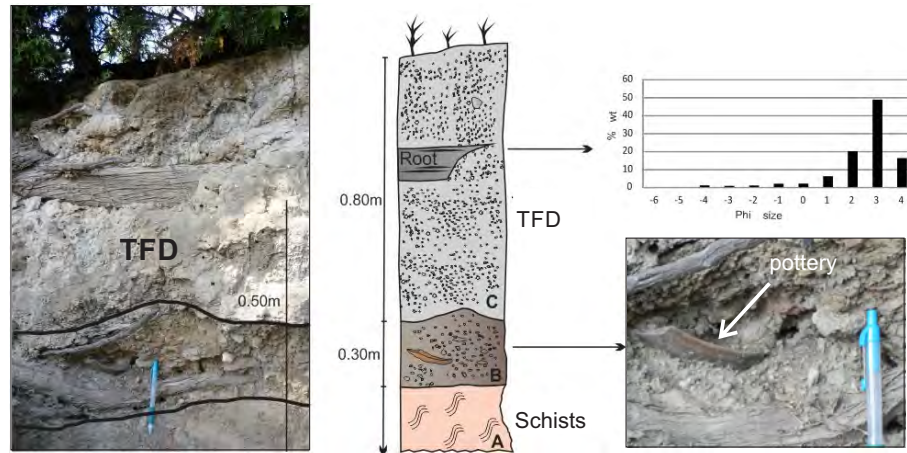
Figure 11. View of section TL13 looking to the west at the steps of San Jesus del Monte Hill. The section shows from the base schists, a debris flow deposit that turns into a pottery rich soil, and the whitish TFD atop grading into the modern soil cover with trees.

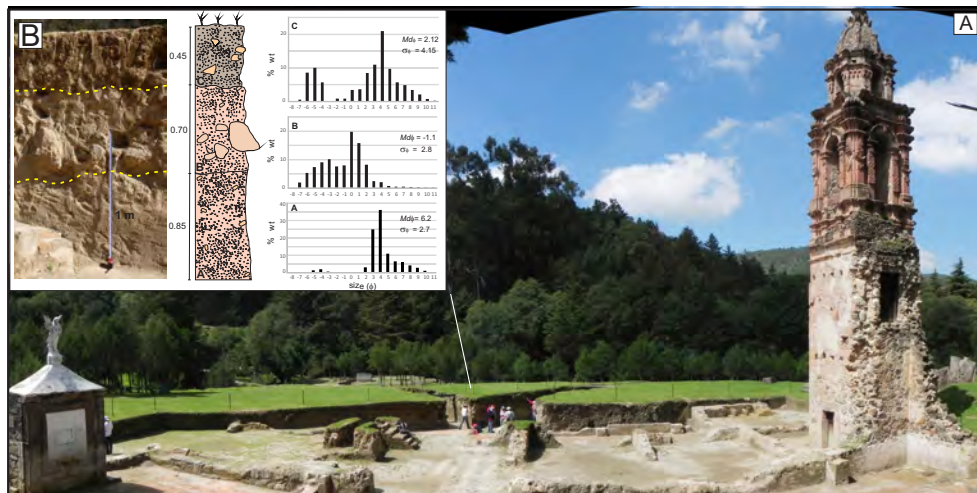
Figure 12. (A) Panoramic view from the east of the remains of El Carmen church buried by the Tailings Flood Deposit (section TL-01). The excavation of the church remains exposed the ancient floor of the sanctuary also observed in insets. (B) Stratigraphic column showing three beds separated by dashed yellow lines and their granulometric bimodal distributions.

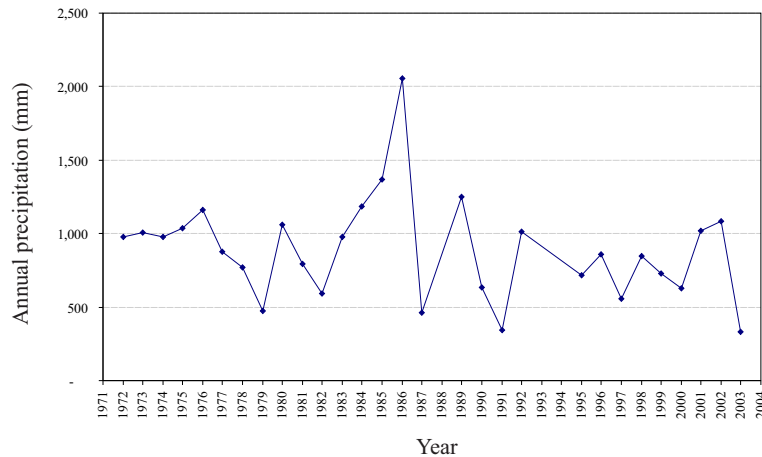
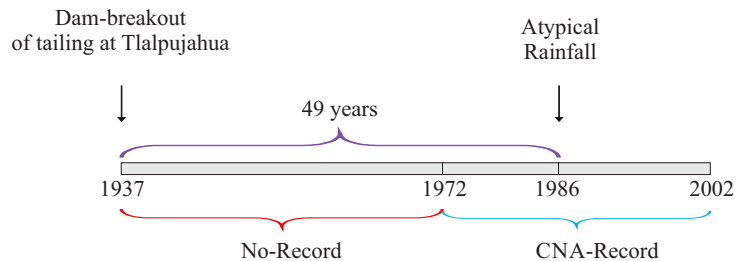
Unfortunately, no local weather stations existed around the MDOT before the failure. The first station (15183-Oro), which became operational in 1972, is relatively close to the Los Cedros metallurgical plant (Fig. 5). This station has a continuous rainfall record from 1972 to 2002, with some small gaps in 1988, 1993, and 1994. By using descriptive statistical methods. Martínez-Medina et al. (2012) concluded that the MDOT showed an average precipitation of 900 mm year⁻¹ (904 mm mode and a median of 34 mm). These results resemble the regional rainfall weather (see Fig. 2). However, it is worth noting that, during this period, at least two years had atypical rainfall (exceeding > 1200 mm). The first is evidently related to the 27 May 1937 catastrophic flow failure and, the second occurred during the 1986 year, when the rainfall exceeded 2000 mm (Fig. 13). Martínez-Medina et al. (2012) argued that return periods for 1800–2100 mm rainfalls occurred every 29 years. On the other hand, there is evidence that atypical rainfall periods have caused other catastrophic debris flows along the Talpujahu-Americas stream as it has been attested by at least two historical floods (older than 1937) observed in the stratigraphic record (site TL-14). One of them, had a coarser granulometry than the 1937 flood, and contained broken glass and blocks from an old bridge destroyed by this debris flow suggesting that previous events along the Talpujahu-Americas stream have had larger magnitudes. By considering the time recurrence of the most recent extreme rainfall event (in 1986) and the sedimentological record, we may expect that an atypical event may occur in the near future in Talpujahu and consequently the risk is still present.

Figure 13. Timeline showing the 1986 year with exceptionally high precipitation recorded in the region of MDOT. Data from the 15183-El Oro meteorological station. The Las Llamas flood occurred during sustained intense rainfall in May 1937 when no weather station existed. It is interesting to note two atypical precipitation events have return periods of 49 years (Corona Chavez et al., 2010).

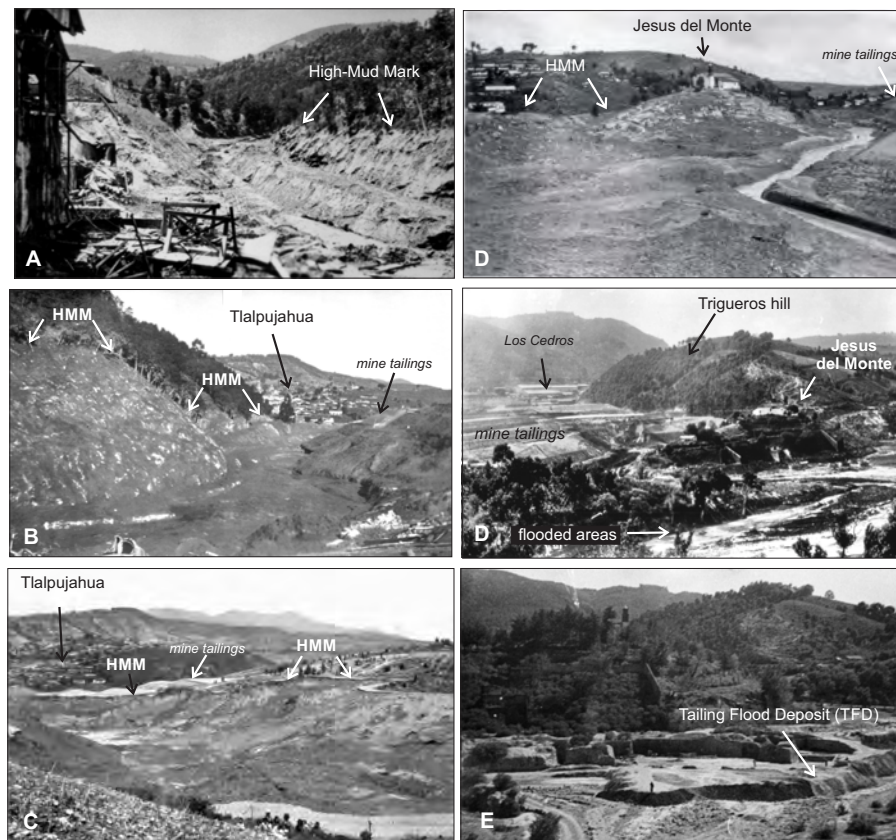
Figure 14. Views of damage caused by the Tailings flood in 1937 at different locations of this study: los Cedros metallurgical plant (A), Trigueros Hill (B), the Dos Estrellas stream between Trigueros and Jesus del Monte (C), and Jesus del Monte (D–F). HMM = High Mud Marks.
