## **Authors Response**

## **Referee 1 – Anonymous**

Abstract. An earthquake with a magnitude of  $M_w = 7.5$  that occurred in Sulawesi, Indonesia on September 28, 2018, triggered liquefaction and tsunamis that caused severe damage and many casualties. This paper reports the results of a post-

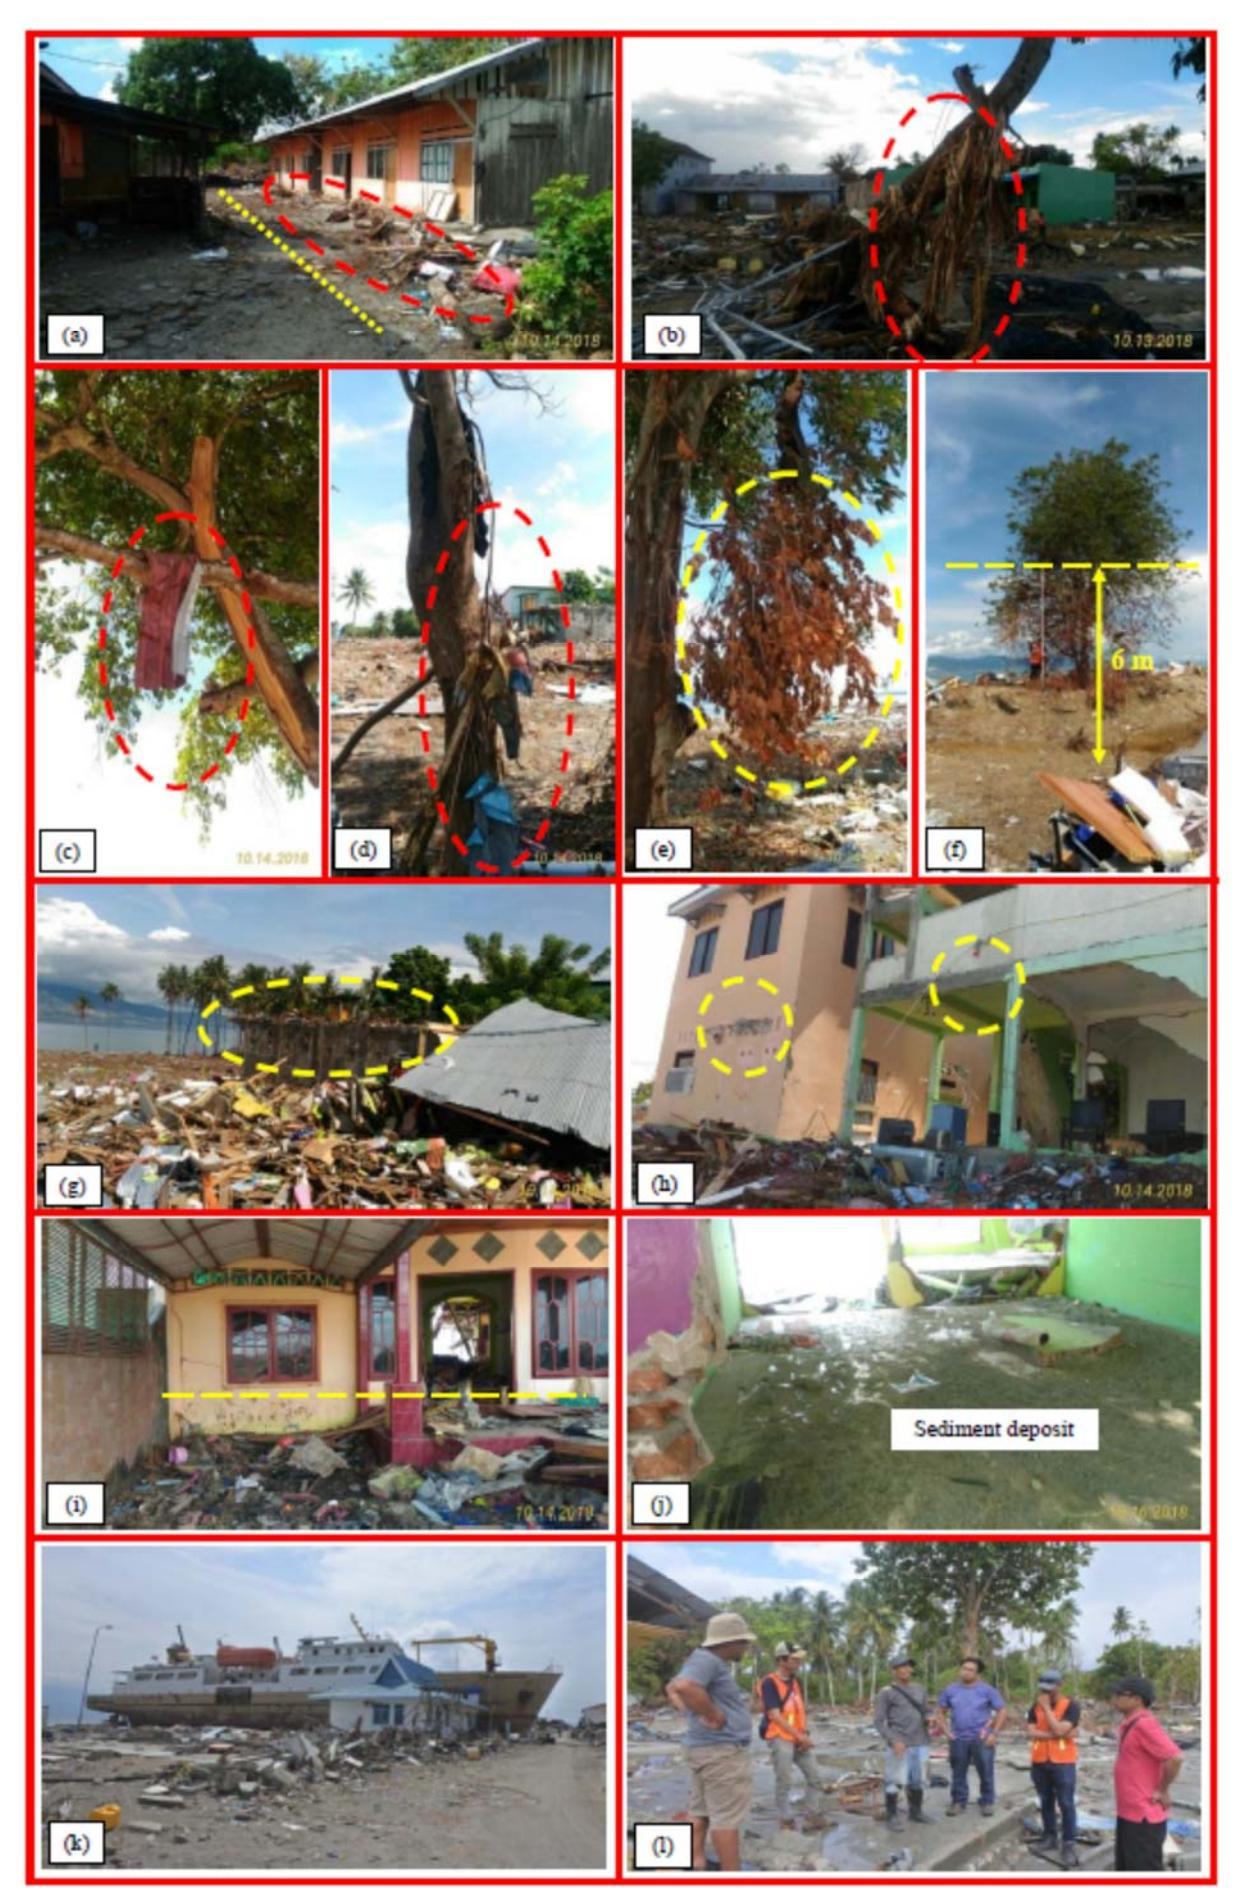
20 and does not erase the tsunami footprint. Our team collected hundreds of traces and water marks left by the tsunami. The tracks were in the form of: a) debris lines, b) debris left on trees, c) broken branches, d) sand trapped in buildings, e) damaged building elements, and f ) brown leaves (submerged in salt water during tsunami event). Figure 2 shows some evidence of runup and inundation traces.

**Figure 2:** Evidence of tsunami runup and inundation. (a) Debris left behind in the residential area of Tondo, (b) debris caught in a tree in Mamboro, (c) and (d) debris stuck in a tree in Tondo, (e) leaves turned brown due to being submerged in salt water, (f) a tree had green leaves at the top and brown at the lower part, indicating the tsunami inundation height (flow depth) limit in Layana, (g) debris lodged on top of a building, (h) broken house element showing tsunami water level, (i) watermark on a house wall in Lero Village, (j)

5 (h) broken house element showing tsunami water level, (i) watermark on a house wall in Lero Village, (j) sand deposit on building floor in Donggala City, (k) a 45-m-long ship moved to land in Wani Harbour, (l) interview with a survivor in Mamboro.

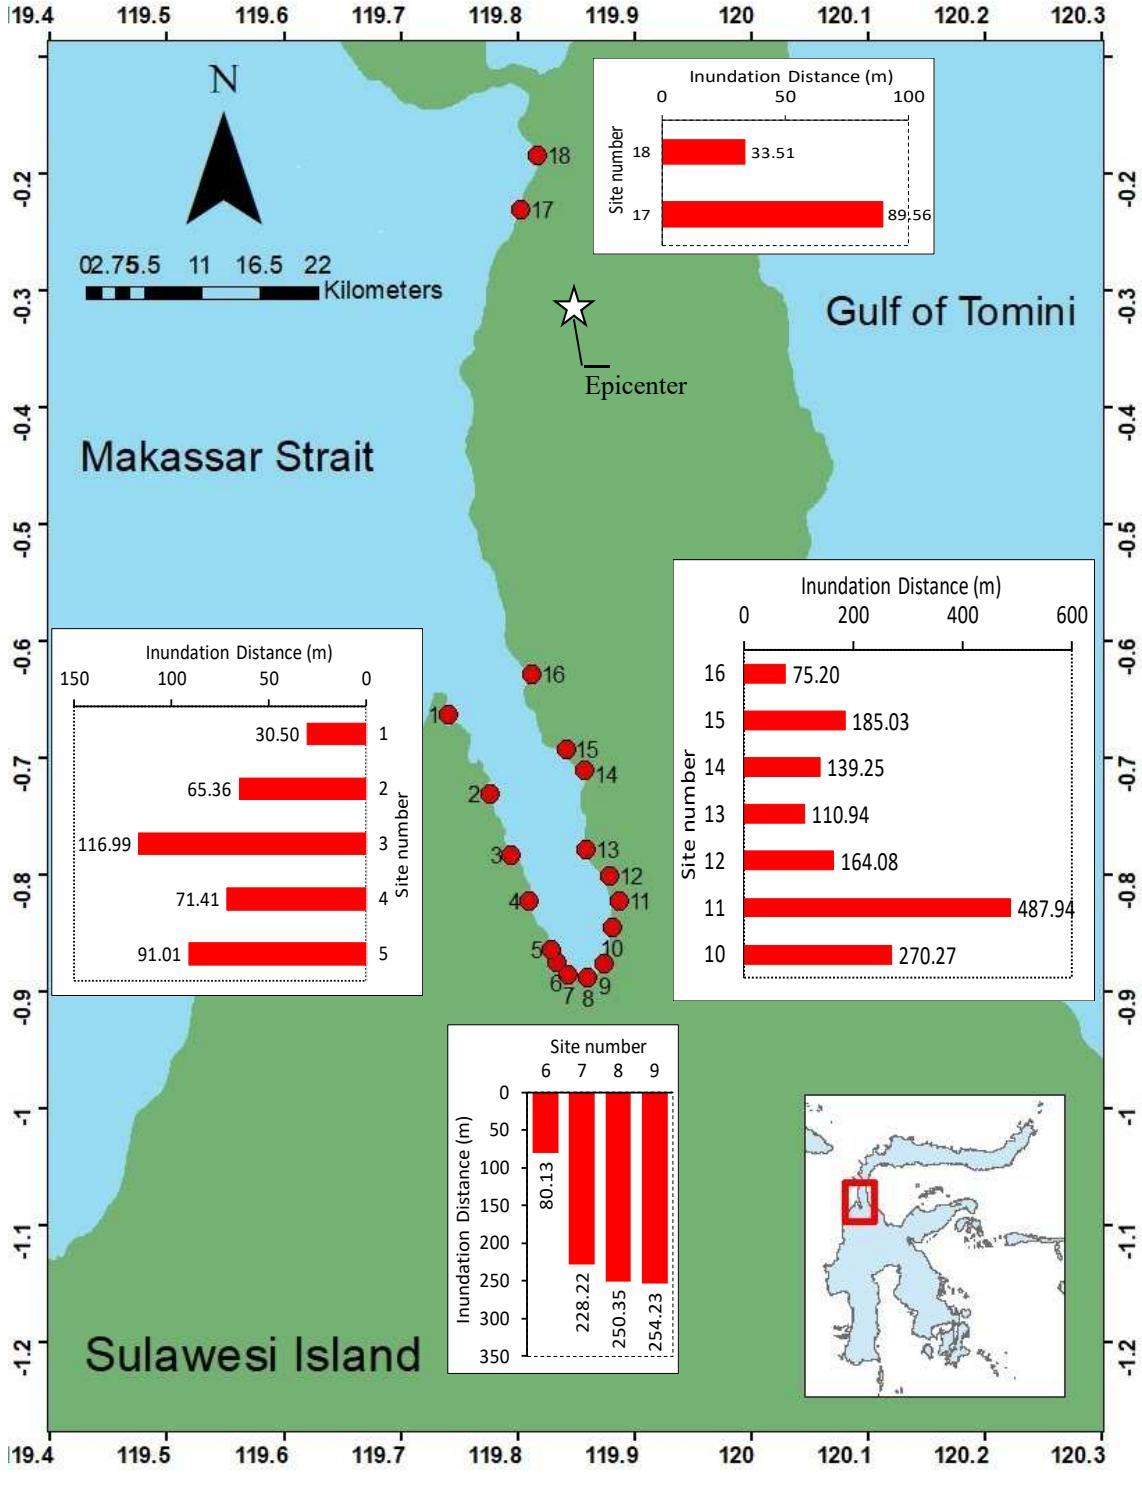
- 10 From Table 1 and Fig. 3, the farthest inundation distance from coastline to tsunami border on land is at the Layana site. This site is a trade complex that supports the economic activities of Palu City in particular and Central Sulawesi Province in general. The buildings damaged at this site functioned as shops, warehouses, and corporate offices. The items scattered in the tsunami were predominantly manufactured goods of economic value. This site is thus monitored closely by security forces to prevent looting. The topography of this site is relatively flat with a slope of 0.013 (1.3%). Because of this sloping

- 15 topography, the tsunami wave reached as far as 511 m inland. The farthest point reached in this area varies greatly because many buildings have long and wide walls that stemmed the tsunami flow further inland. The highest point of the tsunami creeping was found at the Tondo site (Fig. 5). This area has many private boarding houses for students of the University of Tadulako, a state university in the city of Palu. The topography of this area is relatively

10 Figure 3: Measurement results of inundation distances.

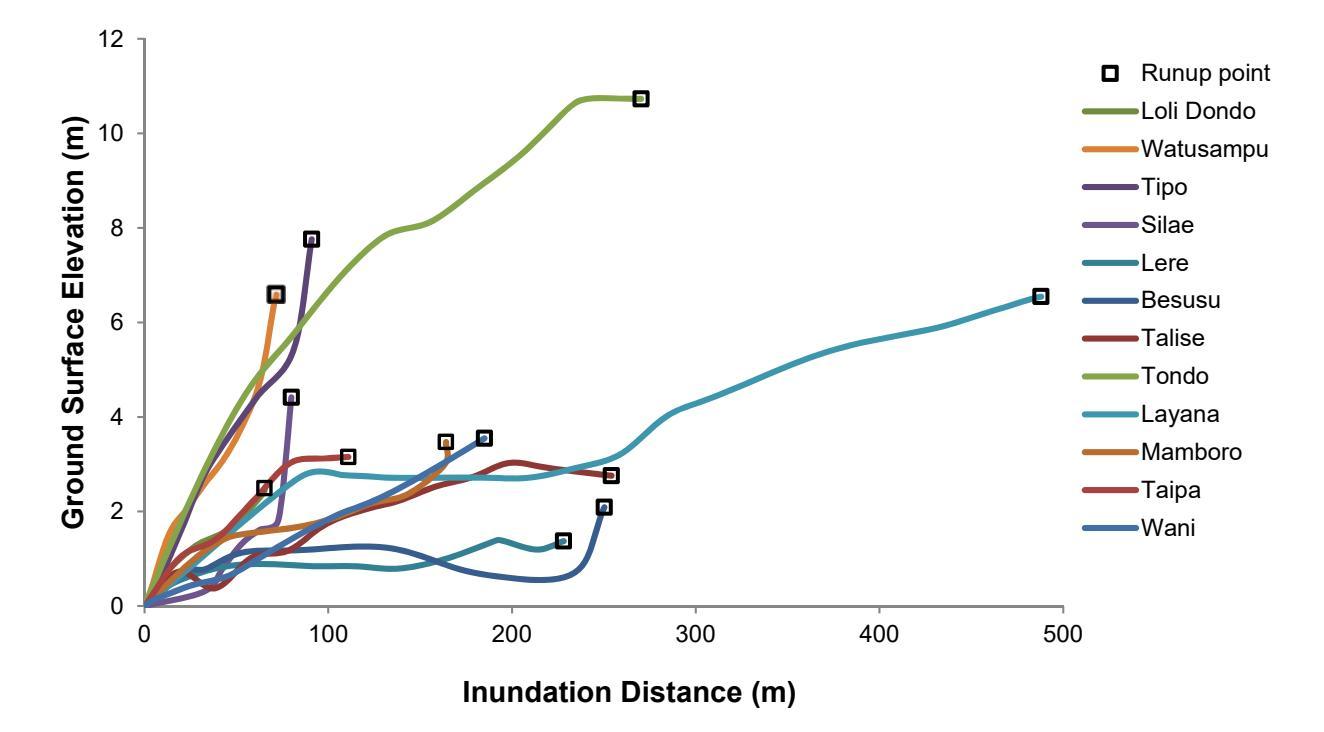
..... The measured runup heights were 10.73, 7.97, 10.14, and 8.50 m, respectively, as shown in Table 1. The runup height of 10.73 m is the highest in this survey (Fig. 5) caused a few building surviving. .....

**Figure 5:** Transects of beach where tsunami wave arrived. The longest inundation distance is at the Layana site and the highest runup is at the Tondo site.

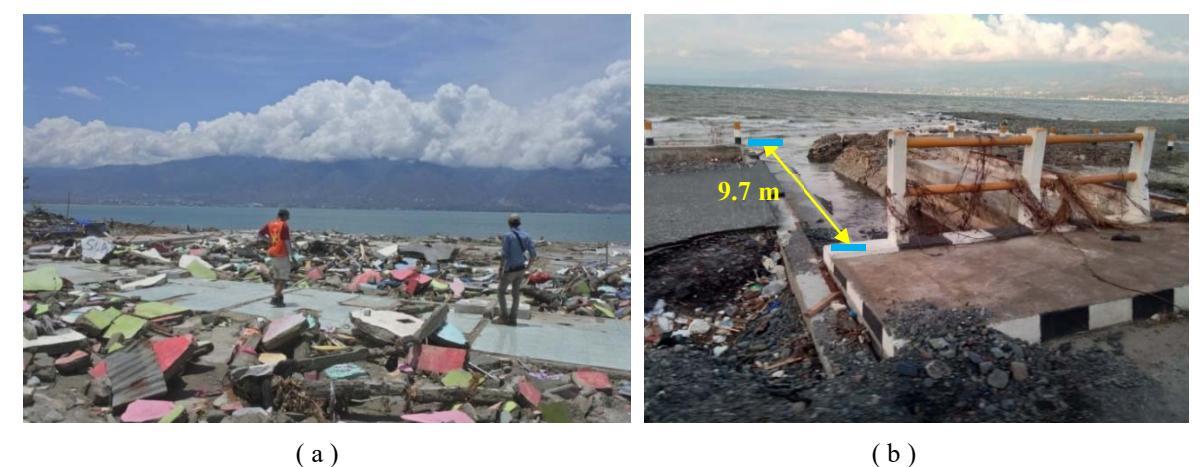
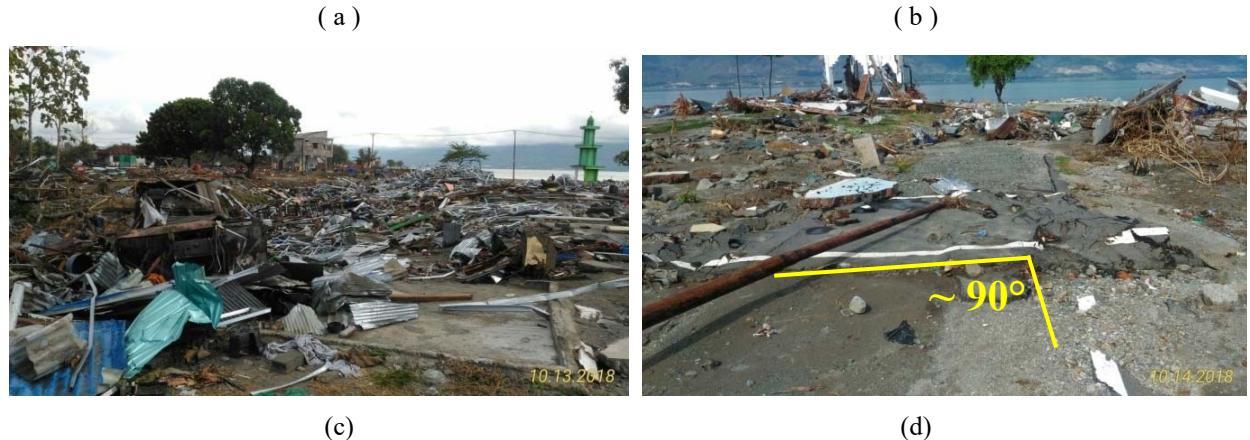
..... The runup height of 10.73 m is the highest in this survey (Fig. 5) caused a few building surviving.

**Figure 6:** (a) Damage caused by the tsunami in Tondo, a residential complex where a lot of private boarding houses were inhabited by students at the University of Tadulako, (b) a reinforced concrete bridge on Cumicumi Road Palu City shifted by 9.7 m by the tsunami,(c) Mamboro Village with 90% of houses destroyed, and (d) asphalt layer of small road turned 90° in Tondo.

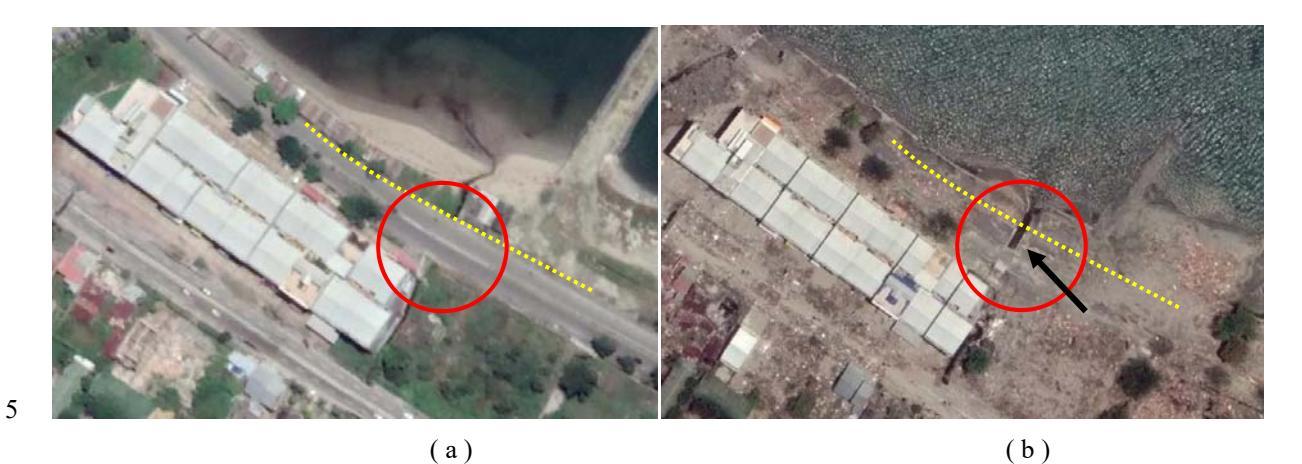
- 30 respectively. As shown, the asphalt layer of the road was broken and the bridge over the sewer channel was shifted away from the coast by the tsunami. The position of this bridge is at the end of Palu Bay (-0.88123°S 119.83907°E). This phenomenon can be further analyzed to determine the tsunami force.

Figure 7: Satellite images taken on (a) September 26, 2017 and (b) October 2, 2018, showing the bridge shift.

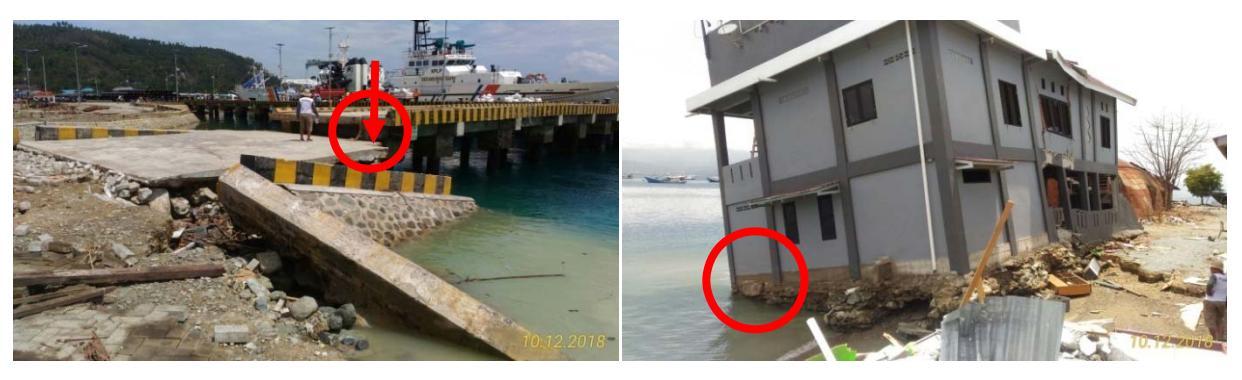
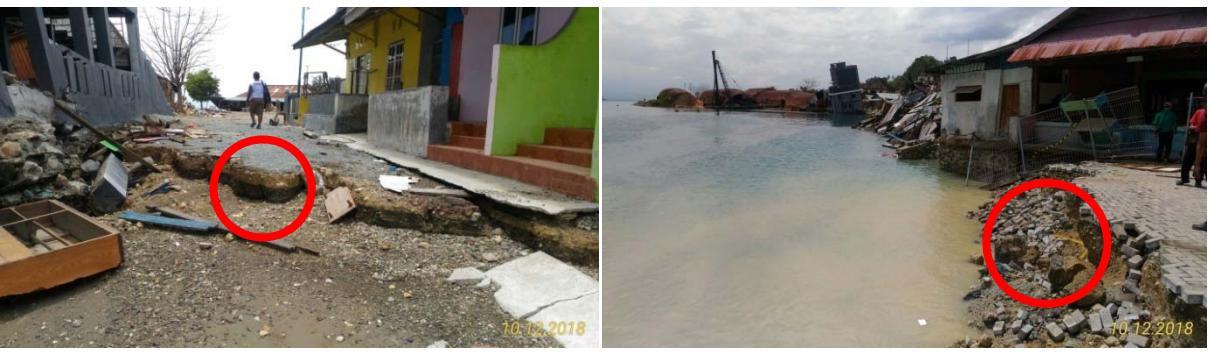
10 **Figure 10:** Landslide in Donggala City. (a) A trestle dropped 0.8 m in Donggala Port, (b) a building on the seaside slip down significantly, (c) the surface of an alley in a settlement dropped 0.4 m, and (d) a layered courtyard with paving blocks dropped around 1.5 m.

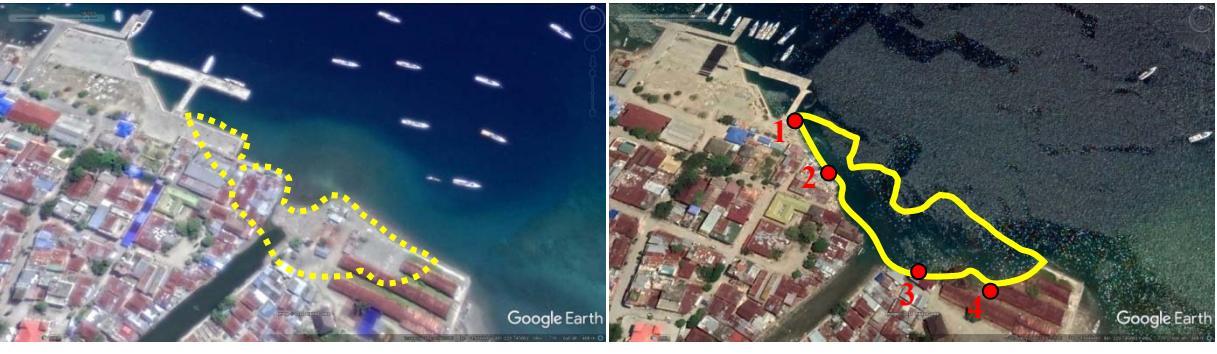
..... The coastal landslides detected by our team in Donggala City (lost surface area of 10,068 m2) and Lero Village (lost suface area of 22,971 m2) are additional evidence of the coastal landslides found by other teams. .....

Figure 11: Possible landslide areas in Donggala (yellow dotted lines). Images were obtained from Google
Earth. Satellite images taken on (a) 6 July, 2016 (more than a year before the earthquake) and (b) 2 October, 2018 (4 days after the earthquake and tsunami). The yellow bounded area is around 10,068 m<sup>2</sup> or 1 hectare. Number 1, 2, 3 and 4 in Fig. 12 b corresponds to Fig. 11 (a), (b), (c), and (d).

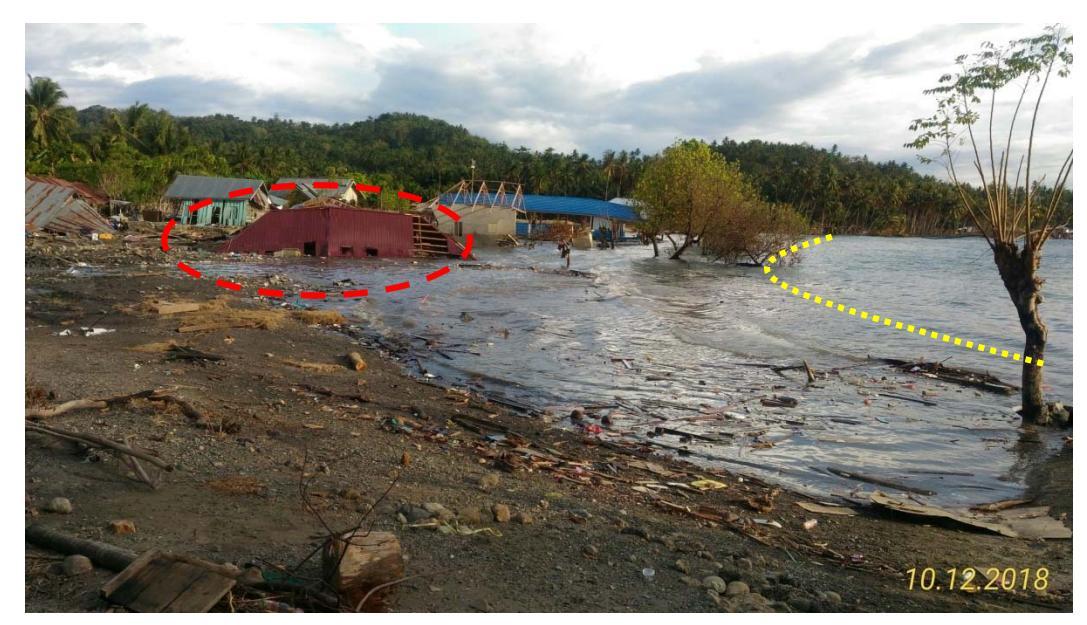
**Figure 12:** Quick landsubsidence in Lero Village. Photograph taken two weeks after the event. Some houses dropped suddenly, around 3-4 m, when the earthquake occurred. Residents of these houses, especially that indicated by the oval, could not save themselves. The yellow dotted line is the former coastline.

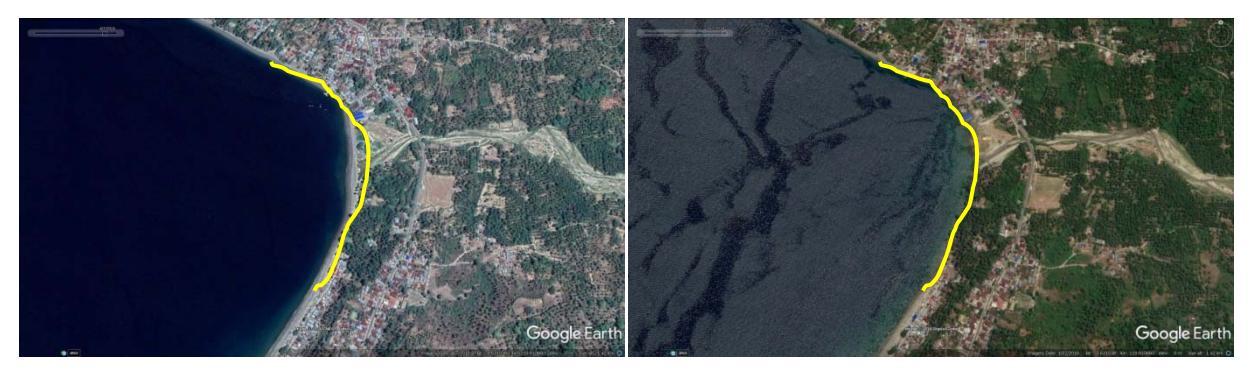
**Figure 13:** Quick land subsidence in Lero Village. Satellite images taken on (a) 7 April, 2016, and (b) 2 October, 2018, from Google Earth, showing conditions after the earthquake and tsunami. The area of land that dropped is 22,971 m<sup>2</sup> or almost 2.3 hectares.
