The 24 July 2008 outburst flood at the western Zyndan glacier lake and recent regional changes in glacier lakes of the Teskey Ala-Too range, Tien Shan, Kyrgyzstan

Abstract. On 24 July 2008, a glacier lake outburst flood (GLOF) occurred at the western (w-) Zyndan glacier lake in the Tong District of Ysyk-Köl Oblast, Kyrgyzstan. The flood killed three people and numerous livestock, destroyed infrastructure, and devastated potato and barley crops as well as pastures. Tuurasuu village and a downstream reservoir on the Zyndan river escaped heavy damage because the main flood was diverted toward the Tong river. RTK-GPS and satellite data (Landsat 7 ETM+, ALOS/PRISM, and ALOS/AVNIR-2) reveal that the flood reduced the lake area from 0.0422 km² to 0.0083 km², discharging 437 000 m³ of water. This glacier lake was not present in a Landsat 7 ETM+ image taken on 26 April 2008. It formed rapidly over just two and half months from early May to the late July, when large amounts of snow and glacier melt water became trapped in a basin in the glacier terminus area, blocked by temporary closure of the drainage channel through the terminal moraine that included much dead-ice. In the same mountain r

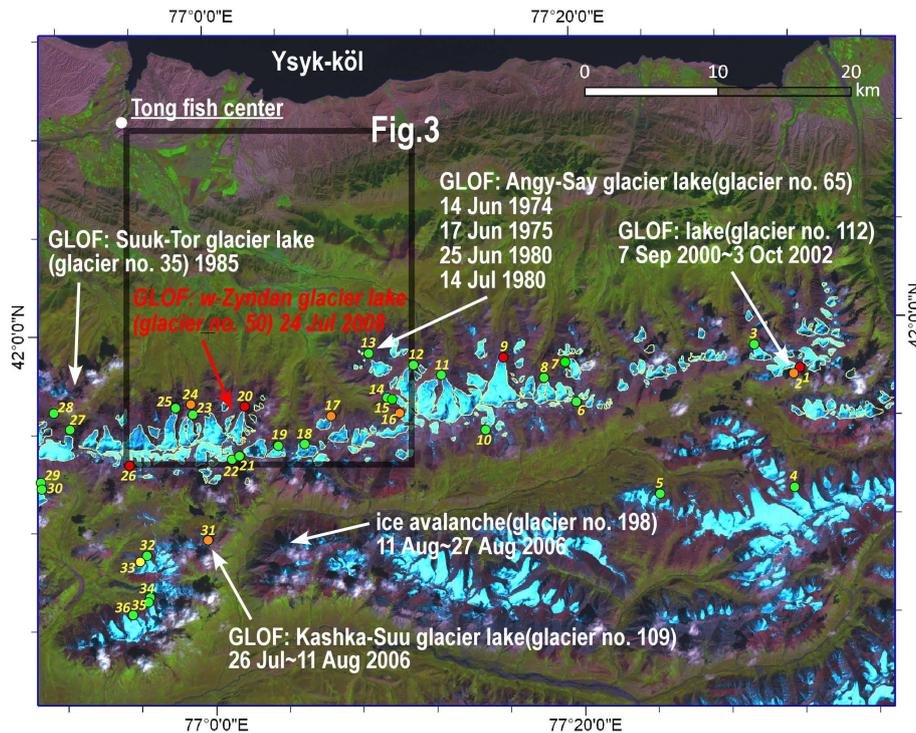
Fig. 2. The locations of glacier-lake outburst floods (GLOFs) since the 1970s in the Teskey Ala-Too range. Colored circles and numbers show the locations of the glacier lakes investigated during 1999–2008 in Fig. 4 (red circles: growing lakes ($>0.001 \text{ km}^2/\text{year}$), orange circles: naturally drained lakes, green circles: no change). The glacier numbers were derived from the glacier inventory (Zabirov, and Sidikov, 1976; Fateev and Cheban, 1969).

In the study area, six glacier lakes (Nos. 2, 16, 17, 24, 31, and 33) produced small outburst floods during 1999–2008 (Fig. 2). Satellite data show remarkable changes in the lake areas and expansion of river channels with fresh flood deposits. Glacier lakes 16 and 33 increased rapidly following their GLOF events. According to local witnesses, no fatalities resulted from the GLOF of lake 31 between 26 July and 11 August 2006 in the Kashka-Suu river and damage was limited to flood deposits covering roads along the Jyluu-Suu river.

This mountain region has 36 glacier lakes. These lakes are small in scale, and most showed no change or only slight expansion from 1999–2008. A factor in the slow growth of these lakes is the glacier shrinkage rate, which has been small in this region compared with that in the Pskem and Ili-Kungöy regions of the outer Tien Shan mountains (Narama et al., 2010a). Using satellite data and our field data, we found that seven glacier lakes, including the w-Zyndan glacier lake, had produced small floods since 1999. Among these seven floods, only the flood from the w-Zyndan glacier lake produced human casualties. Some of these lakes are located in the sparsely populated southern part of the Teskey Ala-Too range (Fig. 2). In that area, flood sediments from the

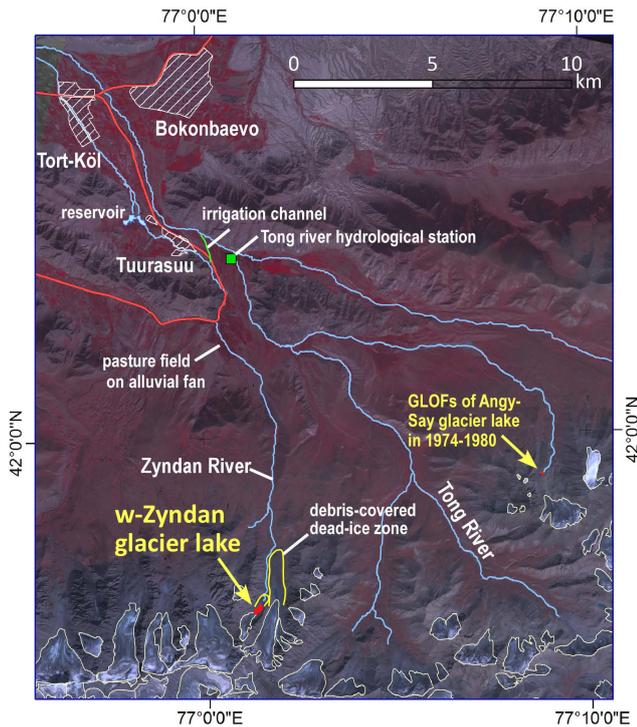
Fig. 3. Study area in the Zyndan river basin.

The w-Zyndan glacier, which is in contact with the w-Zyndan glacier lake, is about 1.2 km long and occupies 0.36 km^2 (Fig. 3). The eastern (e-) Zyndan glacier (Fig. 2: No. 36), located in the same valley as the w-Zyndan glacier, is about 2.6 km long and occupies 1.50 km^2 . The e-Zyndan glacier is in contact with the e-Zyndan glacier lake. A zone of rocks and debris, presumably of morainic origin, and dead ice extends some 700 m downward from the w-Zyndan glacier front (Fig. 3). These glacier lakes have no surface outlet, and meltwater drains through the proglacial body of rock, debris, and ice. The lakes are located in the Tong District of Ysyk-Köl Oblast. The city of Bokonbaevo, the center of the Tong district, with a population of 10 870 people, and the villages of Tort-Köl (population 2932) and Tuurasuu (population 723) are located downstream of the w-Zyndan glacier lake (Kudabaev et al., 2001; Fig. 3). The Zyndan river flows through Tuurasuu village and then into a reservoir built in 1990 to support irrigation and provide water for Tort-Köl. An artificial channel from the Zyndan river to the Tong river provides irrigation water for potato and barely fields from May to July.

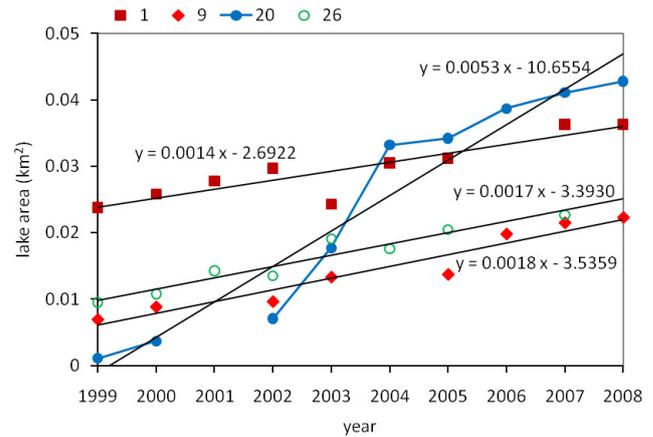
Fig. 4. Area changes of four growing glacier lakes in the Teskey Ala-Too range between 1999 and 2008. The locations of the lakes are shown in Fig. 2.

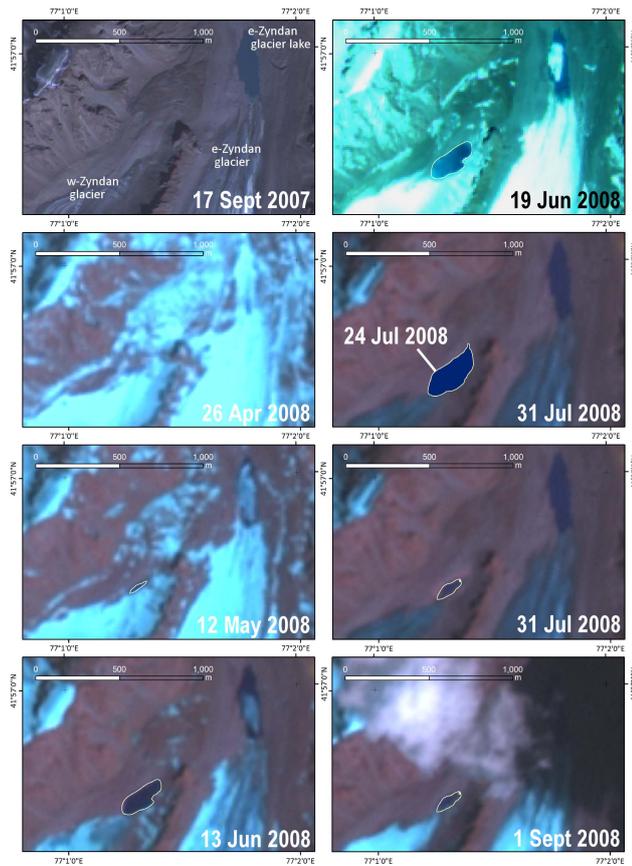
Fig. 5. Evolution of the w-Zyndan glacier lake between 17 September 2007 and 1 September 2008 as shown by satellite images (Landsat 7 ETM+, ALOS/PRISM-AVNIR-2, ALOS/AVNIR-2).

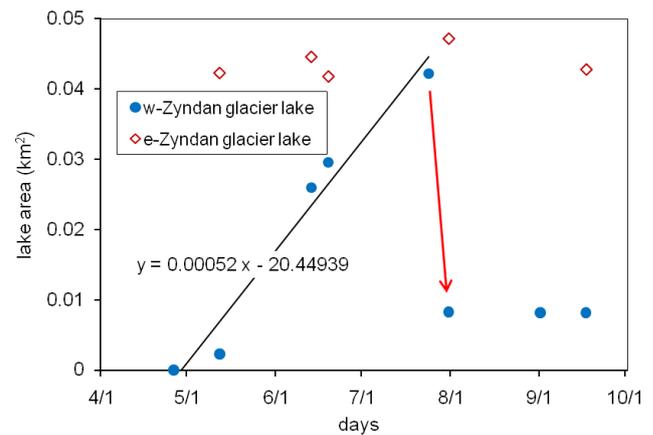
Fig. 6. Area changes of the w-Zyndan and e-Zyndan glacier lakes from April to October 2008.

an additional $200\,000 \text{ m}^3$ were added. This sudden expansion of the w-Zyndan glacier lake was more rapid than normally observed for hazardous glacier lakes and is in sharp contrast to the slower growing e-Zyndan glacier lake (Figs. 5 and 6). The daily expansion rate of $0.0005 \text{ km}^2/\text{day}$ over 10 days for the w-Zyndan glacier lake is on the same order of magnitude as the annual expansion rate of the e-Zyndan glacier lake ($0.0053 \text{ km}^2/\text{year}$) and the largest glacier lake ($0.0059 \text{ km}^2/\text{year}$) in the Kara-Say river of the Kungöy Ala-Too range, as documented by Narama et al. (2009). The w-Zyndan lake level was rising $\sim 30 \text{ cm}$ per day before the outburst. The runoff contribution of the catchment above the lake, which was stored in the latter, was more than $0.086 \text{ m}^3/\text{s}$ between 12 May and 13 June 2008, and was $0.056 \text{ m}^3/\text{s}$ between 13 June and 24 July 2008.

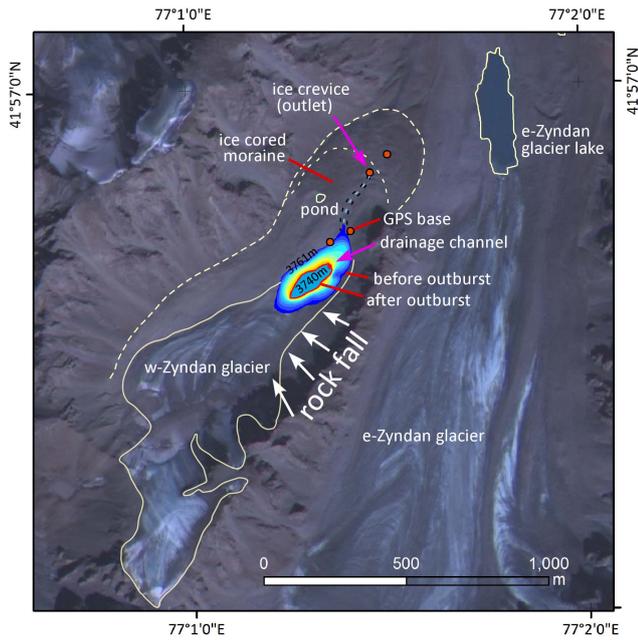
Fig. 7. Area changes in the w-Zyndan glacier lake before and after the 24 July 2008 outburst. Black numbers indicate the elevations of the lake level.

The water level of the w-Zyndan glacier lake was at 3761 m a.s.l. before the catastrophic drainage (Fig. 7). During the outburst, the water level dropped by 21 m . The lake area was 0.0422 km^2 (380 m long; 155 m wide) before the outburst, and reduced to 0.0083 km^2 (180 m long; 65 m wide) after the event (Fig. 6). The change in water volume between immediately before and after the event was $437\,000 \text{ m}^3$. The discharged water volume from the w-Zyndan glacier lake was around nine times the $50\,000 \text{ m}^3$ of water involved in the GLOF that devastated the village of Shahimardan in the Alay range in 1998, killing more than 100 inhabitants (UNEP, 2007).

The w-Zyndan glacier lake is in contact with the glacier ice on its right bank (Fig. 7). The ice shoreline that undercuts the glacier ice (60 cm high and 50 cm deep) indicates the maximum lake level before the outburst (Fig. 8a). Traces of a water channel across the terminal moraine are evidence that lake water overflowed here briefly before occupying the main

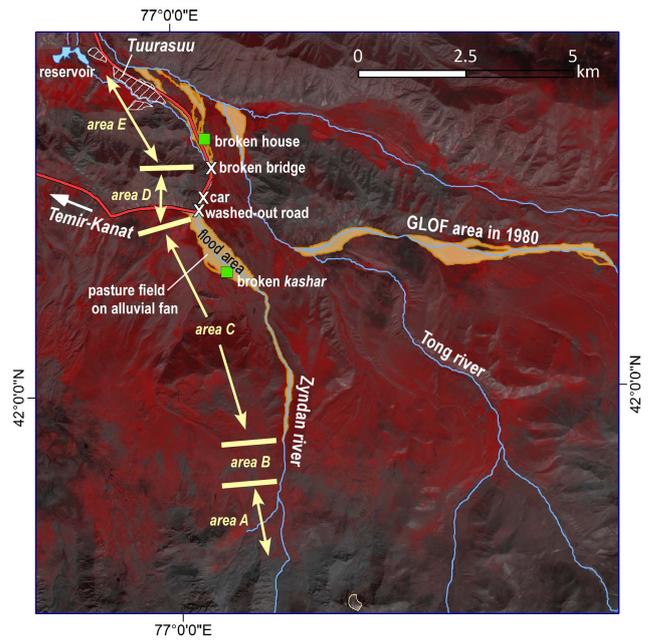
Fig. 9. Downstream flooded areas by the GLOFs in 1980 (Angy-Say) and 2008 (w-Zyndan), and location of selected damages of the 2008 flood.

E; they were finally rescued at around 02:30, 25 July, when the water level in the river dropped again. Video recordings taken from around 18:00–19:00 by local people also showed that dirty flood water (sediment flow) overflowed the river channel along the road in area-D and stranded one person on a debris bank between flooded streams in area-E (Figs. 9 and 10c, d).

We interviewed a family who lives on pastureland on the alluvial fan extending from the foot of the mountain chain (Fig. 9). Figure 10b shows their shed (*kashar*), part of which

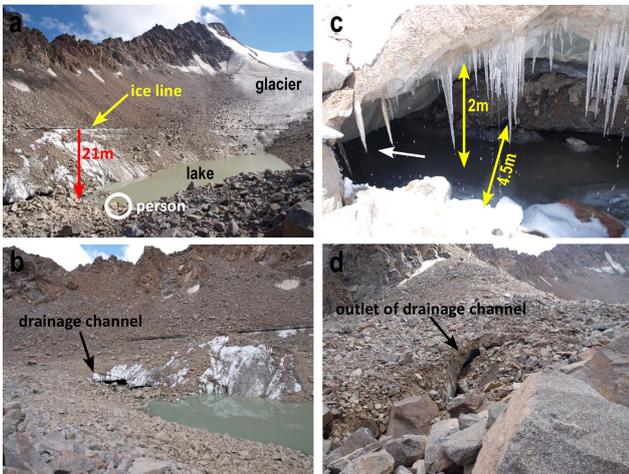
Fig. 8. Photos around the w-Zyndan glacier lake. (a) The w-Zyndan glacier lake after the lake outburst of 24 July 2008 (29 July 2008 by C. Narama). (b) The Ice shore line and drainage channel of the w-Zyndan glacier lake (29 July 2008 by C. Narama). (c) The drainage channel through the dead ice under the terminal moraine (18 July 2009 by C. Narama). (d) Ice crevice in the terminal moraine providing the downstream outlet (29 July 2008 by C. Narama).

drainage channel through the dead ice. The terminal moraine is 20–25 m above the lake water level, and although small in scale, it contains thick dead ice that contributed to dam the lake. An ice cave in the lower part of this moraine shows that lake water discharged through an ice drainage channel

(Fig. 8b, c). A narrow ice crevice from which the lake water discharged was found in the outer slope of the moraine (Fig. 8d). This ice-drainage channel was 350 m in length from the lake to the ice crevice at the outlet.

ice-drainage channel was 4.5 m wide and 3.2 m high, with a water depth of 1.2 m in this part of the channel (Fig. 8c). The size and length of 350 m of the subsurface drainage tunnel and the course of the outburst event suggest that the tunnel was at least in parts already formed before the flood. Substantial flooding through subglacial tunnels from a glacier-dammed lake was also reported in the Yarkant river, China (Zhang, 1992). We visited the site in the same season in 2008 and 2009, but in 2009, more snow was on the ground because of lower summer temperatures, reduced melting, and increased snowfall (12 cm of snowfall was recorded during our field visit on 18 July 2009). The reduced snow and ice melt in summer 2009 due to lower temperatures might explain why the lake was 1.2 m lower in 2009 than in 2008. During our 2009 visit, the water level inside the ice-drainage channel was the same as the lake level (3737 m), indicating a low hydraulic gradient and perhaps a vertically stabilized lake outlet.

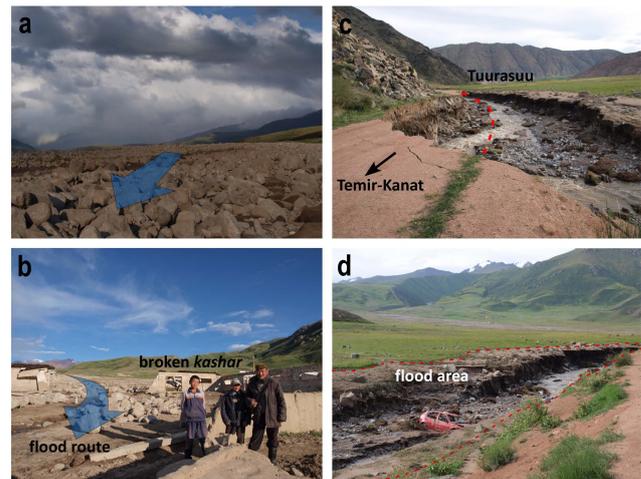
Fig. 10. Photos of damages by the GLOF. (a) 1–2-m diameter boulders deposited on the pasture fields (27 July 2008 by C. Narama). (b) A shed (*Kashar*) partly destroyed by the flood (27 July 2008 by C. Narama). (c) Washed-out road between the Temir-Kanat and Tuurasuu villages (27 July 2008 by C. Narama). (d) Car swept into the Zyndan river at around 22:30 (27 July 2008 by C. Narama).

current) eroded the river channel along the road in area-D (Fig. 10c). Debris deposition was observed on the river bed and agriculture fields in area-E within 15 km from the lake. Most large sediments transported from the mountain site by debris-flow were deposited on the upper part of the alluvial fan, within 10 km from the lake in area-C. In this case, the total channel gradient 8.3° and the ratio 1.3 of the vertical travel distance to the length of travel (H/L) were the same minimum values as found for debris-flows in the European Alps (Chiarle et al., 2007). In the Swiss Alps, flood water from high elevation sources reached only to lowland residential areas a short distance away (Huggel et al., 2002; Chiarle et al., 2007). That is, the outbursting water had characteristics of debris flows, unlike flood waves recorded in the Bhutan Himalayas reaching 200 km downstream (Richardson and Reynolds, 2000). Most of GLOFs in the Tien Shan appear to be the same debris-flow type as found in the Swiss Alps.

was completely destroyed by the flood. They also lost seven sheep and five goats (Table 1). When the flood began, they remained at home, but after 30 min, they waded across the still-clear flood water, which was then about 30 cm deep. Figure 10c and d shows the washed-out road and a car swept into the Zyndan river. This car dropped into the flood at around 22:30, about 6 h after the lake outburst began, at a location where the road connecting Temir-Kanat and Tuurasuu villages had collapsed due to flood erosion of the river banks (Figs. 9 and 11). Three people died in this accident. At the Tong Fish Center, approximately a million fry were being grown for future release into Lake Ysyk-köl and for sale to other areas (Fig. 2). All the fish were killed when muddy flood water mixed with the tank water. At the time of our last visit in summer 2009, the center had been unable to pay their employees' salaries since 23 September 2008, and no plans had been made to reconstruct the facility. At Tuurasuu village, where the Zyndan river flows into the reservoir, the river channel was narrow and was blocked by the deposition of huge boulders, which redirected the flood into the irrigation channel leading to the Tong river (Figs. 3 and 9). As a result, Tuurasuu and the village of Tort-Köl located downstream from the reservoir escaped serious damage. The water gate of the reservoir was opened between around 19:00 and 22:00, but there was no change in water level.

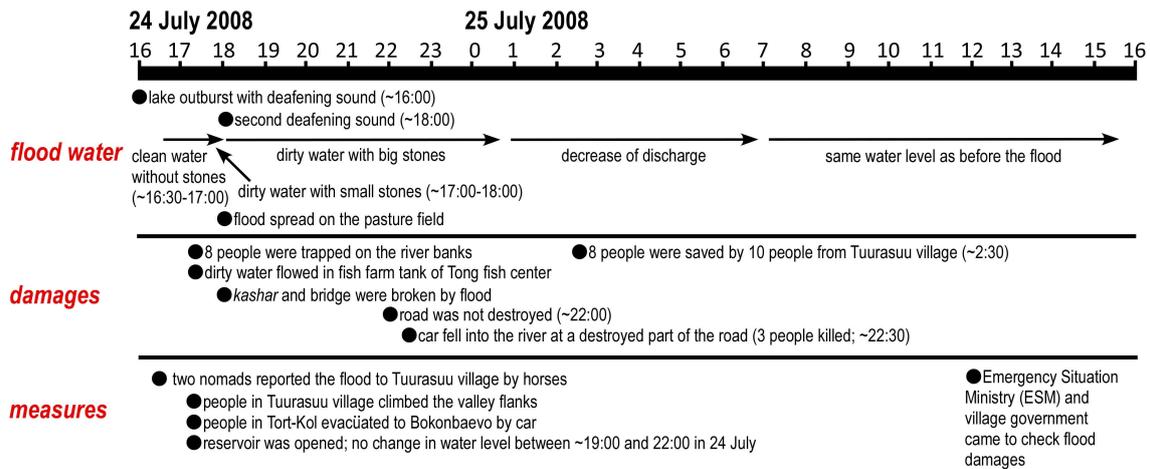
Fig. 11. Timeline for the GLOF event in 2008 of the w-Zyndan glacier lake.

Figure 11 presents a timeline for the GLOF event. Substantially increased river discharge consisting of clean water without debris first arrived at downstream homes 30 min after the beginning of the GLOF, which is assumed to have started in connection with the first loud explosion. Flow discharge was not sufficiently high to entrain additional material because the drainage channel inside the ice-cored moraine was not sufficiently open. Following a second explosion at around 18:00, dirty water with boulders, commonly 1–2 m in diameter, arrived at downstream areas. The boulders of the debris flow were deposited on pastures on the alluvial fan in area-C (Figs. 9 and 10a). The flood discharge continued to increase until midnight (around 01:00) on 25 July 2008, and then decreased until returning to normal discharge values at around 07:00. The flood trapped eight local residents on debris banks in branches of the braided stream system in area-

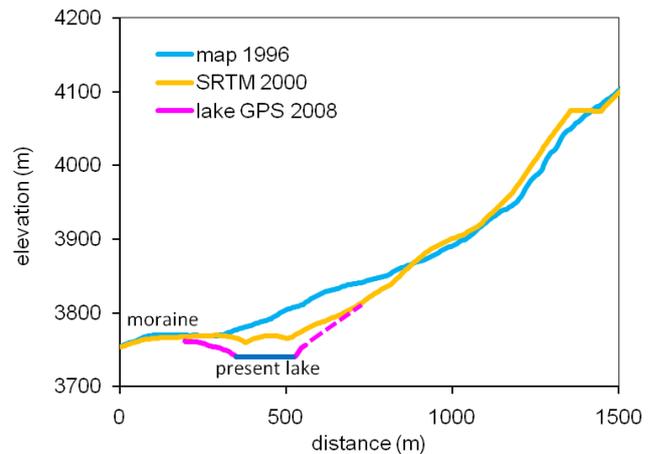
Fig. 12. Elevation profiles of the w-Zyndan glacier surface obtained from DEMs from the 1:25 000 topographic map (1966), the SRTM (2000), and GPS data (2008).

Figure 12 shows the topographic profile of the w-Zyndan glacier, derived from a topographic map-derived DEM (1966), the SRTM DEM (2000), and a Leica RTK-GPS900 data-derived DEM (2008). The map DEM was generated from the 10-m contours of relevant 1:25 000 topographic maps (made by the USSR using aerial photos in 1966). The three topographic profiles along the w-Zyndan glacier surface indicate substantial (up to 40–60 m in lake area) downwasting of the terminus since 1966. By this process, the basin developing at the terminal part could easily collect and retain meltwater from snow and ice (glacier and debris-covered dead ice). Although a small stream channel existed on the surface of the terminal moraine complex (which included much dead ice) for a short period at the time of lake expansion, glacier drainage paths are typically through or underneath the dead ice/moraine complex.

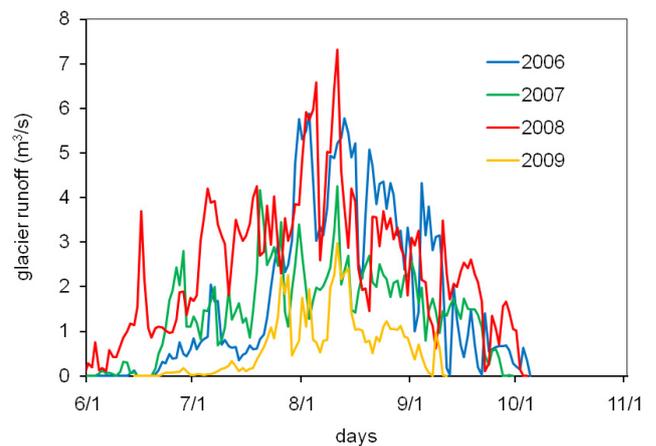
Fig. 13. The changes of glacier runoff estimated in the Chong-Kyzylsuu watershed (Fig. 1) during 2006–2008, based on meteorological data and stake measurements in field observation in the Aylampa glacier (Narama et al., 2010b).

Figure 13 shows the glacier runoff in 2006–2009 in the Chong-Kyzylsuu catchment of the Teskey Ala-Too range (Fig. 1; Narama et al., 2010b). Glacier runoff was calculated using stake measurements on the Aylampa glacier and a heat balance model (Fujita and Ageta, 2000) with automatic weather station data. Glacier runoff from 1 June to 24 July 2008, when the outburst occurred, was much greater than that during the same time period in 2006, 2007, and 2009 (Fig. 13). In this region, snowmelt occurs in April to June, with the melting of glacier ice starting in June and continuing to September (Dikich and Hagg, 2004; Narama et al., 2010b). We roughly assume, therefore, that up to 13 June 2008, the glacier lake volume of more than 237 000 m³ (including the present lake volume) originated mostly from snow and debris-covered dead-ice melt, and that the later volume increase by 200 000 m³ stemmed, to a significant degree, from glacier ice melting between 13 June and 24 July. In fact, the Landsat 7 ETM+ images from 26 April and 12 May 2008 show much snow cover on the moraine and glacier surface; this snow had almost disappeared in the image from 13 June 2008. In addition, the sudden decline of electric conductivity (EC) value in water of the Chong-Kyzylsuu river shows the start of snow melt from 24–25 April 2008 in this region. Although precipitation between 1 April 2008 and 24 July 2008 was not unusually large, the mean daily temperatures from 1 May to 24 July 2008 were significantly higher than those for the same period in 2006, 2007, and 2009 (Narama et al., 2010b). These comparably high air temperatures can be assumed to have led to comparably high rates of snow and ice melting.
