Failure of infrastructure embankments induced by flooding and seepage: a neglected source of hazard

M. Polemio and P. Lollino

Italian National Research Council, Research Institute for Geo-Hydrological Protection, Bari, Italy

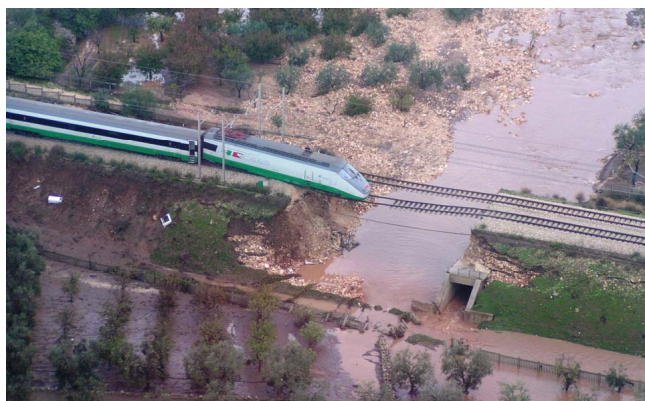
Fig. 3. View of the breach developed in the Acquaviva railway embankment (point 4 in Fig. 4) after 5 October 2005 flooding (picture taken from the upstream side).

In location D of Fig. 4 (see also Fig. 3), where the embankment here examined is located, almost all of the injured people were passengers who miraculously survived a railway disaster: a train went off the rails at high velocity (over 120 km h^{-1}) after crossing a 21 m long portion of the rails that was left unsupported due to the collapse of the underlying 7 m high embankment. The embankment and the corresponding culvert were constructed in the 1990s as part of a new double-track railway, which was built to replace the

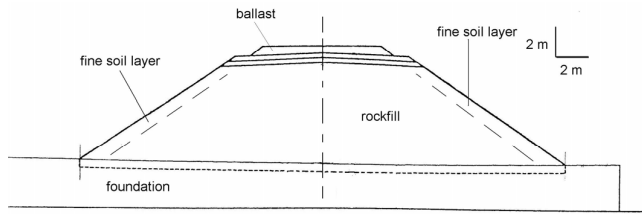
Fig. 6. Schematic cross-section of the Acquaviva embankment.

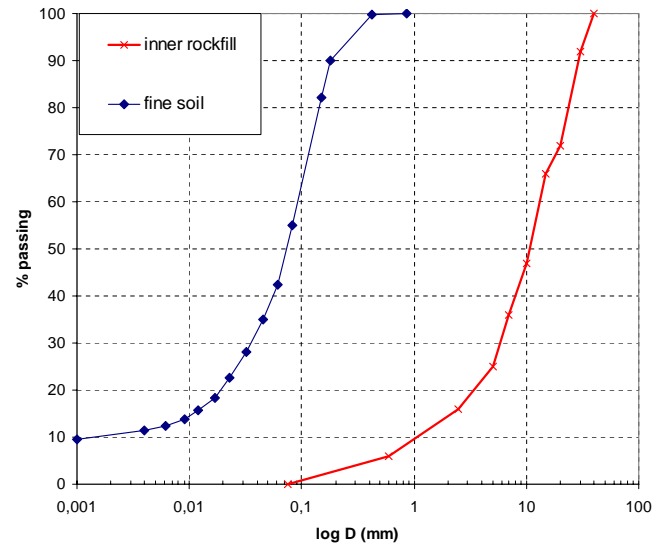
Fig. 7. Grain size distribution curves of the inner rockfill and finer soil along the slopes for the Acquaviva railway embankment.

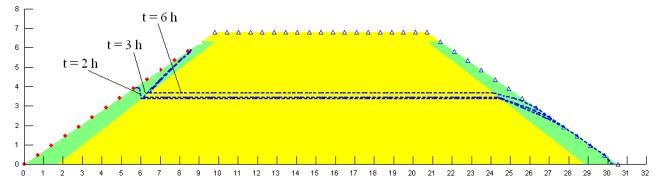
Fig. 10. Saturation level in the embankment at different times in the hypothesis of low permeability soil strata along the two embankment slopes.

The results of the seepage analysis show that the saturation line reaches the maximum level, which in the rockfill remains about horizontal, 3 m above the base of the embankment, during the raising of the impoundment level (Fig. 10). The geometry of the saturation line within the upstream fine soil stratum is directly related to the variation of the upstream boundary condition. Figure 10 also shows that the evolution with time of the saturation line is significantly affected by the difference of permeability of the two soils. In particular, the influence of the fine soil strata along the embankment slopes is highlighted if such seepage domain is compared with that deriving from a similar analysis simulating homogeneous embankment conditions, as shown in Fig. 11. Different pore pressure distributions within the embankment result from these two flow processes. In particular, the values of the pore pressures calculated along the red line indicated in Fig. 8 for the case of homogeneous embankment and those predicted for embankment with two fine soil strata at time $t = 6 \text{ h}$ (i.e. after 3 h of constant maximum reservoir level) are compared in Fig. 12. The figure shows that for the case of fine soil slopes, values of pore pressures higher than for the homogeneous case develop at embankment heights lower than 3 m.

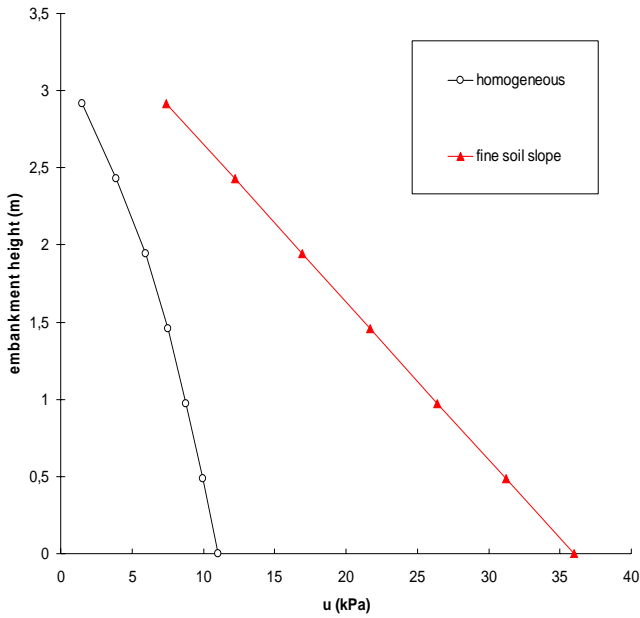
Fig. 12. Pore water pressures calculated at the downstream toe area (see red line in Fig. 8) at time $t = 6$ h (see Fig. 9) for different embankment configurations.

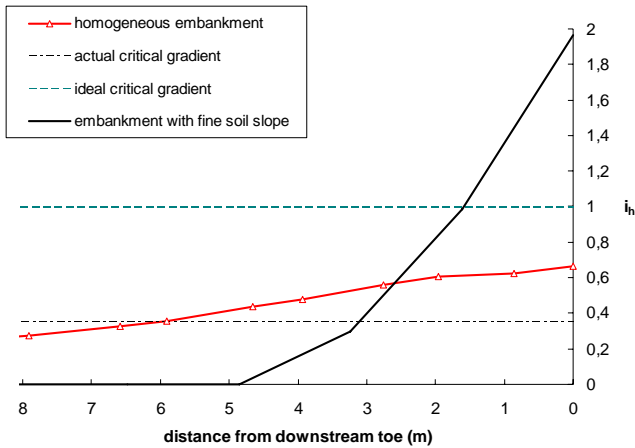
Fig. 13. Outflow horizontal gradient calculated at the downstream toe (see blue line in Fig. 8) at time $t = 6$ h (see Fig. 9) for different embankment configurations and comparison with gradient values critical for the onset of piping.

The values of the horizontal hydraulic gradient at the nodes along the blue line in Fig. 8 have also been calculated at $t = 6$ h and compared for the two configurations of the embankment in Fig. 13. The hydraulic gradient for the homogeneous rockfill embankment reaches the maximum value at the downstream face ($i_h = 0.65$) and then reduces gradually to values less than $i_h = 0.3$ in the very inner portion of the embankment. For the case of a rockfill embankment with low-permeability soil along the embankment faces, the

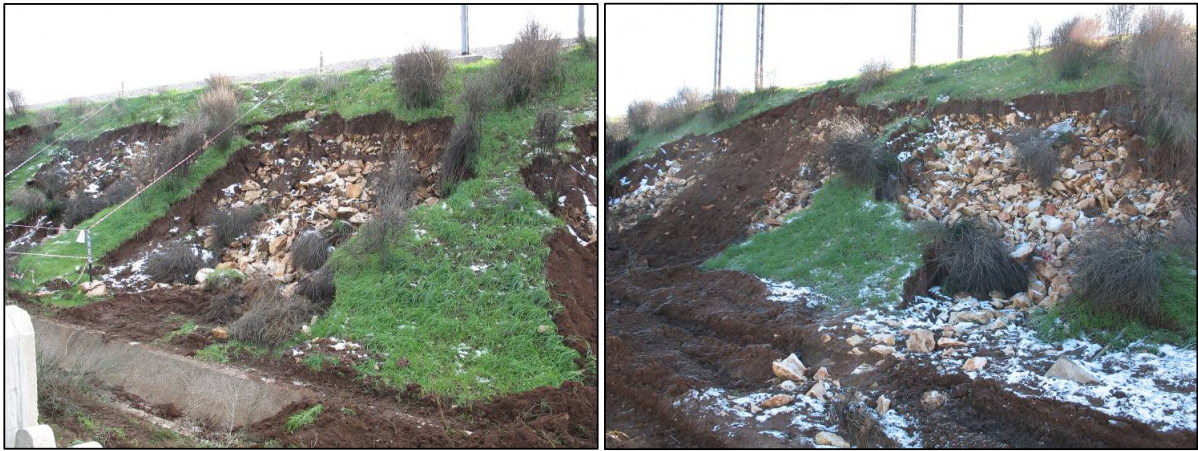
Fig. 14. Unravelling/sliding failures observed along the slopes of the remaining portion of the Acquaviva embankment.

Several shallow sliding or unravelling processes, mainly involving the fine soil strata along the embankment slopes, were observed along the remaining portion of the embankment during field surveys performed after the failure event (Fig. 14). Based on the pore pressure distributions calculated by means of the transient seepage analysis, limit equilibrium back-analyses have been carried out using the Morgenstern-Price method (Morgenstern and Price, 1965) with respect to sliding surfaces along the embankment slopes that resemble those observed in the field (Fig. 15a and b). In particular, the strength parameters of the rockfill have been assigned to be equal to $c' = 0$ kPa and $\phi' = 36^\circ$, since these parameters can be assumed as representative of a lower boundary of the shear strength of the examined rockfill material, whereas the mobilised strength parameters of the fine soil strata along the embankment slopes have been derived as output of the analysis.

These quite high mobilised strength values should confirm that shallow slope instability processes were likely to have occurred along both downstream and upstream slope of the embankment due to the very unfavourable flow conditions that took place in the embankment during the flooding event. Moreover, flow sliding might also have occurred since the soils involved are in the range of soils potentially susceptible to liquefaction and flow sliding according to their particle size distributions, as indicated by Hunter and Fell (2003). Unravelling was also likely to occur along the downstream slope due to very high seepage flow existing at the downstream toe.

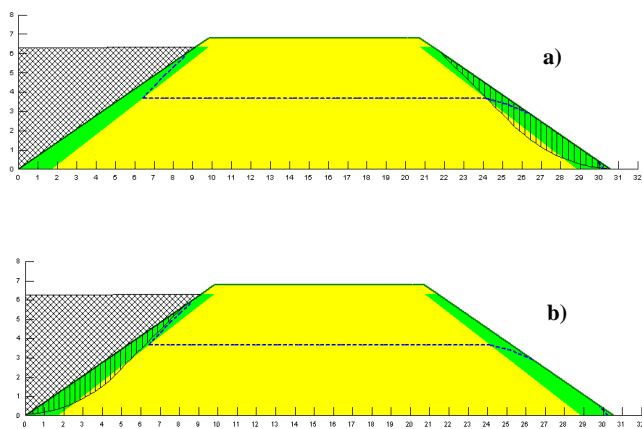
Fig. 15. Back-analysis of the slope stability of the embankment at time $t = 6$ h. Sliding surface assumed along the downstream slope (a) and along the upstream slope (b). The blue dashed line represents the saturation level calculated at the same time.

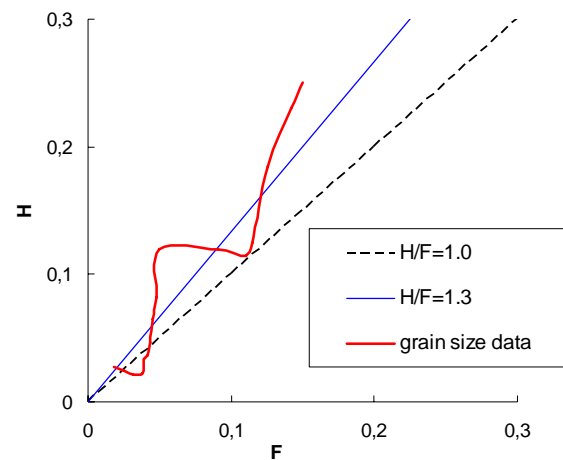
Fig. 16. H/F shape curve calculated for the rockfill grain size curve in Fig. 7 and comparison with critical H/F curves.

derived (Fig. 16). The curve has been defined for F values between 0 and 0.2, since the material is characterised by a uniformity coefficient C_u higher than 3 (see Kenney and Lau, 1985). Figure 16 shows that the curve representative of the embankment rockfill is typical of a material highly unstable for two ranges of diameters: in fact, a minimum value of the ratio $H/F = 0.57$ is obtained for a diameter D in the range $[0.1, 0.3]$ and also a relative minimum $H/F = 1.0$ corresponds to the range of $D = [1, 1.5]$. These values of the stability index clearly confirm the susceptibility of the material to be internally unstable according to the criterion provided by Kenney and Lau (1985). Moreover, the material also is shown to be unstable according to the Kezdi criterion (1979), since the value of the ratio d'_{85}/D'_{15} is higher than 4. The corresponding value of the critical gradient has been then estimated based on the experimental works of Skempton and Brogan (1994). In particular, considering a range of

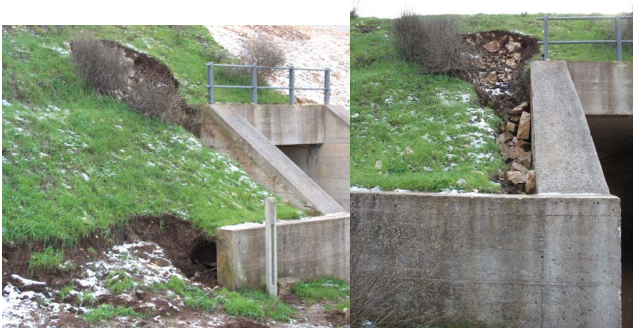
Fig. 17. Photos of the concentrated erosion pipe at the contact between the wall of the concrete conduit and the soil material.

The results of the analysis indicate that the failure of the railway embankment is thought to be induced by internal erosion processes, probably consisting of suffusion of the soil forming the embankment, together with concentrated pipe erosion along the contact between the rockfill and the concrete culvert, that led within a few hours to the global failure of a large portion of the structure.

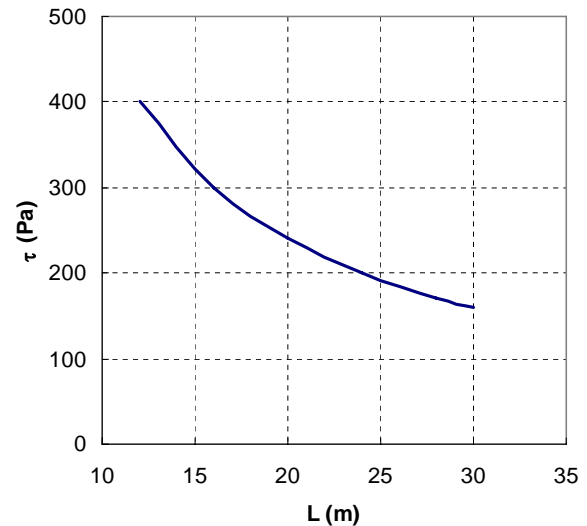
Fig. 18. Estimated hydraulic shear stress in a cylindrical pipe as a function of the pipe length (pipe diameter of $D = 0.5$ m; water head loss of $H_f = 4$ m)

of $H_f = 4$ m, has been carried out. The results are shown in Fig. 18 and indicate values of the shear stress that are higher than the critical shear stress provided for coarse grained soils by Wan and Fell (2004).
