The 13 November 2007 rock-fall at Viale Tiziano in Rome (Italy)

Abstract. The aim of the study was to perform a study on the western slope of the Monti Parioli hill (Rome, Italy) affected by frequent rock-fall phenomena, such as the one that occurred on 13 November 2007.

This goal was achieved by defining a detailed reconstruction of the stratigraphical, geological and geomechanical structure of the slope and by conducting a back-analysis of the rock-fall event using 2-D and 3-D modeling tools.

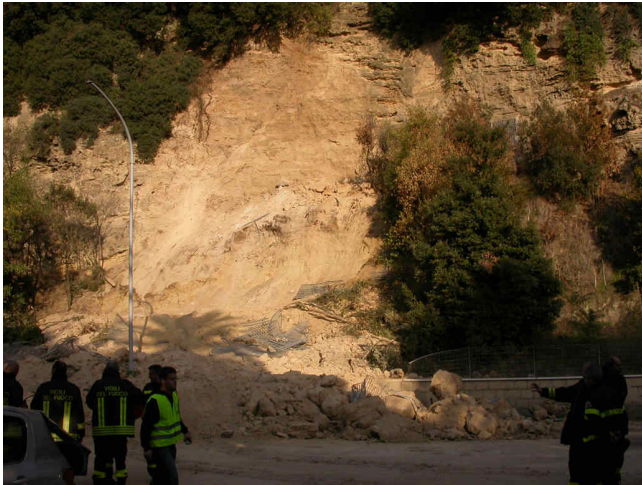
Fig. 1. View of the rock-fall area during the fire department squad's intervention.

On 13 November 2007 at 11:40 LT, a rock-fall occurred in an area approximately 20 m wide and 30 m long on the western slope of Monti Parioli Hill, which sits on Viale Tiziano (Fig. 1). The collapsed material affected half of the road width at a distance of more than 20 m from the foot of the slope. Several moving and stationary cars were damaged, and three people sustained minor injuries.

The collapsed material, later partially removed by the fire department squads, occupied an area of approximately 200 m², with a thickness ranging from 1 m to 4 m. The volume of material in the accumulation area was estimated to be 450 m³ to 600 m³ based on the number of trucks used to

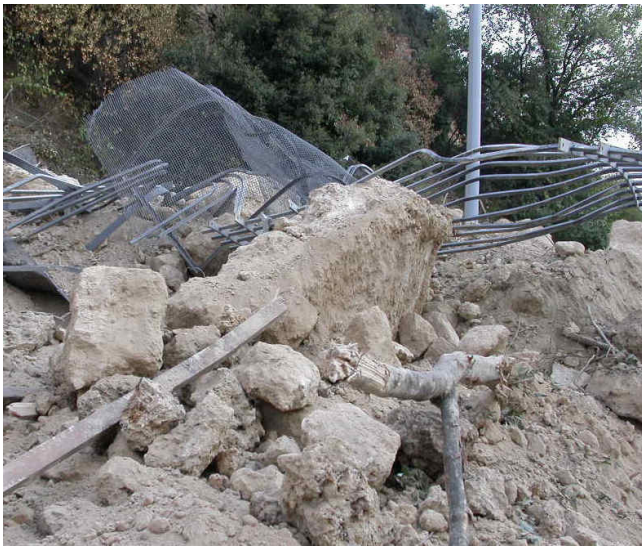
Fig. 2. The fallen mass, mainly composed of sandy material and subordinate lithoid travertine blocks coming from the upper part of the slope; destroyed iron fences, which closed the entrance of a cavity dug in the slope are also visible.

remove the material and on the assessment of the mass missing from the slope. The fallen material was mainly composed of loose, sandy material and subordinate blocks of approximately 1 m^3 to 2 m^3 (Fig. 2) coming from the middle to upper slope, where the rock has a travertine-like structure.

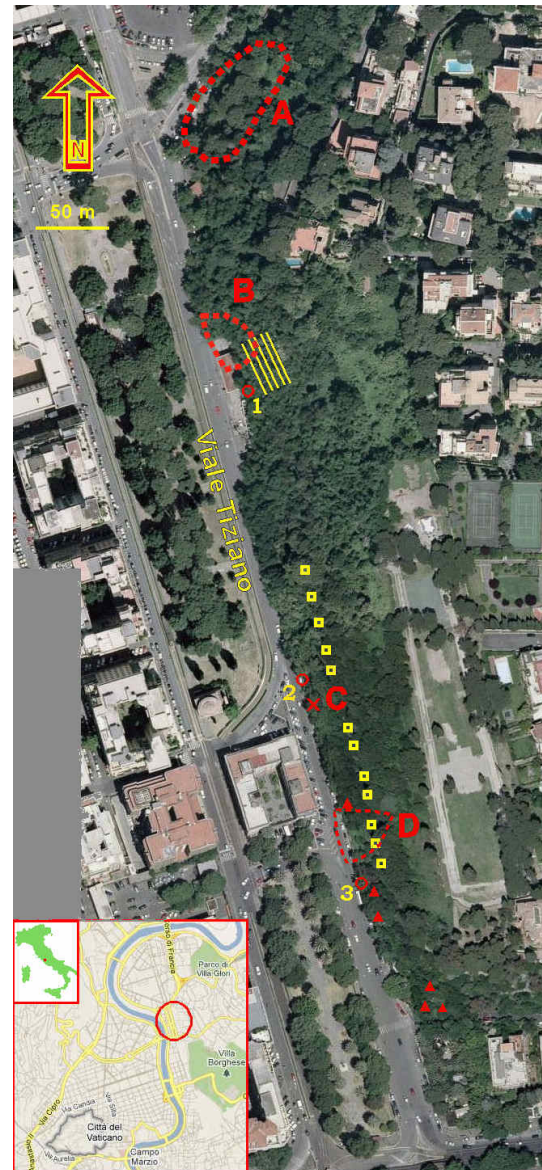
Fig. 3. The western slope of Monti Parioli hill (aerial photograph from Google Maps) and its position inside Roma city area. Letters show the position of previous landslide events (A, B, C) and of study event (D); parallel yellow lines show the portion of the slope remodelled into tiers after 1972 event; small yellow squares indicate the entrance of the upper cavity system; red triangles indicate rock blocks found at the foot of the slope; red circles (numbered in yellow with 1, 2 and 3) indicate the accesses to the lower cavity system (WWII air-raid shelter).

At the northern limit of the slope (Fig. 3, site A), the “Salita dei Parioli” road, which provided access to the top of the hill from the west, was closed in the mid-1980s due to poorly defined landslide events at the second and third bend (Amanti et al., 2008).

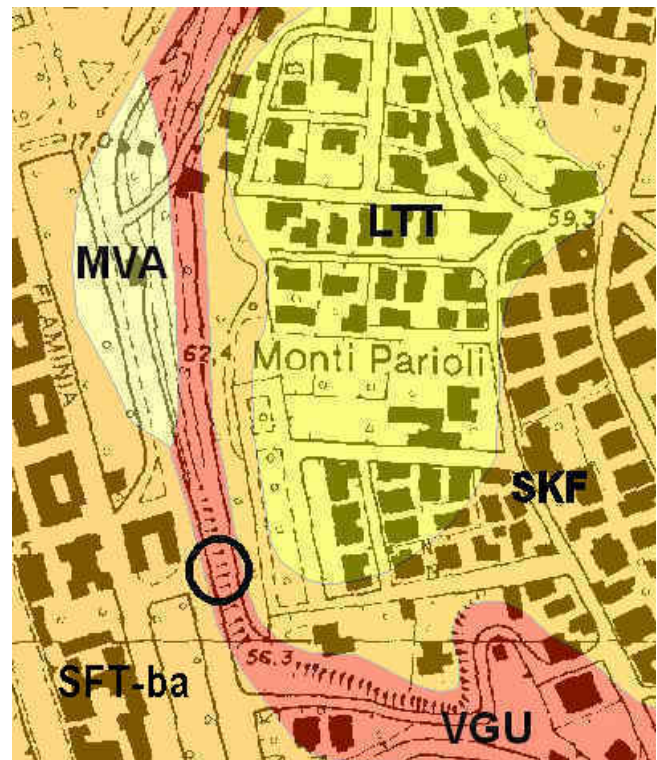
Fig. 5. Geological map of Monti Parioli area, from sheet 374 "Roma", 1: 50 000 scale, Geological Map of Italy. The black circle indicates the location of the study event. Legend. SFT-ba: Tevere R. alluvial deposits (Holocene); LTT-SKF: Tufi Stratificati Varicolori di La Storta and Tufi Stratificati Varicolori di Sacrofano (Middle Pleistocene – Upper Pleistocene); VGU: Valle Giulia Formation (Middle Pleistocene); MVA: Monte Vaticano Formation (Lower Pliocene).

The lithostratigraphic framework (Funciello and Giordano, 2008) is characterised by the presence of volcanoclastic deposits on top of the relief, which are attributed to the formation of Tufi Stratificati Varicolori di Sacrofano (SKF) and Tufi Stratificati di La Storta (LTT) (Middle Pleistocene). They lie on the top of the Valle Giulia Formation (VGU), aged Middle Pleistocene, which overlaps the Monte Vaticano Formation (MVA) just below Viale Tiziano street level (Fig. 5).

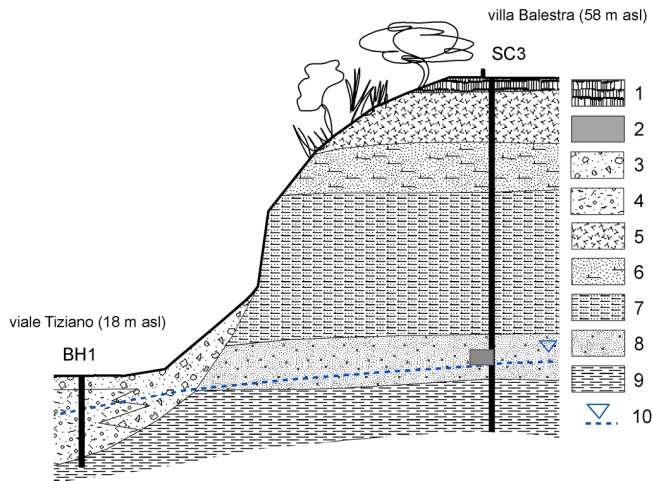
Fig. 6. Geological section. Legend: (1) human backfill and reworked pyroclastics; (2) WWII air-raid shelter; (3) slope detritus (Holocene); (4) Tevere R. alluvial deposits (Holocene); (5) loose pyroclastics (Middle Pleistocene-Upper Pleistocene); (6) calcareous sand (Middle Pleistocene); (7) silty to sandy calcareous beds and phytoclastic travertine (Middle Pleistocene); (8) fine to medium sand and gravel alluvial deposits (Middle Pleistocene); (9) overconsolidated silt and silty clay (Lower Pliocene); (10) water table.

The investigation campaign described earlier led to the establishment of a detailed lithostratigraphic model of the relief (Fig. 6). This lithostratigraphic relief model is needed as a detailed input for the 2-D and 3-D modelling.

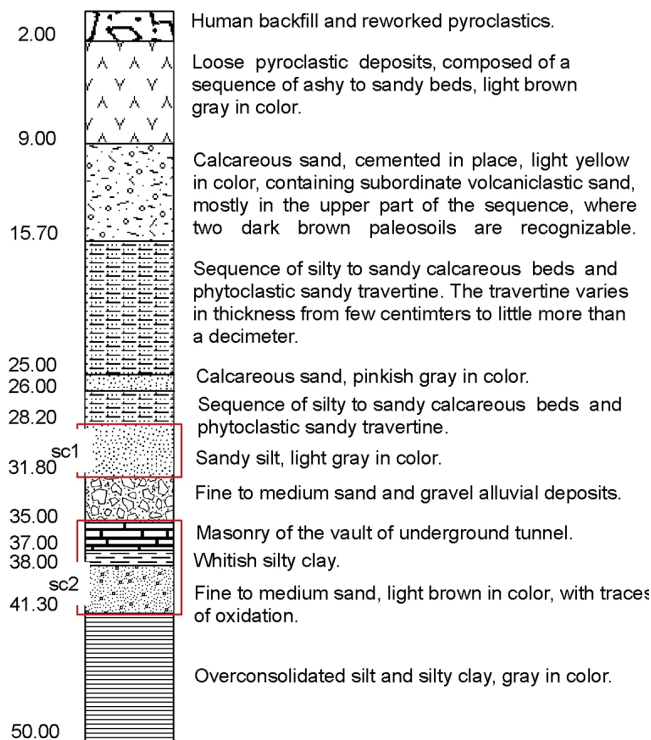
Fig. 7. Stratigraphic sequence of SC3 continuous core borehole. On the left, numbers indicate the depth from ground level. Legend: (sc1) terrains affected by the presence of the upper system of cavities; (sc2) terrains affected by the presence of the lower cavity system (WWII air-raid shelter).

These pyroclastic materials, whose thickness is between 9 m (SC3 in Fig. 7) and 13 m (SC1), are characterised by compression wave velocity (V_p) values of approximately 0.5 km s^{-1} to 0.6 km s^{-1} .

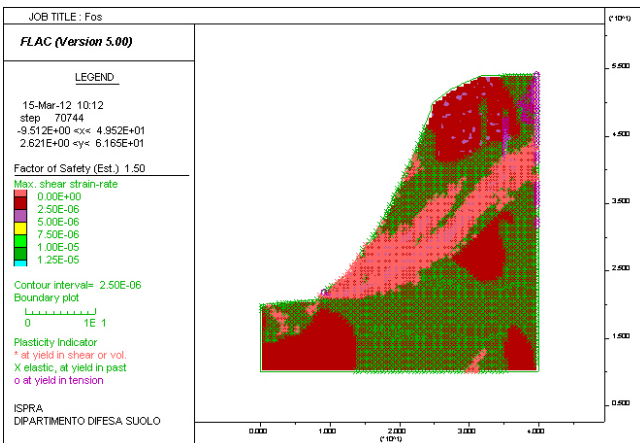
Fig. 10. Section 1. Safety factor and plasticity indicator. In the summit area of the slope, the shear strain rate distribution does not show a well-defined plane of shear failure, but a general state of collapse. The plastic indicators show a state of spread yield at the altitude of 30 m a.s.l., corresponding to the position of the caves. The simulation is not really significant in the vicinity of the right peripheral zone, due to an “edge effect”. The strength values represent the shear strength of the slope material before the application of the reduction technique.

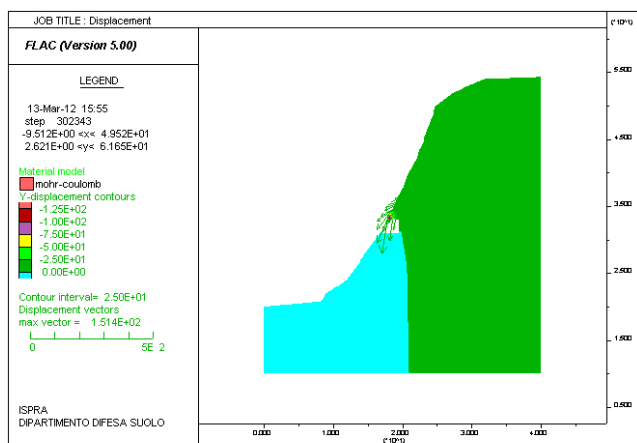
**Fig. 11.** Section 1. Displacement vectors in the pre-collapse movements. The simulation includes the presence of a cave in the section. The resulting collapse mechanism is definitely linked to the collapse of the vault of the cave. The simulation process stops for an excessive deformation that distorts the computing grid beyond the accepted limits.

The stability conditions significantly deteriorate after introducing the presence of the collapsed cavity into the model. Resistance values defined above are not sufficient to ensure stability. Where pre-collapse movements on top of the cave are highlighted (Fig. 11), it is possible to see that the triggering of the collapse is given by the presence of the cavity itself.

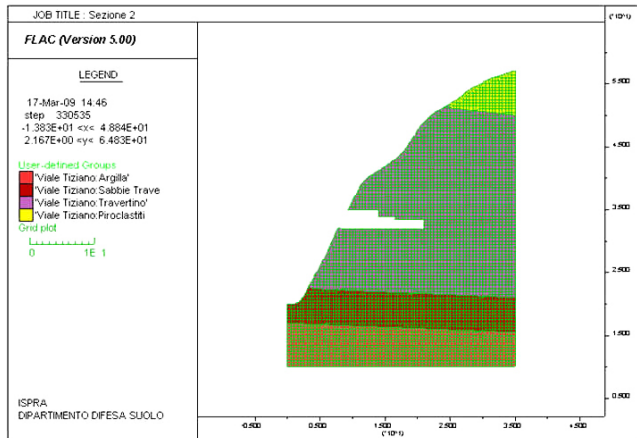
Fig. 12. Section 2. Geological technical model. It has been defined according both to geological field survey and to the results of all carried investigations. This conceptual model represents the stratigraphical conditions and the pore pressure regime, and takes into account the physical and mechanical characterisation of soils to define a numerical model capable of predictive analysis.
