# The 13 August 2010 catastrophic debris flows after the 2008 Wenchuan earthquake, China

Q. Xu<sup>1</sup>, S. Zhang<sup>2</sup>, W. L. Li<sup>1</sup>, and Th. W. J. van Asch<sup>3</sup>

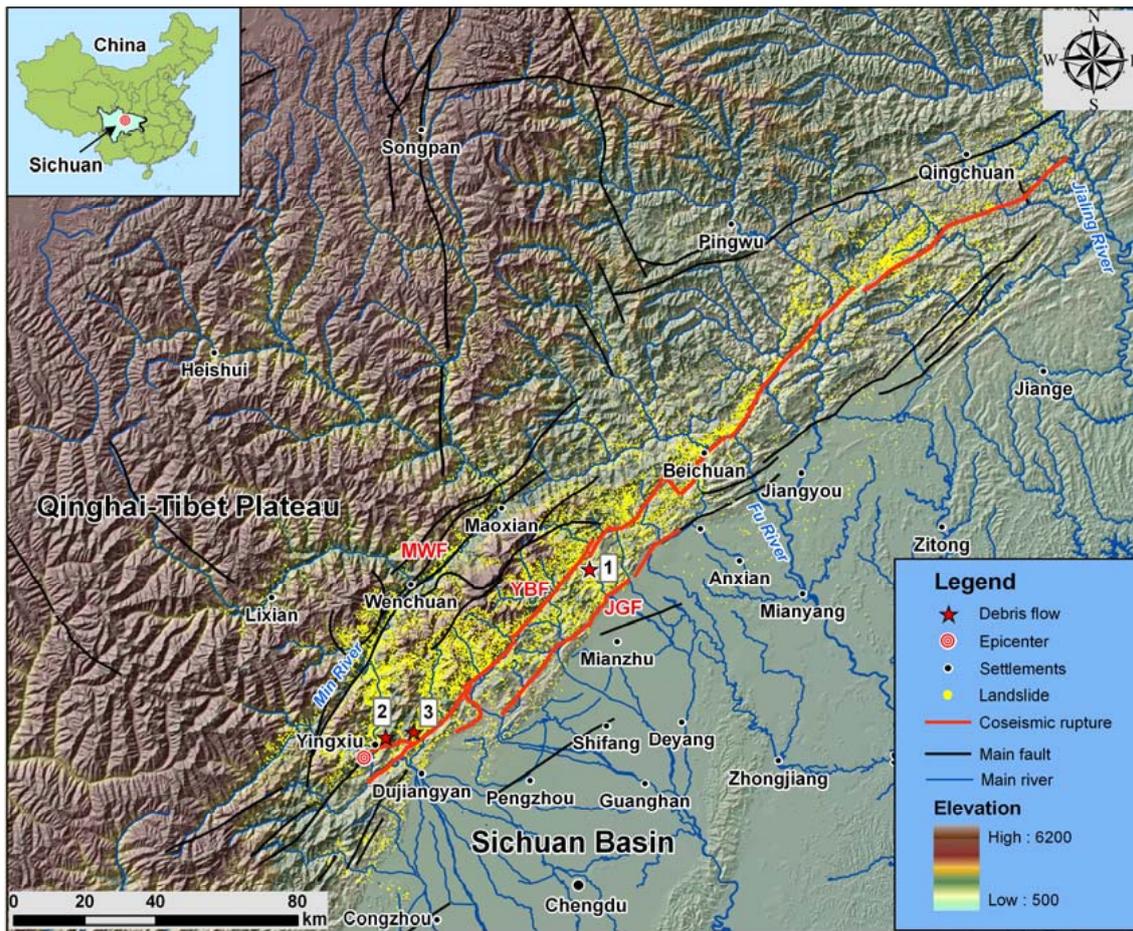
**Fig. 1.** Distribution map of landslides triggered by the Wenchuan Earthquake and three catastrophic debris flows triggered by the rainstorms on 13 August 2010 (MWF: Maoxian-Wenchuan Fault; YBF: Yingxiu-Beichuan Fault; JGF: Jiangyou-Guanxian Fault. 1: Wenjia gully and Zoumaling gully debris flows near Qingping Town; 2: Hongchun gully debris flow; 3: Longchi debris flow). The landslide distribution map was derived from a rapid landslide inventory made by Huang and Li (2009).

On 13 August 2010, heavy rainstorms occurred in a part of the area affected by the 2008 Wenchuan Earthquake. A total of three catastrophic debris flows occurred: the Wengjia gully and Zoumaling gully debris flows near the Town of Qingping; the Hongchun gully debris flow near the town of Yingxiu and the Longchi debris flow near Dujiangyan City (Fig. 1).

The study area is situated in the transitional mountainous belt characterized by rugged mountains and deep valleys (i.e. 2008 Wenchuan Earthquake zone). As shown in Fig. 1, the NE-SW Longmenshan fault zone is formed as an inter-continental transfer fault, which is composed of three sub-parallel thrust faults, including the Maoxian-Wenchuan fault, the Yingxiu-Beichuan fault, and the Jiangyou-Guanxian fault. Due to the extrusion of the Qinghai-Tibet Plateau and the Sichuan Basin, the Longmenshan fault region has always been active until recently with consequently a high frequency of strong earthquakes. The Wenchuan Earthquake crushed the Yingxiu-Beichuan fault (about 240 km length).

Firstly, as shown in Fig. 1, the outbreak points of debris flows are mainly distributed along a seismic active fault, i.e. the Yingxiu-Beichuan fault. The gullies, caused by debris flows, are closely related to these earthquake faults. For example, the central fault crosses the Hongchun and Zoumaling catchment (Fig. 11). The Wenjia gully is just located at the cross-

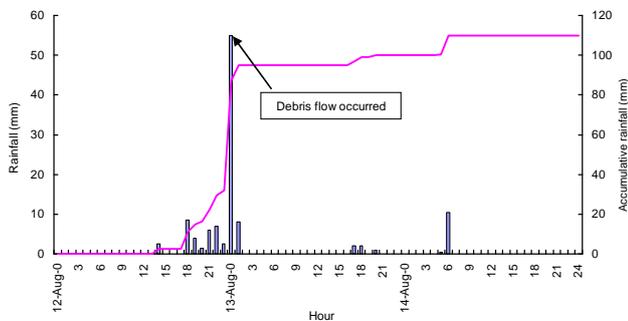
**Fig. 2.** Distribution of hourly and cumulative precipitation between 12 and 14 August 2010 in Qingping Town.

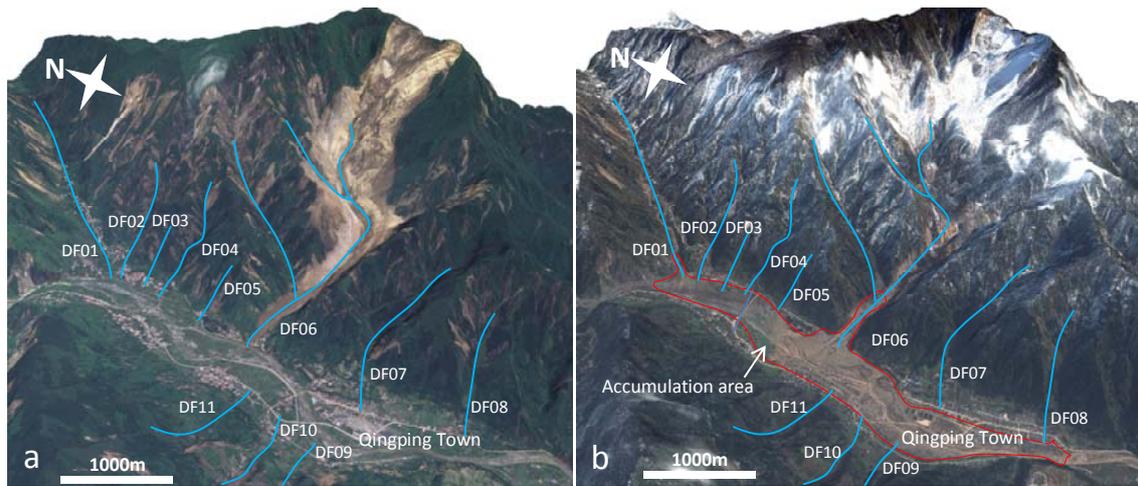
**Fig. 3.** Pre-seismic and post-seismic aerial photographs of the 13 August 2010 debris flow events near to Qingping Town (**a**: taken on 18 May 2008; **b**: taken on 13 December 2010), DF is the abbreviations of Debris Flow gully.

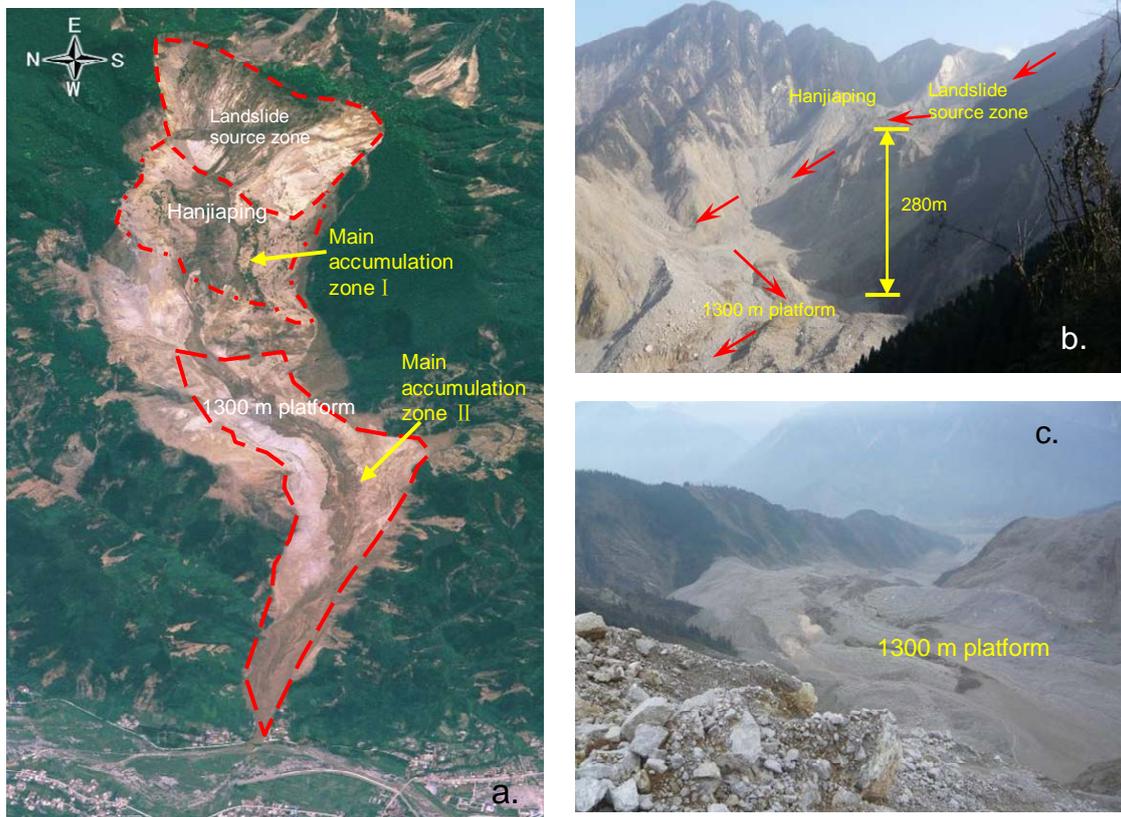
**Fig. 4.** Wenjia gully landslide induced by the 2008 Wenchuan Earthquake ((a): aerial photograph of Wenjia gully landslide after the Wenchuan earthquake taken on 18 May 2008; (b): Wenjia gully landslide source zone, and 1300 m platform; (c): 1300 m platform and loose deposits below it).

The loose materials distributed in the Wenjia gully were deposited by a mass movement occurring during the Wenchuan Earthquake on 12 May 2008. As shown in Fig. 4, when the earthquake happened, a limestone rock mass with a volume of approximately  $5000 \times 10^4 \text{ m}^3$  slid down from an elevation between 1780–2340 m. The huge amount of sliding material transformed into a rock avalanche, moved into a SW direction and entered the so called 1300 m platform (Fig. 4b). Later it turned into an SEE direction along the downstream part of the gully. The high energy of the rock avalanche was able to entrain the shallow, loose, soil material along its flow path increasing the amount of final displaced and depositing material to a total of more than  $7000 \times 10^4 \text{ m}^3$ . Figure 5 shows that a part of the massive deposits with a volume of

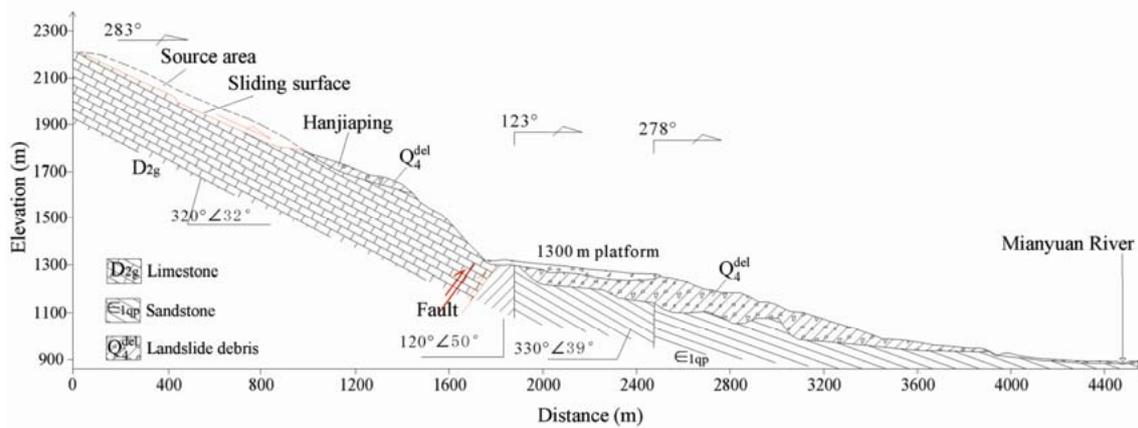
**Fig. 5.** Section of the Wenjia gully landslide (Huang and Zhao, 2010).

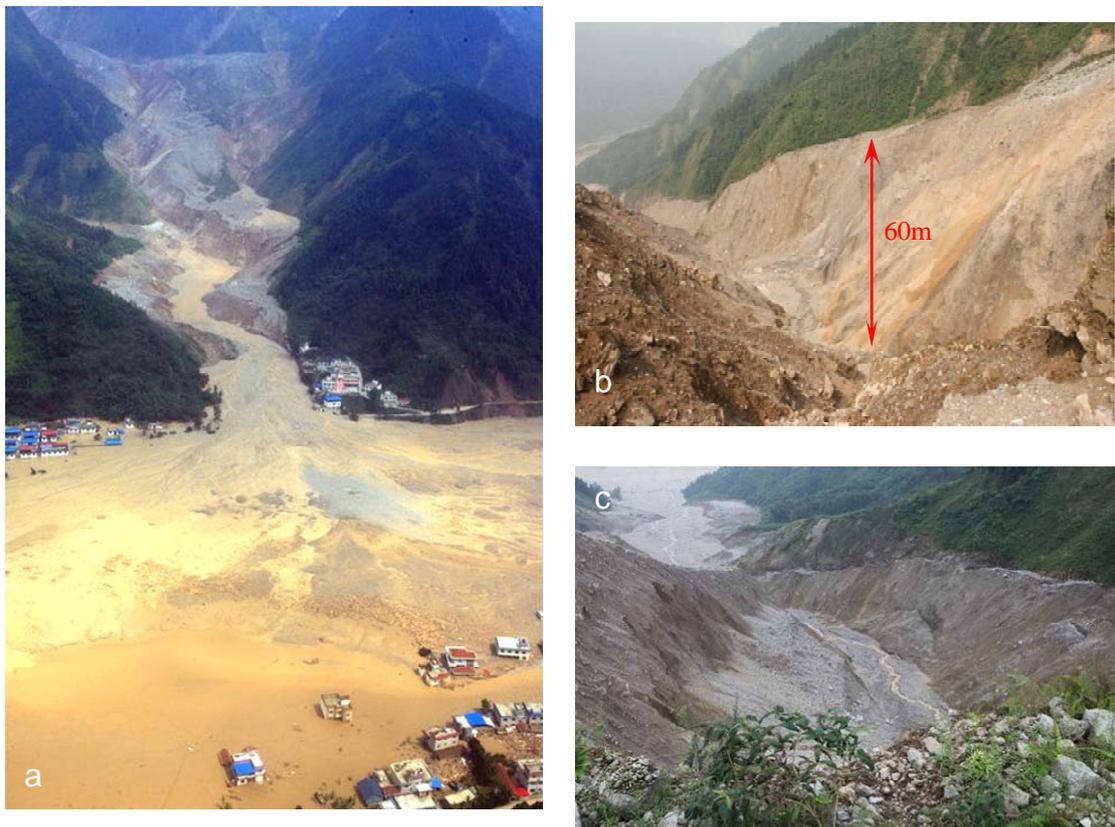
**Fig. 6.** Photos of the Wenjia gully 8.13 debris flow ((a): overview; (b): channel erosion in the Wenjia gully; (c): local widening by slope failures along the Wenjia gully).

posits reached a depth of 40–60 m and a width of 50–100 m (Fig. 6b). Figure 6c shows a widening of the channel erosion on several locations, caused by slope failures during the incision of the channel. When the debris flow happened, a check dam at the entrance of the catchment temporary blocked the material. The dam suddenly failed and increased

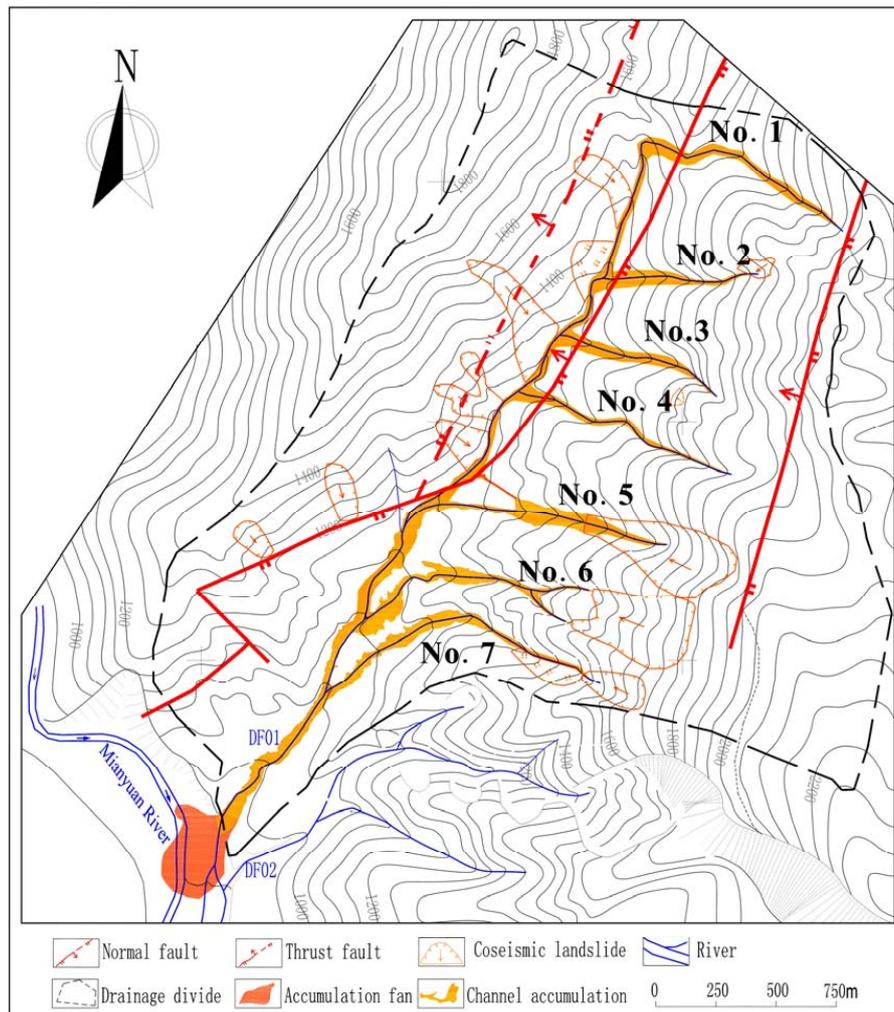
**Fig. 7.** Map of the 8.13 debris flow in the Zoumaling gully.

The Zoumaling catchment formed an ancient debris flow gully, which is composed of one main drainage channel and seven branches (Fig. 7). The channel gradient ranges from 8.5 % to 36.1 %. The upstream terrain of the gully is very steep with a width of 5–15 m. In the middle and downstream part of the gully, the gradient is relatively gentle and the width is 40–60 m. The loose deposits, triggered by the Wenchuan Earthquake, formed the main source for the debris flows in the catchment. The basic data of Zoumaling catchment is listed in Table 3. These seven branches played an important role in the supply of material for the debris flow. The debris source deposits in the 7 tributaries of the Zoumaling gully reached a total amount of  $48.5 \times 10^4 \text{ m}^3$ , surpassing the amount of material of the main gully, which is  $35 \times 10^4 \text{ m}^3$ . Figures 7 and 8 show that the loose deposits almost covered each branch in the catchment. Under

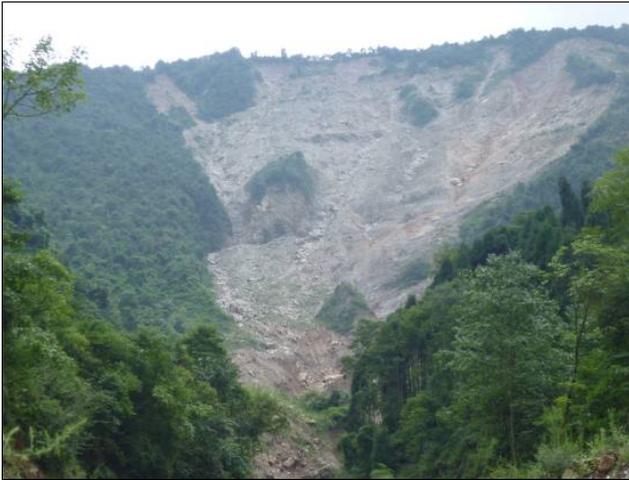
**Fig. 8.** Loose deposits in the upper part of the No. 5 branch of the Zoumaling gully.

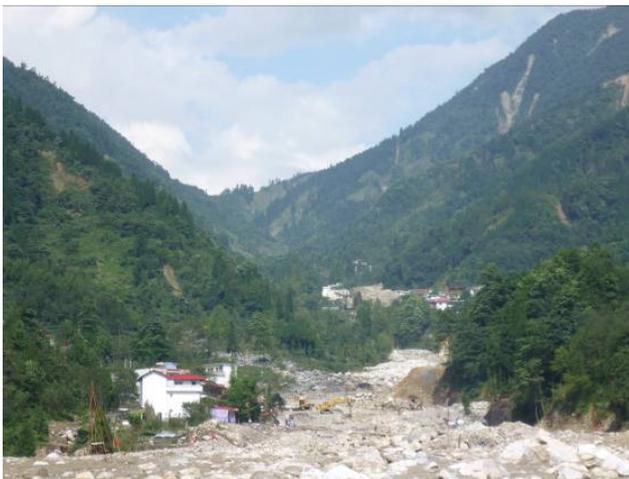
**Fig. 9.** An overview of the Zoumaling gully debris flow.

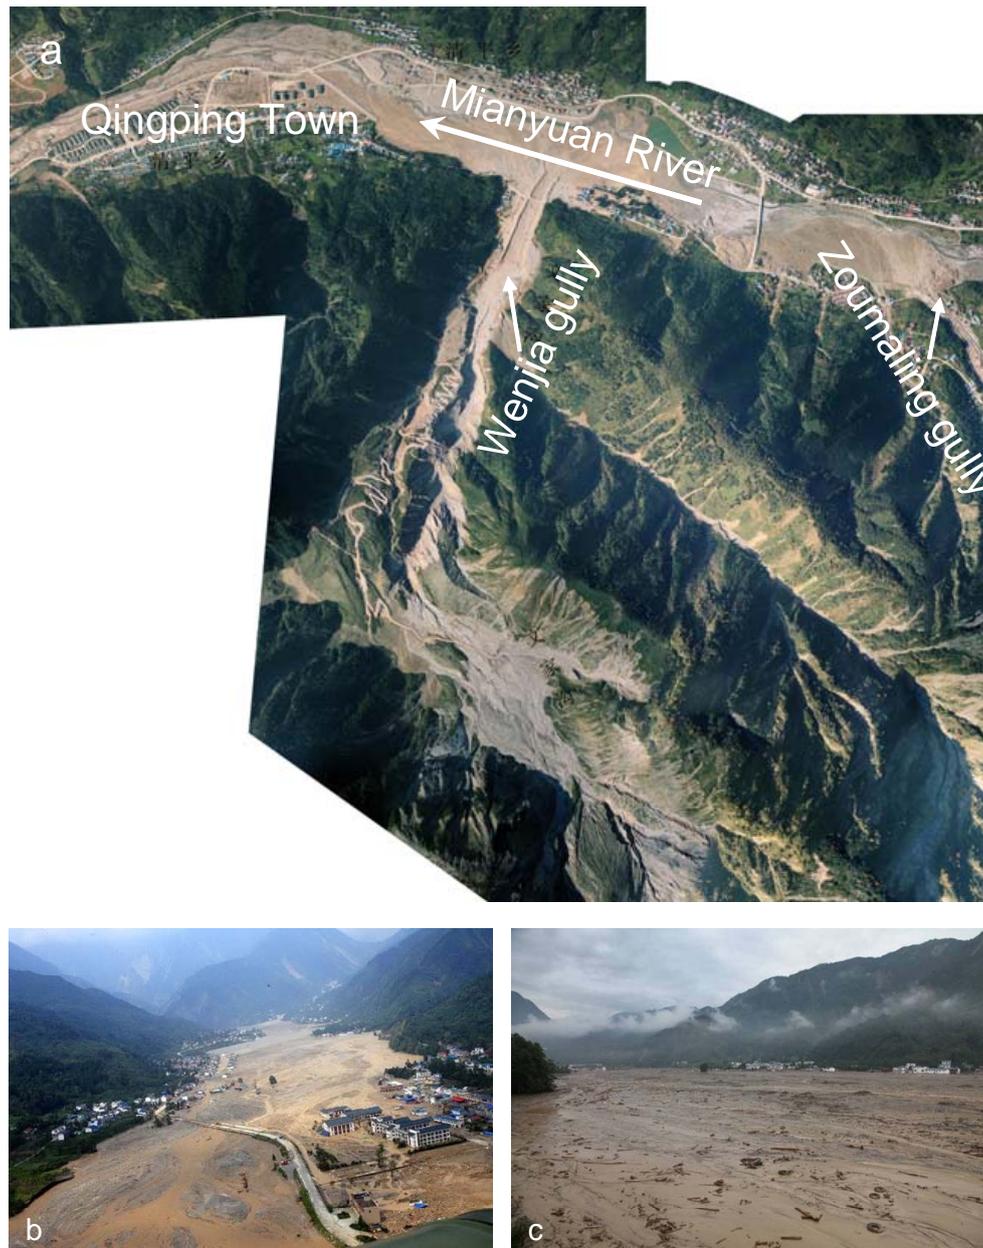
**Fig. 10.** Qingping Town buried by the 8.13 debris flows (**a**: aerial photograph taken after the 8.13 debris flows; **b**: photo of the buried Qingping Town taken from downstream to upstream of the Mianyuan River after the 8.13 debris flows; **c**: photo of the buried Qingping Town taken from upstream to downstream of the Mianyuan River after the 8.13 debris flows.)

As shown in Fig. 10, the whole town of Qingping was covered by a massive amount of deposits, with an area extension of  $140 \times 10^4 \text{ m}^2$ . Figure 10a clearly shows the debris dam formed between the Zoumaling gully and the Wenjia gully. The distance between the two gullies is about 200 m, and a barrier lake was formed in the gap between the two fans. A

“rock-fill field” was formed with a length of about 4.3 km, and a width between 400–500 m and an average thickness of 5 m (Fig. 10b and c). A great number of debris materials consisting of silt and rock blocks destroyed schools, gas stations, and 379 replacement housings. Seven people were killed, 7 people were missing and 33 people were injured. The other gullies mentioned in Table 1 were not involved in the 8.13 debris flow event due to the insufficient amount of source material stored in these valleys.

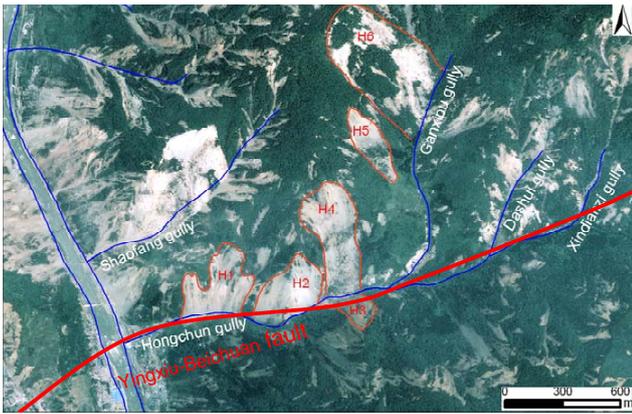
**Fig. 11.** Loose deposits induced by the 2008 Wenchuan Earthquake in the Hongchun gully, with an increase of loose material of about  $150 \times 10^4 \text{ m}^3$ . H is the abbreviations of landslides.

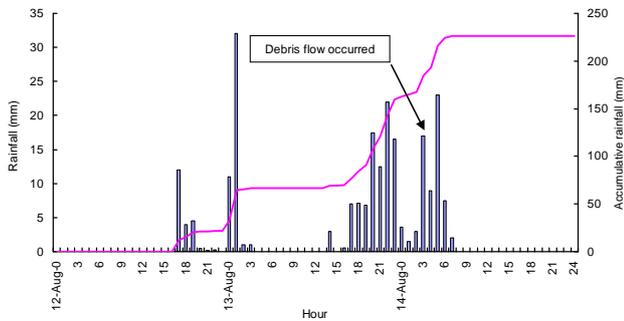
**Fig. 12.** Distribution of hourly and cumulative precipitation between 12 and 14 August 2010 in Yingxiu Town.

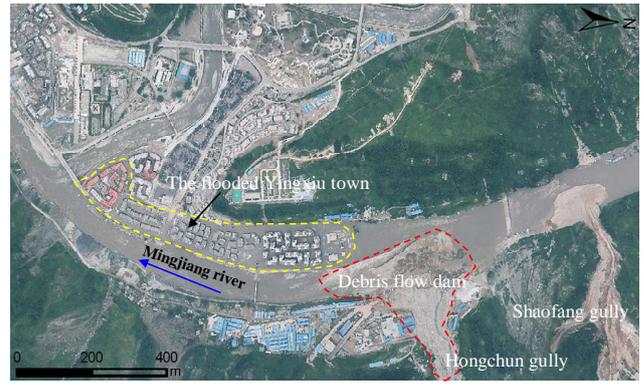
**Fig. 13.** Aerial photograph of the Hongchun gully debris flow and related flood (Supplied by the Sichuan geological environmental monitoring station).

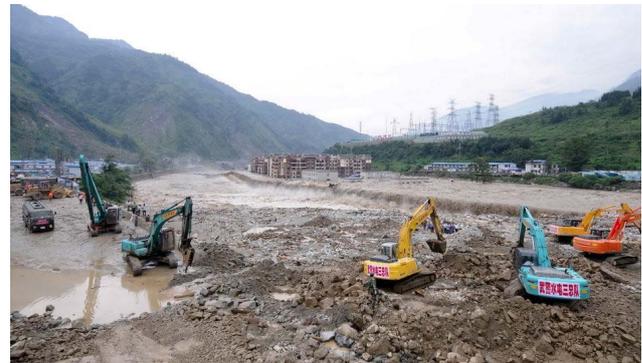
**Fig. 14.** Drainage works for the debris dam in Yingxiu Town after the 8.13 Hongchun gully debris flows.

A rainstorm occurred at 17:00 on 12 August, until 02:00 on 14 August 2010 in the Yingxiu Town region, which almost instantaneously triggered many hill-slope and channelized debris flows. Among them was the debris dam caused by the Hongchun gully debris flow, which changed the course of the river causing the flooding of the newly reconstructed Yingxiu town. Figure 12 shows the hourly and cumulative rainfall for this rain event. On 12 August 2010, 19.9 mm of rainfall was recorded between 17:00 and 24:00. A total of 126.8 mm rainfall was recorded during the entire day of 13 August. On 14 August, 23.4 mm was recorded between 0:00 and 02:00. A total cumulative rainfall of 162.1 mm in 33 h was recorded from 17:00 on 12 August until 02:00 on 14 August. Many eyewitnesses said that the most important debris flows started around 03:00, and ended at 04:30. Around  $40 \times 10^4 \text{ m}^3$  debris material was deposited into Minjiang River plane, forming a 10 m high natural debris dam 100 m in length across the river, and 150 m in width along the river. After that, a flood destroyed the Yingxiu New Town. Figure 13 is an aerial photo taken on 15 August 2010, showing the debris dam and the inundated Yingxiu Town. The estimated maximum discharge of the river through the town was  $570 \text{ m}^3 \text{ s}^{-1}$  shortly after the debris flow occurrence and reached a value of  $1400 \text{ m}^3 \text{ s}^{-1}$  on 15 August (Tang et al., 2011). After an emergency dredge of the debris dam, the Yingxiu New Town finally recovered again to a safe area (Fig. 14).

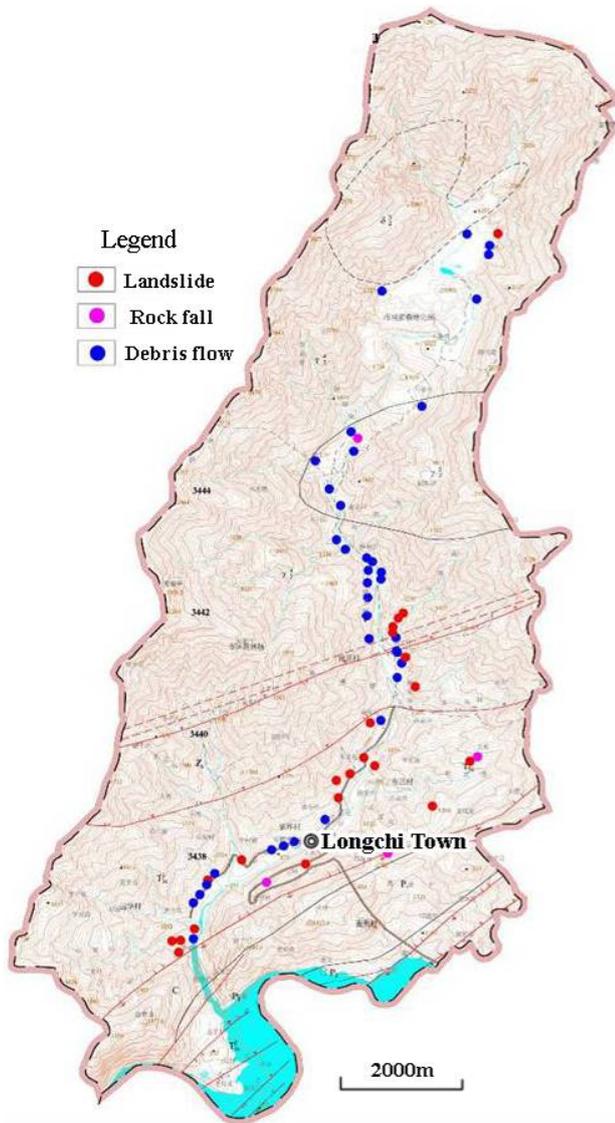
**Fig. 15.** The new geo-hazards triggered by the rainstorm on 13 August 2010 along the Longxi River.

The deposits of Longchi debris flow were mainly distributed along both sides of the Longxi River. During the field survey, 63 new landslides triggered by the heavy rainstorm on 13 August 2011 are detected (Fig. 15). The

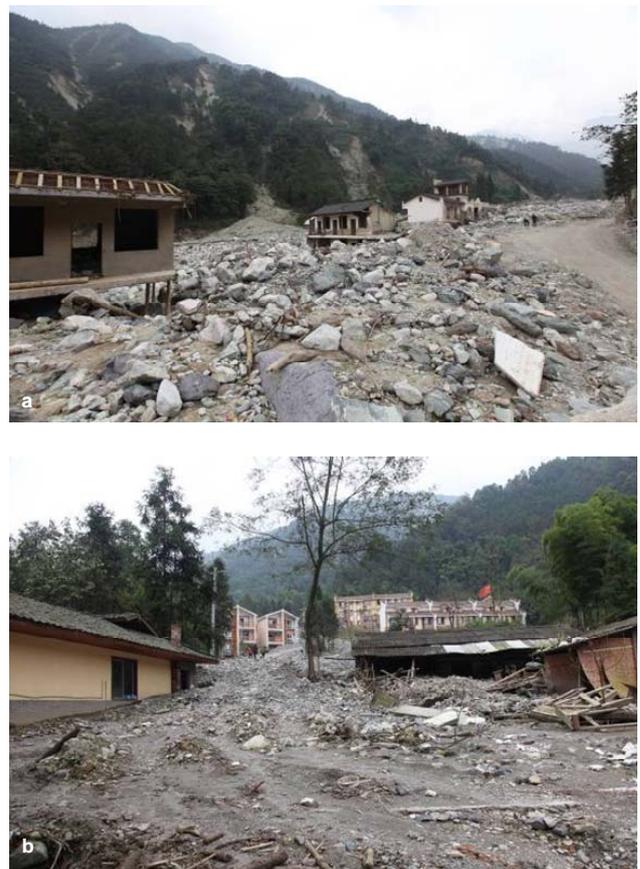
**Fig. 16.** Residential housing destroyed by the 8.13 Longchi debris flow in the Longxi catchment ((a): the housing located along the Longxi river destroyed by the debris flow; (b): the housing located on the right side of Longxi river was destroyed by the debris flow).

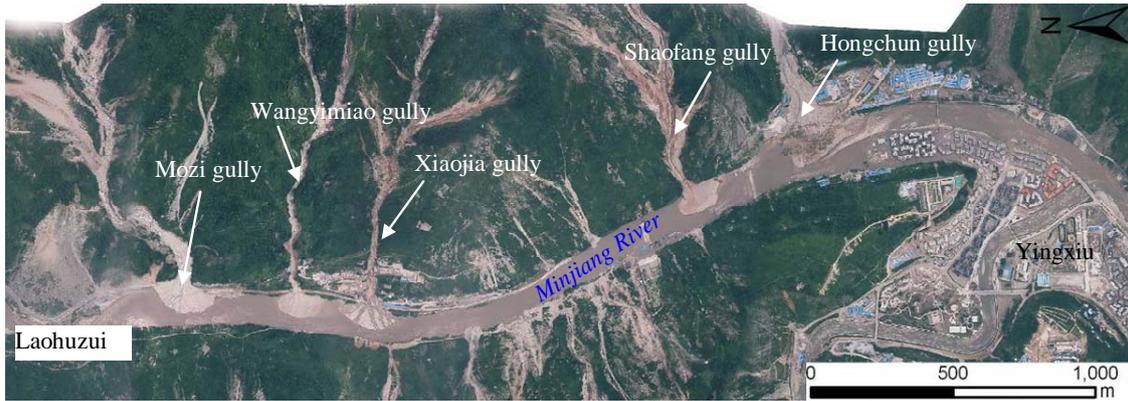
**Fig. 17.** Aerial photograph of the 8.13 debris flows between Yingxiu Town and Laohuzui along the Minjiang River (provided by the Sichuan geological environmental monitoring station).

abundant. Under rainfall condition, the debris flows can be triggered in every gully, showing the simultaneous character of these processes (Fig. 17).

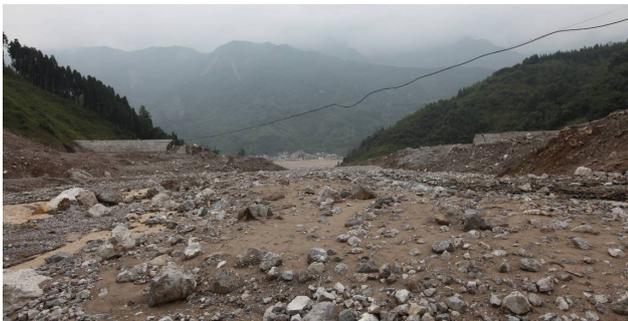
**Fig. 18.** Check dam destroyed by the 8.13 debris flow near the outlet of the Wenjia gully.

The devastating debris flows which happened after the Wenchuan Earthquake destroyed a number of protective constructions (Fig. 18) were caused by three factors: (1) High speed. The terrains of the Wenchuan Earthquake area are very steep with high channel gradients, generating high flow velocities. (2) Large magnitude. Due to the presence of abundant source materials, large magnitudes of debris flow material are always triggered with consequently extensive deposition areas, for instance, the spreading areas of the Wenjia gully and the Zoumaling gully debris flows. (3) Intermittent character. Due to the blocking effect of slope material in the channels, the debris flow events show paroxysmal and intermittent features.

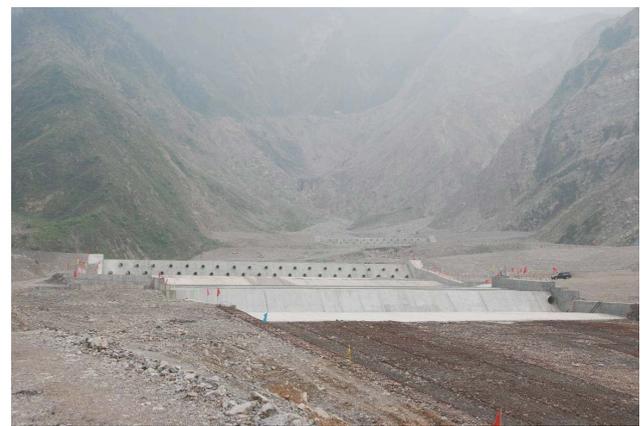
**Fig. 20.** Drainage system constructed in the upstream part of the Wenjia gully.

1. Control water supply. When the water source is sufficient at the part of headstream or upper valley, the drainage measures, such as drainage tunnels and surface-cut drains, should be used to cut or remove surface water. This method minimizes the amount of surface water flowing into the gully and mitigates or even eliminates the triggering conditions of debris flows. For example, the Wenjia gully has about  $3000 \times 10^4 \text{ m}^3$  source material accumulated in the lower part of the catchment on the "1300 m platform". This material can easily be transformed into debris flows by channelized water erosion. Considering the special terrain in the Wenjia catchment, after the 8.13 debris flow, a one diversion tunnel was constructed near the "1300 m platform", which leads a diversion of the upstream surface water into the No. 1 branch as shown in Fig. 19. The length of the diversion tunnel is 450 m, the inner cross-section is  $4.5 \times 3.5 \text{ m}^2$  and the gradient is 5%. In order to improve the diversion capacity, two check dams with 5 m height and one sand trap were built upstream of the diversion tunnel entrance (Figs. 19 and 20). The main role of the dams is to prevent the deposits coming from the upstream branches (No.2–No.4) from block the diversion tunnel. The surface water coming from upstream can be diverted into the No. 1 branch by filtering in the sand trap. During the rainy season from June to August, 2011, several rainstorms with rainfall intensities similar to the 8.13 events attacked the Qingping Town again, and the mitigation measures which were completed in May 2011 proved to be effective in the Wenjia gully. Figure 21 shows a cumulative rainfall of 368.5 mm in the Wenjia gully region from 30 June to 4 July 2011. On 4 July, the rainfall intensity was  $43 \text{ mm h}^{-1}$  with a duration of 10 h. The floods and debris flow, which developed in the upstream part of the catchment was diverted successfully through the tunnel. From 14 to 21 August 2011, the cumulative rainfall reached an amount of 404.5 mm, and the flood was

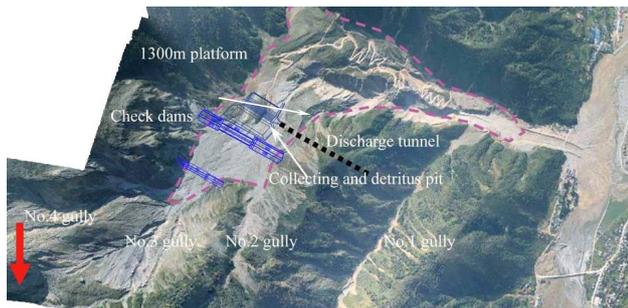
**Fig. 19.** An overview of the Wenjia gully debris flow and the remedial works.

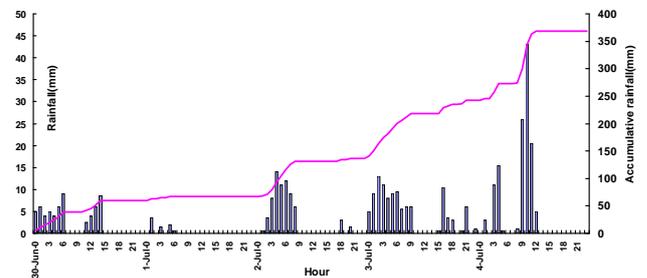
**Fig. 21.** Distribution of hourly and cumulative precipitation between 30 June and 4 July 2010 in Qingping Town.

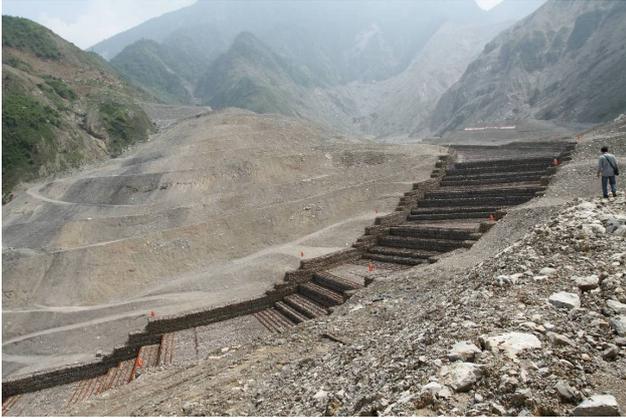
**Fig. 22.** A flexible erosion prevention system constructed in the Wenjia gully.

3. Control of the channelized erosion by using flexible drainage channels. Considering the channel erosion characteristics of the debris flows occurring after the Wenchuan Earthquake, drainage channels with consistent flexible reinforced stone cages are used to mitigate the concentrated erosion. During the debris flow process, some local failures of the drainage system may lead to infiltration of water into the loose deposits. A new runoff erosion channel can be formed and continually expanded, which could result in a failure of the drainage system. Compared to the traditional reinforced concrete drainage systems, the reinforced flexible stone cages could self-repair the damaged parts. Moreover, it is easy to repair the local failures and replace the stone cages. After the 8.13 debris flows, flexible drainage systems were constructed in the channelized midstream part of the Wenjia gully (Fig. 22) and the downstream part of the Hongchun gully. This type of mitigation method also proved to be effective during the debris flow events which happened during the 2011 rainy season.
