# Epic landslide erosion from mountain roads in Yunnan, China – challenges for sustainable development

R. C. Sidle<sup>1,\*</sup>, M. Ghestem<sup>2</sup>, and A. Stokes<sup>3</sup>

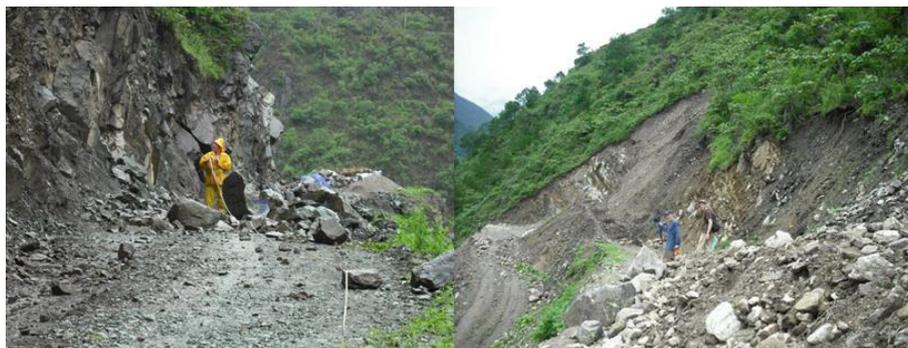
**Figure 2.** The highest landslide erosion occurred along a 1-year old road (DXD) leading to a remote village and a future hydropower plant just south of Daxingdi, Yunnan.

The DXD road had a large number ( $> 31.3 \text{ km}^{-1} \text{ yr}^{-1}$ ) and the highest rate ( $43\,789 \text{ Mg ha}^{-1} \text{ yr}^{-1}$ ) of road-fill landslides (Table 2; Fig. 5). Of the 27 fill failures that occurred along this monitored segment of road, the average gradient below the road was  $44.4^\circ$ . As such, when unconsolidated rock and soil material from the blasting and excavation was deposited on these steep side slopes, it sometimes failed immediately or shortly thereafter during a large storm. In contrast, two other road segments (FG1 and GXK) had significantly higher (about 9 to 16 times higher) landslide erosion along cut slopes compared to fill slopes (Fig. 5). These differences can be partially attributed to the gentler slope gradients immediately downslope of the road which contributed to the low numbers and volumes of fill slope landslides. The GXK road segment had only 2 fill failures with an average volume of  $58 \text{ m}^3$ , while the FG1 road had 12 failures with an average volume of  $124 \text{ m}^3$ . The WTW road segment, and especially the FG2, SFG1, and SFG2 segments, each had similar levels of cut slope and fill slope landslide erosion (Fig. 5). The greater than 4-fold increase in cut slope landslide volume in SFG2 (lower segment) compared to SFG1 (upper segment) is attributed the deeper road cuts into fractured bedrock in the lower segment (Fig. 3). Much fewer, though larger (mean mass =  $96.6 \text{ Mg}$ ), failures occurred along rocky cut slopes of SFG2, while more, though much smaller (mean mass =  $10.4 \text{ Mg}$ ) soil failures occurred along cut slopes of SFG1 (Table 2).

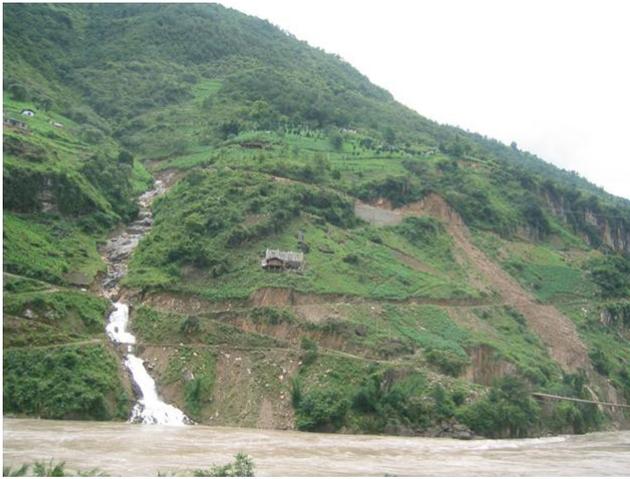
**Figure 3.** Road leading to a mountain village on the west side of the Salween River about 45 km south of Fugong. Upper portion of the road had (SFG1) the lowest landslide erosion of all surveyed segments, while the lower portion of the road (SFG2) had fewer numbers of, but larger, cut slope failures. Landslide erosion rates were significantly higher at SFG2 compared to SFG1 – 3.5 times higher for fill slope and 4.4 times higher for cut slope failures. The access bridge across the river is in the lower right corner of the photo.

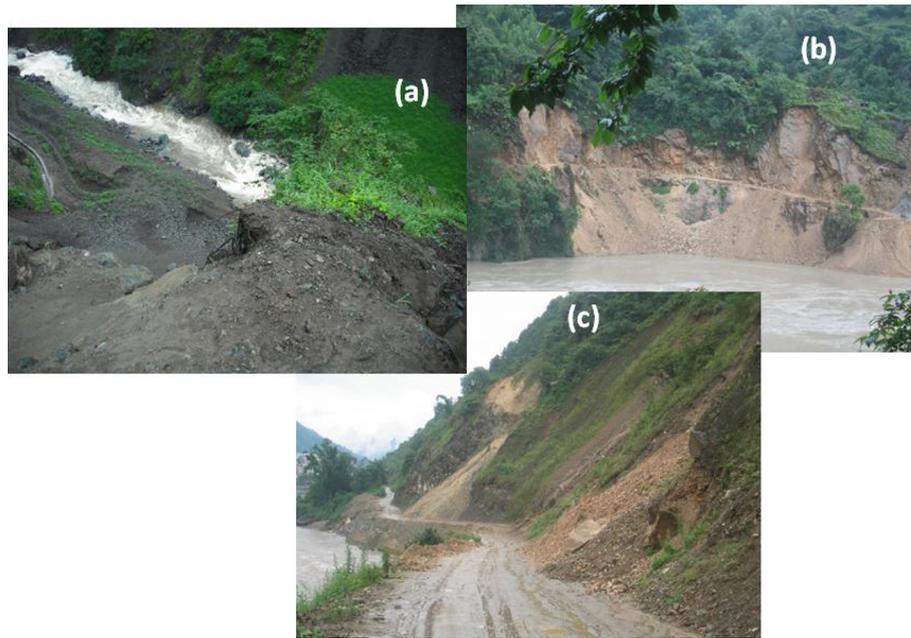
Figure 4. High rates of landslide sediment delivery to the Salween River from the (a) WTW and (b) FG1 roads.

landslide erosion also had the highest estimated sediment delivery (86 %); similarly high sediment delivery rates were estimated at WTW (82 %) and FG1 (80 %) partly due to their proximity to the Salween River (Fig. 4).

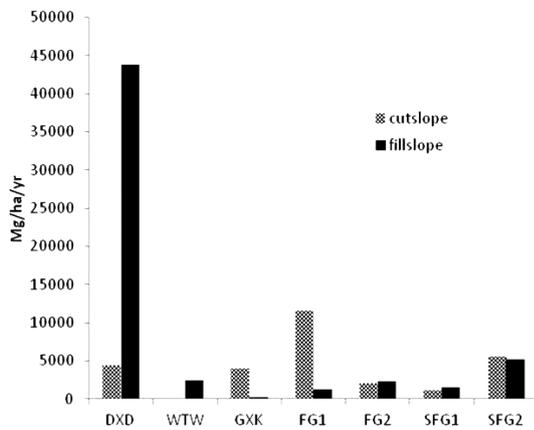
Figure 5. Landslide erosion from cut slopes and fill slopes for the seven surveyed road segments.

The relative proportion of landslide erosion along cut slopes and fill slopes varied among sites and was strongly influenced by terrain characteristics, the depth of road cuts into the hillside, and the disposition of fill material. Overall, more landslide sediment was produced from fill slopes (38 170 Mg) compared to cut slopes (29 055 Mg) even though cut slope failures outnumbered fill failures by 235 to 77 (more than a 3 : 1 ratio). Three examples stand out as having disproportionately higher cut slope or fill slope landslide erosion.

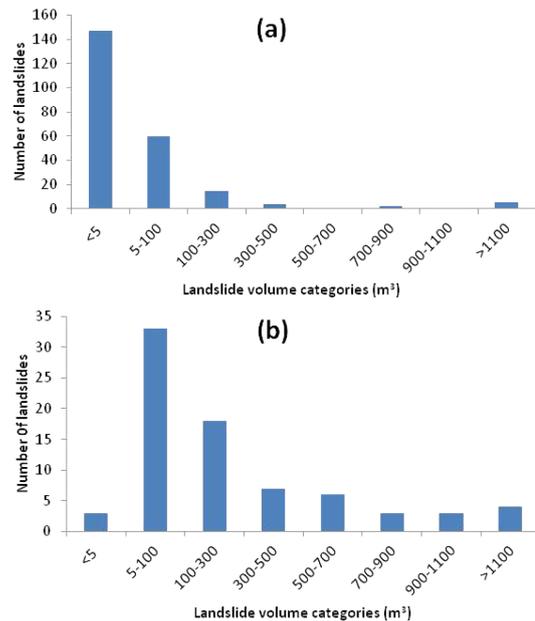
Figure 6. Size distribution for all surveyed landslides from (a) cut slopes ( $n = 235$ ) and (b) fill slopes ( $n = 77$ ).

The distribution of all cut slope landslides ( $n = 235$ ) was heavily skewed to small failures ( $< 5 \text{ m}^3$ ) (Fig. 6a). More than 88 % of all cut slope failures were  $< 100 \text{ m}^3$  ( $< 130 \text{ Mg}$ ). In contrast, fill slope landslides ( $n = 77$ ) followed a more Gaussian size distribution that was only somewhat skewed towards smaller failures (Fig. 6b). About 66 % of all fill slope failures were in the range of  $> 5$  to  $100 \text{ m}^3$  and less than 4 % were  $< 5 \text{ m}^3$ . Very large ( $> 1100 \text{ m}^3$  or  $> 1430 \text{ Mg}$ ) landslides along cut and fill slopes comprised only 2 and 5 % of the respective landslide numbers for these sites (Fig. 6). Nevertheless, the small number of very large

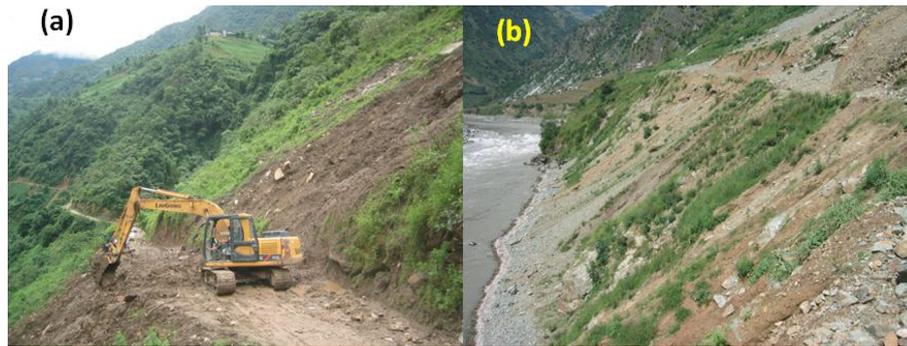
**Figure 7.** (a) A section of the FG2 road several kilometers north of Fugong that was temporarily closed by a landslide; and (b) secondary road to a small mountain village near Daxingdi (not included in our landslide survey) that was abandoned during construction because of excessive landslides.

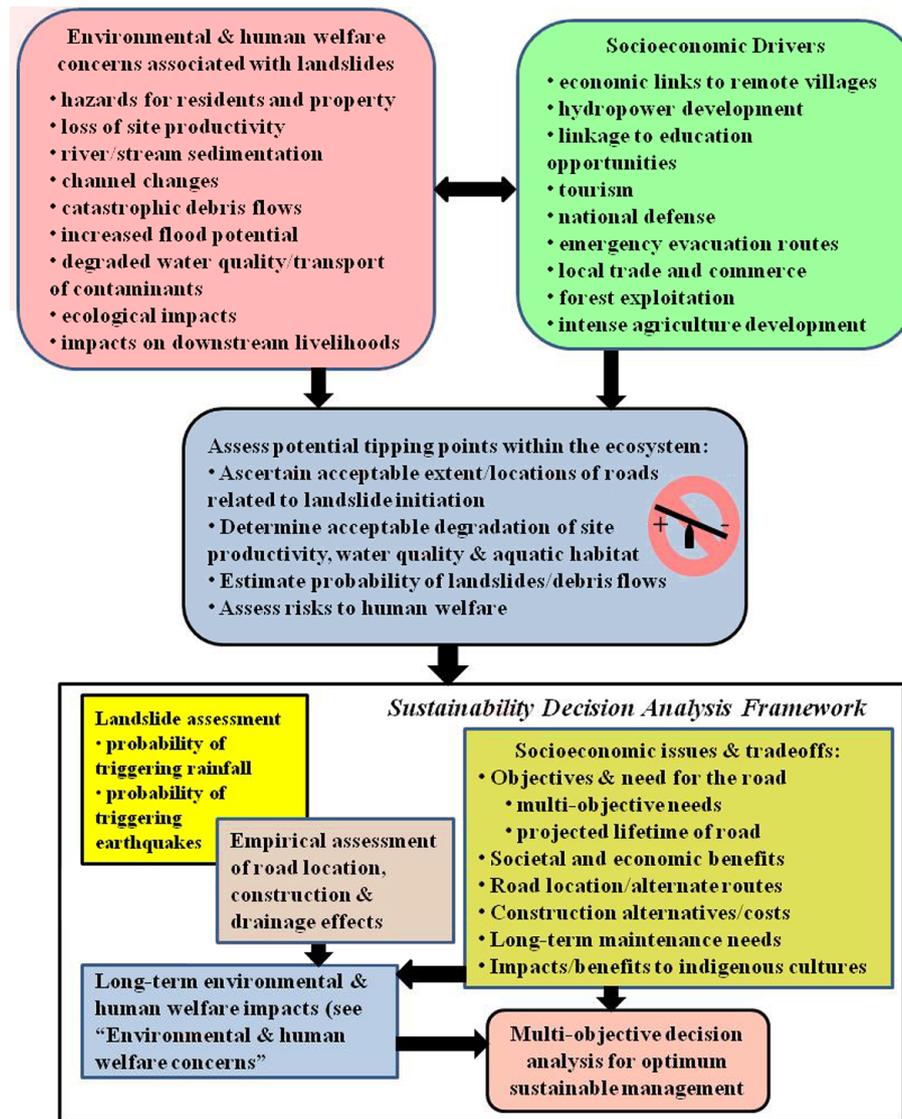
**Figure 8.** Decision framework for sustainability assessment of mountainous terrain in northwestern Yunnan, China, where extensive road construction is being proposed (modified extensively from Sidle et al., 2013).

2006). Furthermore, planting deep rooted woody vegetation on road fills can enhance long-term stability (e.g., Stokes et al., 2009). Such a systems-based approach that considers all possible road uses and benefits against environmental and human welfare costs (Fig. 8) offers a much more robust and sustainable alternative.

vironmental consequences of unintended forest exploitation (Fig. 8).
