Contributing factors to the failure of an unusually large landslide triggered by the 2014 Ludian, Yunnan, China, $M_s = 6.5$ earthquake

Z. F. Chang¹, X. L. Chen², X. W. An¹, and J. W. Cui¹

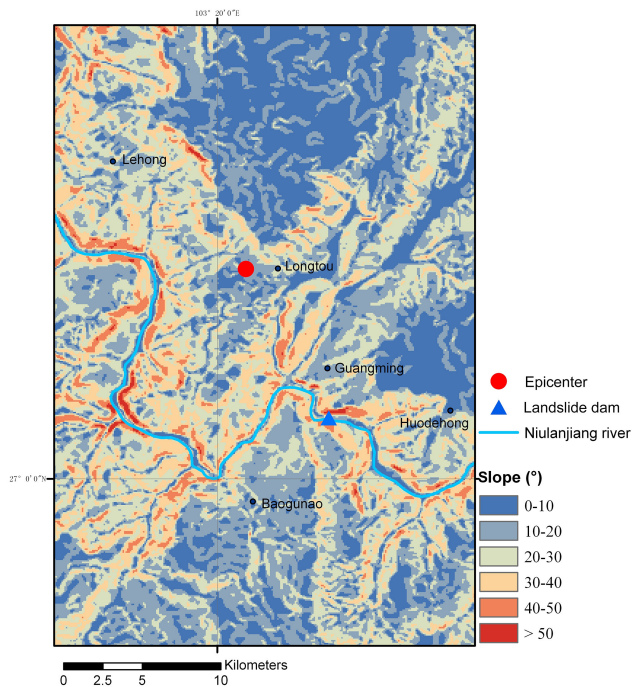
Figure 3. Map showing slope angles in the Ludian area.

Geographically, the Ludian seismic area is situated in the northeastern Yunnan–Guizhou plateau. Before Miocene times, it was a relatively intact and uniform peneplain. Since the end of the Miocene, due to many tectonic movements, this area has been uplifted and eroded. Consequently, the original peneplain was reformed into steep mountainous landscape with many intermountain lowlands (basins). As a major river in southwest China, the Niulanjiang River flows from southeast to northwest through the Ludian seismic area. Incision depths of up to 1200–3300 m form V-shaped valleys. On either bank of this river, the slopes are usually very steep. In the epicentral area of the 2014 Ludian earthquake, 80 % of the slopes steeper than 40° are located along the banks of the Niulanjiang River and its tributaries south of the epicenter (Fig. 3); while in the north and east of the seismic area, the terrain is relatively gentle, dominated by middle-height and low hills, with steepness generally less than 20° (Fig. 3).

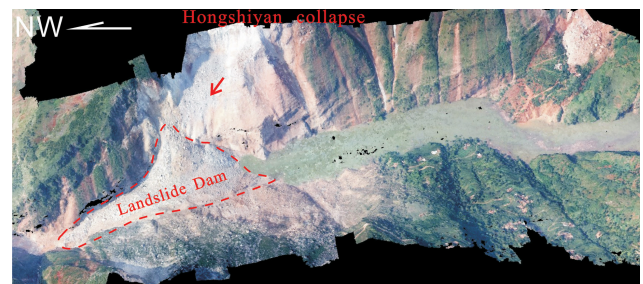
Figure 4. Unmanned aerial vehicle photo showing the landslide dam on the Niulanjiang River. (Image provided by the Institute of Geophysics, China Earthquake Administration. The strata dip is 15–30°.)

The Ludian $M_s = 6.5$ earthquake triggered a very large landslide on the right bank of the Niulanjiang River near the Hongshiyan village (27.035° N–103.397° E). The earthquake also partly reactivated an old landslide on the opposite left bank. Both landslides combined to produce a barrier that dammed the river, resulting in a lake (Fig. 4).

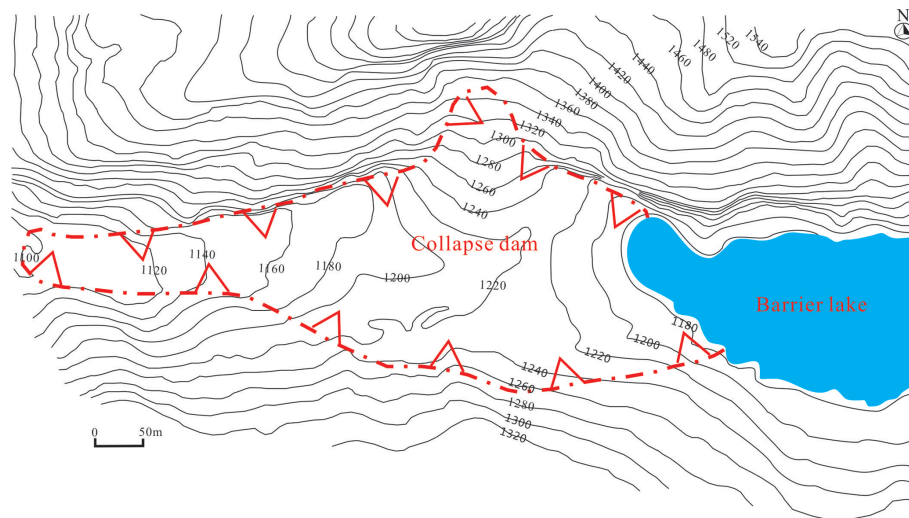
Figure 5. Plan of the landslide dam on the Niulanjiang River at Hongshiyuan. Contours are elevations above sea level (modified from Institute for Earthquake Engineering Survey of Yunnan Province, 2014).

The landslide at Hongshiyan dams the V-shaped valley of the Niulanjiang River. It is 1000 m long and 270 m wide, with a surface area of $2.8 \times 10^5 \text{ m}^2$. The elevation is 1216 m at the dam top, and 1110 m at the dam base, with the maximum height of the dam 120 m above river level (Fig. 5). The total volume of the dam is estimated to be about $1.0 \times 10^7 \text{ m}^3$ (Institute for Earthquake Engineering Survey of Yunnan Province, 2014).

the right bank and 1270 m on the left, respectively. Upstream the dam slope is relatively steep with an average slope ratio of 1 : 2.5; while downstream the dam slope is less steep with an average slope ratio of 1 : 5.5 (Figs. 5 and 6).

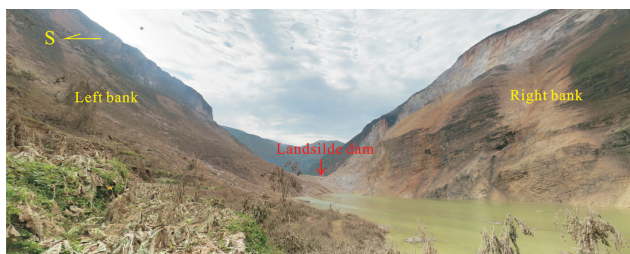
Figure 6. Overall look of the landslide dam at Hongshiyuan (view toward west).

The old landslide lies on the southern side of the landslide dam (Fig. 6). It is 1200 m wide at the base, 900 m from the top to the bottom, with an average thickness of 70 m and a volume of $5.67 \times 10^7 \text{ m}^3$ (Fig. 7). The upper slopes are steep

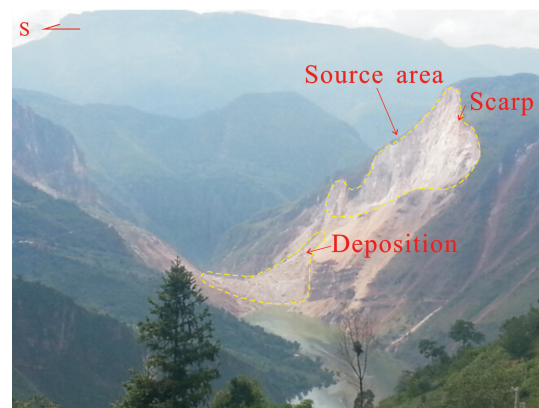
Figure 8. New landslide induced by the 2014 Ludian quake on the right bank of the Niulanjiang River at Hongshiyuan (view toward west).

The avalanche on the right bank of the Niulanjiang River triggered by the 2014 Ludian earthquake is the primary source of the debris forming the landslide dam at Hongshiyuan. Its source is at an elevation of 1680 m. The source area is 890 m long and the highest rear scarp is up to 500 m (Fig. 8). The total volume is estimated at about $1.0 \times 10^7 \text{ m}^3$. Field investigations indicate that the avalanche consists of medium-bedded dolomitic limestone and dolostone intercalated with sandstone and shale of Ordovician, Silurian, Devonian and Permian systems. These rocks are laced with numerous joints and fissures. In particular, unloading cracks and broken rocks characterize the upper part of the slope. Detailed descriptions of this landslide are in the next section.

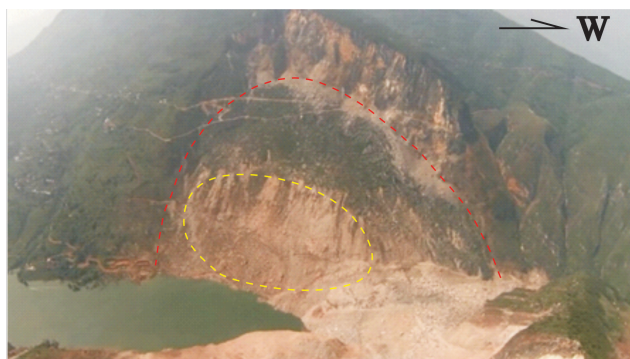
Figure 7. Photo showing the old landslide on the left bank of the Niulanjiang River. Red dashed line denotes old landslide. Yellow dashed line shows the frontal part that collapsed during the 2014 Ludian event (view toward south).

The rear scarp of the old landslide, which is 300 m high (elevations of rear and frontal edges are 1850 and 1550 m, respectively), suffered from local collapse (red dashed line in Fig. 7) during the 2014 Ludian $M_s = 6.5$ quake, and part of its front slipped into the river (yellow dashed line in Fig. 7). Meanwhile, the surface layer of this old landslide became loose, causing big boulders (the largest is up to 5 m in diameter) and pebbles to slide into the river, which joined the

avalanche from the right bank to create the dam on the river. Nevertheless, the main body of this old landslide remained relatively stable during the shock, except for cracks on its surface.

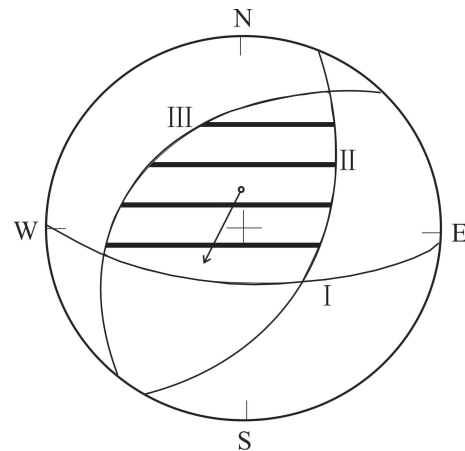
Figure 10. Wolf projection of joints in individual avalanches at Hongshiyan (projection of lower hemisphere). I: steep joint parallel to river, II: steep joint at a normal angle to the river, III: interbed joint (see Table 2).

We use the projection on the equator plane of the WolfNet to describe the structure of the rock on the slope around the landslide (Fig. 10). It can be assumed that the steep joint at a normal angle to the river (I) and that which is parallel to the river (II) cut the rock body into a small mass. In addition to the gentle dipping joint (III), they will generate an unstable

block (shaded area in Fig. 10). Under seismic shaking, this block is prone to slip toward the open side of the slope (along river flow) (arrow in Fig. 10).

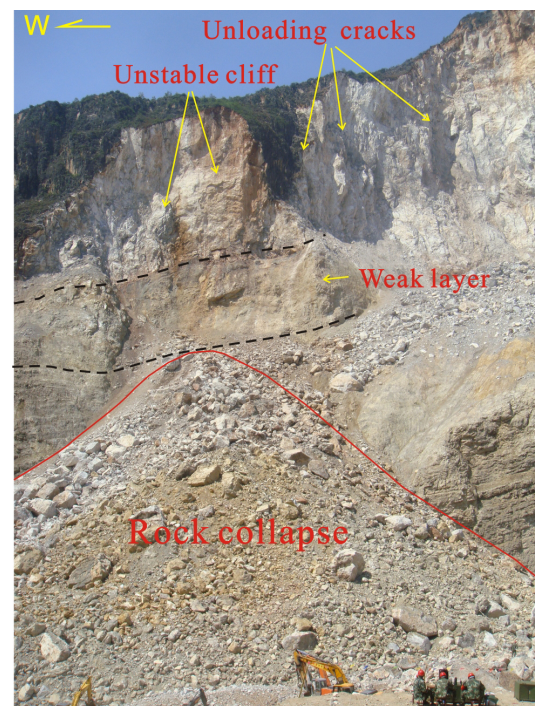
**Figure 11.** Rock structure that unleashed the rock avalanche at Hongshiyuan during the Ludian earthquake.

At this site, the upper portion of the slope is dolomite that is relatively strong, while sandy mudstone and shale constitute the lower portion and are relatively weak (Figs. 9 and 11). In natural conditions, the brittle rock in the upper portion of the slope is prone to fracturing, while the weak rock in the lower portion of the slope deforms plastically. Under seismic shaking, this weak rock would be compressed, inducing instability in the rock of the upper portion, and becoming a potential sliding surface. The weak rock in the lower portion has many cracks and joints present. The weak layer served as the slip surface during the landsliding (Fig. 11).

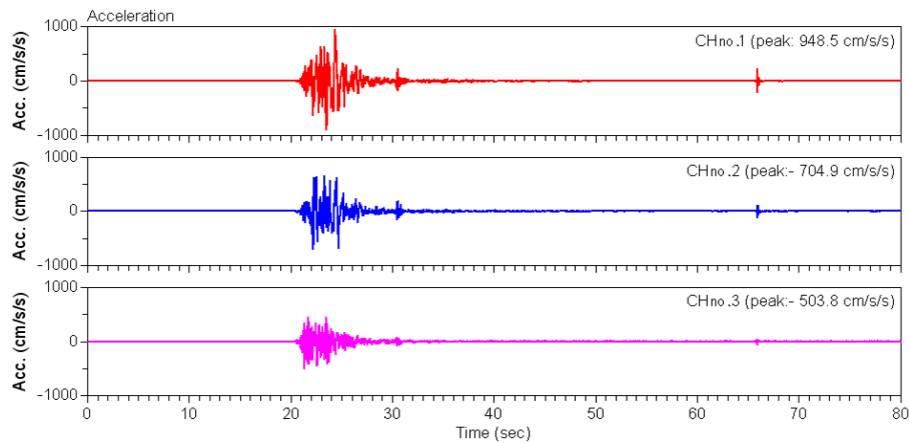
Figure 12. Peak ground accelerations recorded by the Longtoushan seismic station during the 2014 Ludian $M_s = 6.5$ earthquake. Red: EW component, blue: NS component, pink: vertical component.

Although the 2014 Ludian earthquake is a moderate-sized event, the Longtoushan seismic station near the epicenter recorded high acceleration values of ground motion. The peak ground accelerations of NS, EW and vertical components are 948.5Gal, 704.9Gal and 503.8Gal, respectively (Fig. 12). The intensity of the most heavily affected area is IX degree according to the Chinese seismic intensity scale (Seismic Intensity Zoning Group et al., 1990).

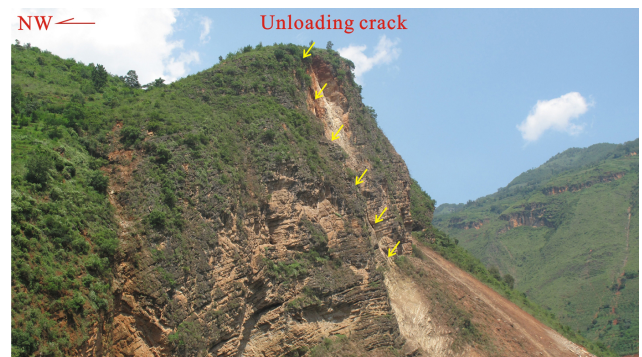
Figure 13. Unloading fissures (shown by yellow arrows) on the rear edge of slope at Pearl Spring.

Under extensional stress, numerous unloading fissures have developed in the rock of the slopes along the valley of the Niulanjiang River near Hongshiyuan. Both banks of the river comprise steep slopes, with numerous unloading cracks. On the surface, many medium to steeply dipping unloading fissures are seen that are parallel to the river. For instance, on the slope behind the Pearl Spring on the upstream right bank, about 1.8 km from the seismic dam near Hongshiyuan, there is a long unloading crack (Fig. 13). It dips almost vertically, parallel to the bank, with a maximum opening width of about 15 cm (Fig. 13). Cut by this crack, the rock surrounding it is nearly separated from the slope, forming a dangerous rock mass that is 30–40 m high, 15 m wide and 5 m thick, with a volume of 3000 m³. Beneath this rock mass, thin beds of rock dip gently downstream. Gentle terrain appears below the steep slope, where the upper portion of the rock mass has partly broken off and is hanging (Fig. 13).

From observations to fissures on the surface of either bank of the river, the depth of the intense unloading zones is estimated to be over 50 m. Such fissures and rock structure may jointly form unstable rock masses on the slope, which would become a favorable place for large-scale landsliding.
