Earthquake response of heavily damaged historical masonry mosques after restoration

Ahmet Can Altunışık and Ali Fuat Genç

Department of Civil Engineering, Karadeniz Technical University, Trabzon, 61080, Turkey

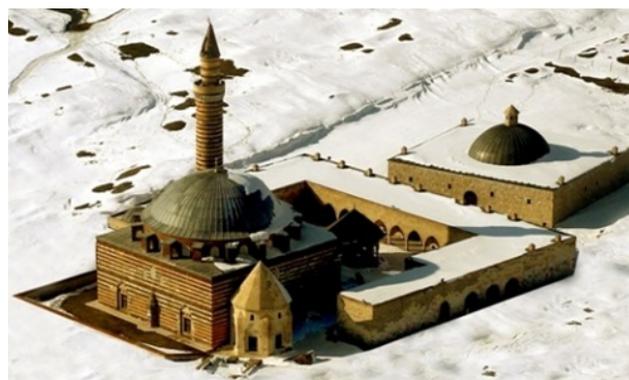
Figure 1. Undamaged view of the Hüsrev Pasha Mosque and social complex.

and Settlement of Turkey in 1996. Because of this characteristic, the mosque has been damaged severely by earthquakes. The mosque and social complex which had stood for centuries were damaged by the 1839 earthquake and fire. After this unfortunate event the complex was restored. During World War I the complex and mosque were vandalized heavily. In addition to these events, the complex and mosque were ruined by the 2011 Van earthquakes. The minaret and last prayer area were heavily damaged in these earthquakes. Today the prayer area and shrine are structurally sound, but the rest of the complex is highly damaged or has been destroyed. For this reason the mosque was closed for praying, and the aim of the restoration project is to open the mosque for praying. Undamaged views of the mosque are given in Fig. 1.

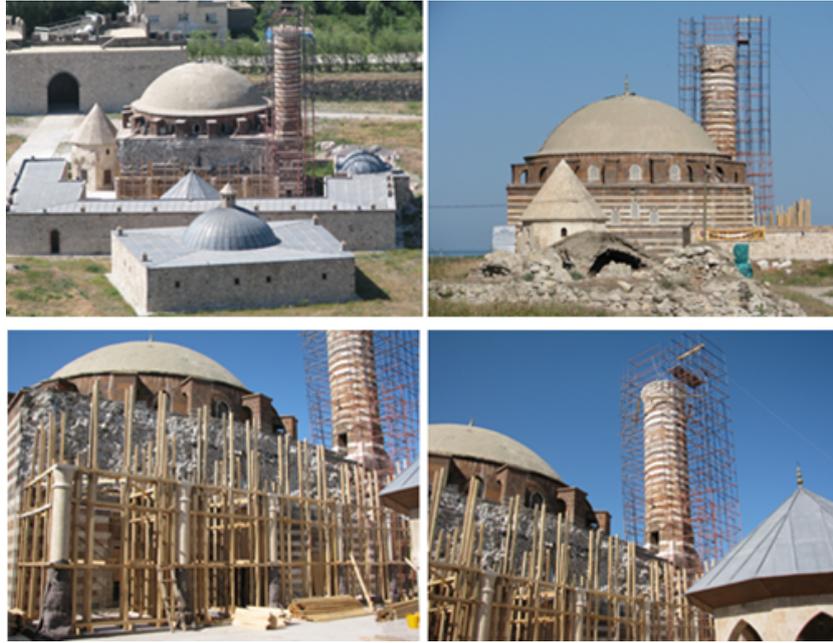
Figure 2. Damaged views of the Hüseyin Pasha Mosque.

Today there are some influences which detrimentally affect the structural performance of the mosque. These influences are structural cracks, material deformations, destroyed parts of the carrier system, and environmental issues (e.g., algae and humidity). Some views of these influences and damaged views of the mosque are shown in Fig. 2.

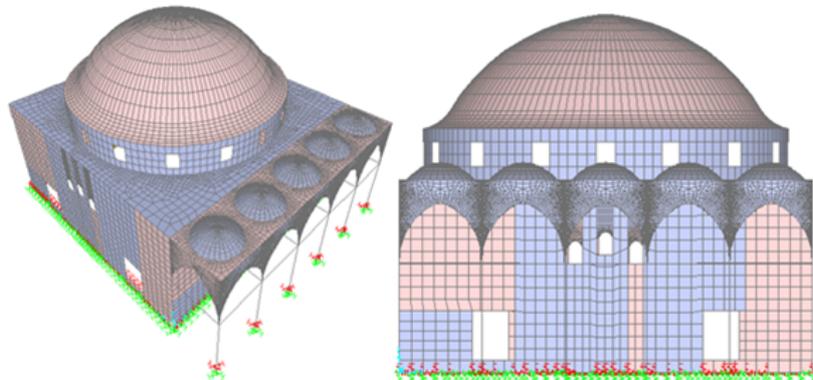
Figure 3. Finite element model of the mosque with 16 window openings.

The mosque had 16 window openings before the restoration, so the finite element model of the mosque was designed with 16 window openings. The model of the mosque has 27 297 nodes, 127 frame elements, 25 653 area elements and 102 460 3-D solid elements. The finite element model of the mosque with 16 window openings is shown in Fig. 3.

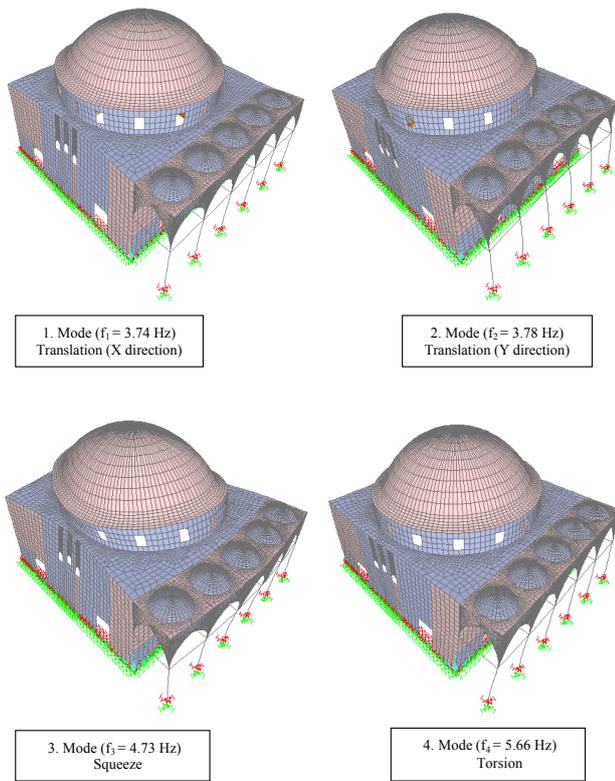
Figure 4. First four mode shapes and frequencies.

Dynamic characteristics were obtained with modal analysis. A 5 % damping ratio was used in the analysis. A total of 20 mode shapes was obtained after the analyses. The first four mode shapes and frequencies are given in Fig. 4.

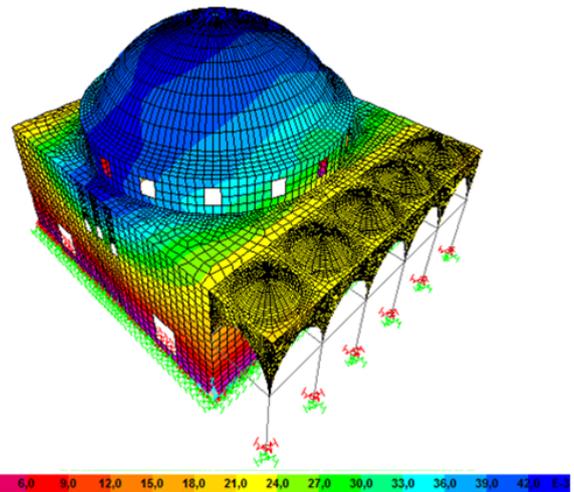
Figure 5. Maximum displacements contour diagram of the mosque with 16 window openings under dead load and earthquake load in the x direction (G + EX).

The maximum displacements contour diagram of the Hüsrev Pasha Mosque with 16 window openings under dead load and earthquake load (G + EX) is shown in Fig. 5. It can be seen in Fig. 5 that the maximum displacement occurred at the middle point of the big dome and had a value of 42.0 mm. In addition, these displacements have a decreasing trend from the top of the dome to the lower part of the mosque.

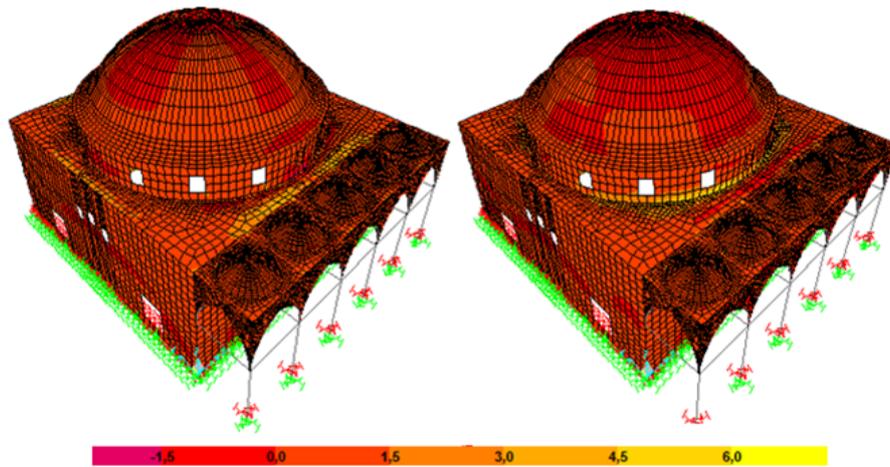
Figure 6. Maximum tensile stresses contour diagram for the outer and inner surfaces of the mosque with 16 window openings under dead load and earthquake load (G + EX).

The maximum tensile stresses contour diagram is shown in Fig. 6. It is seen in Fig. 6 that the maximum values of the tensile stresses for the outer surface of the mosque occurred at the side and in the lower part of the big dome, near the window spaces and transition areas between the side walls, and measured 1.05 MPa. The maximum tensile stresses for the inner surface of the mosque had a value of 1.00 MPa.

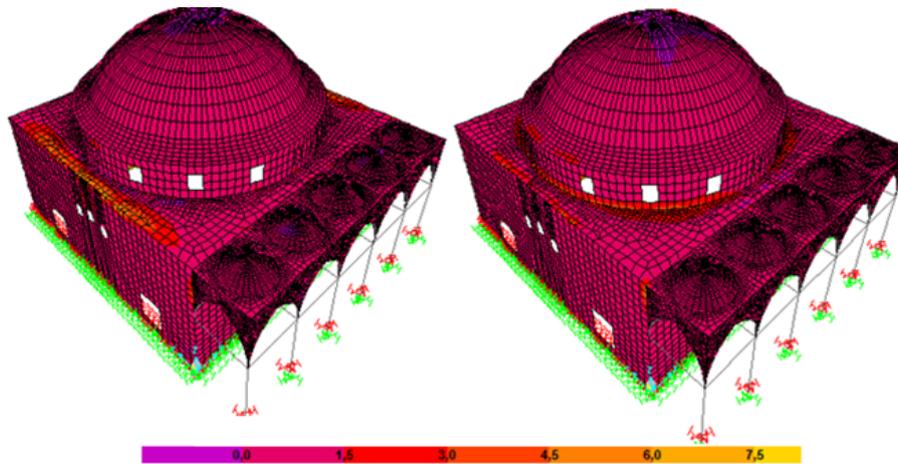
Figure 7. Maximum compression stresses contour diagram for the outer and inner surfaces of the mosque with 16 window openings under dead load and earthquake load (G + EX).

The maximum compression stresses contour diagram for the outer and inner surfaces of the Hüsrev Pasha Mosque with 16 window openings under dead load and earthquake load (G + EX) is shown in Fig. 7. It is seen in Fig. 7 that the maximum values of the compression stresses for the outer surface of the mosque occurred between the dome and the side wall transition areas, near window spaces on the dome, and measured 2.05 MPa. Additionally, these maximum compression stresses for the inner surface of the mosque had a value of 1.85 MPa.

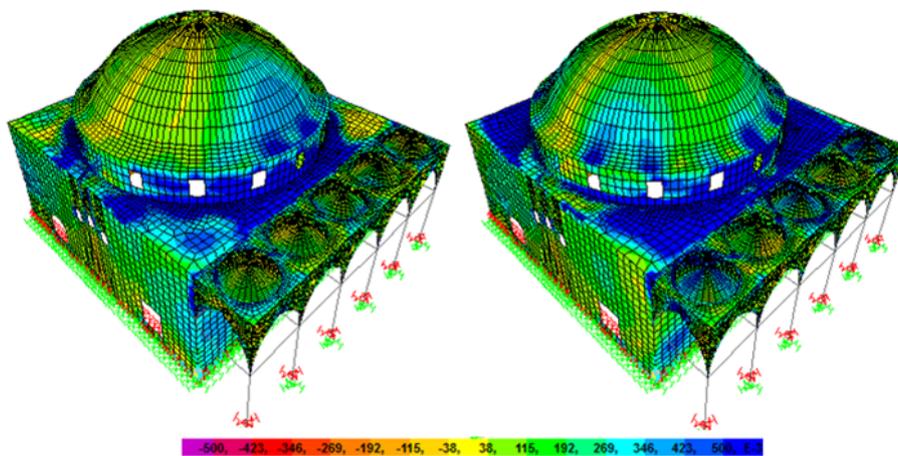
Figure 8. Maximum shear stresses contour diagram for the outer and inner surfaces of the mosque with 16 window openings under dead load and earthquake load (G + EX).

The maximum shear stresses contour diagram for the outer and inner surfaces of the Hüsrev Pasha Mosque under dead load and earthquake load (G + EX) is shown in Fig. 8. It is seen in Fig. 8 that the maximum values of the shear stresses for the outer and inner surfaces of the mosque are 0.65 and 0.60 MPa respectively.

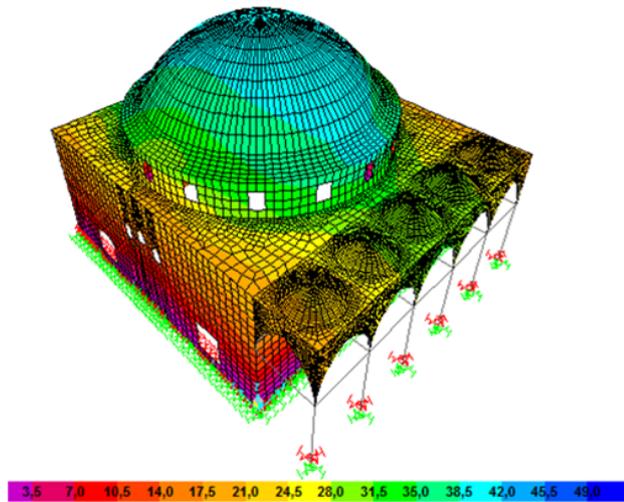
Figure 9. Maximum displacements contour diagram of the mosque with 16 window openings under dead load and earthquake load in the y direction (G + EY).

The maximum displacements contour diagram of the Hüsrev Pasha Mosque with 16 window openings under dead load and earthquake load (G + EY) is shown in Fig. 9. It can be seen in Fig. 9 that the maximum displacement occurred at the middle point of the big dome and had a value of 44.0 mm. In addition, these displacements have a decreasing trend from the top of the dome to the lower part of the mosque.

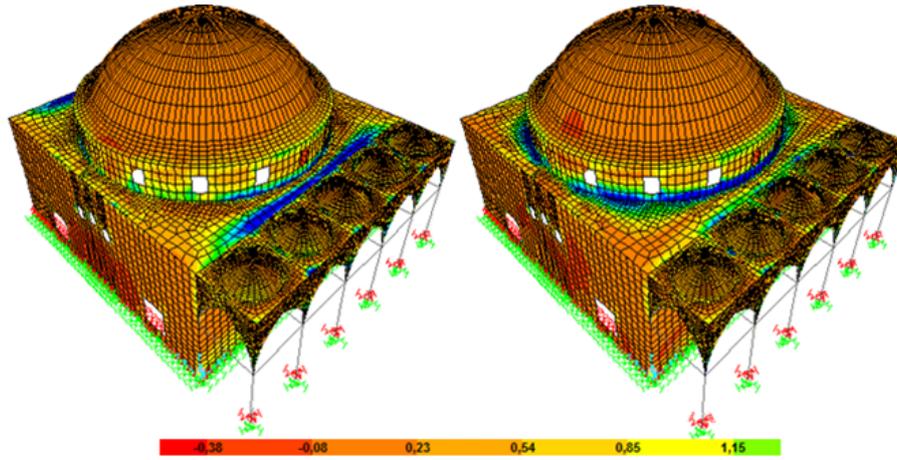
Figure 10. Maximum tensile stresses contour diagram for the outer and inner surfaces of the mosque with 16 window openings under dead load and earthquake load (G + EY).

The maximum tensile stresses contour diagram is shown in Fig. 10. It is seen in Fig. 10 that the maximum values of the tensile stresses for the outer surface of the mosque occurred at the side and in the lower part of the big dome, near the window spaces and transition areas between the side walls, and measured 0.95 MPa. The maximum tensile stresses for the inner surface of the mosque had a value of 0.75 MPa.

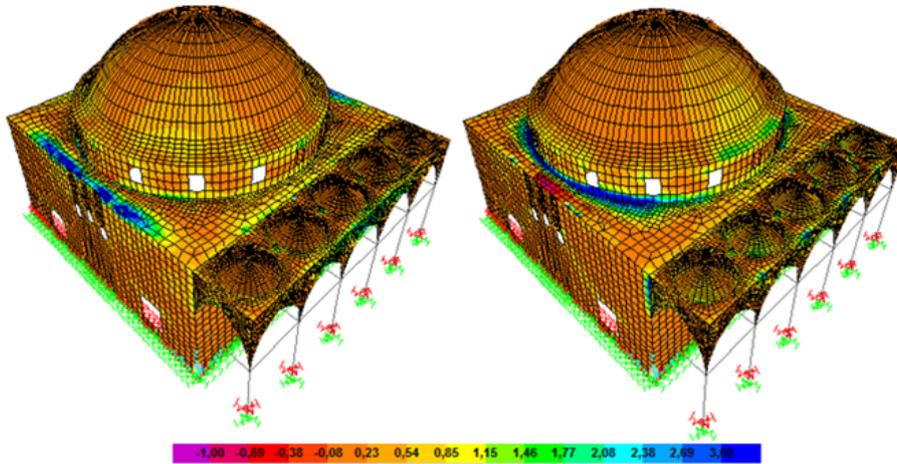
Figure 11. Maximum compression stresses contour diagram for the outer and inner surfaces of the mosque with 16 window openings under dead load and earthquake load (G + EY).

The maximum compression stresses contour diagram is shown in Fig. 11. It is seen in Fig. 11 that the maximum values of the compression stresses for the outer surface of the mosque occurred between the dome and the side wall transition areas, near window spaces on the dome, and measured 1.15 MPa. Additionally, these maximum compression

stresses for the inner surface of the mosque had a value of 1.10 MPa.

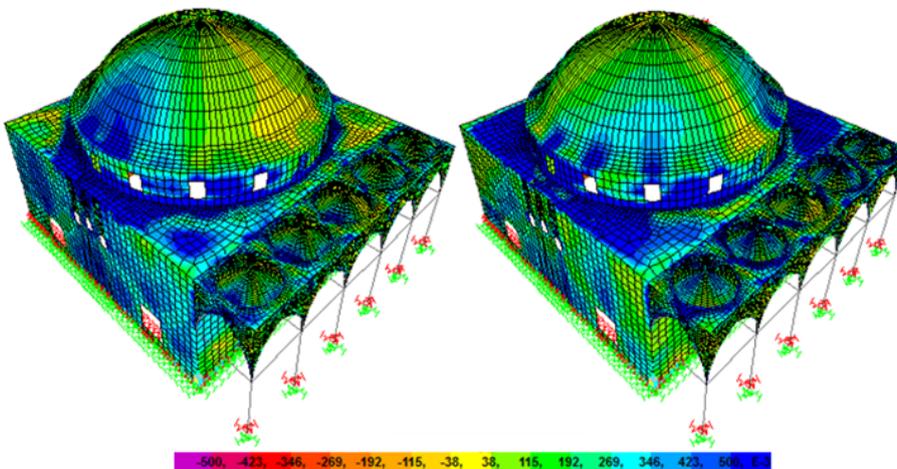
Figure 12. Maximum shear stresses contour diagram for the outer and inner surfaces of the mosque with 16 window openings under dead load and earthquake load (G + EY).

The maximum shear stresses contour diagram for the outer and inner surfaces of the Hüsrev Pasha Mosque under dead load and earthquake load (G + EY) is shown in Fig. 12. It is seen in Fig. 12 that the maximum values of the shear stresses for the outer and inner surfaces of the mosque are 0.60 and 0.55 MPa respectively.

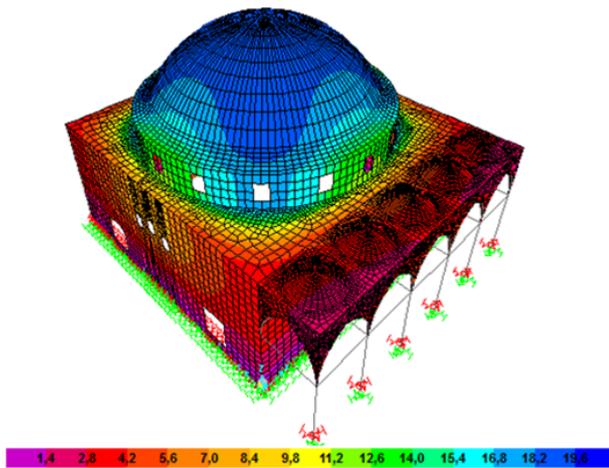
**Figure 13.** Maximum displacements contour diagram of the mosque with 16 window openings under dead load and earthquake load in the z direction (G+EZ).

The maximum displacements contour diagram of the Hüsrev Pasha Mosque with 16 window openings under dead load and earthquake load (G+EZ) is shown in Fig. 13. It can be seen in Fig. 13 that the maximum displacement occurred at the middle point of the big dome and had a value of 19.6 mm. In addition, these displacements have a decreasing trend from the top of the dome to the lower part of the mosque.

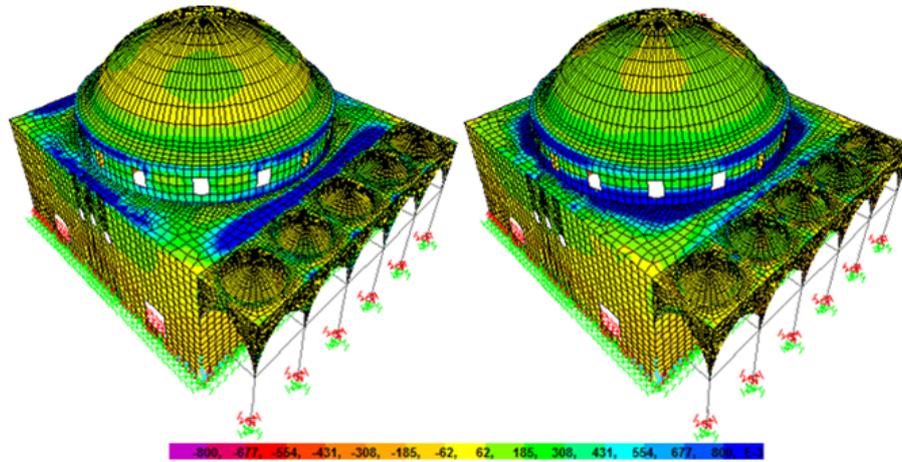
Figure 14. Maximum tensile stresses contour diagram for the outer and inner surfaces of the mosque with 16 window openings under dead load and earthquake load (G+EZ).

The maximum tensile stresses contour diagram is shown in Fig. 14. It is seen in Fig. 14 that the maximum values of the tensile stresses for the outer surface of the mosque occurred at the side and in the lower part of the big dome, near the window spaces and transition areas between the side walls,

and measured 0.85 MPa. The maximum tensile stresses for the inner surface of the mosque had a value of 0.80 MPa.

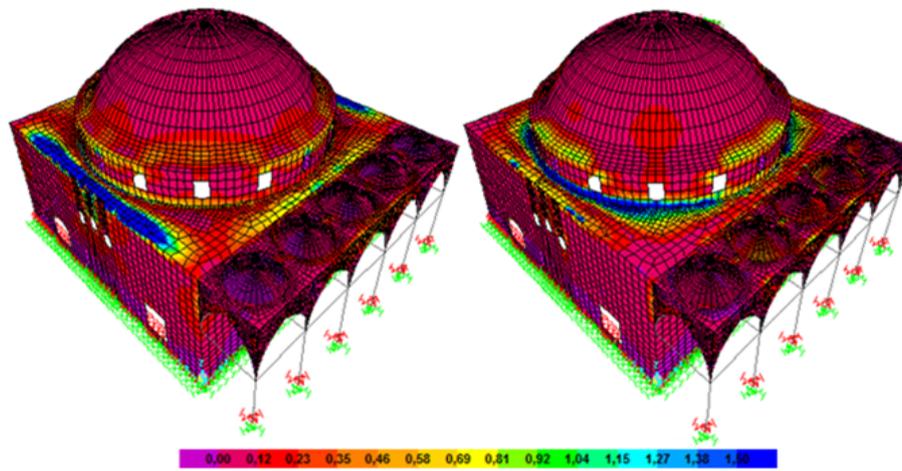
Figure 15. Maximum compression stresses contour diagram for the outer and inner surfaces of the mosque with 16 window openings under dead load and earthquake load (G+EZ).

The maximum compression stresses contour diagram is shown in Fig. 15. It is seen in Fig. 15 that the maximum values of the compression stresses for the outer surface of the mosque occurred between the dome and side wall transition areas, near window spaces on the dome, and measured 1.35 MPa. Additionally, these maximum compression stresses for the inner surface of the mosque had a value of 1.25 MPa.

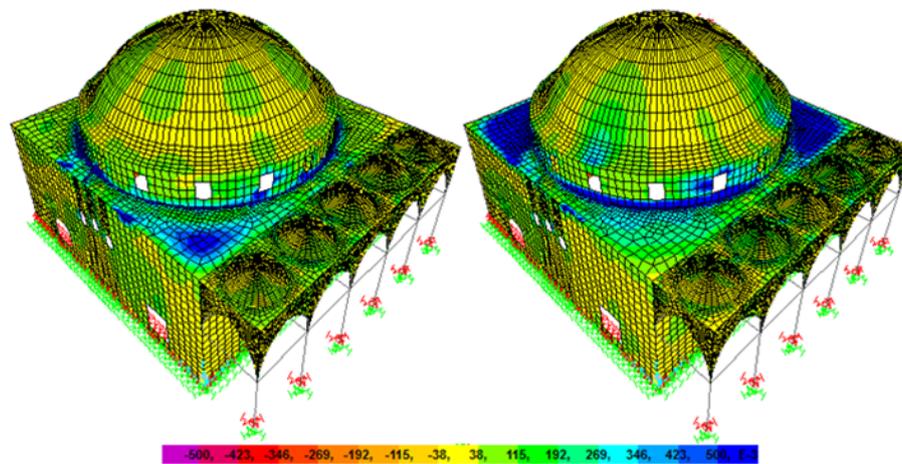
Figure 16. Maximum shear stresses contour diagram for the outer and inner surfaces of the mosque with 16 window openings under dead load and earthquake load (G+EZ).

The maximum shear stresses contour diagram for the outer and inner surfaces of the Hüsrev Pasha Mosque under dead load and earthquake load (G+EZ) is shown in Fig. 16. It is seen in Fig. 16 that the maximum values of the shear stresses for the outer and inner surfaces of the mosque are 0.50 and 0.45 MPa respectively.

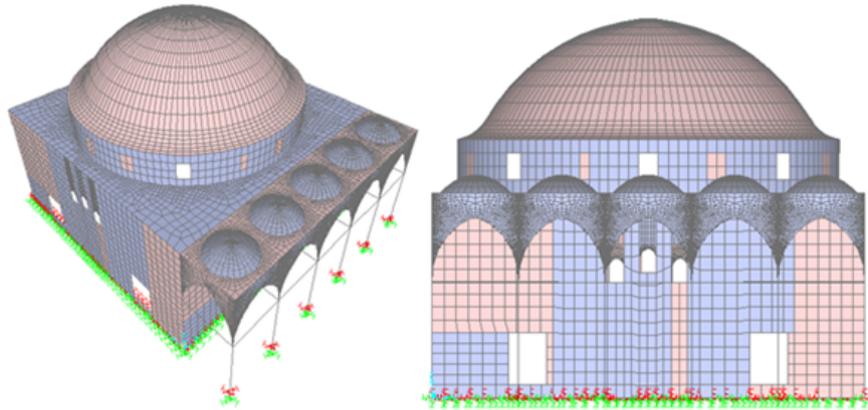
Figure 17. Finite element model of the mosque with eight window openings.

The mosque had eight window openings before the restoration, so the finite element model of the mosque was designed with eight window openings. The finite element model of the mosque with eight window openings is shown in Fig. 17. Using the modal analysis, the first four natural frequencies were obtained, with values of 3.81, 3.87, 4.81 and 5.78 Hz respectively. Mode shapes were obtained as translation in the x direction, translation in the y direction, squeeze and torsion respectively. Results of earthquake analyses are given in Table 3.
