Brief communication: Rapid assessment of damaged residential buildings in the Florida Keys after Hurricane Irma

Abstract. On 10 September 2017, Hurricane Irma made landfall in the Florida Keys and caused significant damage. Informed by hydrodynamic storm surge and wave modeling and post-storm satellite imagery, a rapid damage survey was soon conducted for 1600+ residential buildings in Big Pine Key and Marathon. Damage categorizations and statistical analysis reveal distinct factors governing damage at these two locations. The distance from the coast is significant for the damage in Big Pine Key, as severely damaged buildings were located near narrow waterways connected to the ocean. Building type and size are critical in Marathon, highlighted by the near-complete destruction of trailer communities there. These observations raise issues of affordability and equity that need consideration in damage recovery and rebuilding for resilience.

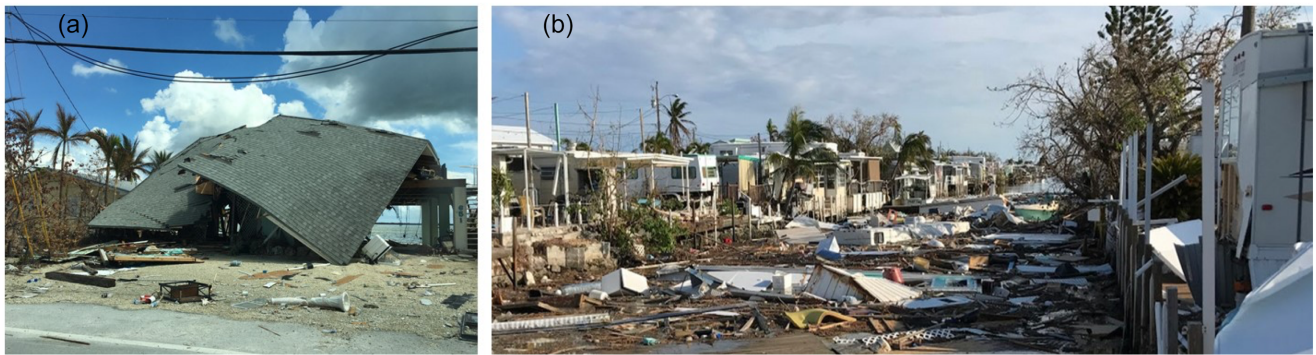
Figure 2. Photos of damage in (a) Big Pine Key: storm surge damage beside a waterway (left side of building) and (b) Marathon: trailer community with house debris filling a waterway.

We find that the destroyed and severely damaged buildings were caused largely by hydrodynamic forces induced by storm surge and waves. For example, Fig. 2a shows that storm surge and waves completely crashed the lower part of a building in Big Pine Key. Figure 2b shows debris from damaged trailers floating in the water in a trailer community in Marathon. Although direct observation of the surge and wave heights are not available at the two sites, the observed storm surge damage is consistent with the high surge and wave heights estimated by the hydrodynamic modeling (Fig. 3a and b). The assessed damage state for each building appears in Fig. 3c and d. The number of buildings assigned into each category is shown in Table 1. The slightly
