Brief communication: Post-wildfire rockfall risk in the eastern Alps

The aim of this work is to describe the impact of a wildfire which occurred in August 2018 at a steep rock wall in the heavily toured world heritage site “Hallstatt” in the Salzkammergut region in Upper Austria (47°33′27.00″ N, 13°38′37.03″ E). In order to assess the impact of the wildfire on the recent and future rockfall activity in the area, a helicopter flight and field survey were carried out. The survey was conducted by Sandra Melzner of the Geological Survey of Austria as part of the project “Georisks Austria” (GEORIOS). The focus of the inspection was on the identification of possibly changed potential rockfall areas and loosening of the rock due to the strong heat effect (Melzner, 2018) with regards to the rockfall hazard analysis conducted in 2014 (Melzner, 2015). The area was revisited conducted

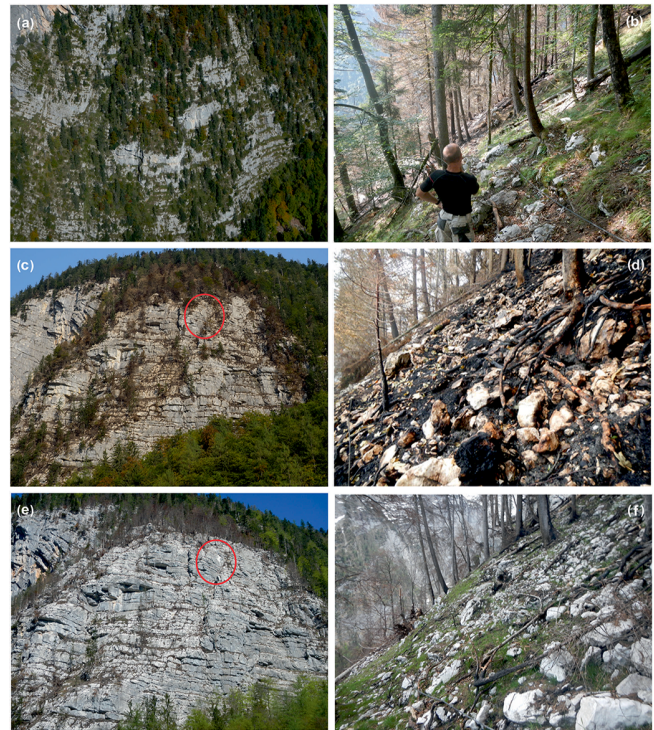
Figure 1. Temporal changes of the wildfire affected area: biomass, soil and rock characteristics before the wildfire in 2014 (a), in the border between burned and not-burned forest in August 2018 (b), directly after the wildfire in August 2018 (c, d), and 8 months after the burn in April 2019 (e, f). Post-wildfire rockfalls (red circle in e) with a volume of about a few cubic metres are recognizable.

On 21 August 2018 at 09:30 LT a wildfire was presumably initiated by a carelessly discarded cigarette or the reflection of a broken glass bottle at the foot of the rock wall. At that time there were three groups of about 20 climbers on the via ferrata. Since the fire could only be extinguished from the air by helicopters, the via ferrata had to be evacuated to protect the climbers from falling rocks and branches caused by the downwind of the helicopters while fighting the fire. The fire rapidly spread up the rock wall (area size of about 3 ha) affecting the trees growing mainly on the bedding planes of the limestone (Fig. 1). The protection forest beneath the rock

Indicators of fire severity (Figs. 1 and 2) are the colour of the trees and the decomposition degree of the leaves and needles. Unaffected trees have a green and unaltered colour, whereas burned or heated trees are easily recognizable by their brown colour. Varying degrees of consumption of the needles and leaves and organic matter can be related to different classes of fire severity. According the classification

The vertical relief of the rock walls, the anabatic winds and patchy vegetation pattern caused an upward jumping of the fire, resulting in a spotty fire pattern (Fig. 1). Thus, the res-

Increased rockfall activity of rather smaller rock blocks is recognizable during as well as after the wildfire. The destabilization of small rock blocks and the burn of tree roots may also cause the destabilization of larger rock masses (Fig. 1). These would pose a significant risk to the houses and infrastructure. Above the steep rock wall, some greater boulders in and on top of the scree slope can be remobilized as secondary rockfalls by falling trees or undercutting erosional processes (Fig. 4).

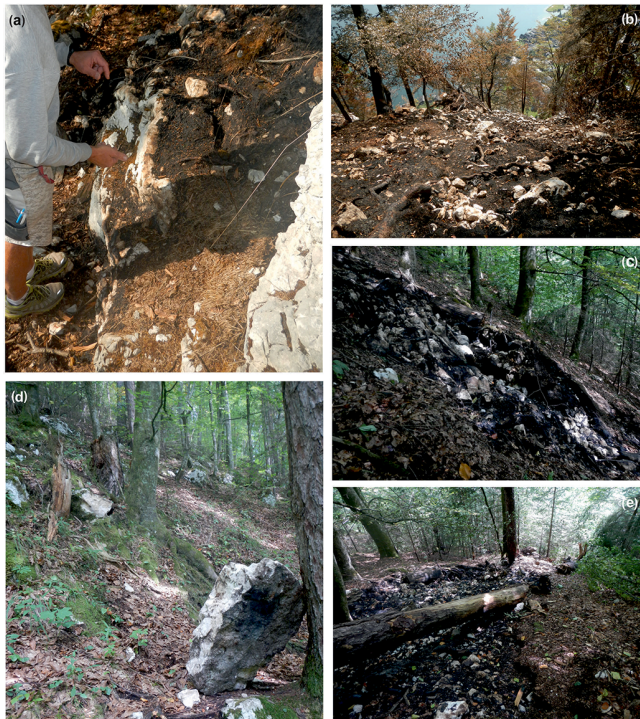
Figure 2. Indication of wildfire severity. (a) Crack development in the scree. (b) Ash and needles cover the terrain with a “sealing effect” reducing the infiltration capacity. (c) Talus slope beneath the rock wall is covered by a thin soil layer. (d) Rockfall boulders detached during the wildfire are often easily identifiable by their black colour. (e) The protection forest beneath the rock wall only was affected to a very minor extent due to the anabatic winds and high moisture of the brown rendzina and brown earth.

wall was not affected by the fire (Fig. 2). During the night of 21 to 22 August the first evacuations of the houses beneath the rock wall took place as burned trunks, rootstocks and rock blocks were falling down the rock wall, the latter approaching two houses. Sixteen mapped rockfall boulders which reached the settlement area had volumes smaller than 0.3 m³ (Fig. 3). With the exception of minor damage to one building, no severe damage to buildings occurred, and local inhabitants were not injured. In the following days the firefighter brigades tried to extinguish the fire from above the rock wall with fire hoses and from the air with helicopters carrying water containers and buckets. In total, four police and military helicopters were flying during the days of the fire, refilling the buckets with water from the nearby Lake Hallstatt every two minutes. During the 4 d of the firefighting operation, up to 100 people (firefighters, police officers, military personnel and mountain rescue team members) were on duty every day. Unusual low-wind conditions and rainfall (starting on 24 August 2018) prevented the spread of the fire towards the village of Hallstatt. The official end of the firefighting mission was on 28 August 2018. A rockfall hazard and risk assessment conducted by the Geological Survey of Austria (Melzner, 2015) formed an important part of the
