# Integrated risk assessment due to slope instabilities in the roadway network of Gipuzkoa, Basque Country

**Abstract.** Transportation corridors such as roadways are often subjected to both natural instability and cut-slope failures, with substantial physical damage to the road infrastructure and threats to the circulating vehicles and passengers. In the early 2000s, the Gipuzkoa Provincial Council of the Basque Country in Spain noted the need for assessing the risk related to the geotechnical hazards of its road network, in order to assess and monitor their safety for road users. The quantitative risk assessment (QRA) was selected as a tool for comparing the risk of different hazards on an objective basis. Few examples of multi-hazard risk assessment along transportation corridors exist. The methodology presented here consists of the calculation of risk, in terms of probability of failure and its respective consequences, and it was applied to 84 selected points of risk (PoR) over the entire road network managed by the Gipuzkoa Provincial Council. The types of encountered slope instabilities that are examined are rockfalls, retaining-wall failures, and slow-moving landslides. The

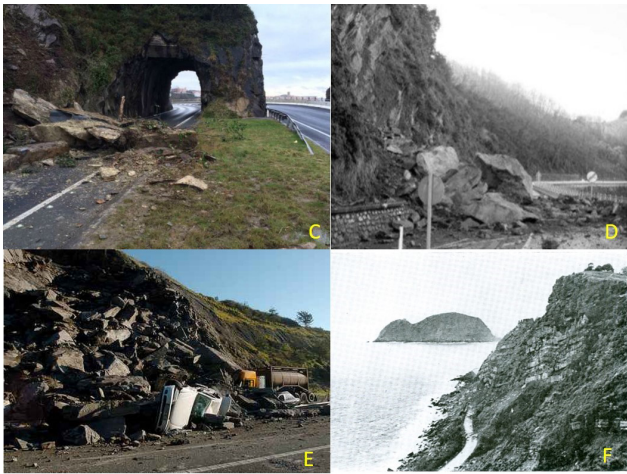
**Figure 3.** Examples of rockfall magnitudes (C, D, E, F) in the study area in relation to the classes of Table 2 (source: magnitudes C, D, E; Javi Colmenero; F, Servicio Geológico de Obras Públicas).

Rockfalls are a major threat to the roads of Gipuzkoa. The rockfall hazard magnitude is classified according to the volume of the detached mass. Figure 3 shows representative examples of different rockfall magnitudes. A frequency or probability of occurrence is attributed to each volume class and the extent of disruption of the transportation corridor is determined.

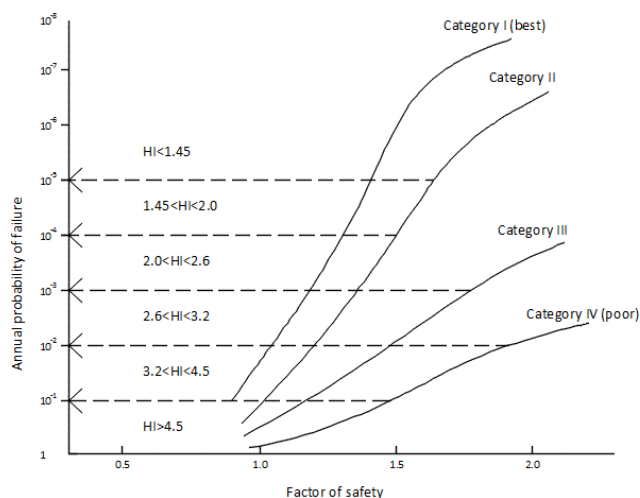
**Figure 4.** Classification of the engineered slopes and their relation to the annual probability of failure (modified from Silva et al., 2008).

Silva et al. (2008) have associated the safety factor of engineered slopes for a given project category with the probability of failure. For this, the structures are classified according to the level of engineering design. Category I comprises engineered slopes which were designed, constructed, and managed using the most advanced state-of-the-art knowledge. Category II includes constructions with normal standards. Category III includes constructions without specific designs that do not follow standards, and Category IV those with a poor or completely missing engineering knowledge basis. As the HI is an adaptation of the SF that takes into consideration additional criteria for the level of functioning of the structure, a similar relation between annual probability of failure of the anchored retaining walls can be established as well. The relation is presented in Fig. 4 and Table 7.

**Table 7.** Annual probability of failure for HI values, according to Fig. 4.

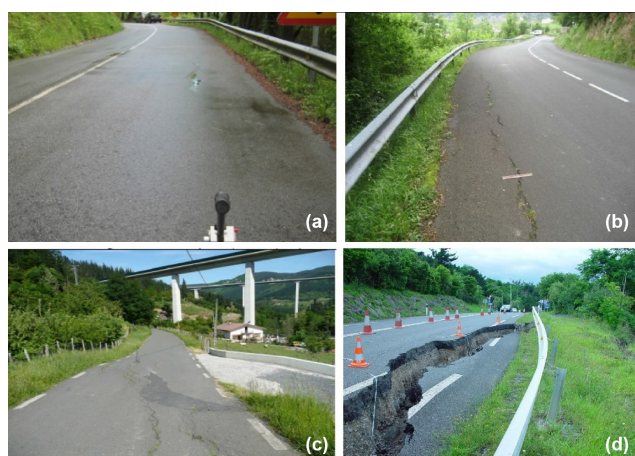
**Figure 5.** The four damage levels identified on the roads of Gipuzkoa: (a) no/slight damage, (b) moderate damage, (c) severe damage, and (d) partial/total destruction.

In the case study, horizontal velocity data are available from the inclinometer measurements. After 2010, deformation readings were consistently taken every 3 months. In that sense, although the monthly velocity measurements have a limited precision, they can provide certain information on the landslide movement patterns. We inspected the in situ damage, in order to establish the relation between the velocity and the road damage. Four levels were identified, as shown in Fig. 5 and described qualitatively in the following.

- *Damage level A (landslides of low intensity).* There are rarely cracks and deformations. No speed reduction is

required while driving. Crack sealing and resurfacing is periodically performed over periods longer than 1 year.

- *Damage level B (landslides of moderate intensity).* Damage includes pavement deformation and cracks and/or roadside destruction, without affecting the functioning of the road. If proper signalling is present, the chance of an accident is very low. Traffic conditions can be normally maintained if regular sealing and resurfacing is performed until a more permanent solution can be found.

- *Damage level C (landslides of high intensity).* Pavement deformation is substantial, including the presence of steps and puddles, and there is a partial rupture of the platform partly or entirely affecting traffic lanes and/or the roadside. The normal functioning of the road is disturbed. Traffic is not interrupted, although restrictions such as alternative pass and traffic light regulations are required. Accidents might occur if the vehicles enter the affected zone without previous signalization. The normalization of the traffic conditions requires slope stabilization and road repair.

- *Damage level D (landslides of very high intensity).* Displacements are of the same order of magnitude as for level C, but with the vertical component prevailing and providing the possibility for complete destruction and loss of the pavement continuity. This situation is typical for roads situated on the crest or on the boundaries of landslides. The functioning of the road is seriously affected. There is a high likelihood of an accident due to vehicles falling into generated depressions. High-priority stabilization works and reconstruction of the road are required.

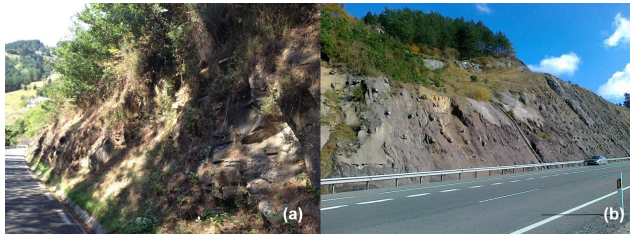
**Figure 7.** (a) PoR L1C of the road GI-3324 (from km 0.700 to 1.450) without protection measures; (b) PoR P4C of the road N-1 (km 407.395 to 407.680) with protection measures.

We indicatively present the risk for two different cases of rockfall-affected sections: the PoR L1C, situated at the local road GI-3324 (from km 0.700 to 1.450), and the PoR P4C of the highway N-1 (km 407.395 to 407.680). The two PoR are shown in Fig. 7.

Rock instabilities at the PoR L1C are due to the unfavourable structural conditions of the rock mass, leading to planar and wedge failures, with a safety factor of the

blocks on the slope seemingly smaller than 1. In a few areas toppling mechanisms are also observed. Although rockfalls occur with a frequency higher than two events per year, there is no historical record of the events. The road platform is in a good state without major impact signs, indicating that no high-magnitude events have been occurring. Thus, the magnitude–frequency relation of events here is evaluated considering the slope properties from Table 3, and applying Eq. (2) for the calculation of the  $I_F$ . For low joint persistence ( $I_P$ : Low), scar density greater than 0.3 ( $I_{DC} > 0.3$ ), presence of differential erosion ( $I_E$ : Yes), number of points with potential rockfalls greater than 11 ( $I_{FP} > 11$ ), and SMR between 40 and 80 ( $I_{SMR}$ : 40–80), the index  $I_F$  results to be 6, which, according to Table 4, corresponds to an annual frequency of events equal to 1. This frequency is proportionally distributed amongst the magnitude classes A, B, and C, according to the in situ observed relative frequency of potential unstable volumes (45 % for < A:  $0.5 \text{ m}^3$ ; 40 % for B:  $0.5\text{--}5 \text{ m}^3$ ; 15 % for C:  $5\text{--}50 \text{ m}^3$ ). This results in annualized expected frequency of events equal to 0.45, 0.40, and 0.15, respectively, for each magnitude class. No protection measures exist; thus, no correction is made on that frequency. The risk is then calculated for each magnitude size A, B, and C and summed up following Eq. (1), considering the UC of Table A1. The total annual risk for L1C is 1.55.

For the PoR P4C, a similar procedure was followed. For moderate joint persistence ( $I_P$ : Moderate), scar density equal to 0.16 ( $I_{DC}$ : 0.1–0.3), absence of differential erosion ( $I_E$ : No), number of points with potential rockfalls equal to 4 ( $I_{FP}$ : 3–10), and SMR index between 0 and 40 ( $I_{SMR}$ : 0–40),  $I_F$  results equal to 5, which corresponds to an annual frequency of events equal to 0.2. This frequency is distributed amongst the magnitude classes: 0.08 for A, 0.09 for B, 0.01 for C, 0.01 for D, and 0.01 for E. In this case, a correction is applied on the annual frequency. Considering that the slope is partially protected by gunite and bolts in a poor state of maintenance, and that a ditch with a width smaller than 5 m exists, the summative frequency correction factors for the two types of measures from Table 6 are 0.45 and 0.2 for magnitudes A and B, respectively. For higher magnitudes, the existing protection measures are not considered to be efficient. The annual frequencies of each size after correction are 0.03, 0.07,

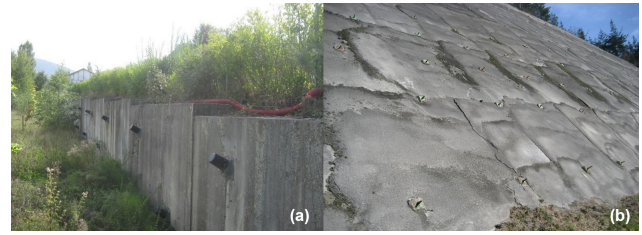
**Figure 8.** (a) PoR P2A of the road AP-8-1-1 (from km 77.140 to 77.210) where the crest of the slope and the retaining wall with anchors is seen; (b) C8A of the road G-2634 (32.980 to 33.150) with gunite, rock bolts, and anchors.

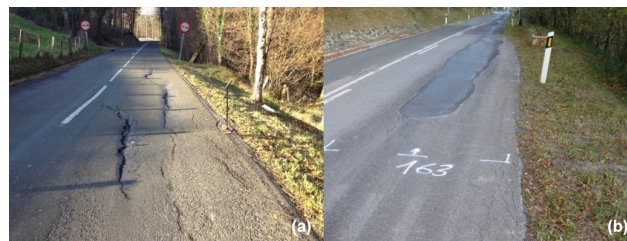
**Figure 9.** Road sections situated within slow-moving landslides with damage shown: (a) PoR C3C of the road GI-2133 (from km 8.280) with observed deformations and cracks on the road pavement; (b) PoR C9G of the road GI-2637 (from km 17.891 to 18.220) showing minor cracks already sealed.

Two examples of PoR that were subjected to damage by being situated within slow-moving-landslide areas are presented here: the C3C and the C9G (Fig. 9).

The PoR C3C involves a rotational landslide, occurring in the interface between clay colluvial soil and rock. It affects a road section of almost 200 m, with a retaining wall of 1 m height over 41 m. There is not a historical record of the damage evolution. The road platform is found to be cracked and vertically deformed, as well as the ditch. For about 20 m the cracks are 2–3 cm wide and mostly affect one direction of the road. The most probable reason for the instability is the presence of water and the deficient drainage causing humidity and water flows. Slope movements occur during high-rainfall episodes, which was also confirmed by the indications of the inclinometers, as explained in the following.

There are two inclinometers that started measuring in November 2013, initially with a monthly frequency, which are 14.5 and 15.5 m deep, respectively. Movements were found to be concentrated at a depth of 0.5–2.0 m (corresponding to the thickness of the colluvium soil layer). The inclinometer measurements indicate that the soil movements directly respond to the total monthly precipitation intensity, expressed in  $\text{mm month}^{-1}$ , with records of up to  $8 \text{ mm month}^{-1}$  and cumulative displacement higher than 100 mm. These movement rates correspond to Pattern Z (Fig. 6, left). According to Table 10, the annual probability of exceeding low damage is 1, moderate damage is also 1, and high damage is 0.02. As field inspections indicated that no scarp or shear crack is present, the potential for very high damage was eliminated. Consequently, the probability of occurrence of only high damage is  $P_h = 0.02$ , only moderate damage is  $P_m = 1 - 0.02 = 0.98$ , and only low damage is 0 (moderate damage constantly overlaps with low damage). Applying Eq. (2) and the costs of Table A1 for a total length of affected road of 200 m, the resulting risk here is 66.18.

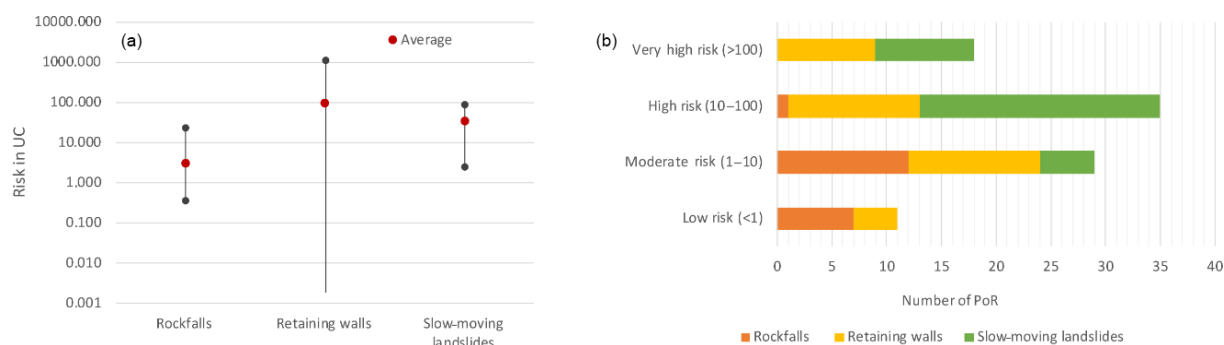
**Figure 10.** (a) Average, maximum, and minimum calculated risk for each hazard type; (b) number of PoR per hazard type in each risk class.
