# Damage induced by the 25 April 2015 Nepal earthquake in the Tibetan border region of China and increased post-seismic hazards

**Abstract.** The seismic effects in Nyalam, Gyirong, Tingri and Dinggye counties along the southern border of Tibet were investigated during 2–8 May 2015, a week after the great Nepal earthquake along the Main Himalaya Thrust. The intensity was VIII in the region and reached IX at two towns on the Nepal border, resulting in the destruction of 2700 buildings, seriously damaging over 40 000 others, while killing 27 people and injuring 856 in this sparsely populated region. The main geologic effects in this steep rugged region are collapses, landslides, rockfalls, and ground fissures, many of which are reactivations of older land slips. These did great damage to the buildings, roads, and bridges in the region. Most of the effects are along four incised valleys which are controlled by N-trending rifts and contain rivers that pass through the Himalaya Mountains and flow into Nepal; at least two of the larger aftershocks occurred along the normal faults. And, the damage is not related to the faulting of N-trending rifts but rather is distributed along the inte

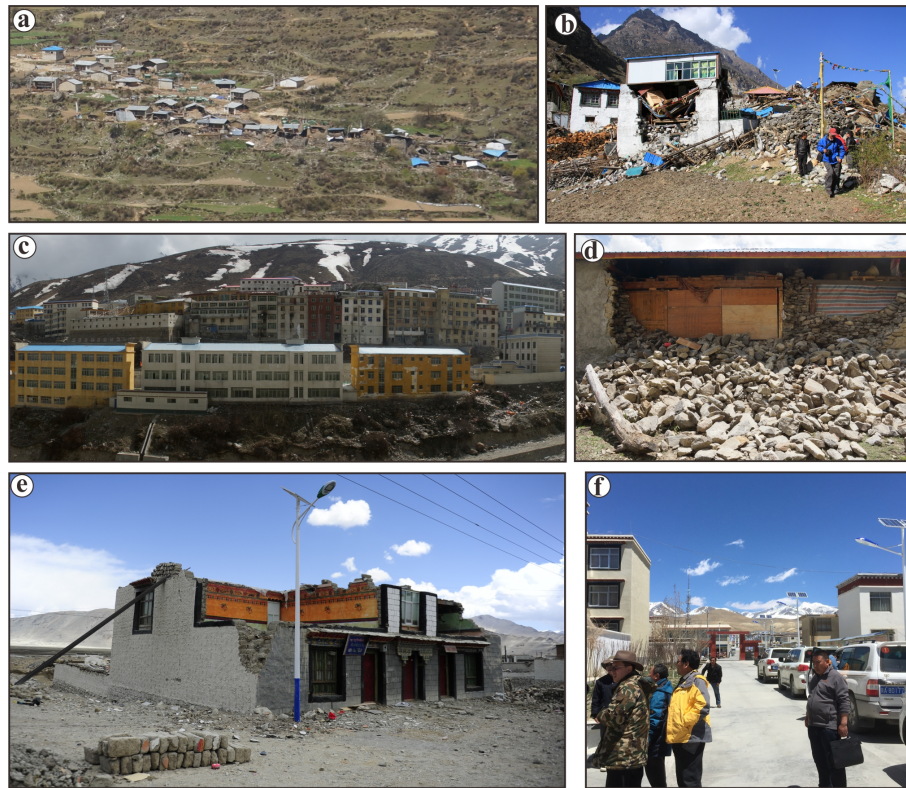
**Figure 3.** Building damage resulting from different earthquake intensities. (a) Many of the old stone pile or mud brick houses collapsed, but the new brick houses rarely collapsed at Gangba Village in Sale Town in the intensity VIII zone. (b) Similar building damage at Zhuobude Village of Rongxia Town in the intensity VIII zone. (c) Most buildings with a brick or concrete structure did not collapse, but many walls showed obvious damage at Nyalam City located in the intensity VIII zone. (d) Some walls of the stone pile or mud brick houses collapsed at Rema Village, Jilong County, in the intensity VII zone. (e) Similar building damage at Chentang Town, Dinggyê County, in the intensity VII zone. (f) Most of the houses remain intact, and only few or individual walls of buildings had apparent small cracks in Gyirong City in the intensity VI zone.

The specific structural damage is usually related to the material and type of building construction in these areas; the heaviest destruction occurred near the Nepal border. In this region with few trees, most of the houses are of simple stone and adobe construction, and these fared poorly during the earthquake, with the majority being destroyed near the Nepal

border (Figs. 3b, d, e, 4c). Houses with cement-bonded stone or brick construction survived much better (Figs. 3a, 4d), and those of good brick or reinforced concrete construction suffered the least (Figs. 3c, 4f) and provided a contrast with those of poorer materials (Figs. 3a, 4e).

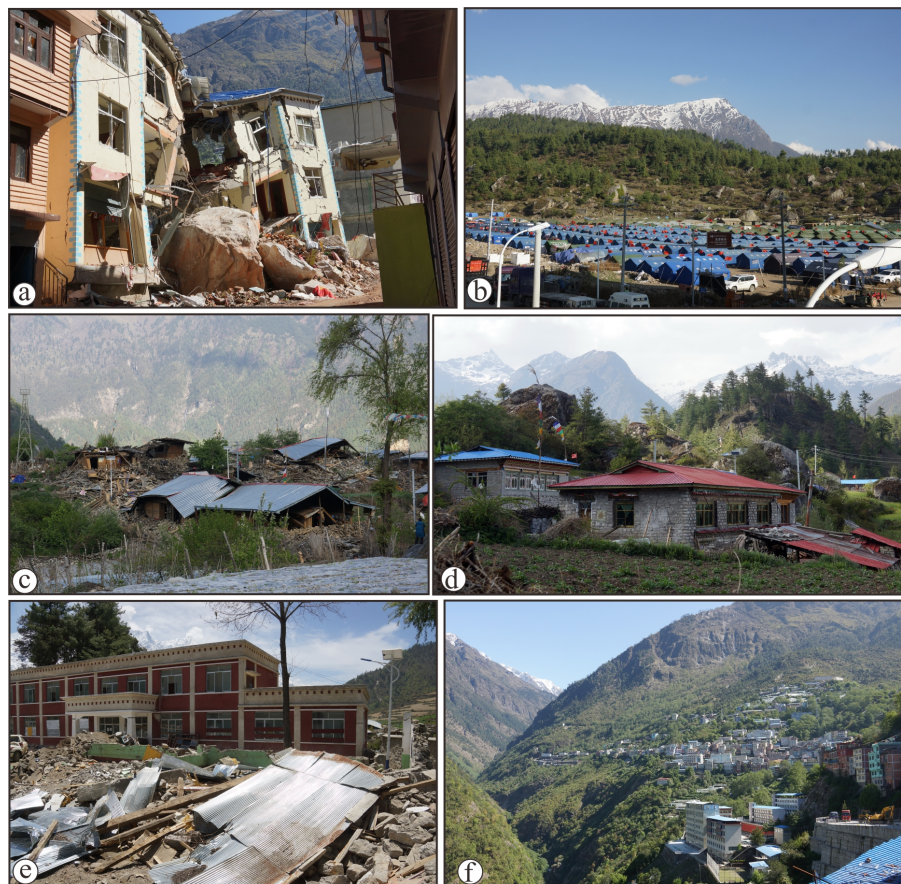
**Figure 4.** Typical earthquake damage in southern Tibet and comparison of houses of different construction (locations shown in Fig. 5). (a) Huge rockfall that smashed the resident committee office building at Disigang Village, about 0.7 km south of Zhangmu, where seven persons were killed (intensity IX) (site 1, Fig. 5a). (b) A temporary settlement for earthquake survivors at Jilong. (c) Destroyed houses of stone block masonry or adobe construction in Jifu Village southwest of Jilong (intensity VIII) (site 8, Fig. 5b). (d) Houses of cement-bonded stone or brick construction in Jifu Village (intensity IX). (e) Destroyed old houses and new buildings that are still standing at Sale Town Primary School (intensity VIII) (site 7, Fig. 5b). (f) Few collapsed houses at Zhangmu due to the brick structure or reinforced concrete construction (intensity IX).

The Chinese intensity scale considers the varying effects on different building types, and this usually improves the reliability of the general intensity assignment, but locally it may lead to assigning different values, if there is a greater variation in damage than usual between types. This could be the case in these areas where the effects appear to reach either intensity VIII or IX depending on the type of structure used to assign intensity. The apparent highest intensity, IX, from destruction, that equaled some parts of Kathmandu, for older self-built stone masonry or adobe structures with poor seismic resistance, whereas for the newly built cement-bonded stone, brick, or concrete structures it was no more than intensity VIII, and the rating lies between (Figs. 3 and 4). For example, in Jifu Village about 2.4 km south of Jilong, all the houses built of stone block masonry were almost completely destroyed, whereas most newly built ones of cement-bonded stone or brick are still standing with only minor cracks in the walls (Fig. 4c–d), and the same variation is also seen at Sale

All of Zhangmu is located on a group of old landslides (Figs. 4a, 7a, and 7b). Discontinuous tension fissures, which are tens to hundreds of meters long, about 10 cm wide and 2 to 4 m deep, were found at its upper edge and on its sides after the earthquake (Fig. 8a and b). These fissures indicate the possibility of the failure of the entire landslide group.
