# The mudflow disaster at Villa Santa Lucía in Chilean Patagonia: understandings and insights derived from numerical simulation and postevent field surveys

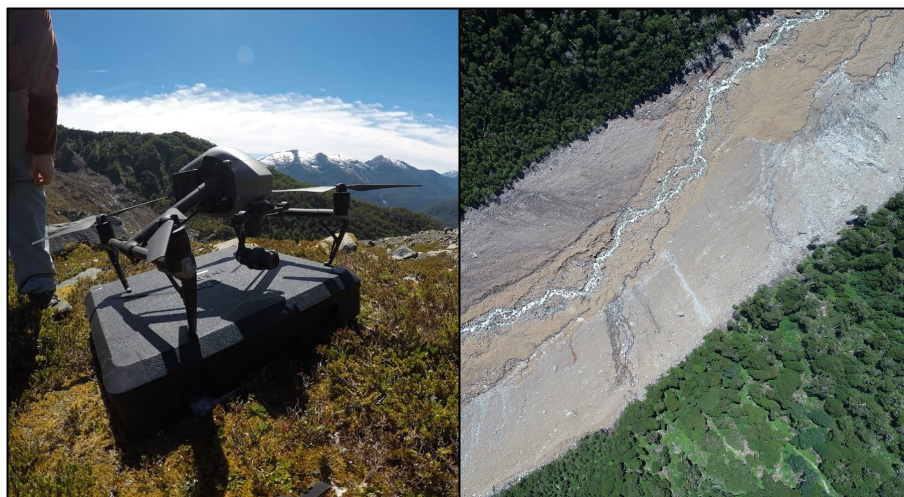
**Figure 5.** UAV mapping survey.

A fieldwork campaign was carried out in January 2019 to map in high resolution the area using an unmanned aerial vehicle (UAV). We used aerial photogrammetry to produce a high-resolution DEM for some parts of the study area. Aerial photogrammetry creates 3D models from 2D images, obtaining geometric characteristics of the objects they represent. We used an Inspire II UAV with a Zenmuse X4 camera to capture aerial photos (Fig. 5). We did not have differential GPS during this survey to take control points to correct the DEM generated. Therefore, we just used this DEM to corroborate that the DEMs with lower resolution and that were freely available were able to capture specific features such as canyons or small changes in slopes that could affect the hydrodynamic simulation and the path of the flood. We also generated a high-resolution mosaic to observe details of the mudflow deposition to improve the delimitation of the affected area. We used the software Agisoft PhotoScan Professional 1.4 desktop to process the images. The software performs the reconstruction of images by spatial coincidence among the elements represented in each image.

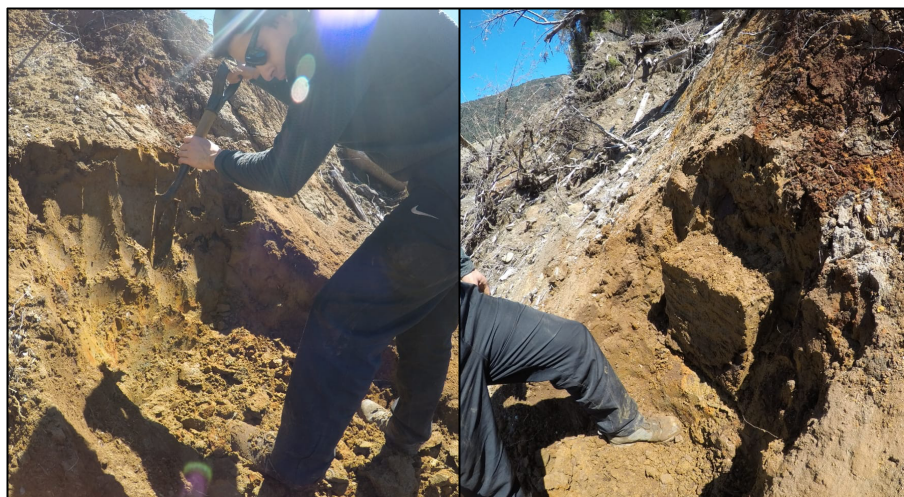
**Figure 6.** Extraction of an undisturbed soil sample.

It was not possible to carry out the extraction of unaltered geotechnical samples from the upper part, mainly due to the 5 km of steep terrain, including a section that needed to be climbed to transport the material by foot. However, we extracted soil samples in the middle-low part of the first section of the flow (Fig. 6). The geotechnical soil sample rep-
