Run-up, inundation, and sediment characteristics of the 22 December 2018 Sunda Strait tsunami, Indonesia

Wahyu Widiyanto^{1,2}, Shih-Chun Hsiao¹, Wei-Bo Chen³, Purwanto B. Santoso², Rudy T. Imananta⁴, and Wei-Cheng Lian¹

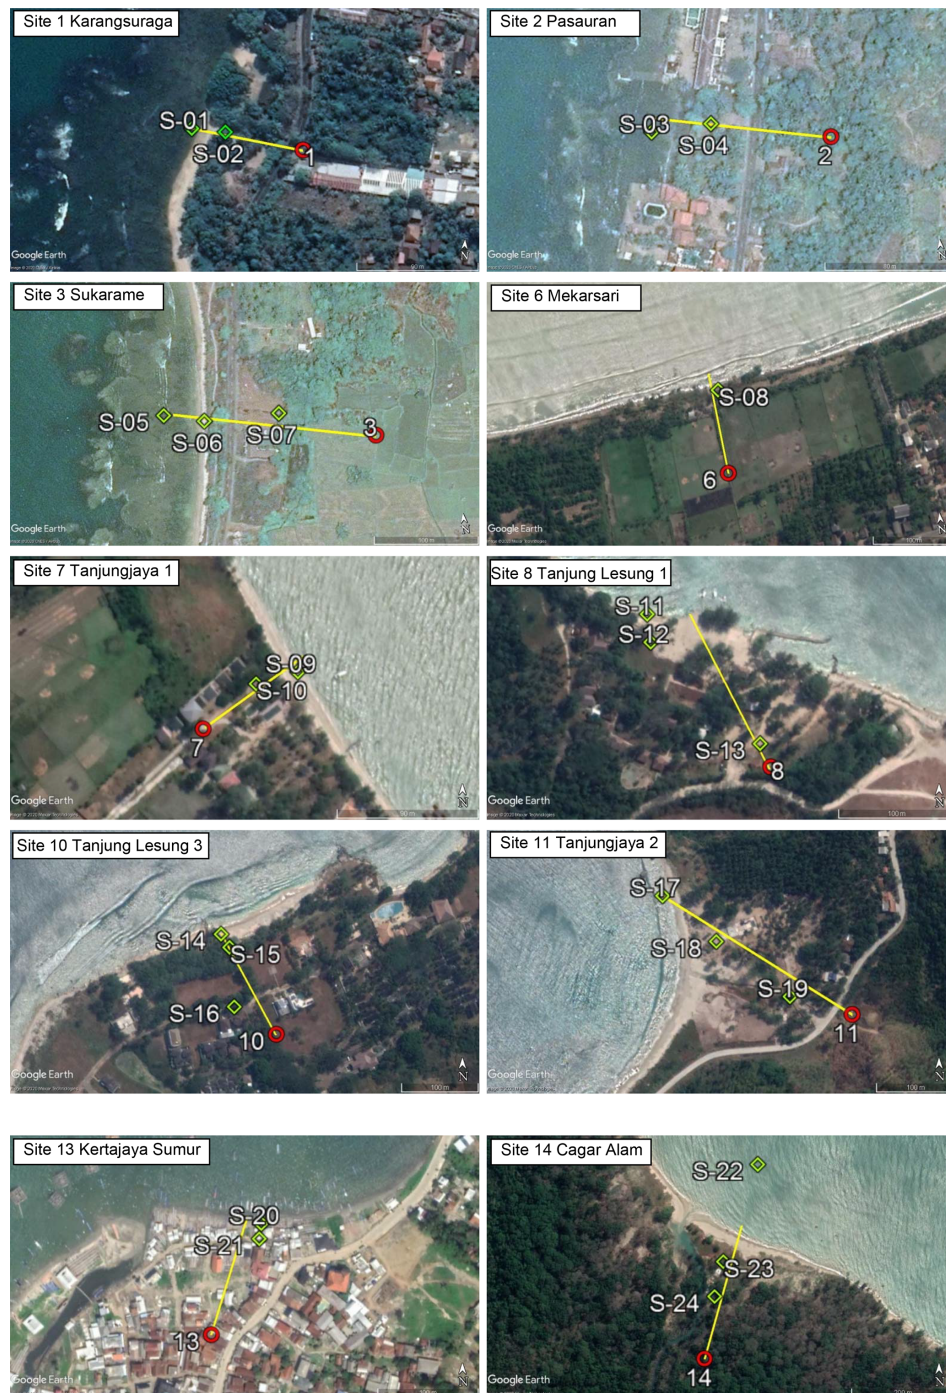
Figure 2. Aerial photographs from © Google Earth of transects including highest run-up point and deposit pit.

Sediment samples were collected from selected points at measurement locations that could be in the swash zone, nearshore, on berms, or in deposit areas (Table 2 and Fig. 2). The measurement of deposit thickness in sandy sheets was carried out by digging a number of shallow holes. The measured thickness was considered to be near the maximum thickness. This method was qualitative and subjective because tsunami deposits are discontinuous, sporadic, and scattered over a flooded area. Sand sheets deposited on land vary greatly due to the influence of sedimentary sources and to-

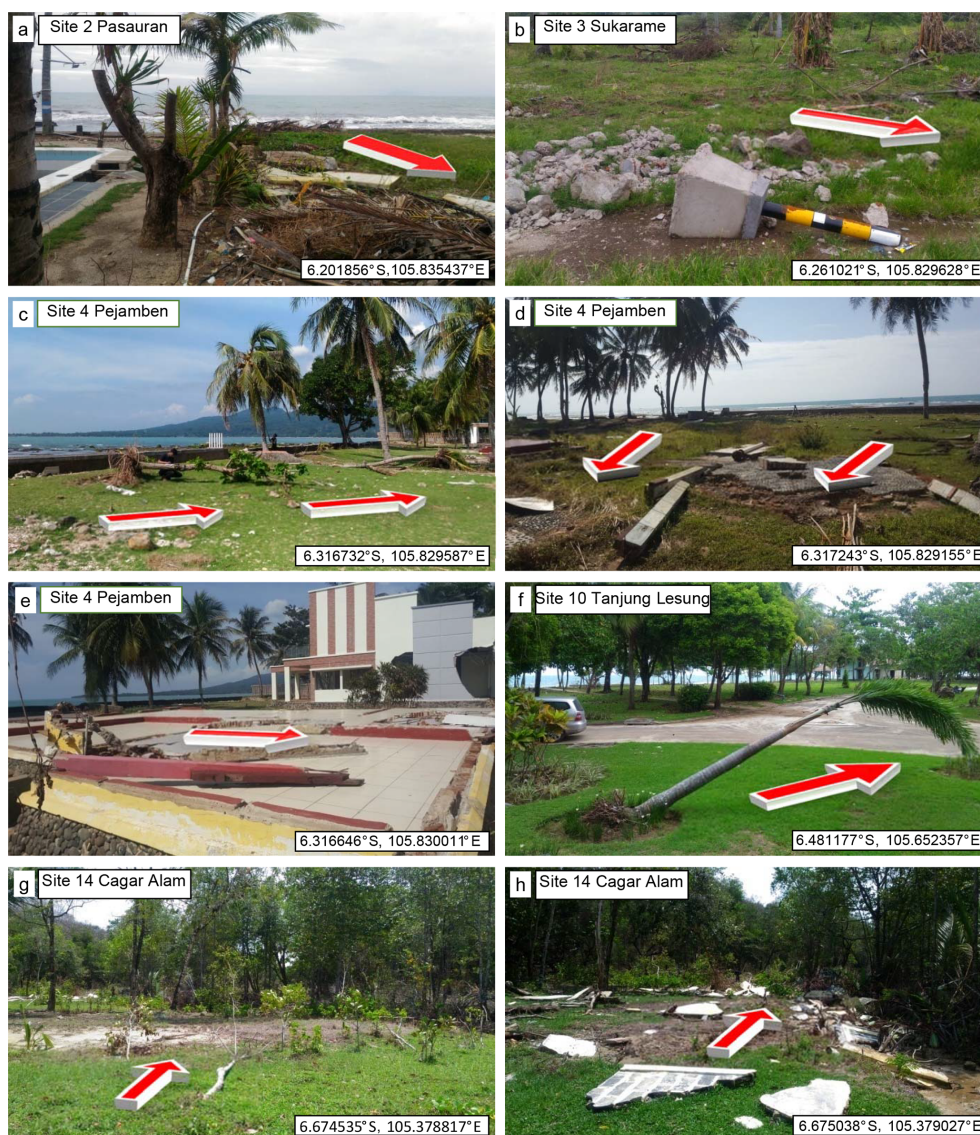
Figure 3. Evidence of tsunami direction. Arrows show the direction of tsunami flow on the ground surfaces.

The tsunami spread out from its source on the Anak Krakatau volcano to the beaches at the edge of the Sunda Strait. To determine the direction of the tsunami that arrived at the beach, we obtained information from eyewitnesses. The tsunami hit at night, and thus its arrival was difficult to see. Fortunately, it hit during a full-moon period, so there was some light. In addition to eyewitness accounts, we obtained evidence in the field related to the direction of the tsunami propagation. The evidence was in the form of fallen tree trunks, sloping vegetation and shrubs, damaged buildings, and building components carried away by the flow (Fig. 3).

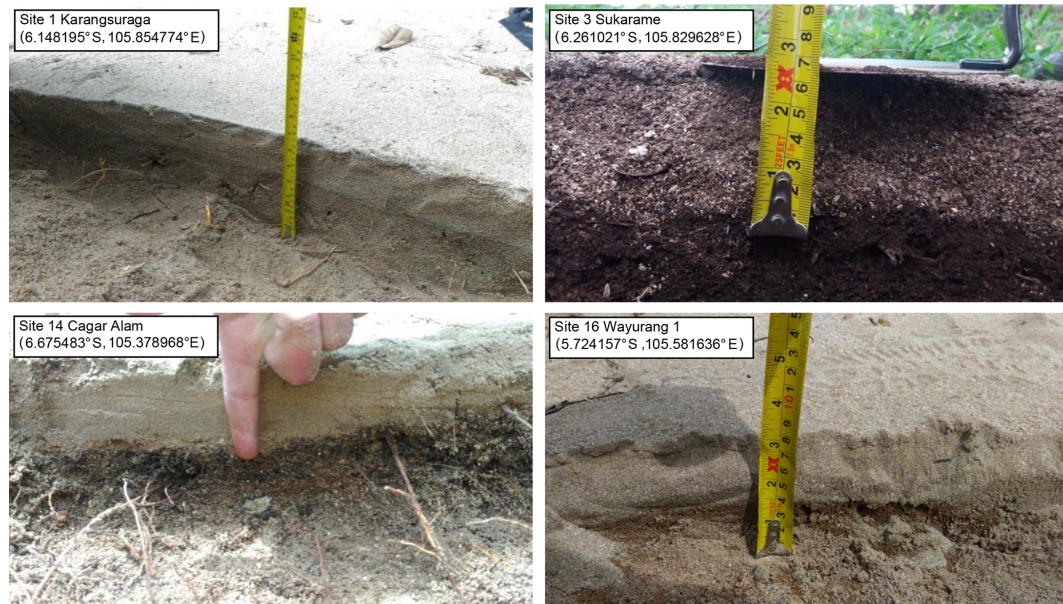
Figure 5. Tsunami sediment deposits; test pits were made to measure the deposit thickness.

to another at the survey sites. We chose a test pit with significant thickness for sampling. The thickness was likely near the maximum sediment thickness in the area.

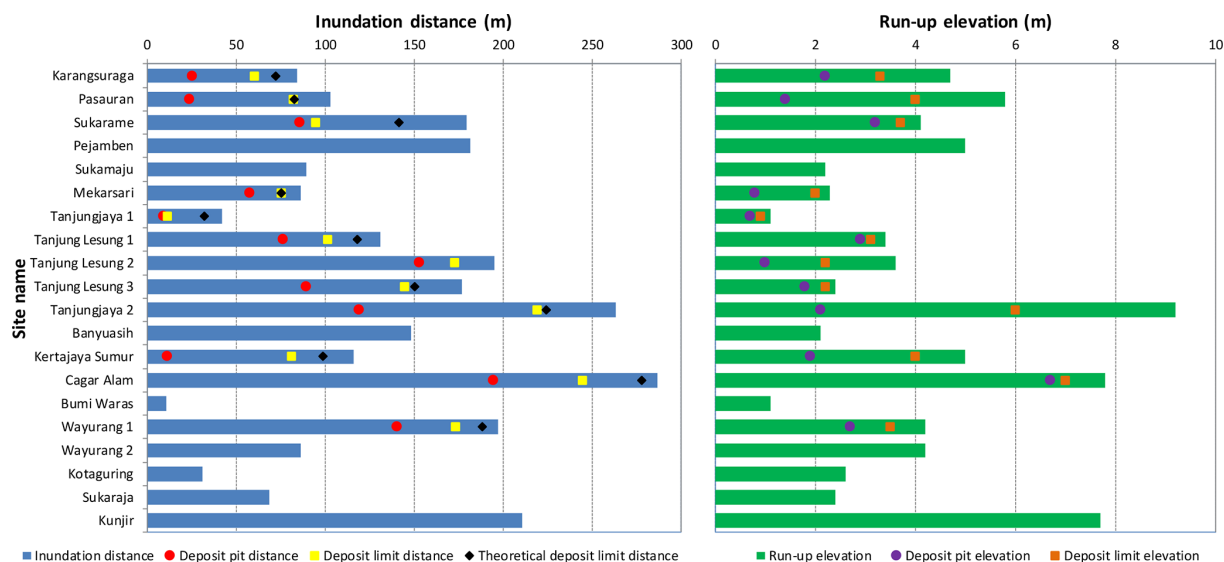
Figure 6. Positions of deposit pits and deposit limit compared to inundation distance and run-up elevation. Theoretical approach for tsunami deposit only available for distance not for elevation.

where w_s is the settling velocity, T is a period from the time of the first wetting to final drying of inundated ground, and H is the tsunami height. Figure 6 shows the distance of measured sediment deposition and water run-up compared to the distance of theoretical sediment deposition calculated using

Eqs. (1) and (2); the results are in good agreement. However, Sukarame, Tanjungjaya 1, and Cagar Alam do not fit well. The three locations have morphological conditions that may not be ideal for applying the theoretical approach. Sukarame has a beach scarp, and the tsunami flows across a stream around 90 m from the coastline. Tanjungjaya 1 also has a beach scarp, and there is a seawall, although not so high, that may block the sediment movement. Even though Tanjungjaya 1 has abundant material, a low-amplitude tsunami caused little sand transport. Cagar Alam has a relatively larger stream than Sukarame. In addition, Cagar Alam has dense vegetation since it is part of a national park.

As can be seen in Fig. 6, the distance from the coast of the area with significant sediment deposits caused by the tsunami (deposit pit distance) varied in the range of 9–195 m (average

82 m) from the shoreline or 10 %–70 % (average 45 %) of the inundation distance. Moreover, the limits where tsunami sediments were found that can still be seen with the naked eye (deposit limit distance) are around 11–244 m (average 122 m) from the coastline or 30 %–90 % (73 % on average) of the inundation distance. Figure 6 also presents the elevation of the deposit pit and deposit limit to the run-up elevation. The average elevation of the deposit pit and deposit limit are 43 % and 72 % of the run-up elevation, respectively.

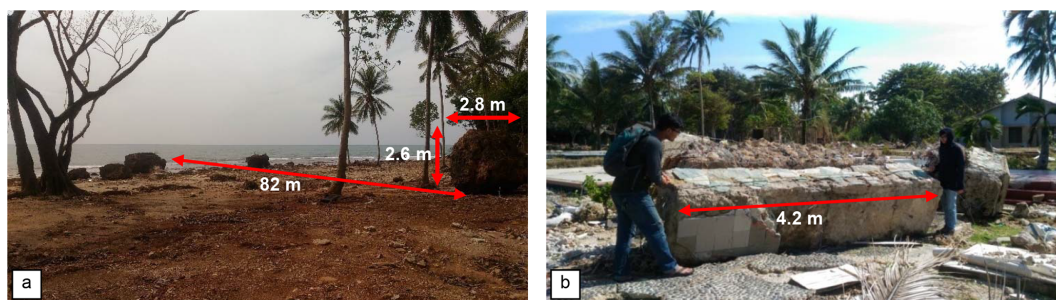
Figure 7. (a) Boulder that moved around 82 m inland in Tanjungjaya 2 and (b) an element of seawall that moved around 30 m inland in Pejamben.

The largest boulder, measuring 2.7 m in diameter (10.4 t), was found at site 11 (Tanjungjaya 2), as shown in Fig. 7a. This boulder moved from its original point in the swash zone to 82 m inland. Other smaller stones were scattered around it. In Tanjung Lesung (sites 8–10), pebbles, cobbles, and small boulders (25–50 cm) were scattered up to 40 m from the coastline. At site 4, the seawall built to protect a hotel

and villas was partly destroyed and moved ashore. A seawall chunk, measuring $1\text{ m} \times 1\text{ m} \times 4.2\text{ m}$ (9.5 t), made from rubble mound and mortar moved as far as 30 m from its place of origin (Fig. 7b). Other smaller chunks were also moved.

where μ is the friction coefficient, m is the boulder mass (kg), g is the gravitational acceleration, C_d is the drag coefficient, A_n is the area of the boulder projected normal to the flow (m^2), and ρ_w is the density of seawater (kg m^{-3}). The velocities were calculated from Eq. (3) to be $u \geq 4.5\text{ m s}^{-1}$ and $u \geq 4.0\text{ m s}^{-1}$ for the 10.4 t (Fig. 7a) and 9.4 t (Fig. 7b) boulders, respectively.
