## Brief communication: The northwest Himalaya towns slipping towards potential disaster

**Abstract.** The NW Himalaya (India) has been one of the most affected terrains of the Himalaya, subject to frequent disastrous landslides owing to active tectonics and multiple precipitation sources. This article focuses on two towns (Joshimath and Bhatwari) of Uttarakhand in the NW Himalaya, which have been witnessing subsidence for decades. Up until 9 January 2023, Joshimath had witnessed widespread cracks in more than 500 houses, which has prompted social unrest in the region. The hillslopes surrounding both towns comprise highly jointed gneisses with schistose interlayer rock mass. Both towns have subsidences and holes in the road, broken retaining walls, and displaced boulders, and the houses have cracks in the walls and holes. Recently, such slope instability phenomena have increased, which is leading to social movements in the region seeking government action such as possible evacuation and rehabilitation. The present study used a continuum-modelling-based slope stability simulation to determine the response of these hillslopes under various loading conditions: gravity, rainfall, buil

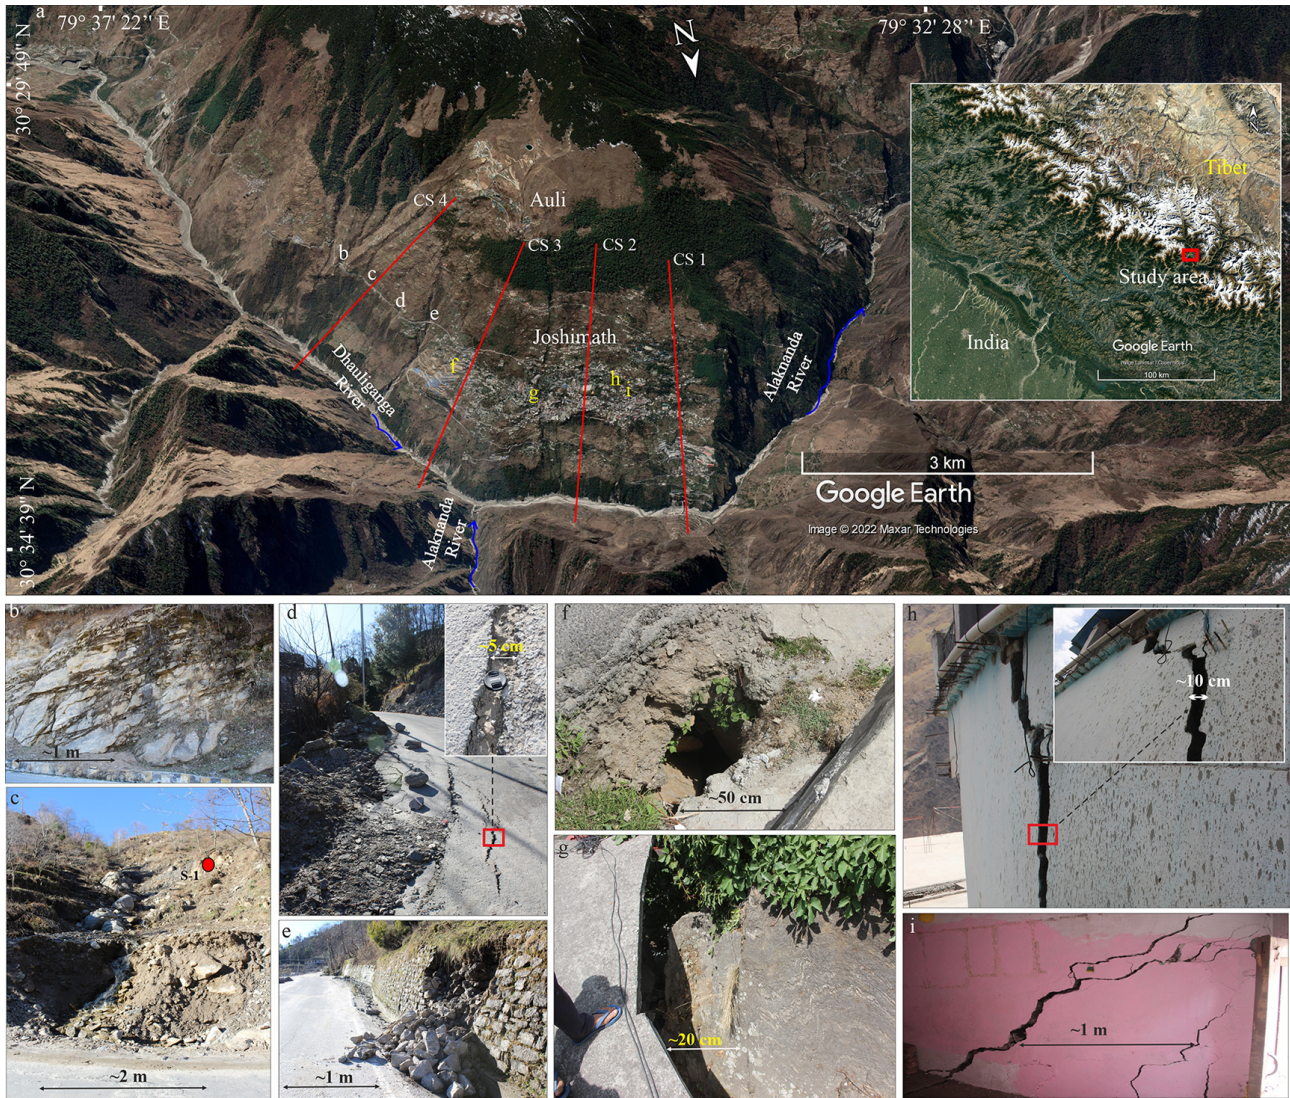
**Figure 1.** Field observation of Joshimath. (a) Location of Joshimath with the inset highlighting its position in the NW Himalaya. © Google Earth for panel (a). CS 1 to CS 4 mark the position of 2D slope sections used for the slope stability evaluation. (b) Rock mass exposure and (c) natural drainage (Nala) through the hillslope. Position of soil sampling site (S-1), (d) cracks and displacement in the road, (e) bulging and collapse of retaining wall, (f–g) displaced hillslope material and hence displaced pavements, and (h–i) cracks in houses. Picture (f–i) courtesy: Atul Sati.

to a hotspot, which is experiencing changing climate and rapid anthropogenic influence. Field observation of the town revealed that the hillslope of the town comprises highly jointed gneisses with schistose interlayer rock mass, and both towns have subsidences and holes in the road, broken retaining walls, and displaced boulders, and the houses have cracks in the walls and holes (Fig. 1). Loose hillslope material comprising sandy gravel soil (Fig. 1c), exposed on the eastern part of the town, points towards the possibility of a paleo-landslide on which most of the town is located. The last big earthquake (29 March 1999:  $M_w$  6.6) occurred within a 26 km hypocentral distance from this town.

Details of slope configuration, material models, and input parameters is summarized in Supplement Annexure I. For both towns, four 2D slope sections (CS 1 to CS 4) were taken to minimize the uncertainty caused by subjectivity associated with a single slope section (Figs. 1, 2). A configuration model is shown in Supplement Fig. S4. Although the 3D slope stability could have been more informative, the subsurface regime is yet to be explored for a more comprehensive understanding.

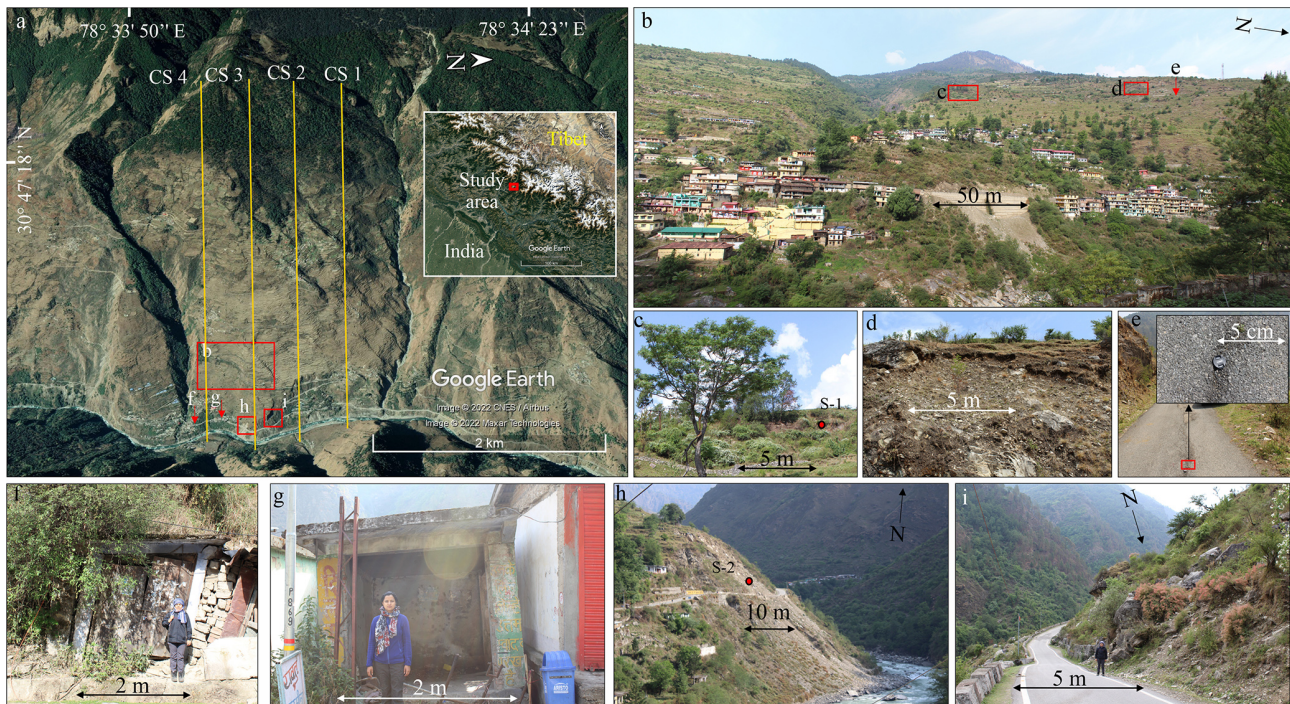
**Figure 2.** Field observation of Bhatwari. © Google Earth for panel (a). (a) Location of Bhatwari with the inset highlighting its position in the NW Himalaya. CS 1 to CS 4 mark the position of 2D slope sections used for the slope stability evaluation. (b–d) Exposed scarp. S-1 refers to the soil sampling site, (e) cracks and displacement of the road, (f–g) tilting houses and shops, (h) active slope failure at the slope toe, and (i) big gneissic boulder implying a paleo-landslide site.

Another town that is included in this article is Bhatwari (Fig. 2). As per the census (2011) of the government of India, it had a population of 1268 that is 1.0 % lower than that of the year 1991. Though the population migration from hilly terrains to plain areas is becoming a common phenomenon in the NW Himalaya owing to socioeconomic priorities, the decreasing human population of this town might also be due to such slope instability problems. Similar to Joshimath, Bhatwari is also situated along a narrow gorge incised by the Bhagirathi River Valley. The hillslope of the town comprises gneissic rock mass, and the MCT-I (locally termed the Vaikrita Thrust: VT) and MCT-II (locally termed the Munsyari Thrust: MT) faults pass through the northern and southern sides, respectively, of this region (Supplement Fig. S1). Two tributaries merging into the Bhagirathi River bound the hillslope from the northern and southern sides. Bhatwari is also situated on the orographic barrier setting and hence receives  $1063 \pm 124 \text{ mm yr}^{-1}$  avg annual (years 2000–2021) rainfall (Supplement Fig. S2). Field observation revealed exposed scarps in the upper part of the town, cracks in the road, and tilting houses (Fig. 2b–g). Big (1.2–1.5 m) boulders and active slope failure in the loose material at the slope toe indicate the possibility of a paleo-landslide on which Bhatwari is located (Fig. 2h–i). Yadav et al. (2020) have also noted the material displacement in the range of  $12\text{--}22 \text{ mm yr}^{-1}$  during the years 2006–2016 at this location. The last big earthquakes

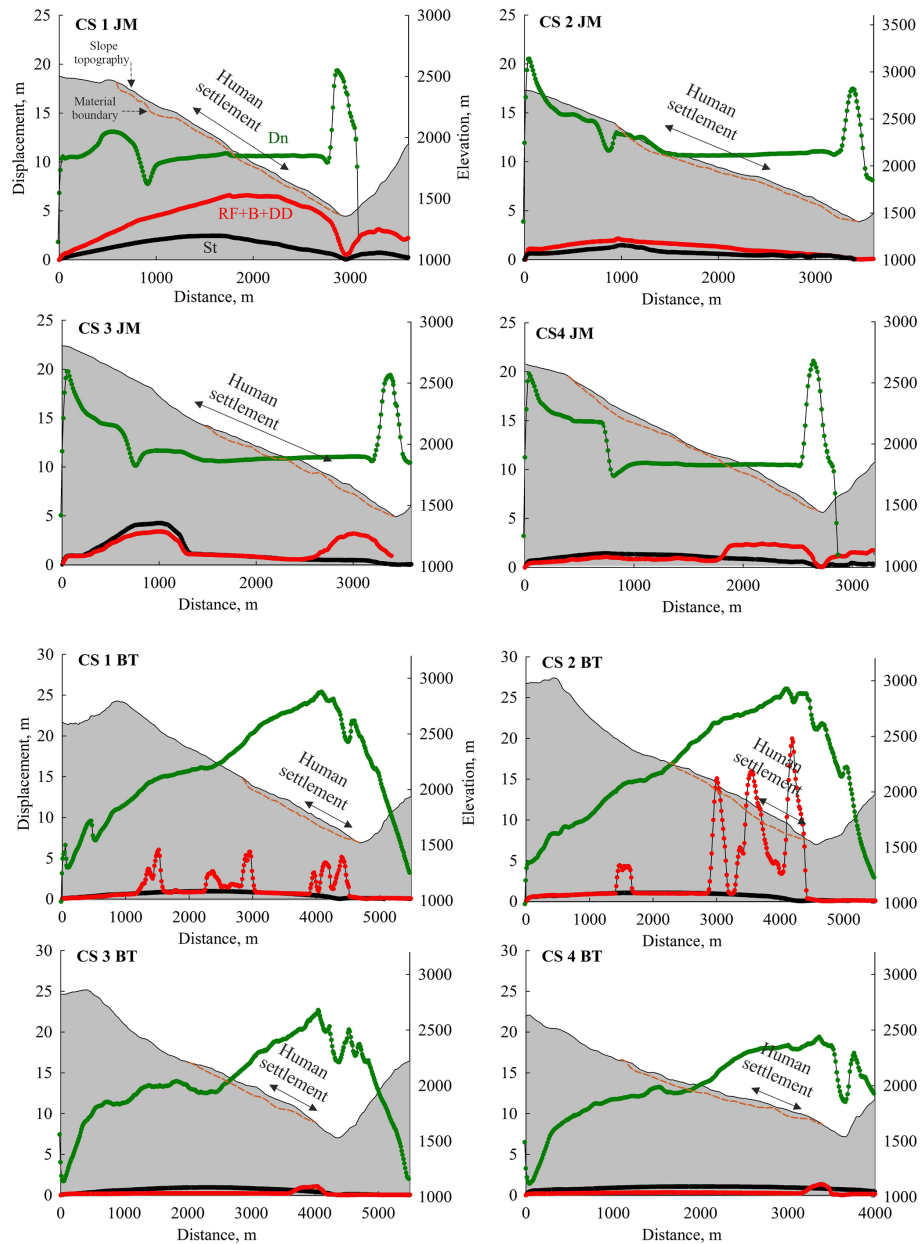
**Figure 3.** Results of the slope stability evaluation. CS 1 JM to CS 4 JM refer to Joshimath slope sections, whereas CS 1 BT to CS 4 BT refer to slope sections of the Bhatwari hillslope. Dn, RF, B, DD, and St refer to dynamic, rainfall infiltration, building load, domestic discharge, and static load, respectively.

Stability evaluation results for both locations are discussed using the total (horizontal and vertical component) displacement in the top 5–10 m material layer along the slope surface. If horizontal and vertical displacements refer to “ $x$ ” and “ $y$ ”, the total displacement is equivalent to  $\sqrt{(x^2 + y^2)}$ . Displacement profiles for Joshimath revealed that the slope may yield a 1–4 m displacement under gravity load conditions. This gravity (or static) condition also refers to the equilibrium state. The gravity-caused displacement might increase by up to  $\sim 6$  m under the combined effect of rainfall (RF) infiltration, building/house load (B), and domestic discharge (DD)

(Fig. 3). In Fig. 3, JM and BT refer to Joshimath and Bhatwari, respectively. The CS 1 and CS 3 sections of Joshimath yield relatively higher displacement under these loads, particularly near the slope toe. Under seismic load conditions, displacement increases rapidly in the range of 8–22 m, particularly at the knickpoints of the slope surface and near the slope toe. Relatively higher seismic displacement at the slope toe is attributed to stress accumulation at the slope toe and a narrow geomorphic setting, resulting in constructive seismic interference, as also noted in other case studies involving earthquake-induced landslides (Meunier et al., 2008). Notably, the slope crest region comprises a debris layer that must have affected topographic amplification and hence the relatively lower displacement, as also noted in a recent study in the SE Carpathians (Kumar et al., 2021a).

Similarly to the Joshimath hillslope, displacement profiles for the Bhatwari hillslope show dominance of higher displacement (up to  $\sim 25$  m) at the slope toe under seismic load conditions (Fig. 3). Notably, under the combined effect of rainfall, domestic discharge, and building load, the CS 1 and CS 2 sections of the Bhatwari slope comprise pockets of higher displacement (5–20 m), particularly near the slope toe. This could be attributed to a thicker debris deposit and a cluster of human settlement at the location of these slope sections (CS 1 and CS 2).
