Early warning system for ice collapses and river blockages in the Sedongpu Valley, southeastern Tibetan Plateau

Abstract. The Tibetan Plateau and its surroundings have recently experienced several catastrophic glacier-related disasters. It is of great scientific and practical significance to establish ground-based early warning systems (EWSs) to understand the processes and mechanisms of glacial disasters and warn against potential threats to downstream settlements and infrastructure. However, there are few sophisticated EWSs on the Tibetan Plateau. With the support of the Second Tibetan Plateau Scientific Expedition and Research Program (STEP), an EWS was developed and implemented in the Sedongpu Valley, southeastern Tibetan Plateau, where repeated river blockages have occurred due to ice/rock collapse debris flow. The EWS collected datasets of optical/thermal videos/photos, geophone waveforms, water levels, and meteorological variables in this sparsely populated zone. It has successfully warned against three ice-rock collapse–debris flow–river blockage chain events, and seven small-scale ice-rock collapse–debris flow events. Meanwhile, it was found that the low-cost geophone can

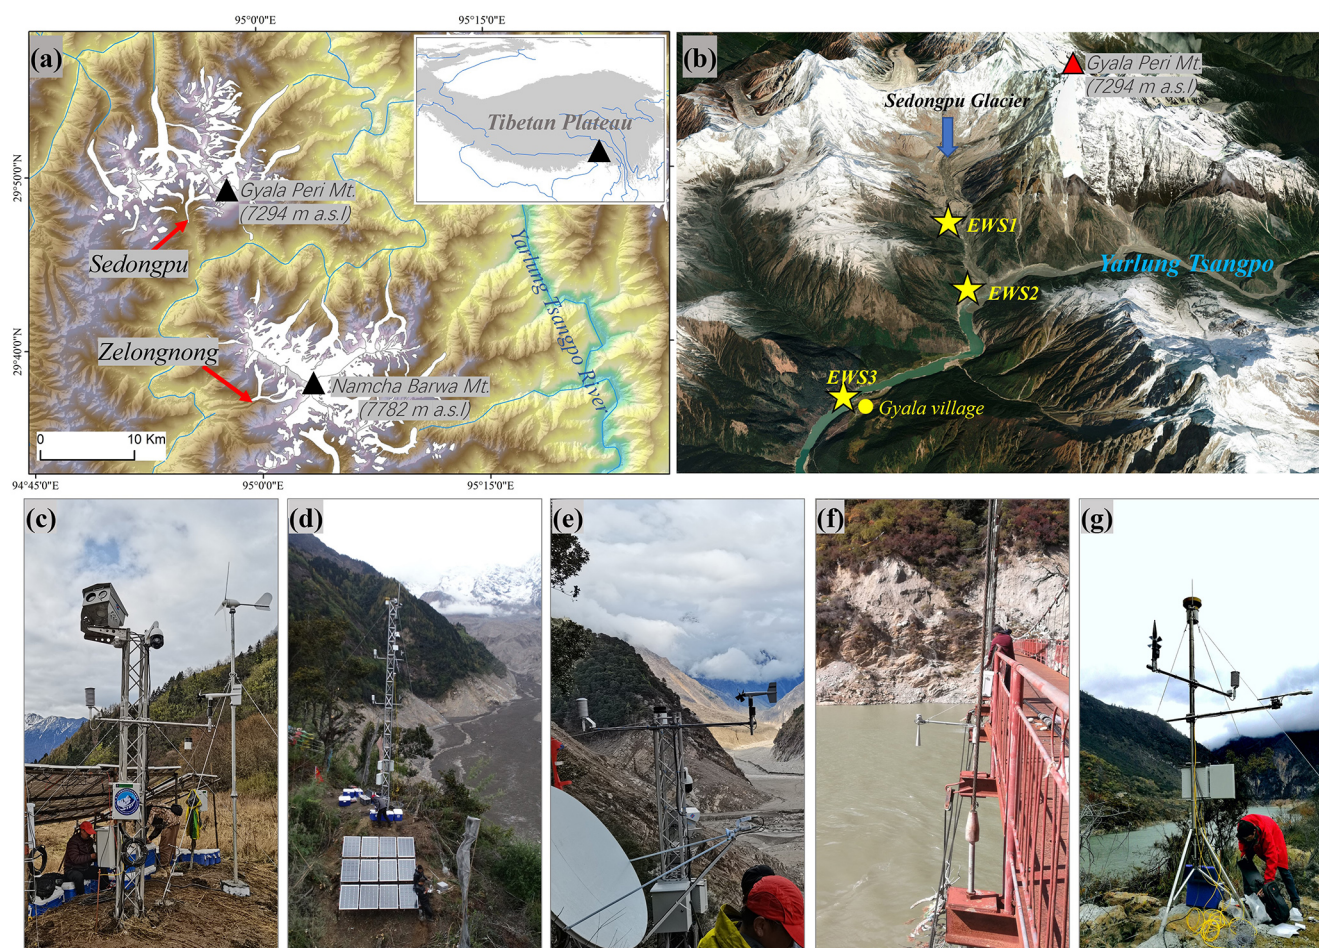
Figure 1. Study region and early warning systems. (a) Glacier distribution around the Mt. Namcha Barwa and the Mt. Gyala Peri in the southeastern Tibetan Plateau with the Sedongpu Glacier and Zelongnong Glacier; (b) @Google Earth image showing the 3D topography of the Sedongpu Valley and the locations of three early warning systems: EWS1–3 (yellow stars); (c) the EWS1 inside the Sedongpu Valley for ice collapse observations; (d) the EWS2 of the 10 m observation tower, which was installed near the Sedongpu Valley outlet but was destroyed by the massive ice-rock collapse on 22 March 2022; (e) the rebuilt EWS2 near the Sedongpu Valley outlet to warn the blockage of the Yarlung Tsangpo River; and (f, g) the EWS3 of the radar water level sensor and the automatic weather station (AWS) with pressure water level sensor near the Gyala village.

Since 2019, the EWSs have been progressively built along the Sedongpu Valley. The EWSs consist of three parts (EWS 1–3) with different monitoring instruments and scientific functions (Fig. 1c–g and Table 1).

In May 2022, a 4 m observation tower with various monitoring sensors was constructed on the right bank of the glacial terraces at 3308 m a.s.l. in the Sedongpu Valley (Fig. 1b and c). Owing to logistical inaccessibility, all instruments were transported by helicopters. The objective of EWS1 is to monitor the location, magnitude, and process of the ice-rock collapse inside the Sedongpu Valley. The overall monitoring system consists of the following five parts.

v. *Data transmission and power supply.* All datasets were transmitted via the Asia-Pacific satellite (Asiasat 7). Owing to the heavy monsoon cloud cover and less efficient solar power generation in this region, power is supplied by both solar panels and wind (Fig. 1c).

Ice-rock collapses generally produce debris flows that are deposited near the Sedongpu Valley outlet and then block the Yarlung Tsangpo River (Chen et al., 2020; Tong et al., 2019). The EWS2 was installed near the valley outlet to monitor the river blockage. In fact, a 10 m integrated observation tower, equipped with time-lapse optical and thermal cameras and various meteorological variables (wind speed/direction, air temperature, relative humidity, four components of radiation, rainfall, atmospheric pressure) was installed 150 m above the valley floor at the valley outlet in October 2019 (Fig. 1d). However, this EWS2 was destroyed by the collapse-induced

In May 2021, the EWS2 was re-established in the upstream region to avoid possible destruction by debris flows of similar magnitude as in March 2021 (Fig. 1e). Similar to the monitoring equipment at EWS1, EWS2 was equipped with optical and thermal cameras to monitor the status of the Sedongpu Valley outlet, a three-component SmartSolo geophone with a transmission threshold of 10 to indicate the power of debris flows and various meteorological sensors (Table 1). The video was stored locally on the hard disc, and hourly photos were transmitted to the service via satellite.

stream of the Sedongpu Basin. The water level will soon rise when the Yarlung Tsangpo River is partially or completely blocked by debris flow from the Sedongpu Valley. Therefore, the water level is a very important early warning indicator. Two different types of water level sensors were used to provide sufficient redundancy and to avoid possible sensor failures. A Campbell CS477 radar water-level sensor (10 min interval) and a Campbell CS451 pressure transducer (5 min interval) were installed separately in October 2019 and May 2021 to provide real-time records of the water level in case of river blockages (Fig. 1f).

Considering the relatively open topography near Gyala village, an automatic weather station was also installed (Fig. 1g) for long-term monitoring of the regional background of climate change by measuring air temperature; relative humidity; wind speed/direction; precipitation; four components of radiation including incoming shortwave radiation (S_{in}), reflected shortwave radiation (S_{out}), incoming longwave radiation (L_{in}), and outgoing longwave radiation (L_{out}) using a CNR4 net radiometer; and air pressure using a Vaisala PTB110 barometer (Table 1).

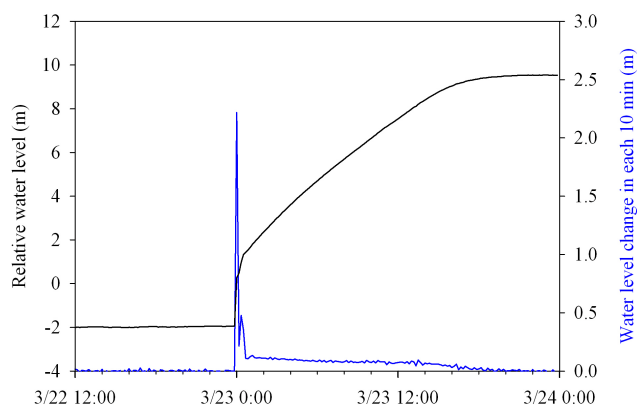
Figure 2. A total water level rise of 11 m (black line) caused by the damming of the Yarlung Tsangpo River on 22 March 2021, with the rate of water level rise every 10 min (blue line).

On 22 March 2021, a massive ice-rock collapse occurred from the northern ridge of Mt. Gyala Peri, and the resulting mass flow temporarily dammed the Yarlung Tsangpo River. Based on a comparison of pre- and post-event DEMs, the total collapse volume was estimated to be $\sim 50 \text{ Mm}^3$ (Zhao et al., 2022). The water level sensor at EWS3 sent an automatic warning message due to a sudden 2.2 m rise in the river level between 23:50 LT on 22 March and 00:00 LT on

23 March (Fig. 2). The water level continued to rise at a rate of $0.6\text{--}0.8 \text{ m h}^{-1}$, rising by a total of 11 m before stabilizing at approximately 18:00 LT on 23 March 2021. This collapse turned into a highly mobile mass flow which destroyed the EWS2 installed near the Sedongpu Valley outlet (Fig. 1d). Unfortunately, the video of this chain disaster was not recorded.

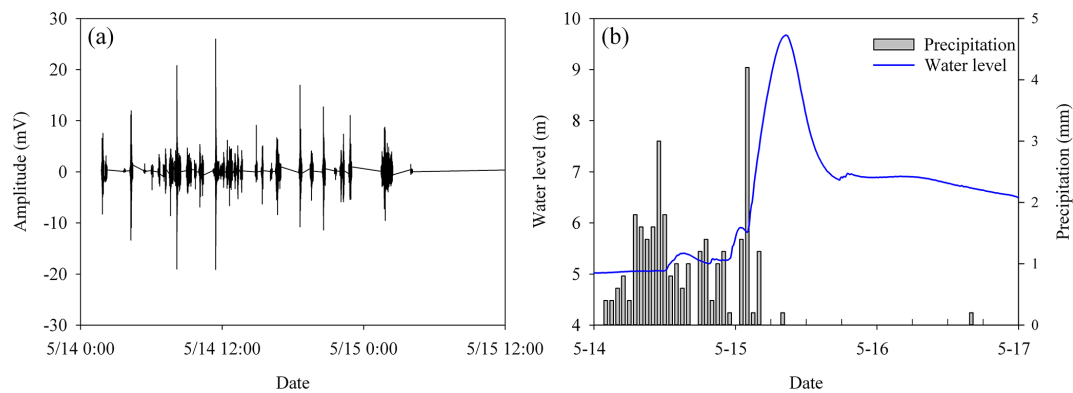
Figure 3. The recorded geophone waveform at EWS1 due to frequent ice-rock collapses on 14 May 2022 (a) and the rising water level of the Yarlung Tsangpo River due to the blockage on 15 May 2022 along with the hourly precipitation (b).

On 14 May 2022, the geophone at EWS1 warned that repeated collapses occurred in the Sedongpu Valley (Fig. 3a). The most pronounced shaking occurred at approximately 10:00 and 12:00 LT, with both waveform amplitudes exceeding 20. However, both EWS2 near the Sedongpu Valley outlet and EWS3 near Gyala village did not show river blockage and water level rising before midnight on 14 May 2022. Between 23:50 LT on 14 May and 00:00 LT on 15 May, the water level sensor at EWS3 sent a warning message, and the water level rose by a total of 4 m before stabilizing at around 20:00 LT on 15 May 2022 (Fig. 3b). Infrared imagery at EWS2 showed that the Yarlung Tsangpo River was temporarily completely dammed and then released, consistent with the rapid rise and fall in the water level (Fig. 4a and b). The AWS at EWS1 recorded a total rainfall of 31.6 mm during the period from 14 to 17 May with intensive rainfall (7 mm) occurring between 01:00 and 04:00 LT on 15 May (Fig. 3b). Overall, the ice-rock collapse and intensive rainfall provided favourable conditions for the formation of a diluted debris flow, resulting in the temporary blockage of the Yarlung Tsangpo River (Fig. 4a and b).

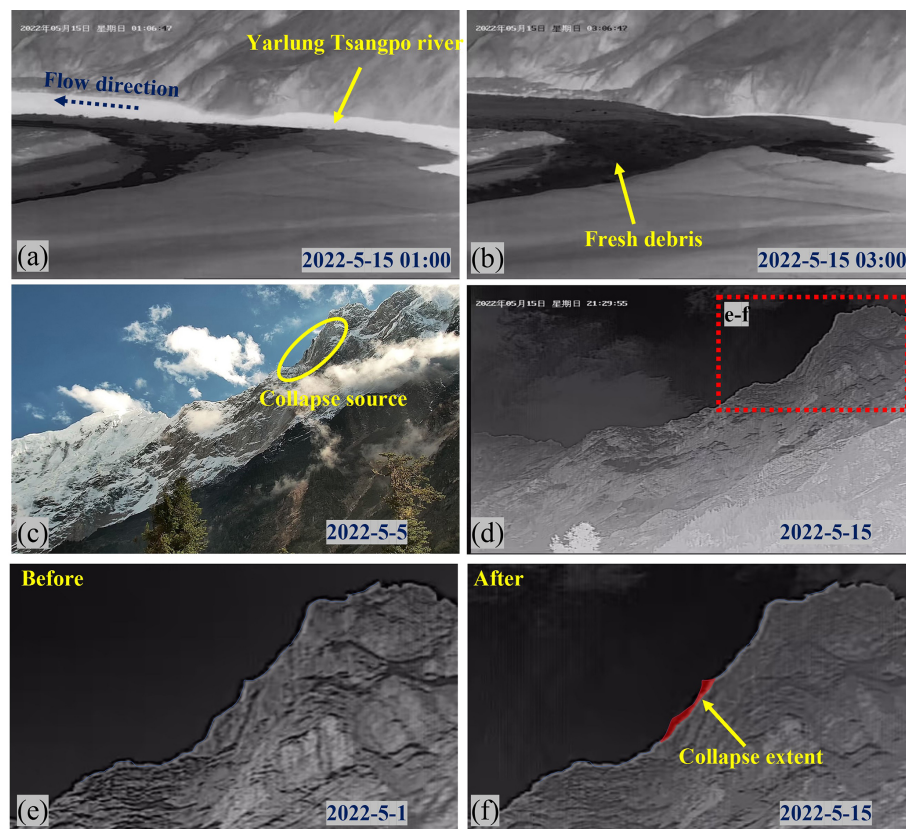
Figure 4. The debris-induced blockage of the Yarlung Tsangpo River (a, b) and the optical and thermal images showing the topographic conditions at the targeted monitoring of the collapsed area (c, d), with the zoomed region (red dashed rectangle) shown in panels (e) and (f), and the change of ridgeline before and after the repeated ice-rock collapses on 14 May 2022 and the extent of the collapse source outlined in transparent red.

A comparison of both optical and infrared photographs before and after the ice-rock collapse showed that repeated collapses occurred on the northern ridge of Mt. Gyala Peri (Fig. 4c–f), which is close to the locations of previous massive ice-rock collapses in 2017 (Käb et al., 2021) and 2021

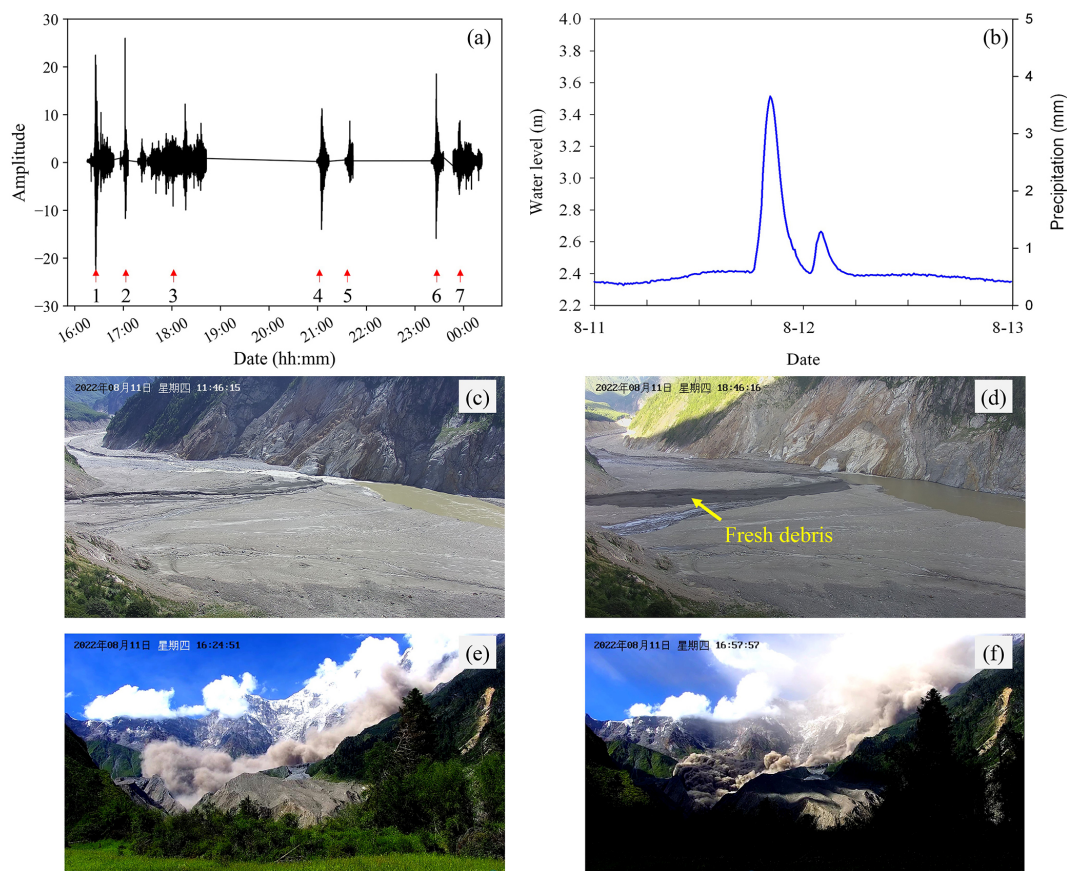
Figure 5. The recorded waveform of seven collapses on 11 August 2022 (a) and the water level rise by small-scale debris flow and precipitation condition (b), the photos taken before and after the occurrence of fresh debris flow into the Yarlung Tsangpo River (c, d), and video screenshots of two rock collapses at 16:24 and 16:57 LT on 11 August 2022.

On 11 August 2022, the geophone at EWS1 warned of repeated collapses in the Sedongpu Valley (Fig. 5a). The

first collapse occurred at 16:26 LT, with a waveform amplitude greater than 20, and lasted approximately 5–7 min. The following six repeated collapses occurred within the next 8 h. Among these seven repeated collapses, the waveform showed that the greatest energy was released by the first collapse, with a maximum amplitude greater than 25, and the longest collapse process lasted approximately 84 min during the third event (Fig. 5a).

The warning system at EWS3 indicated that the water level began to rise at around 18:30 LT, rose by 1.1 m at around 20:00 LT, and then started to fall back rapidly (Fig. 5b). Photographs of EWS2 also show that small-scale fresh debris flowed into the Yarlung Tsangpo River, causing partial river blockage (Fig. 5c and d). Comparison between the post- and pre-event optical and infrared imagery at EWS1 showed that the collapsed sources were different from previous ice-rock collapses (Fig. S1 in the Supplement). Two collapsed regions are mainly concentrated a few hundred metres below the mountain ridge, with a few glacier distributions. This evidence suggests that lower ice content within collapsed materials prevents the formation of highly mobile debris flows and thus limits the magnitude of river blockage.

Owing to the sunny weather conditions, the optical video system at EWS1 successfully captured the entire process of the two collapses that occurred during the daytime (Fig. 5e and f, Supplementary videos). Both videos of the two collapses showed that the highly mobile collapsed material resulted in dark yellow dust in the Sedongpu Valley. The colours of both collapses differed from the observed ice collapse recorded in October 2019 (Zhao et al., 2022). This indicates that the majority of the collapsed material on 11 August 2022 was composed of rock. Second, the combination of the video and geophone waveform showed that the size of the collapses was impressive when the amplitude of the geophone waveform at EWS1 was greater than 20. In addition, the onset and duration of the collapse recorded by the geophone were in agreement with the video recordings. These matches demonstrate that the geophone waveform at EWS1 can be used to reflect the onset and magnitude of repeated collapses in the Sedongpu Valley.

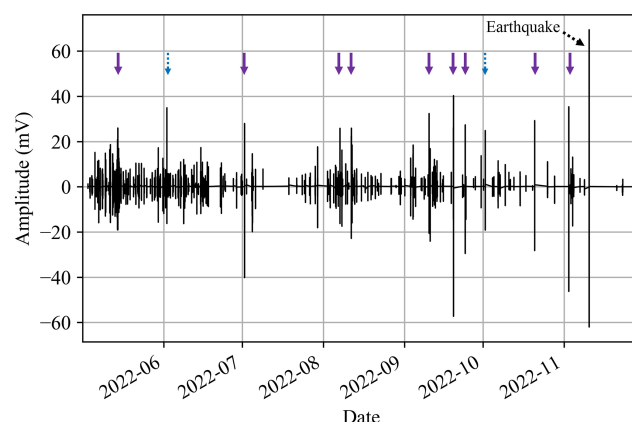
Figure 6. Geophone waveform inside the Sedongpu Valley during the period from May to December with 12 events of waveform amplitude greater than 20. The purple arrow indicates the confirmed collapses and induced debris flows, the dashed black arrow indicates the M_w 5.6 earthquake on 10 November 2022, and the dashed blue arrow indicates two abnormal waveforms.

The study region is located in an active crustal zone that experiences frequent earthquakes (W. Li et al., 2022). A mixed waveform of collapses and earthquakes may result in false warning signals. In fact, the waveforms of ice collapses and earthquakes differ because of different physical processes. Figure 7 shows a comparison of the nine waveforms triggered by the confirmed rock collapses and the M_w 5.6 earthquake on 10 November 2022. The collapse typically lasted for several minutes and produced a continuous waveform (Fig. 7a–i). In contrast, the waveform from an earthquake is usually short-lived owing to the rapid release of rupture energy, e.g. approximately 1 min for a M_w 5.6 earthquake (Fig. 7j). In addition, for the two false warnings (maximum amplitude greater than 20) that occurred on 2 June and 1 October (Fig. 6), the detailed waveform analysis can eas-

ily exclude such false warnings by assessing their waveform duration and characteristics (Fig. S9). These two waveforms are abnormally short and different from the typical collapse-induced waveform, indicating the possible noise. Therefore, in addition to the threshold of the maximum amplitude, the duration and characteristics of the waveform would be re-examined by the experts at STPSER and thus adopted as additional information for the ice-rock collapse warning in the Sedongpu Valley.

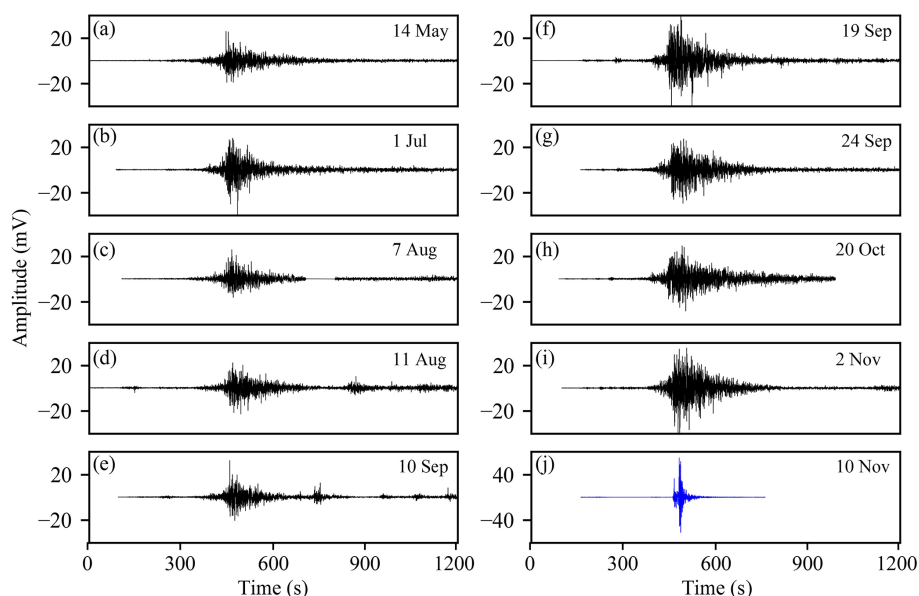
Figure 7. Comparison of the waveforms generated by ice-rock collapses (a–i) and by the earthquake on 10 November 2022 (j). Note the different y-axis limits.

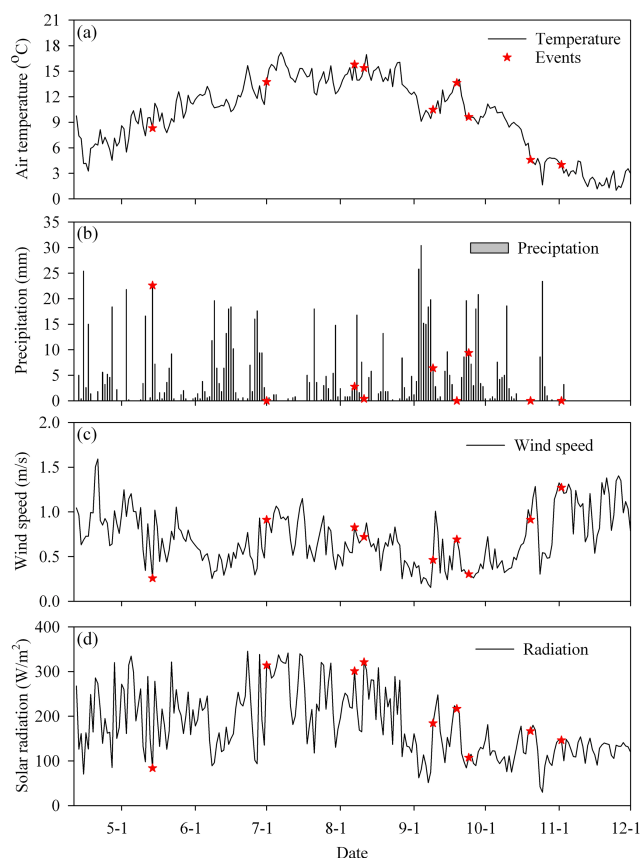
Figure 8. The occurrence of repeated ice-rock collapses (red stars) and the time series of meteorological factors including air temperature (a), rainfall (b), wind speed (c) from EWS1, and the incoming shortwave radiation from EWS3 (d).

The EWS showed that at least nine ice-rock collapse–debris flows were found during the period from April to December 2022 in the Sedongpu Valley. Previous studies show that some catastrophic rockslide–debris flows were triggered by heavy rainfall (e.g. Anderson and Sitar, 1995; Yin et al., 2016). The in situ AWS measurements in/near the Sedongpu Valley provided an opportunity to investigate the relationship between the occurrence of ice-rock collapses and the possible meteorological triggers. Figure 8 shows the variation of meteorological factors such as air temperature, rainfall, wind speed and incoming shortwave radiation and their relevant values in the corresponding ice-rock collapse events (red stars). It is clear that the ice-rock collapses at the Sedongpu Valley could occur under different meteorological combinations (Table S1 in the Supplement). For example, the weather condition of the ice-rock collapse on 14 May 2022 was characterized by relatively colder weather (8.3°C), heavy rainfall (22.6 mm), weaker wind speed (0.3 m s^{-1}), and lower solar

radiation (83.9 W m^{-2}). In contrast, the weather conditions of the ice-rock collapse on 11 August 2022 were warmer (15.4°C), less precipitation (0.4 mm), moderate wind speed (0.7 m s^{-1}), and sunny weather (321.1 W m^{-2}). In addition, it is clear that there were no weather anomalies (e.g. extremely high air temperature or heavy rainfall) prior to the ice-rock events. This suggests that there were no immediate meteorological triggers for these small-scale ice-rock collapses and the associated debris flows in 2022 at the Sedongpu Valley. However, it should be noted that climate change can trigger complex delayed feedbacks in high-mountain regions. Previous studies have shown that the massive ice-rock collapses and glacier detachments occurred concurrently with, or shortly after, positive seasonal air temperature anomalies (Zhao et al., 2022; Bondesan and Francese, 2023). The possible triggers of ice-rock collapse therefore merit further investigation from a variety of perspectives, including the dynamic conditions of temperate glaciers, pre-event seismic activity, and the cumulative role of climate change.

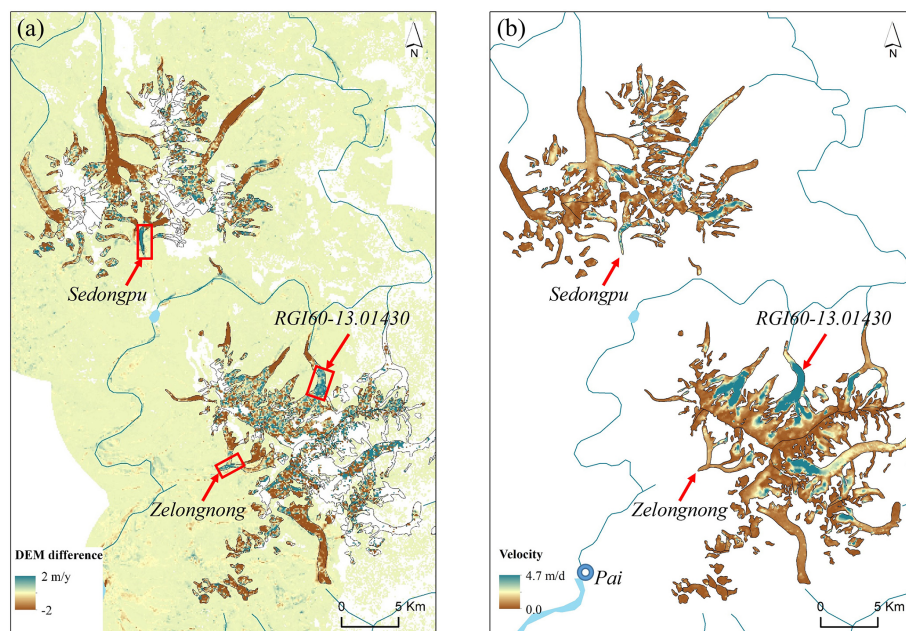
Figure 9. Spatial distribution of mean surface elevation change (m yr^{-1}) during 2010–2020 (Hugonnet et al., 2021) and annual surface velocity (m d^{-1}) in 2017 (Millan et al., 2022) and the locations of the three glaciers with abnormal surface thickening (the red rectangles) and the tower of Pai.

Based on the published datasets, including glacier elevation change during the period 2010–2020 (Hugonnet et al., 2021) and glacier surface velocity during the period 2017–2018 (Millan et al., 2022), it was found that apart from the detached Sedongpu Glacier, there are still two glaciers (Zelongnong Glacier and the glacier numbered RGI60-13.01430) with possible collapse risks in the study region (Fig. 9). As shown in Fig. 9a, the ablation zone of the Sedongpu Glacier has experienced an anomalous glacier thickening ($\sim +2.0 \text{ m yr}^{-1}$) over the last decade, which facilitated massive low-angle glacier detachment in October 2018 (Kääb et al., 2021). A similar anomalous ice thickening near the ablation zone (the red rectangles in Fig. 8a) was also found at the Zelongnong Glacier ($\sim +0.35 \text{ m yr}^{-1}$) and RGI60-13.01430 Glacier ($\sim +0.37 \text{ m yr}^{-1}$). In addition, the spatial distribution of the surface velocity also indicated a high glacier displacement in the ablation zone with possible sliding risks on these glaciers (Fig. 9b).

It is therefore worth paying special attention to the dynamic changes of these glaciers by using high-resolution satellite data and ground-based EWS. Enhanced monitoring, particularly the surface movement monitoring by using a Global Navigation Satellite System (GNSS), is critical for the accessible Zelongnong Glacier, which is very close to the town of Pai with a population of more than 3000, and for the proposed mega hydropower project nearby (Fig. 9b).
