Back analysis of a building collapse under snow and rain loads in a Mediterranean area

Isabelle Ousset, Guillaume Evin, Damien Raynaud, and Thierry Faug

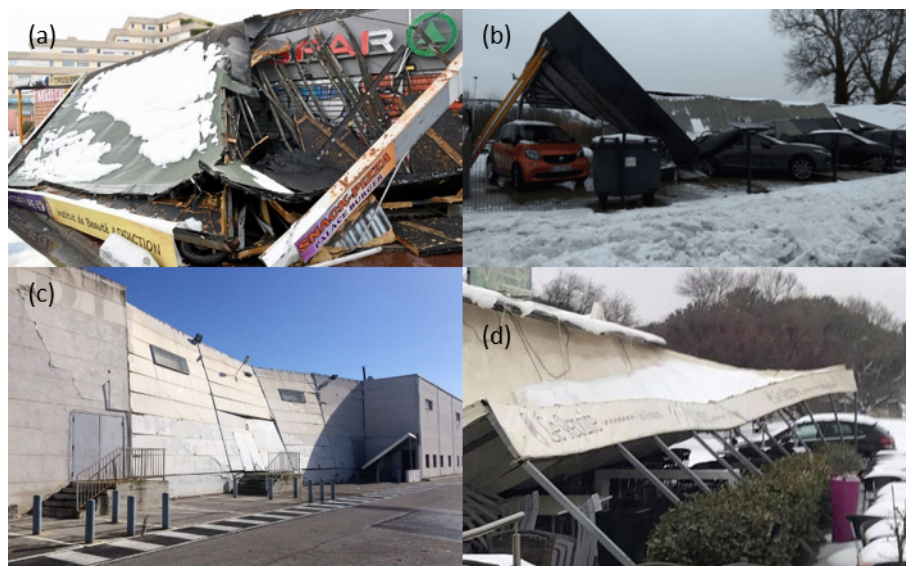
Figure 1. Roof collapses due to heavy snowfalls that occurred on 28 February and 1 March 2018 in the surroundings of Montpellier, France: collapses of (a) the Estanove shopping center in Montpellier (photo credit: © Jean-Michel Mart), (b) a car wash station in Lattes (photo credit: © Le Petit Journal de Lattes), (c) the Darty store in Pérols (photo credit: © France 3 LR/Sébastien Banus) and (d) a restaurant in La Grande-Motte (photo credit: © France 3).

- in France, the collapse of the roof of a warehouse in Satolas-et-Boncel in the department of Isère and of a supermarket in Bricquebec in the department of Manche (January 2010); several collapses of roofs in western France (at least nine store roofs in the department of Manche) in March 2013; and a lot of damage to shops in the department of Hérault at the end of February 2018 in the cities of Béziers, Lattes, Montpellier and Pérols (see examples shown in Fig. 1);

The current paper reports a detailed and specific case study of a roof collapse of a scientific laboratory (formerly Irstea, now INRAE, the Institut National de Recherche pour l'Agriculture, l'alimentation et l'Environnement) which occurred on 1 March around 18:00 LT following an intense rain-on-snow event in a Mediterranean area. Several roof collapses took place in this area in the same period (see Fig. 1).

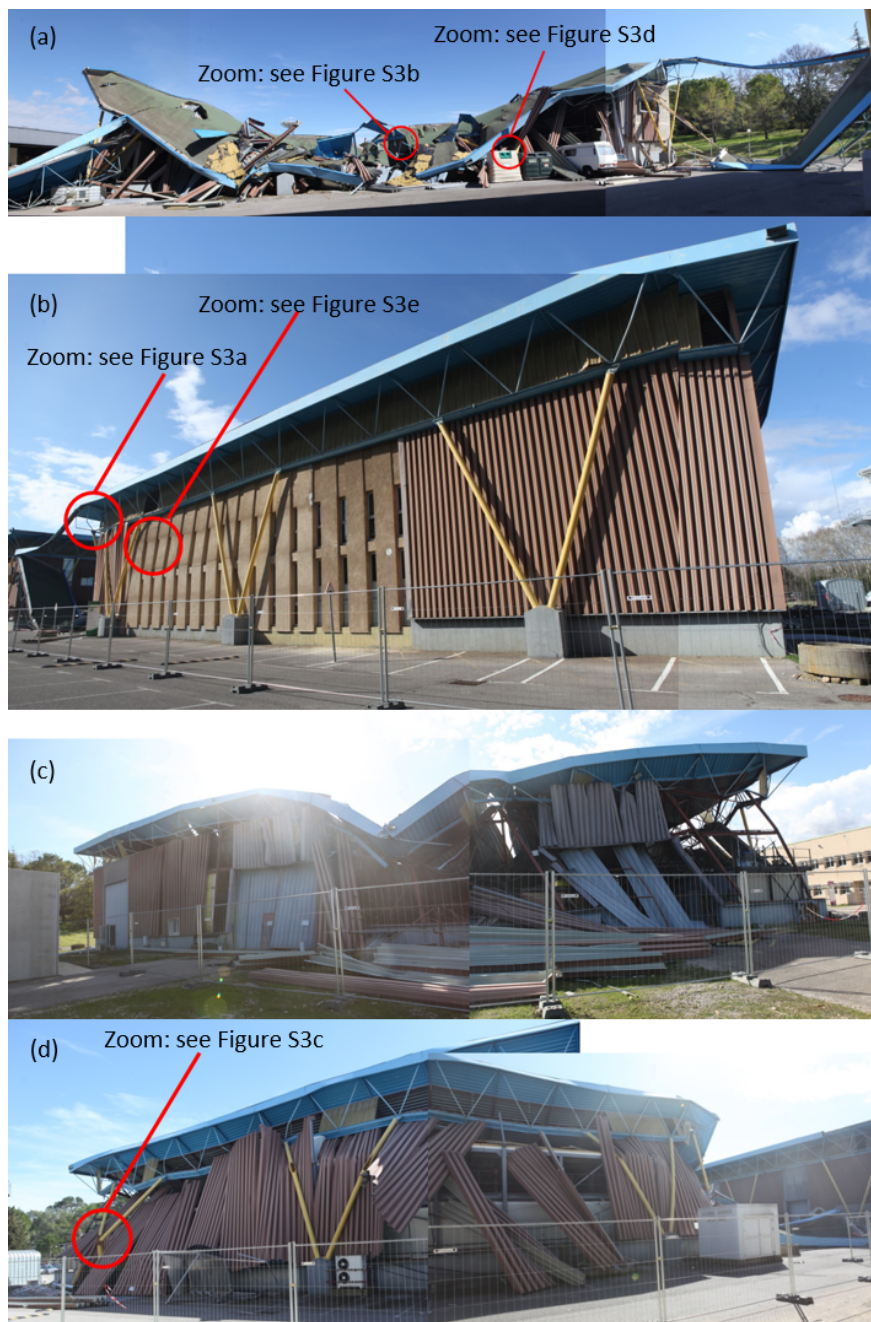
Figure 2. Different pictures showing the extent of damage as observed on 18 March 2018 on the western (a), southern (b), eastern (c) and northern (d) facades of the Irstea Cévennes building.

Figure 2 shows the main damage observed during a field visit on 18 March 2018, shortly after the collapse of the experimental hall of the Irstea Cévennes building in the central part of the structure, in the east–west direction. The western and eastern facades were heavily damaged, as seen in Fig. 2a and c. On the contrary, the other two facades (see Fig. 2b and d) were much less damaged due to the presence of the inner concrete walls of the offices and the inner metal frames of the laboratory rooms along the southern and northern facades, respectively. Local damage observed on structural elements consists of (i) buckling and bending of the roof tubular profiles, (ii) bending and shear of the tubular supporting py-

lons, and (iii) cracking on the walls of the offices (see close-up views of the damage shown in Fig. S3 in the Supplement).

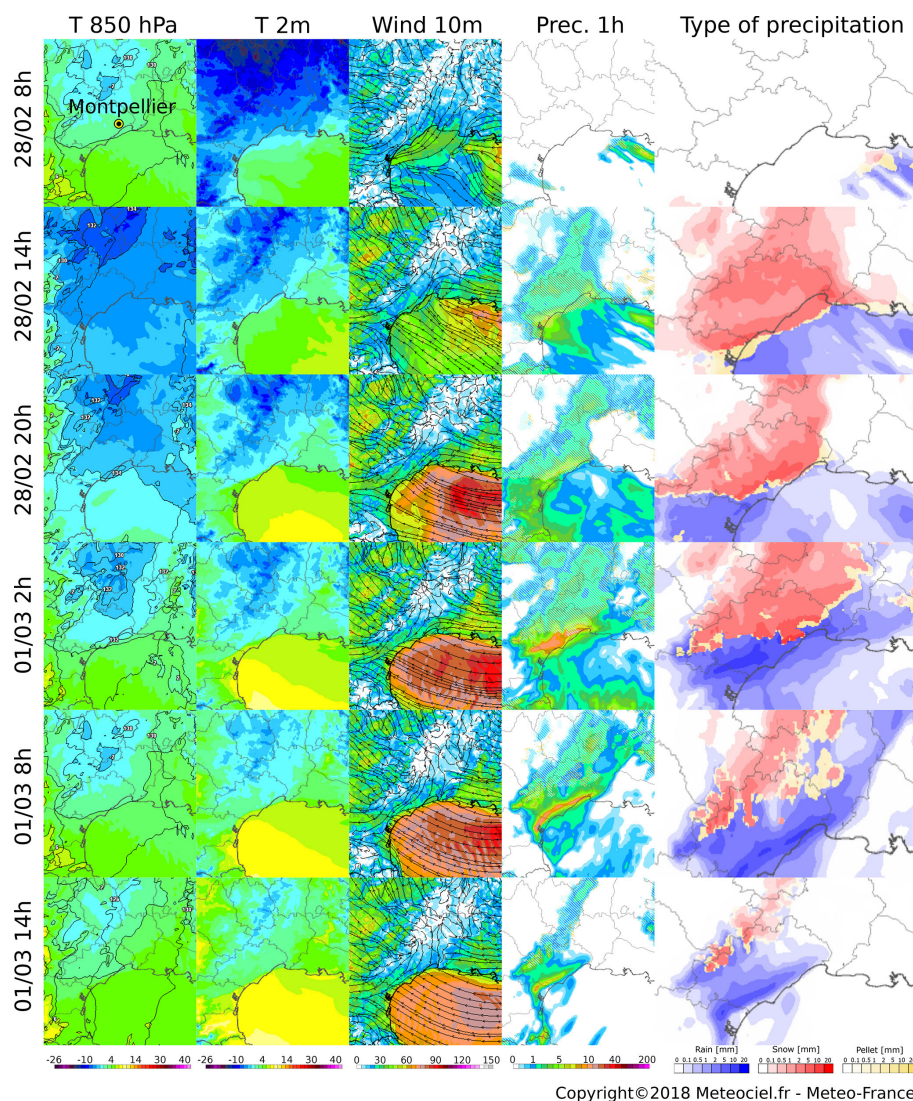
Figure 3. Outputs of the high-resolution AROME model for the following parameters: temperature at 850 hPa [$^{\circ}\text{C}$], temperature at 2 m [$^{\circ}\text{C}$], wind at 10 m [km h^{-1}], precipitation amount accumulated in 1 h [mm] and the corresponding type of precipitation (rain, snow or ice pellet). The maps shown in each row correspond to different runs for a 1 h lead time, from 28 February at 08:00 LT to 1 March at 14:00 LT. Source: Météo-France.

Figure 3 presents the outputs of the high-resolution AROME model for different times and lead times. The regional AROME model assimilates various types of observations (radar, ground measurement data, radio, satellite radiances; see Bouttier and Roulet, 2008) and must be interpreted with care. AROME outputs provide interesting information regarding the spatiotemporal dynamics of the meteorological event. Four parameters are represented: temperature at 850 hPa, temperature at 2 m, wind at 10 m, and precipitation amount accumulated in 1 h.

The last column of Fig. 3 presents the evolution of the type of precipitation simulated by the AROME model for a 1 h lead time. AROME clearly simulates an intense snow event from 28 February 2018 at 14:00 LT until the end of the day, followed by a rain-on-snow event during the night. An in-

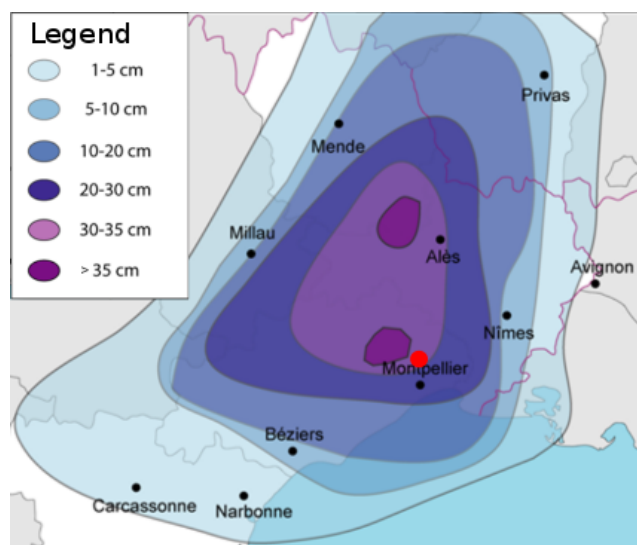
Figure 4. Snow accumulation during the snow event of 28 February 2018, based on 5000 testimonies. The red marker shows the position of the collapsed building. Source: Météo Languedoc.

(<https://www.meteolanguedoc.com/evenements-majeurs-en-languedoc-roussillon/episode-neigeux-du-28-fevrier-2018-jusqu-a-35-cm-pres-de-montpellier/p513>, last access: 5 September 2023) and include different types of information about the meteorological event, including photos from amateurs following their Facebook page (<https://fr-fr.facebook.com/MeteoLanguedoc/>, last access: 5 September 2023). Through their Facebook page, Météo Languedoc asked their 120 000 followers to provide observations and photos supporting these observations. Thanks to the collection of 5000 responses, a robust estimation of the depth of the snowpack at the end of the snow event was obtained, leading to the interpolated field of snow accumulation provided in Fig. 4. The data clearly show that the snow

depth was more important north of Montpellier, likely due to a hill separating the city center from the Lavalette site.

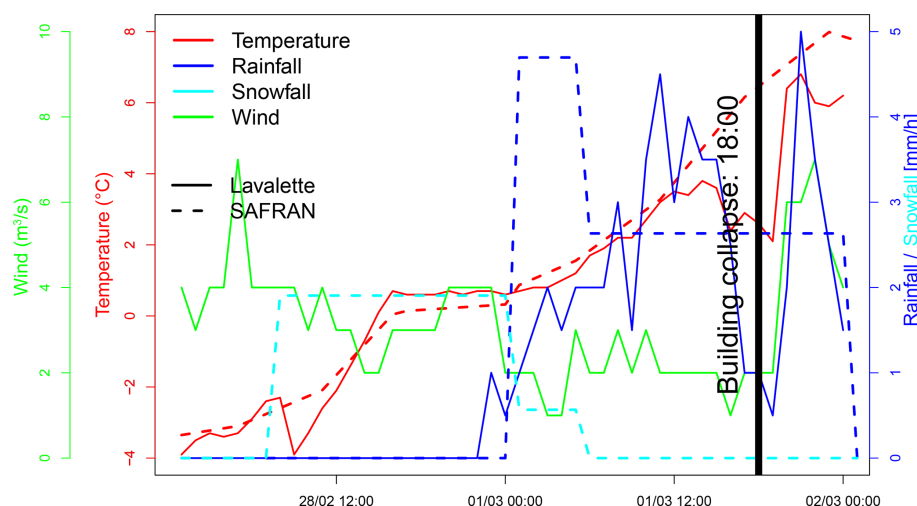
Figure 5. Weather observations at the station of Lavalette (solid lines) and SAFRAN reanalysis at the grid point covering the Irstea building (dashed lines).

Figure 5 shows the evolution of the temperature and rain and snow amounts according to two different and independent sources of information:

Both sources of information clearly show the increase in temperature from the morning of 28 February 2018 until the building collapse. SAFRAN reanalysis records an accumulation of snow water equivalent of 35 mm followed by 58 mm of rainfall before the collapse, with a rain–snow transition during the night between 28 February and 1 March. The rain gauge, which might have underestimated the rainfall accumulation due to the presence of snow in the receptacle, records 45 mm.

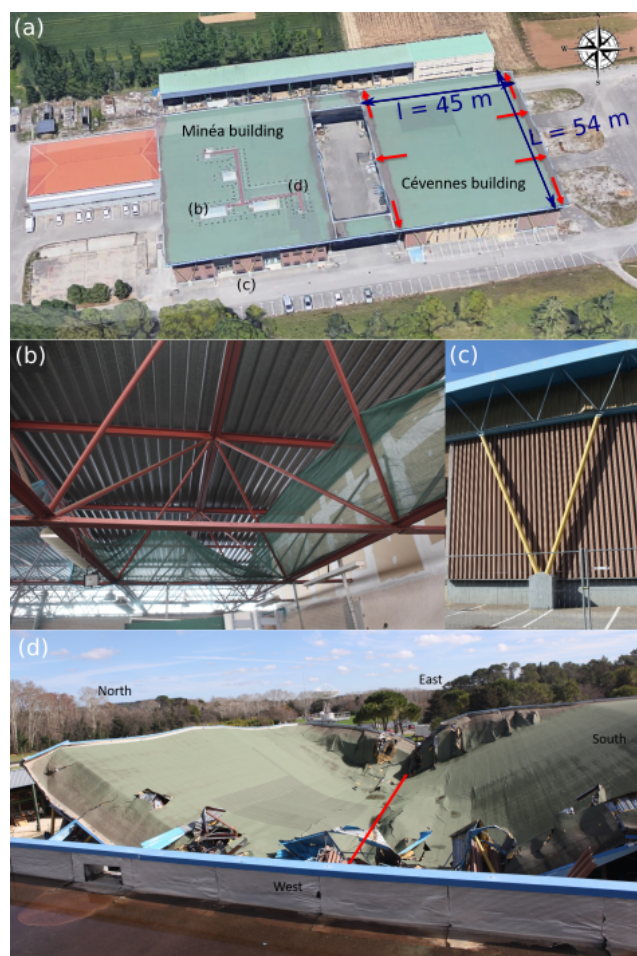
Figure 6. (a) Overview of the Irstea Cévennes building before the damage, with rainwater drainage points indicated by the red arrows. The dimensions of the roof are given in blue, and the height of the building is 10 m. The letters indicate where the photos of the other subplots were taken (photo credit: © Google Earth 2014, adapted by Isabelle Ousset). (b and c) View of the supporting structure of the Irstea Cévennes building before its damage: (b) red-colored metal roof frame and (c) supporting tubular pylons (in yellow) along the facades. (d) Overview of the damaged Irstea Cévennes building. The red line indicates the direction perpendicular to the direction of the main deflection of the roof after the collapse.

both sides of the east–west axis along which the structure collapsed, as shown in Fig. 6d. Thus, it is very likely that buckling was involved at some stage in the roof collapse.

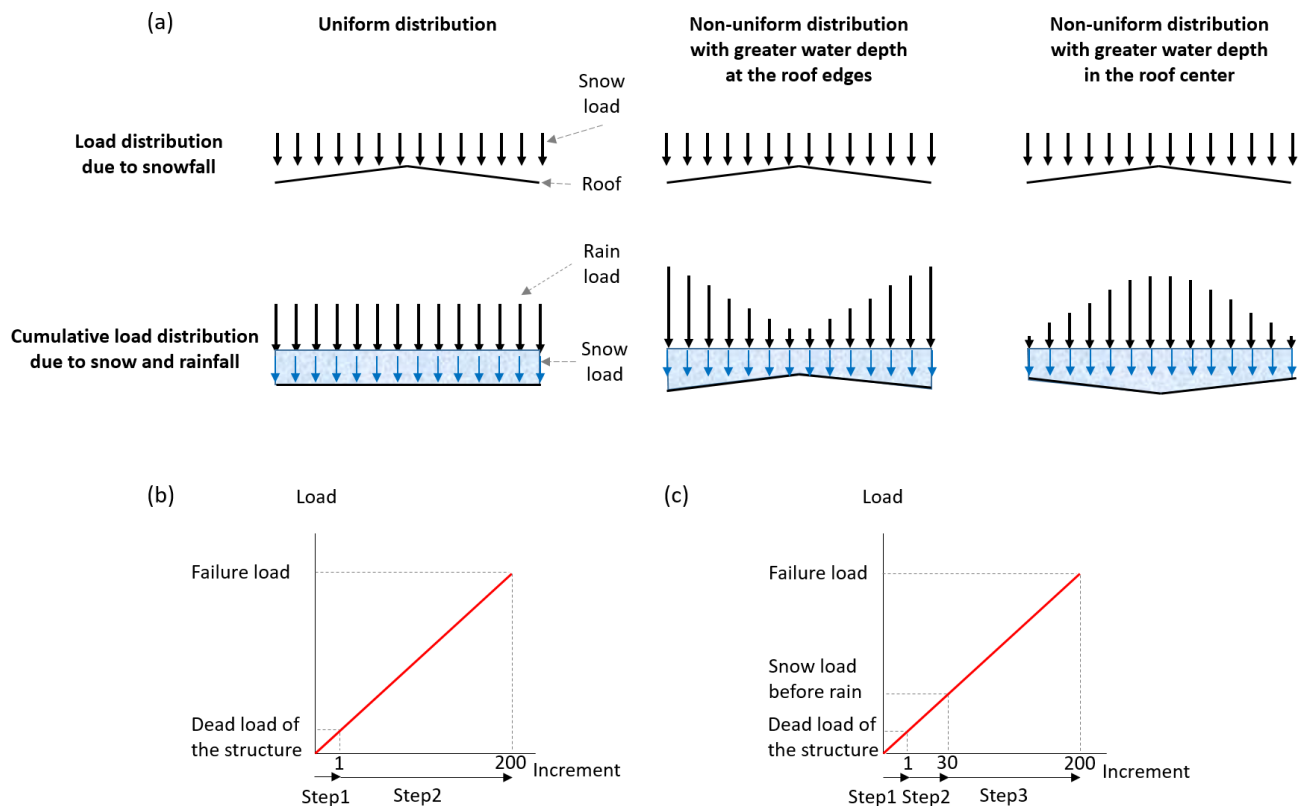
Figure 7. (a) Different assumptions made for the spatial distribution of snow and rain loads and (b and c) load evolution by incrementation for pushover analyses in the cases of a uniform distribution (b) and a non-uniform distribution (c) of rain loads. Note that the increment numbers of steps 2 and 3 are given here as examples only.

Pushover analyses are quasi-static analyses (without dynamic effects) that determine how far the building can go before it collapses completely or partially. Figure 7 illustrates the main steps of this analysis. The first step (step 1 in Fig. 7b and c) takes into account the self-weight of the structure. Then the snow and rain pressure on the structure is gradually and linearly incremented to mimic the load increase during the rain-on-snow event until the structure fails by reaching either the elastic limit of the material or the ultimate limit of the material for a snow and rain pressure equal to the failure force. This linear increase is performed in one step for uniform loads (step 2 in Fig. 7b) and two steps for non-uniform loads (steps 2 and 3 in Fig. 7c). In the latter case, step 2 corresponds to the increase in the uniform load of snow before the rain, whereas step 3 corresponds to the increase in the non-uniform load of water on the snowpack.

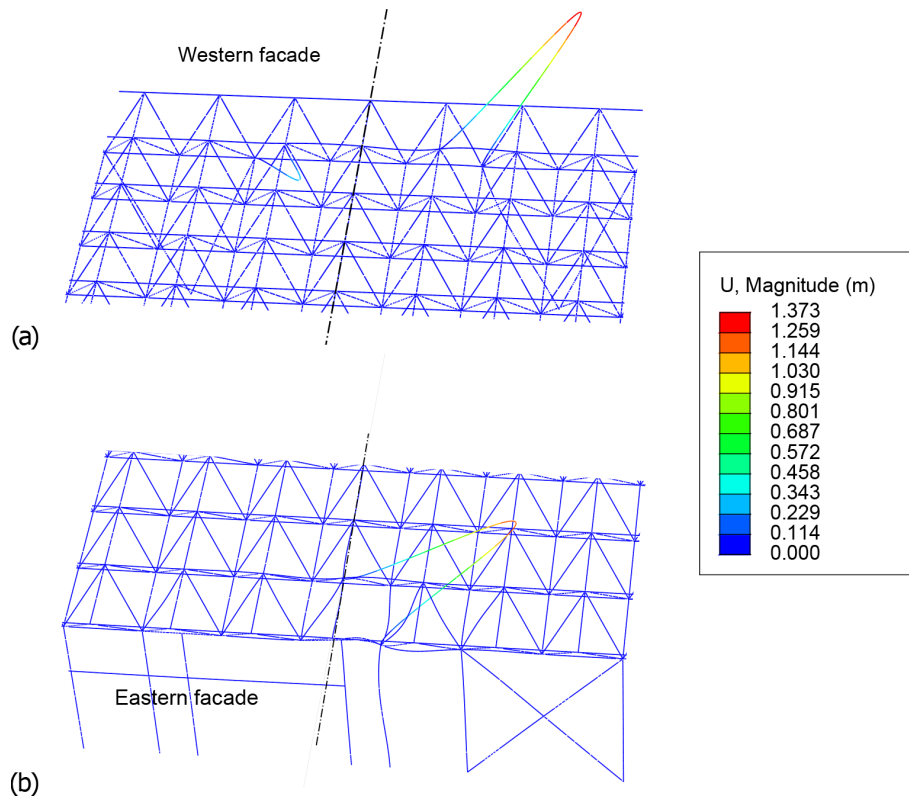
Figure 8. Buckling mode shapes of the structure under a uniform snow and rain pressure field (deformation scale factor = 5.4): **(a)** first mode, above the western facade, and **(b)** fifth mode, above the eastern facade.

The minimum of 645 N m^{-2} (in brown) corresponds to the non-linear buckling load. This value is just below the uniform initial snow load before the rain (736 N m^{-2}) (in teal) and does not depend on the assumption made for the distribution of the rain load. In contrast, the linear buckling analysis gives higher values for the load corresponding to the first eigenvalue mode (from 935 to 945 N m^{-2}). All of these critical buckling loads (in beige) are well below the snow and rain load estimates. This means that this failure could have occurred with the observed snow and rain load. In addition, although it should be noted that the buckling failures remained localized (on a few crossbars located at the eastern and western edges, as shown in Sect. 3 and Fig. 8), they occur on

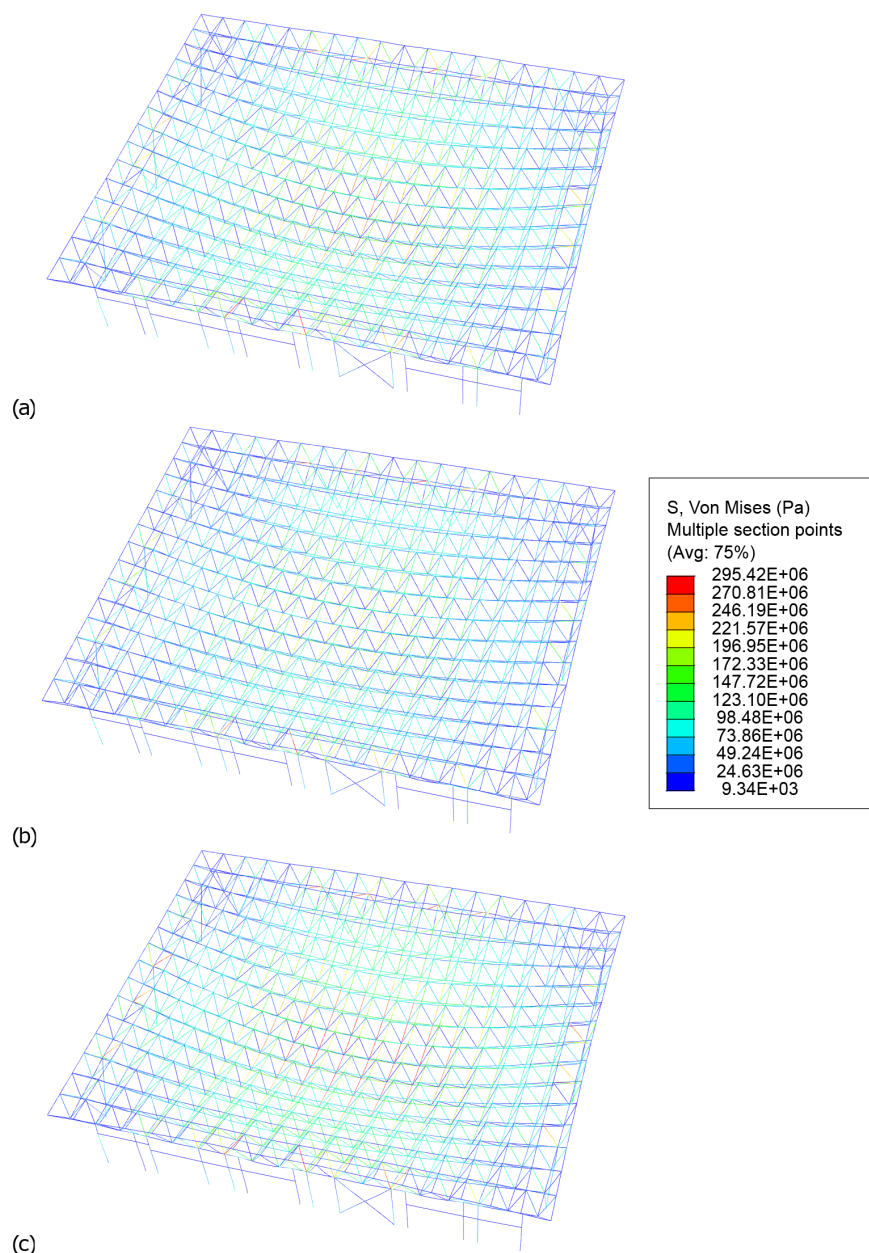
Figure 9. Von Mises stress field (Pa) inside the structure at the real snow and rain load of 1325 N m^{-2} , given by the FE model simulation for the different assumptions made for the spatial distribution of snow and rain: **(a)** uniform, **(b)** non-uniform with greater water depth at the edges and **(c)** non-uniform with greater water depth in the center (a deformation scale factor of 25 is applied to highlight the contrasts).

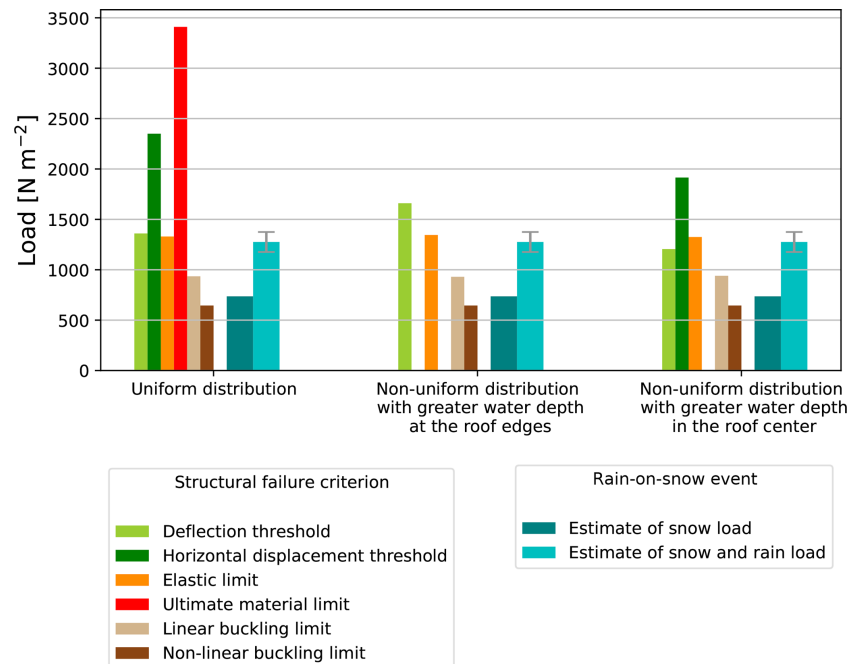
Figure 10. Comparison of the snow loads leading to different failure criteria of the Cévennes building, as calculated by FE model simulations, with the estimated scenario for the rain-on-snow event of 2018, as back analyzed in Sect. 2, in the different cases of snow and rain pressure fields. The structure fails when the observed snow and rain load (on the right, for each assumption of snow and rain distribution) is greater than the calculated failure load (on the left). The latter calculated failure load could not be obtained when code divergence was observed, thus explaining the empty bars in the case of non-uniform rain distributions (see Table 1).

Figure 10 compares the critical loads that would cause a failure according to the FE simulations (Table 1) with the initial snow load of 736 N m^{-2} before the rain and the final snow and rain load values of 1226 to 1325 N m^{-2} estimated from different sources of observations in Sect. 2.

The maximum critical load of 3410 N m^{-2} (in red in Fig. 10) corresponds to the ultimate limit of the material under uniform pressure distribution and is well above the estimated value for the snow and rain load of 1226 – 1325 N m^{-2} (in cyan). Note that for non-uniform snow pressure fields, the ultimate material limit is not reached due to numerical instabilities (lack of convergence). The values obtained from the horizontal displacement criterion are also well above the estimated range of 1226 – 1325 N m^{-2} . The pushover FE simulations thus suggest that neither the ultimate material limit nor the critical horizontal displacement was reached at the time just before the collapse, regardless of the scenario for rain load spatial distribution.
