Evaluating post-wildfire debris-flow rainfall thresholds and volume models at the 2020 Grizzly Creek Fire in Glenwood Canyon, Colorado, USA

Abstract. As wildfire increases in the western United States, so do postfire debris-flow hazards. The U.S. Geological Survey (USGS) has developed two separate models to estimate (1) rainfall intensity thresholds for postfire debris-flow initiation and (2) debris-flow volumes. However, the information necessary to test the accuracy of these models is seldom available. Here, we studied how well these models performed over a 2-year period in the 2020 Grizzly Creek Fire burn perimeter in Glenwood Canyon, Colorado, USA, through the development of a debris-flow response inventory. The study area had the advantage of a network of 11 rain gauges for rainfall intensity measurements and repeat lidar data for volume estimates. Our observations showed that 89% of observed debris flows in the first year postfire were triggered by rainfall rates higher than the fire-wide rainfall threshold produced by the current USGS operational model (M1). No debris flows were observed in the second year postfire, despite eight rainstorms with intensities higher than the

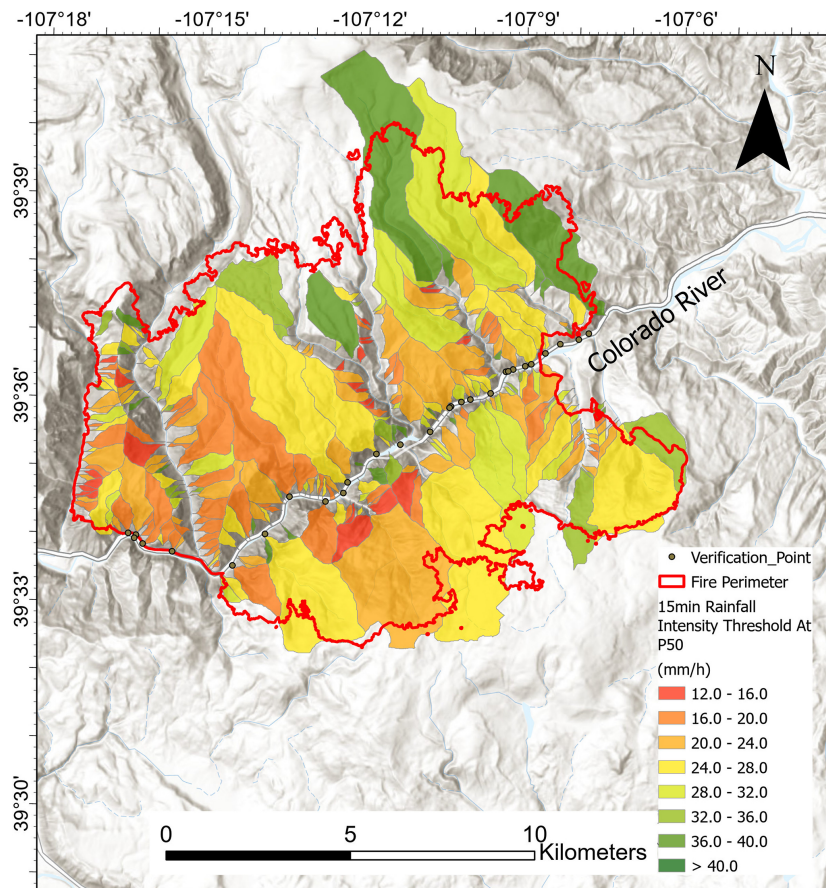
Figure 1. USGS debris-flow hazard assessment produced for the Grizzly Creek Fire perimeter using Eq. (1). The 15 min rainfall intensity threshold is shown for each basin, assuming a likelihood of 50 % (P50). The median value from all of these basins is used to estimate the year-1 15 min rainfall intensity threshold for the entire burn area. Background shaded relief topography credit: ESRI, Garmin, U.S. Geological Survey, and Bureau of Land Management.

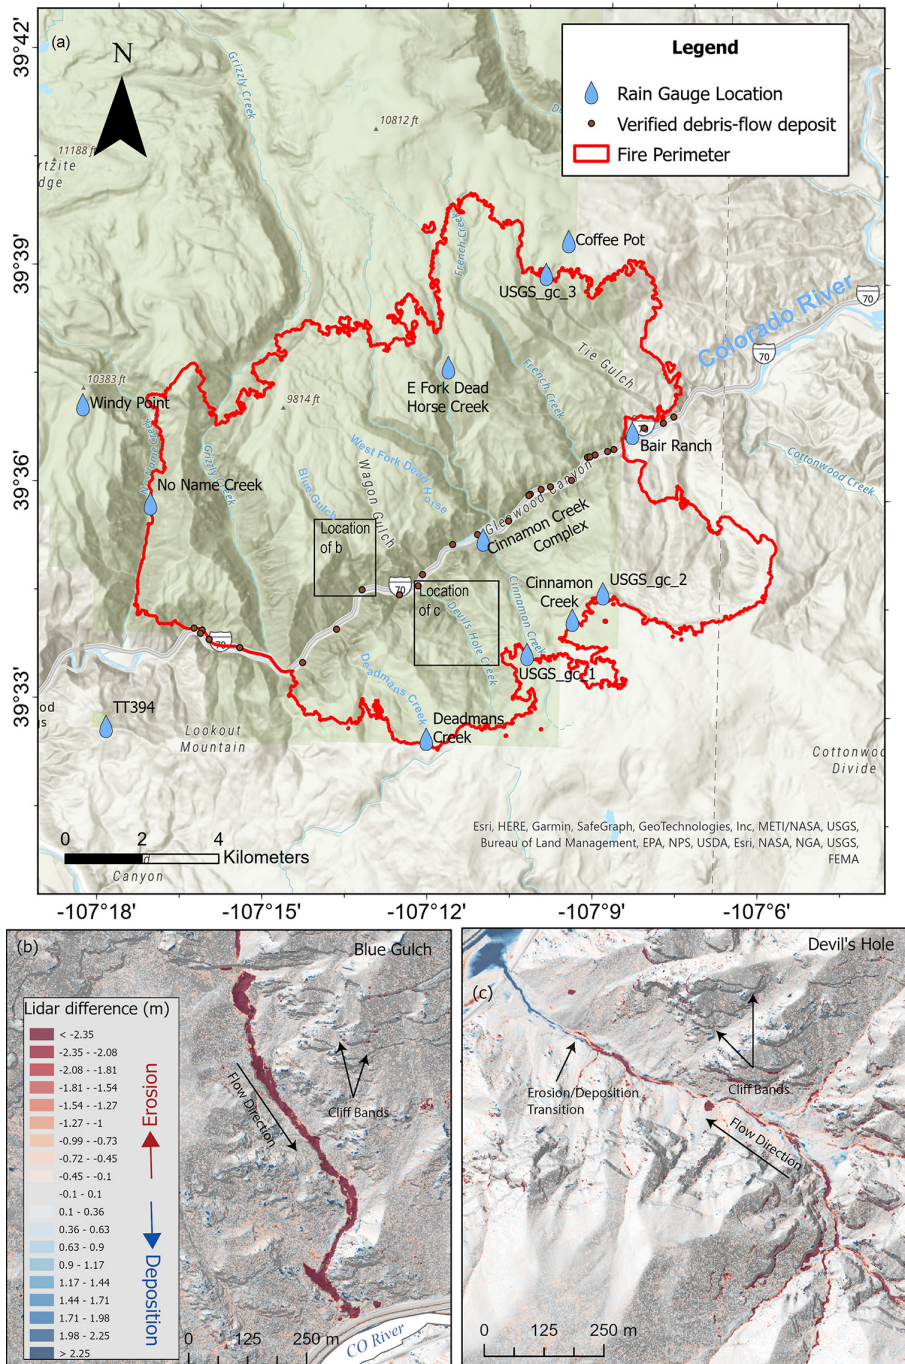
Figure 2. (a) Map showing the burn perimeter, rain gauges, and locations of debris-flow observations. (b) DEM of difference map showing erosion (red) and deposition (blue) in the lower half of the Blue Gulch drainage. (c) DEM of difference showing erosion (red) and deposition (blue) in the lower half of the Devil's Hole drainage.

Three tipping bucket rain gauges were installed in the burn area on 17 September 2020 by the USGS Landslide Hazards Program. These gauges (USGS_gc_1, USGS_gc_2, USGS_gc_3; Fig. 2) were deployed specifically for the task of verifying the hazard assessment model (Fig. 1). An additional seven rain gauges (7) were added during the summer of 2021 by the USGS Colorado Water Science Center to provide situational awareness and inform operational warnings by the National Weather Service and CDOT. We were also able to obtain data from the Bair Ranch gauge operated by CDOT. As a result, a total of 11 rain gauges captured high-frequency (15 min) rainfall intensities in and around Glenwood Canyon (Fig. 2) and provided a relatively dense network of rain data to associate with debris-flow events. All gauges were operating by mid-July 2021, beginning on several different dates (Table 1).

Using the two lidar datasets (1 m pixel), we subtracted the elevation of the post-event lidar from the pre-event lidar ($Z_{2021} - Z_{2016}$) to create a DoD map of erosion and deposition throughout the Grizzly Creek burn area (Figs. 2 and 3). For each debris-flow observation in our inventory, we mapped erosional and depositional areas in each channel with separate polygons by hand. Hillslope erosion, which is below the detection limit of the lidar, was assumed to be minimal based on post-event field observations that indicated minor hillslope surface erosion. We masked cliff areas from the DoD and all slopes $> 45^\circ$ to eliminate lidar artifacts due

tions suggest that the source of sediment for debris flows in Glenwood Canyon (Fig. 2) appeared to be primarily derived from channels. Unlike sites where sediment is sourced primarily from hillslope erosion (e.g., Rengers et al., 2021), debris flows in the Glenwood Canyon study area initiated primarily in channels at small drainage areas and steep slopes (Fig. 4). These differences are likely related to the timing of the debris flows with respect to the wildfire. That is, the fire happened in the fall of 2020, allowing time for partial recovery of soil hydrology during the winter freeze–thaw cycles and vegetation regrowth during the spring and early summer of 2021 (Fig. 4). While hillslope rilling was observed in select areas (Fig. S5), most hillslopes were partially covered with herbaceous vegetation by the 2021 monsoon based on remote sensing data and field observations (Fig. 9). As a result, flow velocities sufficient to initiate debris flows would likely have only been reached in channels.

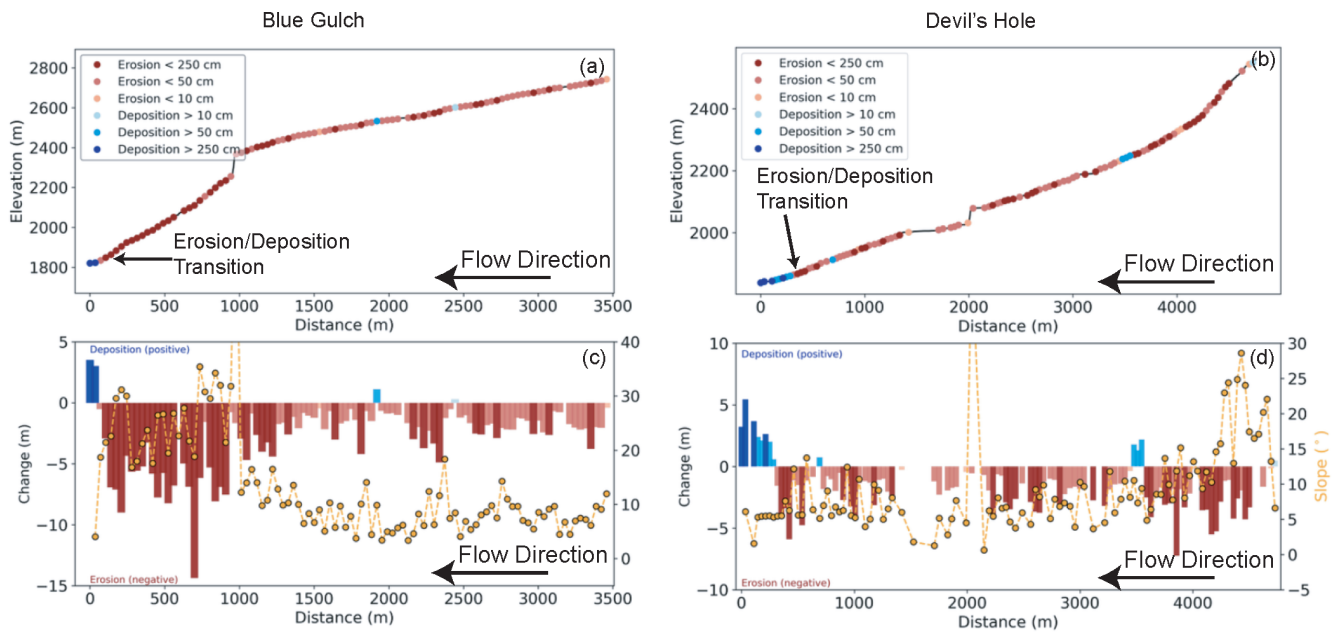
Figure 3. (a) Longitudinal profile of the Blue Gulch watershed. (b) Longitudinal profile of the Devil's Hole watershed. In both (a) and (b) red dots and blue dots represent erosion and deposition, respectively. Areas without a dot did not experience change beyond the level of detection. (c) Measured deposition and erosion in the Blue Gulch watershed. (d) Measured deposition and erosion in the Devil's Hole watershed. In both (c) and (d) local slope is shown on the secondary y axis.

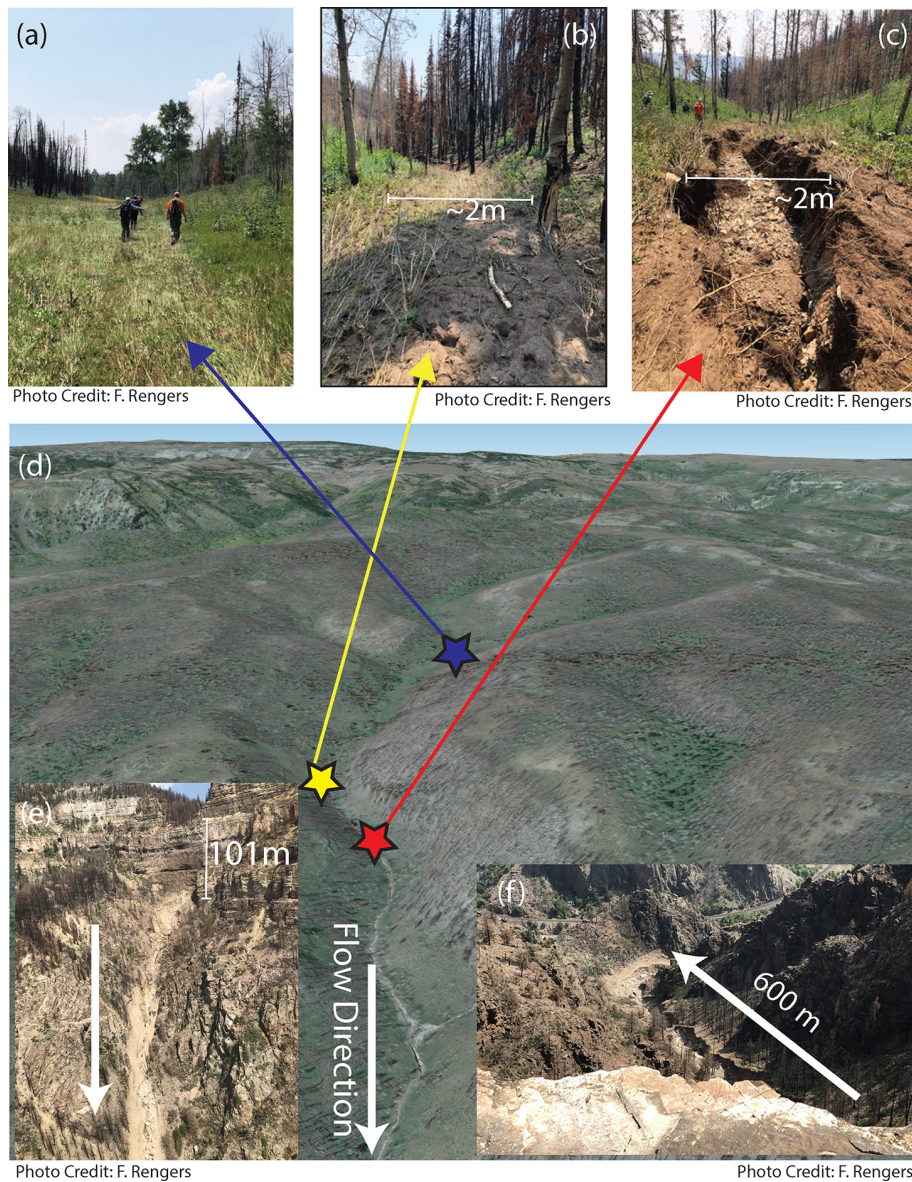
Figure 4. Debris flows were triggered in the Blue Gulch watershed on 29 July and 31 July 2021. Photos from 17 August 2021 show debris-flow initiation transitioning from (a) water flow matting down grass (see people for scale), (b) to incipient erosion of grassy root wads without distinct channel incision, and (c) to channelized erosion below the root layer. (d) © Google Earth imagery of the upper portion of the Blue Gulch watershed. (e) Photo from 18 August 2021 of a cliff (101 m relief) in the Blue Gulch watershed 2.2 km downstream of the initiation location. (f) Photo from 17 August 2021 at the cliff edge (shown in e) illustrating the debris-flow path towards the Colorado River.

(Fig. 4), as has been observed in grassland settings (Rengers et al., 2016). Moreover, field mapping in multiple watersheds (Blue Gulch, Grizzly Creek, and French Creek) confirm the observations of in-channel debris-flow initiation observed in the DoD. Hillslope rilling was only observed in a few locations with relatively low levels of revegetation in 2021 (Fig. S5).

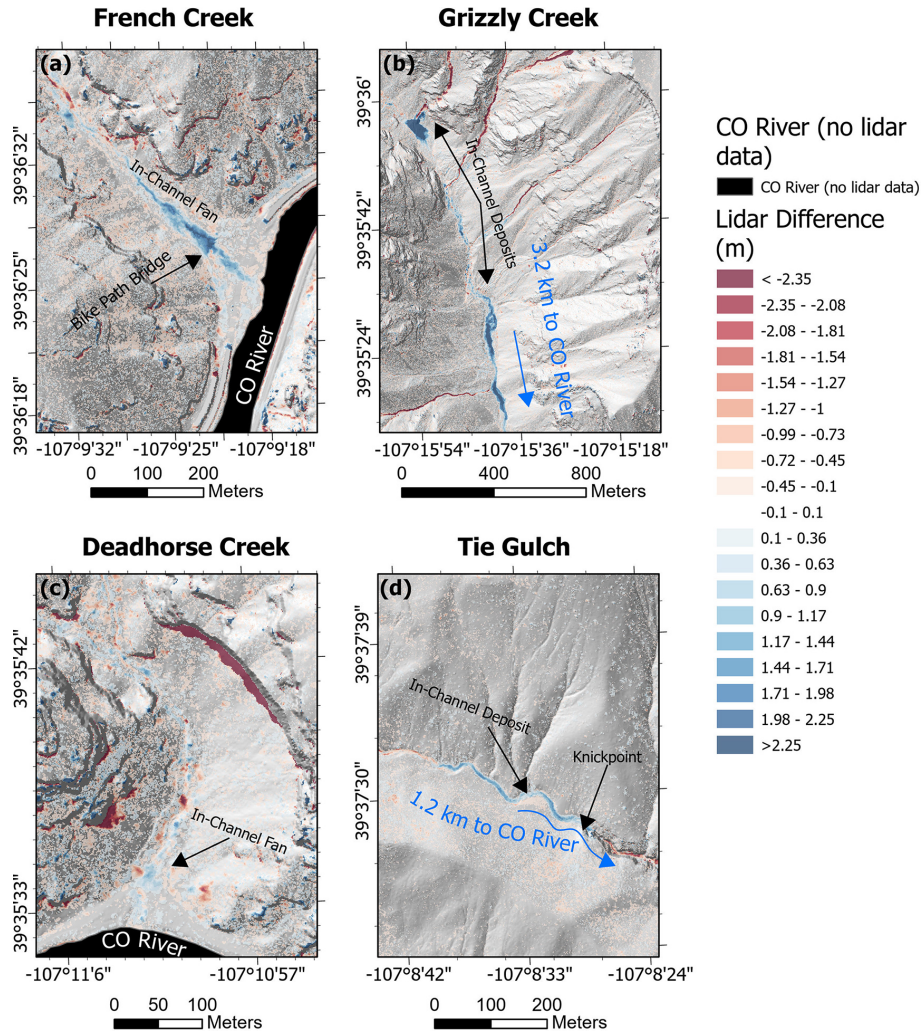
Figure 5. In-channel sediment deposits in large drainage basins. (a) French Creek: a fan forms upstream of the Colorado River, primarily because sediment is blocked by a concrete bike path bridge. (b) Grizzly Creek: several in-channel deposits formed several kilometers upstream of the Colorado River. No fan formed at the outlet of Grizzly Creek. (c) Dead Horse Creek: relatively minor depositional fan forms upstream of the Colorado River. (d) Tie Gulch: in-channel deposits develop upstream of a knickpoint.

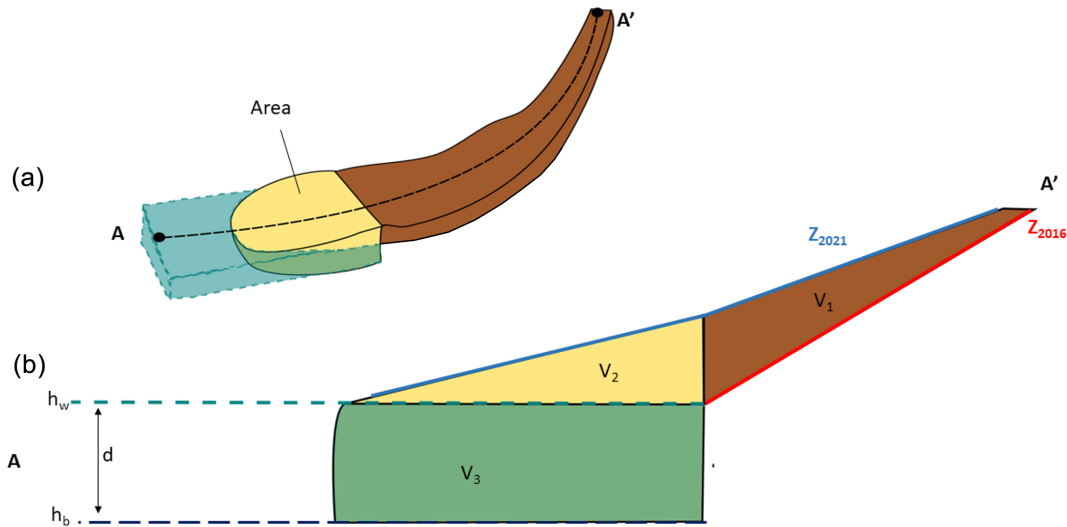
Figure 6. (a) Oblique view and (b) cross-sectional view of the approach used to estimate the volume of deposited sediment in the Colorado River due to unknown bathymetry. The volume of sediment deposition was divided into three zones. V_1 is the sub-areal zone, where a lidar difference can be used to estimate the volume. V_2 is the zone above the water surface. V_3 is the subaqueous zone, and the depth is estimated based on reports from CDOT maintenance crews.

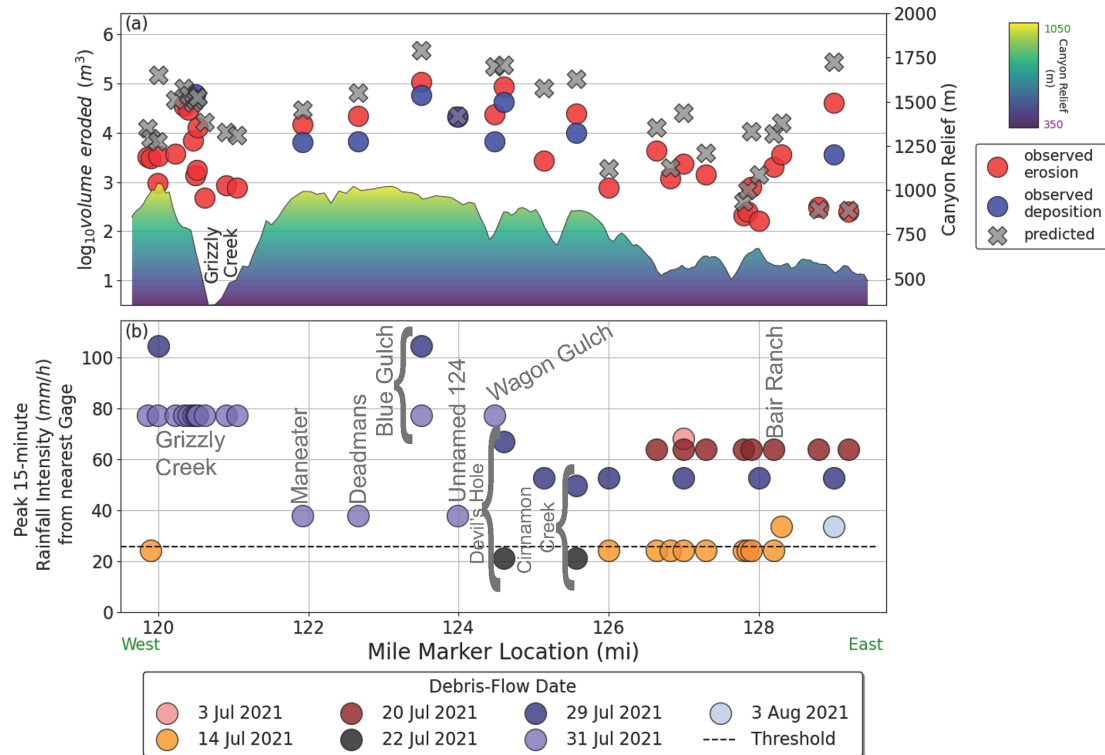
Figure 7. (a) Observed sediment volume (erosional and depositional) and estimated sediment volume using Eq. (2) shown as a function of the mile marker location in Glenwood Canyon. For context, the canyon relief is shown on the secondary axis. The relief profile indicates the elevation from the north side of the canyon approximately parallel to I-70. (b) Peak 15 min rainfall intensity from the nearest representative gauge shown at locations identified by debris-flow date. Note that debris-flow verification points were associated with a mile marker location at the watershed outlet, as this was the preferred method of identification by CDOT personnel. In cases where the channel outlet did not directly intersect I-70, the outlet was simply translated onto a line segment representing I-70 to estimate a mile marker location.

The depositional volumes observed were less than the erosional volumes, as was expected due to sediment disturbance between the time of debris-flow deposition and the lidar flight (Fig. 7).

tensities. However, the spatial footprint of any given storm observed at our study area was highly variable. For example, during the storm on 22 July 2021, rainfall intensities only exceeded the rainfall threshold at 6 of the 11 rain gauges (Fig. S7), and the observed debris flows from that storm intersected a narrow section of I-70 (between mile markers 124–126) (Fig. 7b). In contrast, during the storm on 29 July 2021, rainfall intensities exceeded the rainfall threshold at eight of the nine gauges (two gauges had data gaps at this time; Fig. S7), and debris flows were observed throughout most of the canyon (Fig. 7b).

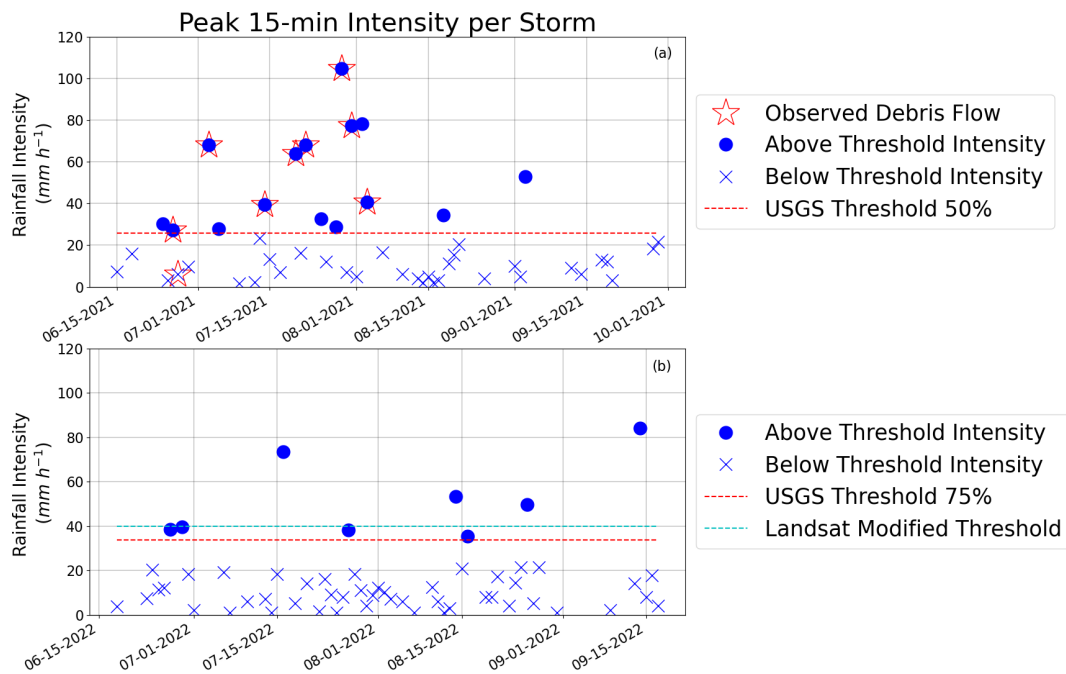
Figure 8. (a) Maximum 15 min rainfall intensity during each storm from the 11 rain gauges near the Grizzly Creek Fire perimeter during the 2021 monsoon. Rainfall rates below the modeled intensity threshold of 25.9 mm h^{-1} (50 % likelihood) are shown with a cross, and those above the modeled threshold are shown with a circle. Any storms that produced a debris flow are indicated with a star. (b) Maximum 15 min rainfall intensity during each storm from the 11 rain gauges near the Grizzly Creek Fire perimeter during the 2022 monsoon. The year 2 (75 % likelihood) of 33.7 mm h^{-1} was used as the USGS threshold. A recalibrated dNBR value from Landsat at the beginning of the monsoon season was used with the M1 model to develop an additional threshold of 40 mm h^{-1} using the 50 % likelihood of debris-flow occurrence. Note that no debris flows were observed in 2022.

When the debris-flow and storm inventories were compared with the P50 rainfall threshold created by the debris-flow hazard assessment in 2021, we observed relatively good performance of the estimated rainfall threshold (Fig. 8a). The I15 values associated with the initiation of one or more debris flows (Fig. 8a) were above the $\overline{I15}_{T21}$ (25.9 mm h^{-1}) produced by the hazard assessment (Staley et al., 2017) in eight out of nine cases during the first year postfire (U.S. Geological Survey, 2020). The only observed debris flow with a rainfall rate below $\overline{I15}_{T21}$ was on 27 June 2021. However, most of the rain gauges were not operating at that time (Table 1 and Fig. S3); therefore, it is possible that the closest available rain gauge was not reflective of the maximum rainfall rate in the storm. In the second summer postfire, the $\overline{I15}_{T22}$ was increased (33.7 mm h^{-1}) and several storms generated I15 rainfall intensities larger than $\overline{I15}_{T22}$; however, no debris flows were documented (Fig. 7b).

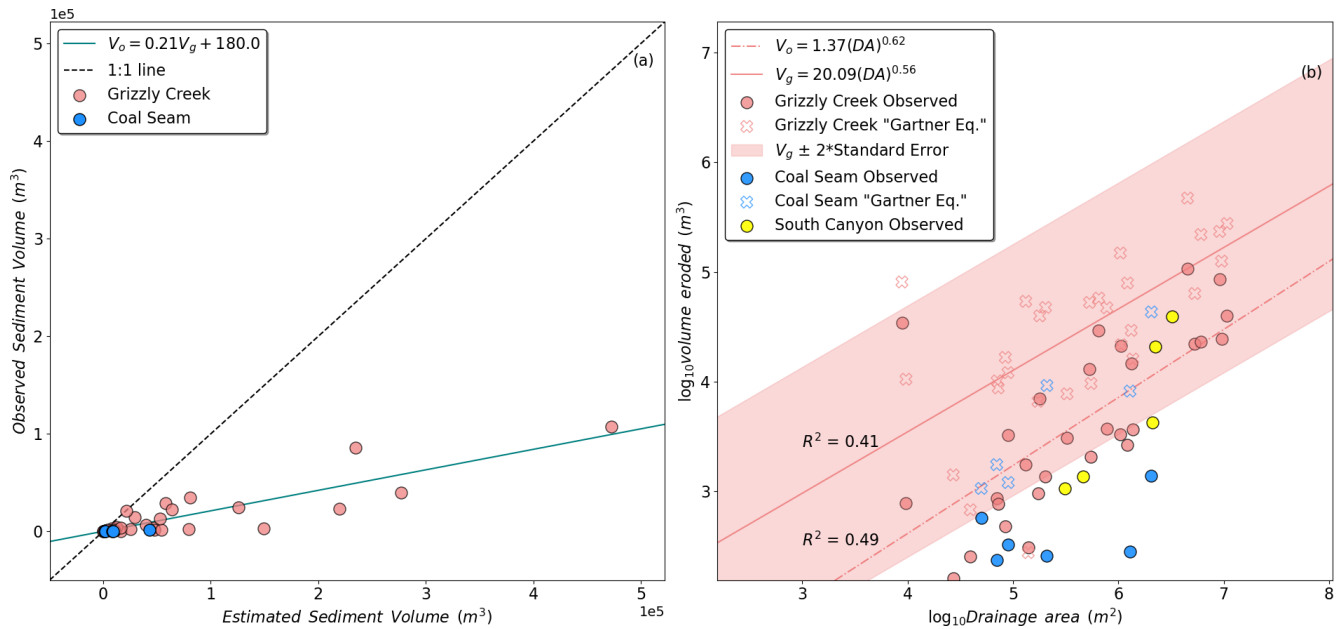
Figure 9. (a) Observed sediment volume (erosional) versus estimated sediment volume using Eq. (2) developed by Gartner et al. (2014). Linear trend line shows the relationship between the estimated (V_g) and observed (V_o) volume at the Grizzly Creek Fire. (b) A comparison of the total volume of observed sediment with estimated volume from Eq. (2) as a function of upstream drainage area (DA). The observation volumes represent the volume of erosion upstream of a transition to deposition. Best-fit power law equations (dashed and solid red lines) were fit to the observed (red circles) and estimated (red crosses) data points for the Grizzly Creek Fire, respectively. R^2 values are reported for these fits.

The volumes from the Grizzly Creek Fire were similar in magnitude to the observed volumes from the two prior post-fire debris flows near Glenwood Canyon, the Coal Seam and South Canyon fires (Fig. 9), suggesting regional similarities between the observed volumes across three different fires. Moreover, the trend of volume overestimation by Eq. (2) was observed in both the Grizzly Creek Fire data and the Coal Seam Fire data (Fig. 9). This suggests that the overestimation of Eq. (2) is not related to fire- or storm-specific characteristics of the Grizzly Creek Fire. Rather the overestimation of Eq. (2) is more likely related to regional differences in sediment, vegetation, and sediment transport processes tied to the regional geomorphology.

lar magnitude to the historic volumes even when normalizing by upstream contributing drainage area (Fig. 9b), suggesting that there are regional controls on postfire debris-flow volume. The Coal Seam debris-flow volumes were overestimated between 1.8–35 times by Eq. (2). Nevertheless, because of the linear nature of the offset in the volume estimate (Fig. 9), it may be possible to apply a linear correction to the estimated volumes to obtain a regionally corrected volume estimate.

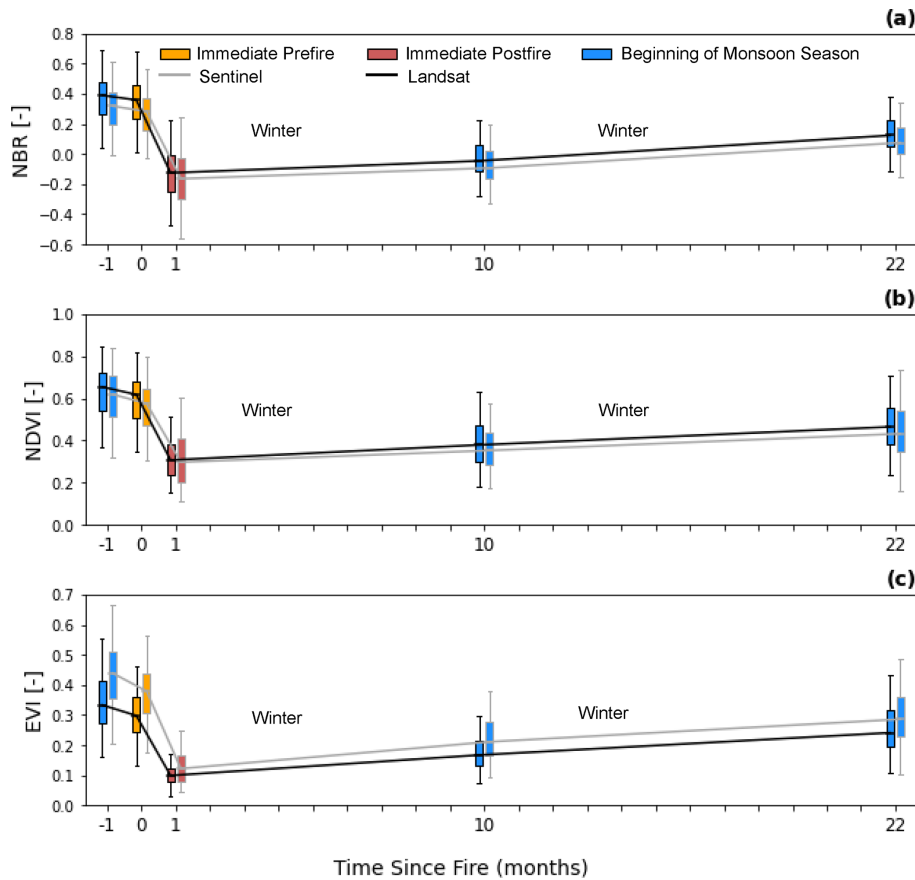
Figure 10. Landsat- (black outline) versus Sentinel-derived (gray outline) measurements of the (a) normalized burn ratio (NBR), (b) normalized difference vegetation metric (NDVI), and (c) enhanced vegetation index (EVI) for the 2020 Grizzly Creek Fire. Boxplots summarize the distribution of the mean reflectance metric for each modeled basin (U.S. Geological Survey, 2020) that intersects the burn area for the beginning of the monsoon season (blue), immediately before the fire (orange), and immediately after the fire (red).

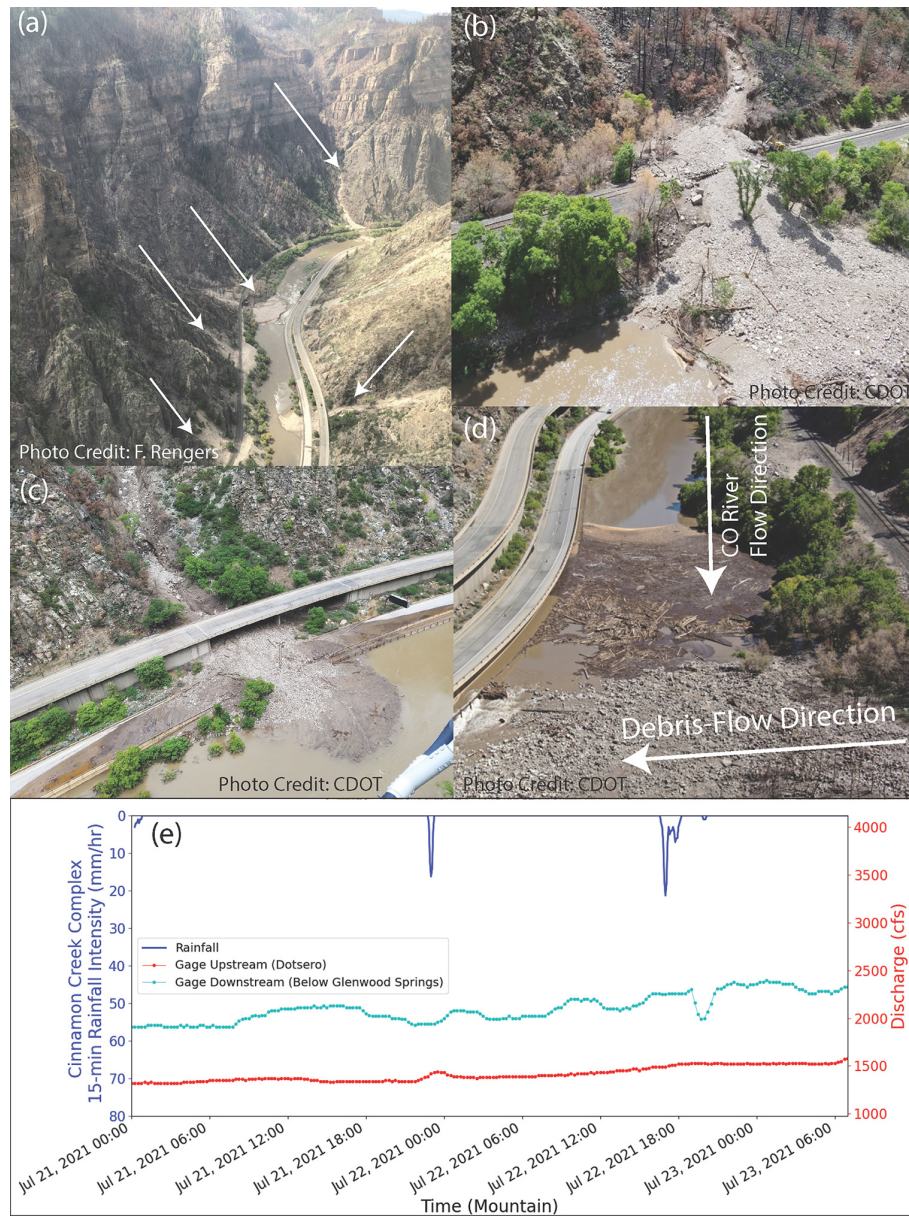
Figure 11. (a) View of debris-flow paths and deposits in the Colorado River looking southwest on 18 August 2021. Arrows indicate new debris-flow paths. (b) Sedimentation on the railroad in Glenwood Canyon on 1 August 2021. (c) Sedimentation on the lower deck of I-70 on 1 August 2021. (d) Photo of temporary damming of the Colorado River on 22 July 2021. (e) Damming can be observed in the discharge record of the Colorado River on 22 July 2021. The upstream discharge in the Colorado River (red) rises steadily in response to the closest-measured 15 min rainfall intensity (blue). When the debris flow at Devil’s Hole temporarily dammed the Colorado River, a drop in discharge is observed at the downstream river gauge (cyan).

the riverbed (Fig. 11a). The debris-flow response following the Grizzly Creek Fire illustrates how debris flows can affect multiple locations during many different storm events, putting different types of critical infrastructure at risk.

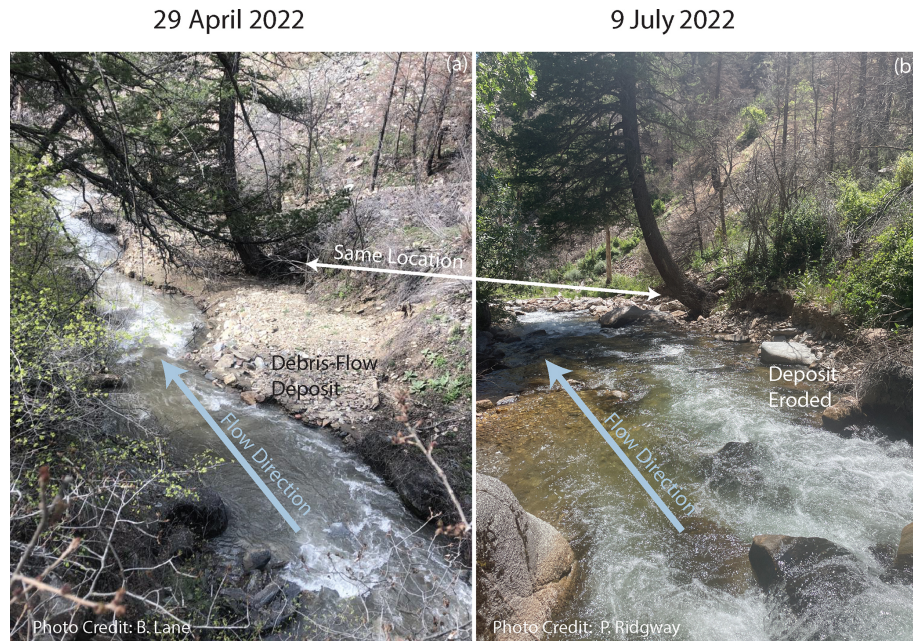
Figure 12. (a) Small debris-flow fan in Grizzly Creek at the beginning of the 2022 snowmelt season. (b) Vertical and horizontal incision of the same fan after the snowmelt runoff.
