Automating tephra fall building damage assessment using deep learning

Eleanor Tennant¹, Susanna F. Jenkins², Victoria Miller³, Richard Robertson⁴, Bihan Wen⁵, Sang-Ho Yun², and Benoit Taisne²

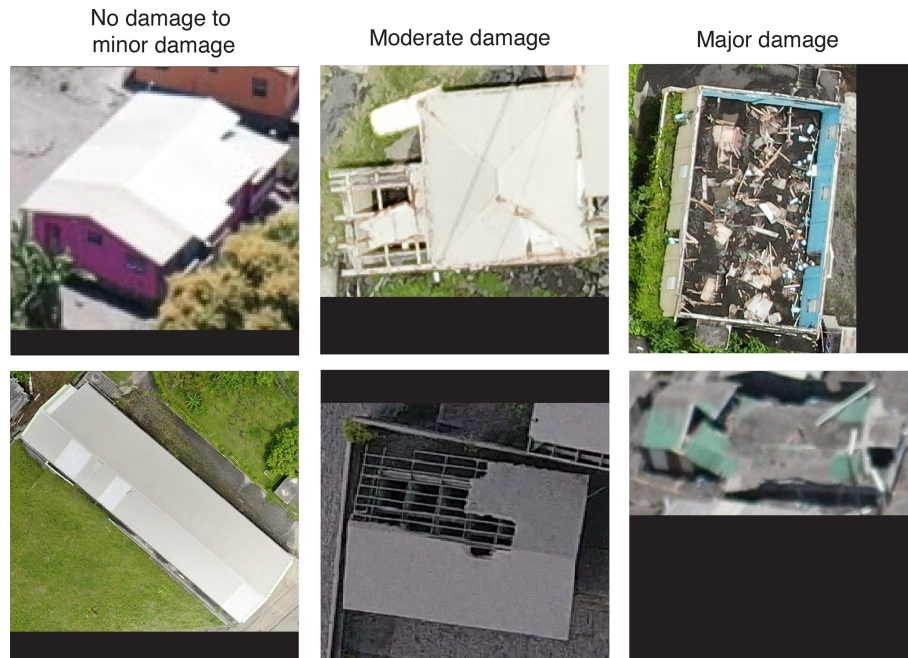
Figure 2. Example of the three damage states used in this work: no damage to minor damage, moderate damage and major damage.
