# Optimization strategy for flexible barrier structures: investigation and back analysis of a rockfall disaster case in southwestern China

This paper reports on a flexible rockfall barrier that was damaged by rockfall impact on the road leading to the Jiguanshan National Forest Park in Chengdu, Sichuan Province, China. A series of field investigations were conducted to identify the trajectories of the rockfalls and gather information on the rockfalls and flexible barrier damage. A digital slope model was created based on an unmanned aerial vehicle (UAV) survey. Essential physical characteristics, including the rockfall trajectory and impact kinetic energy, were assumed. Combining the investigation information, a finite element (FE) model containing a part of the slope, the rockfalls, and the flexible rockfall barrier was established. A back analysis of the dynamic process of rockfalls impacting the protection system was then performed to replicate the damage evolution process of the protection system and to reveal the damage mechanism of the actual protection project. Finally, optimized design strategies were proposed with the same material types and specifications used in the exi

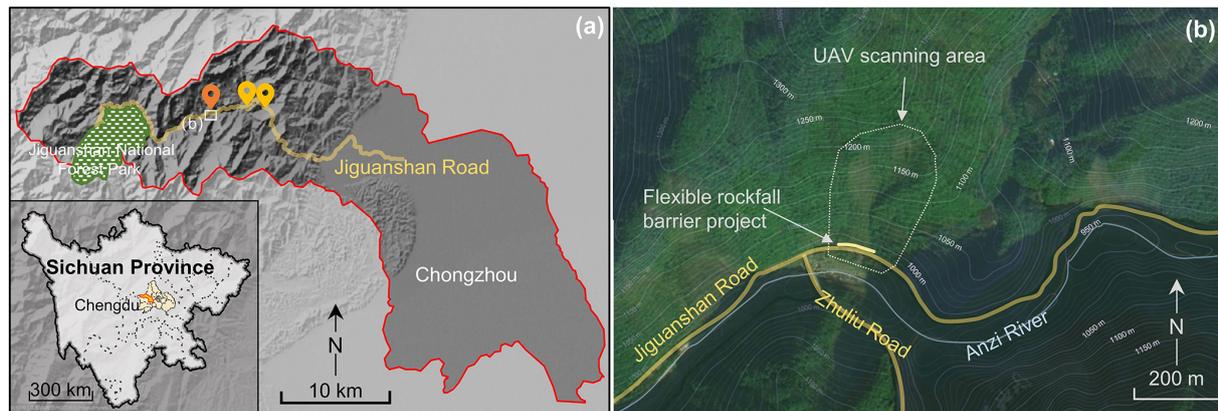
**Figure 1.** Geological map of the rockfall disasters: (a) regional terrain and the location of the three disaster sites. Map data: [https://datav.aliyun.com/portal/school/atlas/area\\_selector](https://datav.aliyun.com/portal/school/atlas/area_selector) (last access: 27 July 2023). (b) Regional aerial image of the case presented in this paper. Image: <https://www.tianditu.gov.cn/> (last access: 27 July 2023).

As shown in Fig. 1a, Jiguanshan National Forest Park is situated in Chongzhou, southwest of Chengdu – with its back toward Longmen Mountain and its front facing Chengdu Plain – and in the middle south section of the Longmen Mountain structural belt, with complex structural conditions. The southeast of Chongzhou is plain, the centre and western regions of the southeast are hilly, and the broad western areas are covered with low mountain and high mountain landforms. The faults and folds in the low mountain regions of the west cause the rock mass to be broken and cleavage fissure to develop, deeply cut the terrain, and result in a significant relative height difference (Yang et al., 2023). The authors investigated multiple cave-in rockfall disasters that damaged the flexible barriers along the Jiguanshan Road leading to the Jiguanshan National Forest Park in mid-November 2020. Three flexible rockfall barrier projects with similar structural forms experienced system overturning and damage from buckling steel columns, with the most common buckling forms being “C”-shaped compression buckling and “S”-shaped bending and torsion buckling (Figs. 1a and 2). This paper provides a detailed investigation and analysis of one of the three disaster sites where the intercepted rockfalls were still inside the protection system, so that more information could be gathered at that site (Figs. 1b and 4).

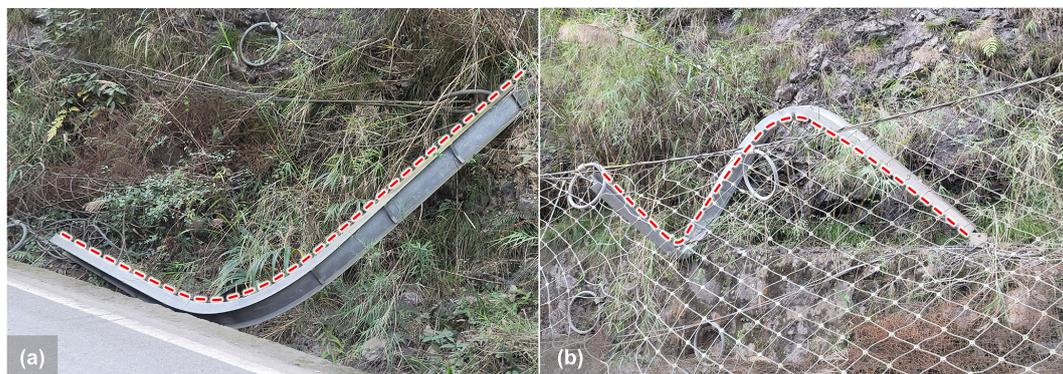
**Figure 2.** Steel column buckling forms of the other two flexible rockfall barrier projects: (a) “C”-shaped compression buckling and (b) “S”-shaped bending and torsion buckling.

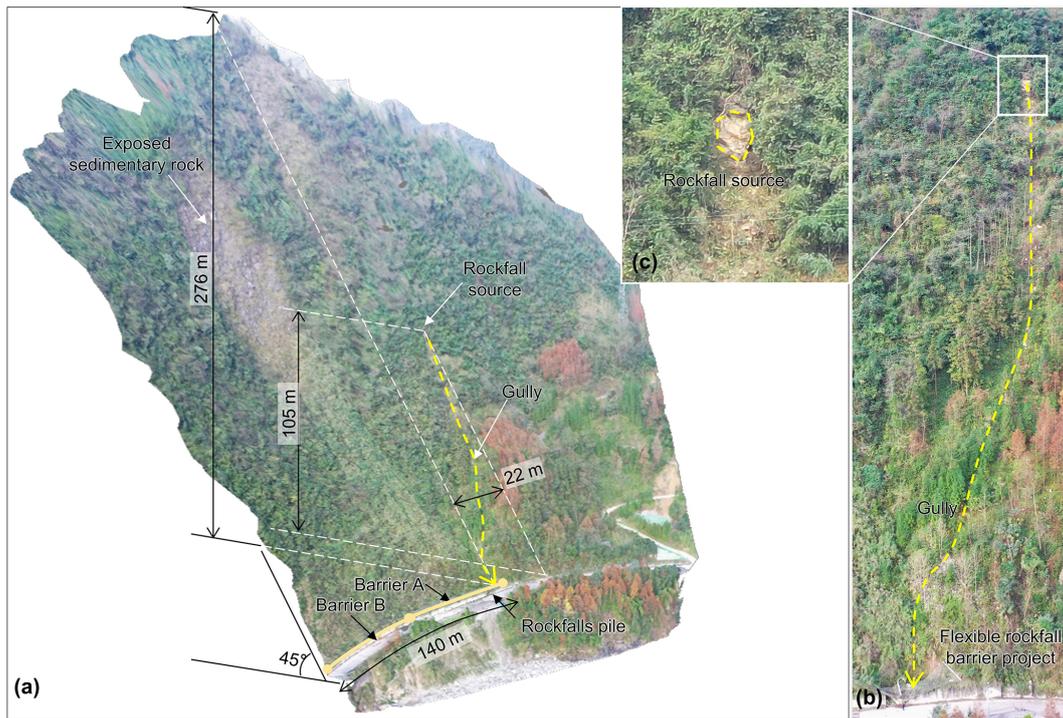
**Figure 3.** Investigation results of the rockfall source area and trajectory. (a) The digital model of the slope; (b) rockfall impact gully; (c) rockfall source.

Based on the slope inclination photography obtained by UAV, a 3D digital model of the terrain was constructed using ContextCapture software (Bentley, 2021), with a reduction accuracy of centimetre level. The 3D model of the scanned slope is depicted in Fig. 3a; it is roughly 276 m high and at an angle of 45°, with a steep top and a gentle bottom. The hill was primarily covered by medium-high shrubs and bushes. Its foot was predominantly covered by plants including ferns, bamboo, and reed-like herbs, typical in southern and southwestern China. Sedimentary rock formations were exposed in the concave cavity that divided the rock into broken blocks or pieces of various sizes. The area on the slope where new rock layers were exposed after rock spalling was presumed to be the source of rockfalls. The rockfall source was located 105 m above the stopping point at the bottom of the hill and was 22 m lateral along the road. A small amount of gravel and debris was scattered in the gully, and the vegetation along the front section of the gully was severely destroyed. The gully, about 2 m wide, had a minor quantity of rubble and garbage spread throughout it, and the vegetation along the front half of the gully had been severely devastated (Fig. 3). Rockfalls

Two flexible rockfall barriers, Barrier A and Barrier B, have a total length of roughly 140 linear metres and are 70 linear metres long (Fig. 3a). They were situated above the retaining wall at the base of the slope mentioned in Sect. 2.1. Barrier A, impacted by rockfalls, was the subject of a thorough investi-

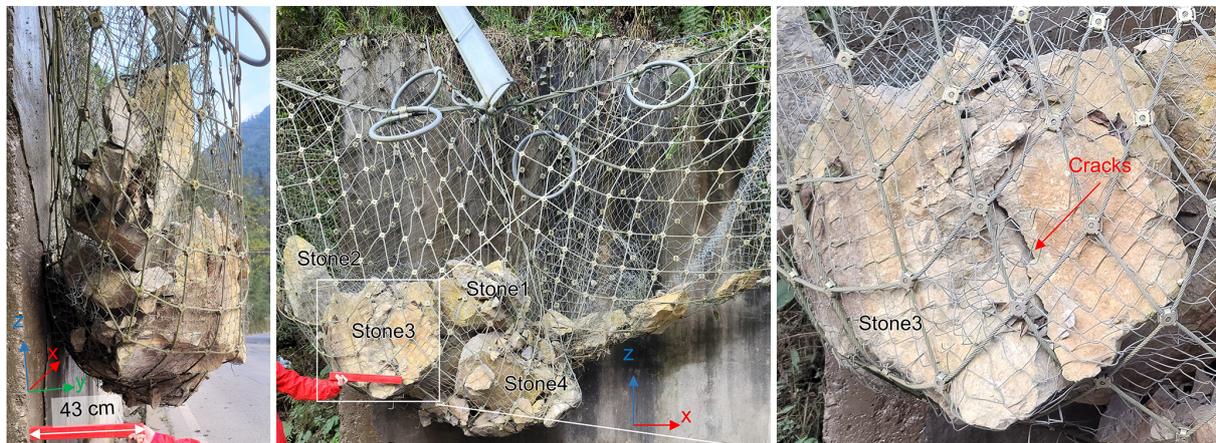
Many intercepted rockfalls, mostly tuff and muddy, were pocketed inside the nets of the protection system, as depicted in Fig. 4, with sharp angles and disparate blocks. The four largest blocks of these stones could be approximated as four cubes: Stone 1 was  $0.5\text{ m} \times 0.5\text{ m} \times 0.5\text{ m}$ , Stone 2 was  $0.3\text{ m} \times 0.3\text{ m} \times 0.7\text{ m}$ , Stone 3 was  $0.8\text{ m} \times 0.9\text{ m} \times 0.7\text{ m}$  and Stone 4 was  $0.4\text{ m} \times 0.4\text{ m} \times 0.4\text{ m}$ . Stone 3 with cracks was thought to have been broken after hitting the barrier, while the other stones seem to be have been crushed in the movement. The diameter of the remaining debris was about 0.05–0.1 m.

**Figure 4.** Rockfalls piled up in the net.

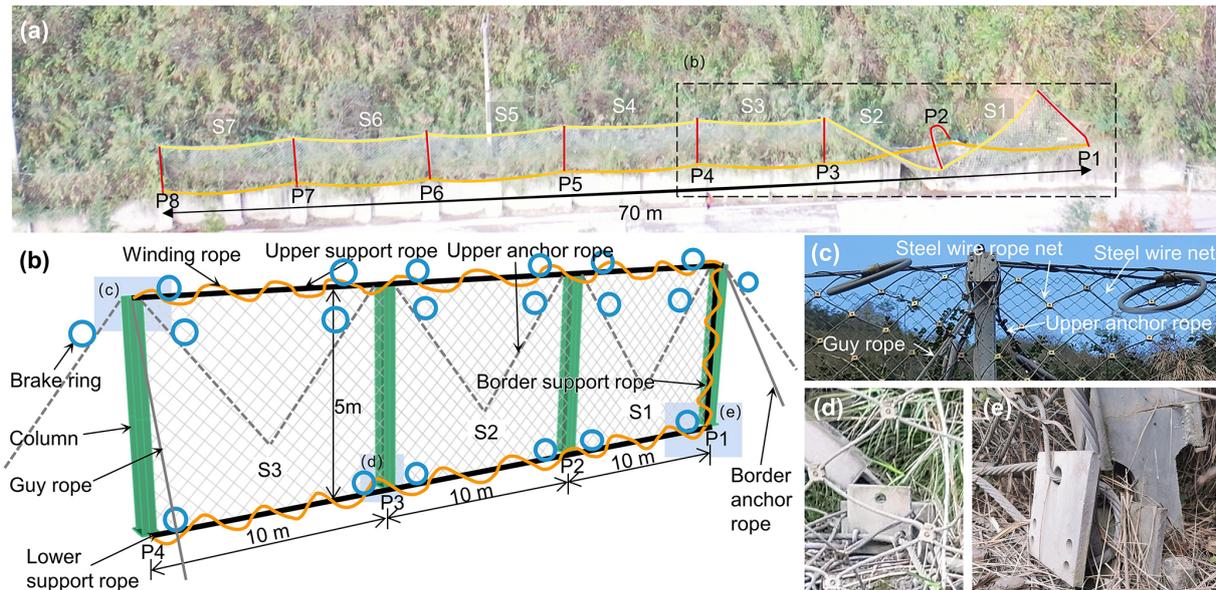
gation in this research (Fig. 5a). Eight support posts divided Barrier A into seven spans, each 10 m wide. Two of the seven spans, S1 and S2, were damaged by rockfalls and collapsed. The eight 5 m high steel columns served as the support posts, numbered P1–P8, and were bolted to the base with a specific swing space in both the longitudinal and transverse directions (Fig. 5b and 4e). Bolted to the top of the retaining wall were the bases. To guarantee the stability of the steel columns, the upper anchor ropes, border anchor ropes, and guy ropes were snapped to their top (Fig. 5c). The ends of steel columns P1 and P8 were fixed with support ropes (including upper, lower, and border support ropes) by rope buckles (Fig. 5e), the upper support rope of the middle spans was lapped to the top of the support posts (Fig. 5c), and the lower support rope of the middle spans passed through the rings on the column bases (Fig. 5d). As energy-consuming devices, brake rings were connected to the upper anchor rope and to the upper and lower support cables near each column end (Figs. 5b and 4c). A steel wire rope net and steel wire mesh net made up the interception unit (Fig. 5c). The steel wire mesh net was con-

**Figure 5.** Structure composition of the flexible barrier. (a) Overall photo of the project; (b) relationship of component connections; (c) details of column head; (d) failure of column base at the mid-span; (e) failure of border column base.

1. The steel column was buckled and destabilized. Due to extreme buckling instability, column P2 could not withstand further pressure (Figs. 6a and 5b).

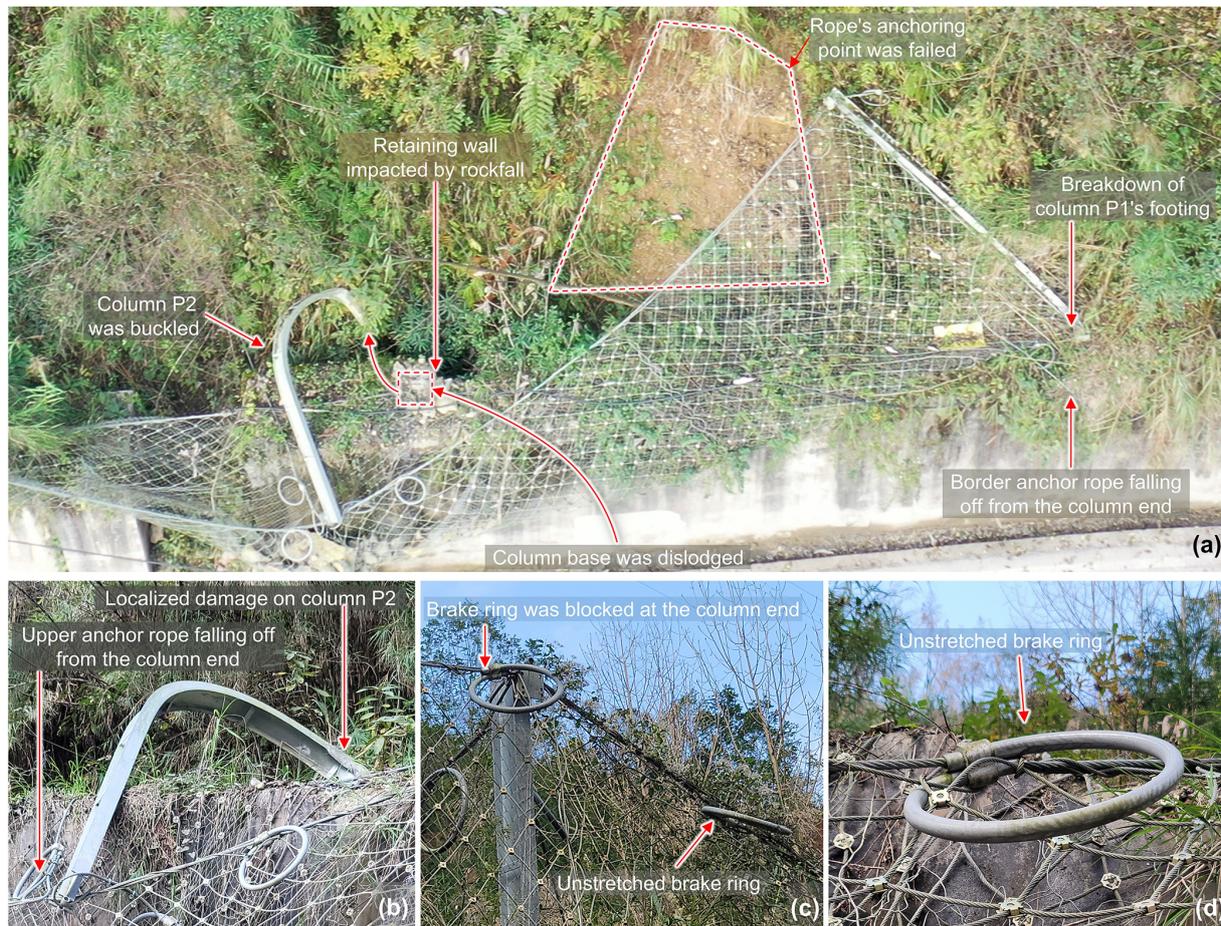
2. The column base was dislodged. The base of steel column P2 detached from the column base on top of the concrete retaining wall (Fig. 6a).
3. The rope anchoring point failed. Due to the anchoring end falling off, the upper anchor ropes connecting steel columns P1 and P2 were not properly functioning (Fig. 6a).

**Figure 6.** Damage phenomena of the flexible barrier. (a) The damaged two-span structure; (b) failure of column P2; (c) non-working brake rings on both sides of column P3 end; (d) connection relationship between the brake ring and the support rope and the steel wire rope net.

The lower right-side section of the lower flange of P2 steel column exhibited symptoms of localized damage, which leads us to believe that this was where the collision occurred (Figs. 6a and 8a). The initial velocity of Stone 1 in Sect. 3.2 was set to 0.5,  $-5$ , and  $5.5 \text{ m s}^{-1}$  to ensure it harms the net after hitting the steel column flange in P2. For Stones 2, 3, and 4, uniform initial velocities of  $-4.8$ ,  $-7$ , and  $4.8 \text{ m s}^{-1}$  were defined, respectively (the velocities listed above are the  $x$ -,  $y$ -, and  $z$ -axis sub-velocities, shown in Fig. 10).

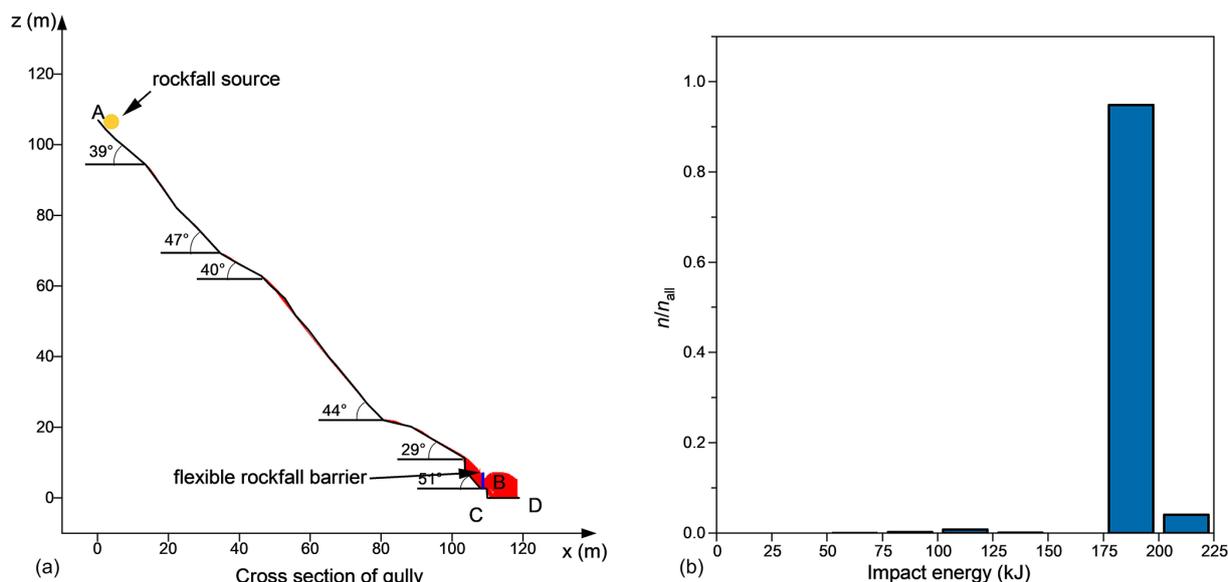
The number of rockfalls that reached the net ( $n_{\text{all}}$ ) after 10 000 calculations was 3433. Figure 7b depicts the distribution of the kinetic energy of rockfalls that impact the flexible barrier. The impact energy ranges from 73.64 to 220.6 kJ, with a maximum value lower than the project's design protection energy level. The final determination of the impact energy of the stone impacted on the system was 100 kJ in the

**Figure 7.** Rock mobility analysis: (a) trajectory of rockfall and (b) probability distribution of kinetic energy of falling rocks at the flexible barrier.

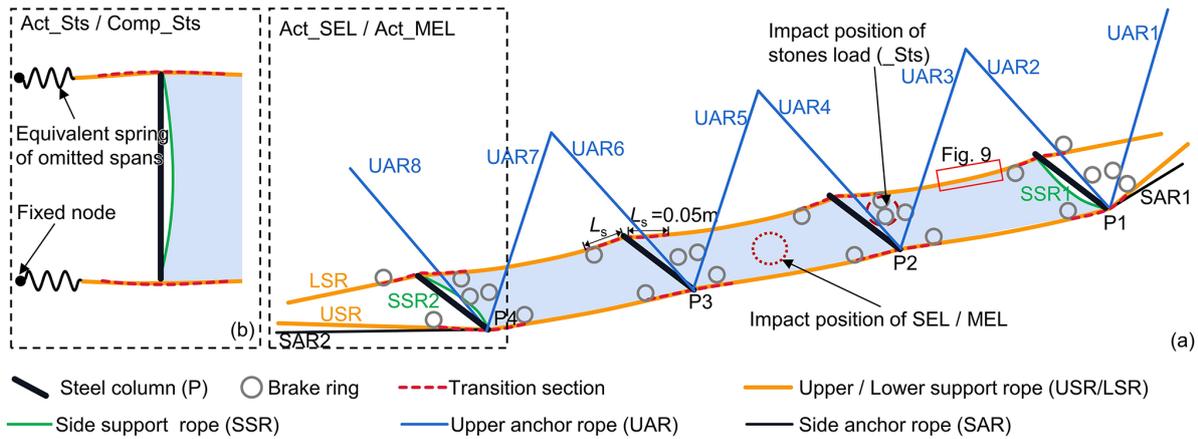
**Figure 8.** Structure representation of the actual model (Act\_) and the comparative analysis model (Comp\_). (a) Act\_SEL and Act\_MEL. (b) Act\_Sts and Comp\_Sts.

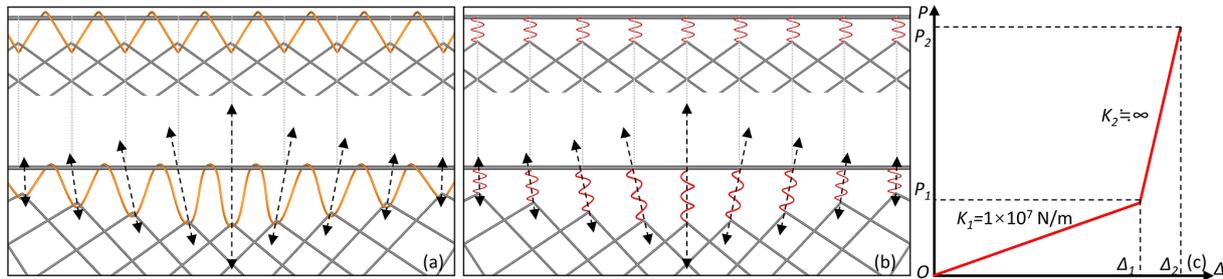
**Figure 9.** Spring equivalent model for winding rope. (a) Before and after winding rope deformation. (b) Before and after spring equal model deformation. (c) Bilinear constitutive model of the winding rope spring.

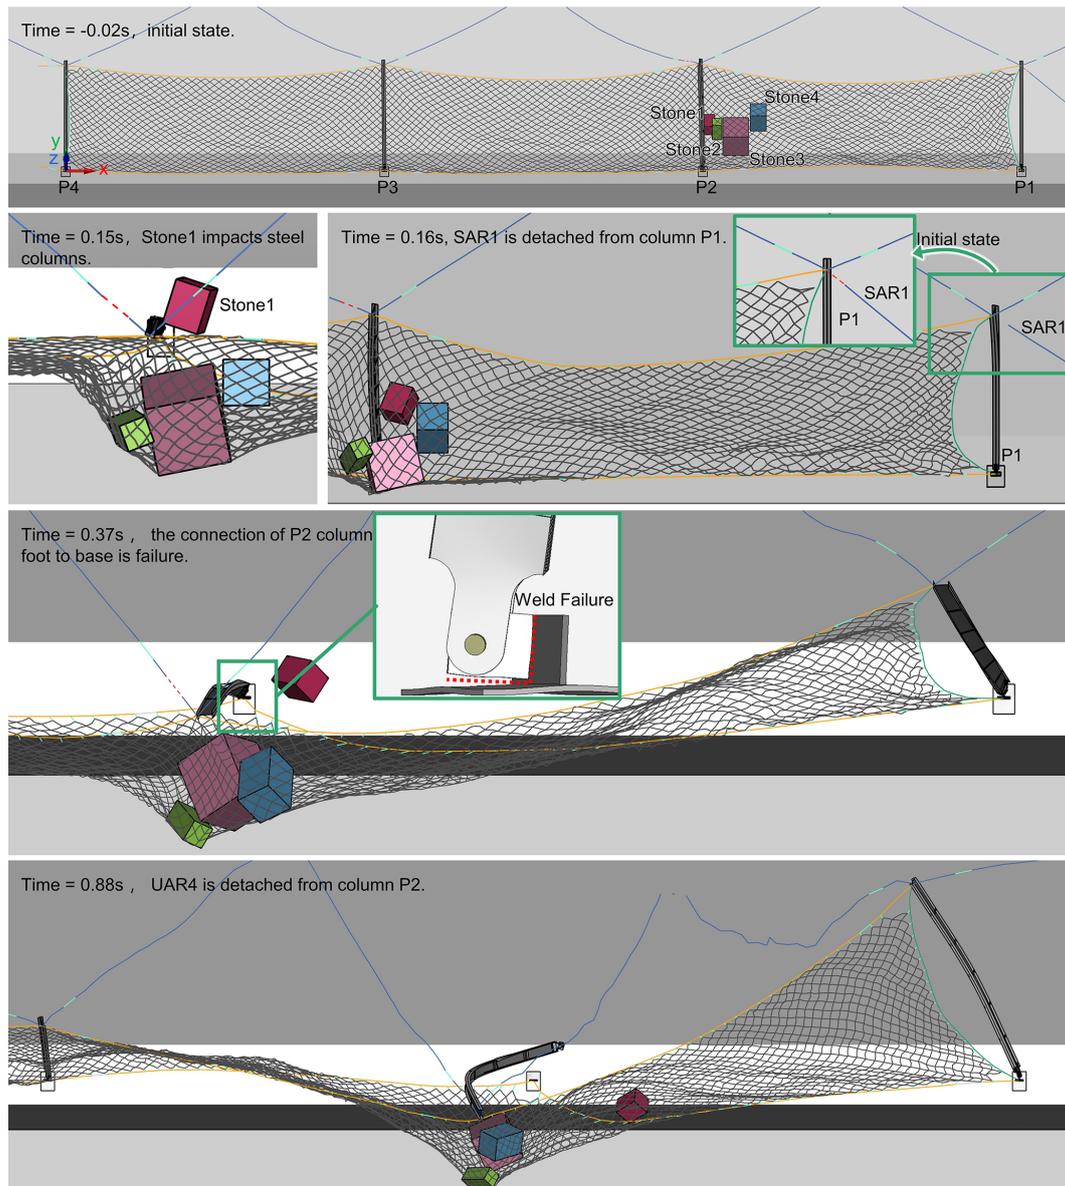
The process of rockfall impacting the flexible rockfall barrier is depicted in Fig. 10 as calculated by Act\_Sts, restoring critical phenomena such as anchor rope shedding, rope anchorage point failure, and the base connection plates of column failure. Finally, the entire protection system was destroyed, and the rockfalls were piled up to the right of the S1 and S2 nets near the end of column P2, essentially in the same state as the actual project.

**Figure 10.** Key frames of the impact process (the 0 instant occurs when Stone 3 touches the wire rope net).

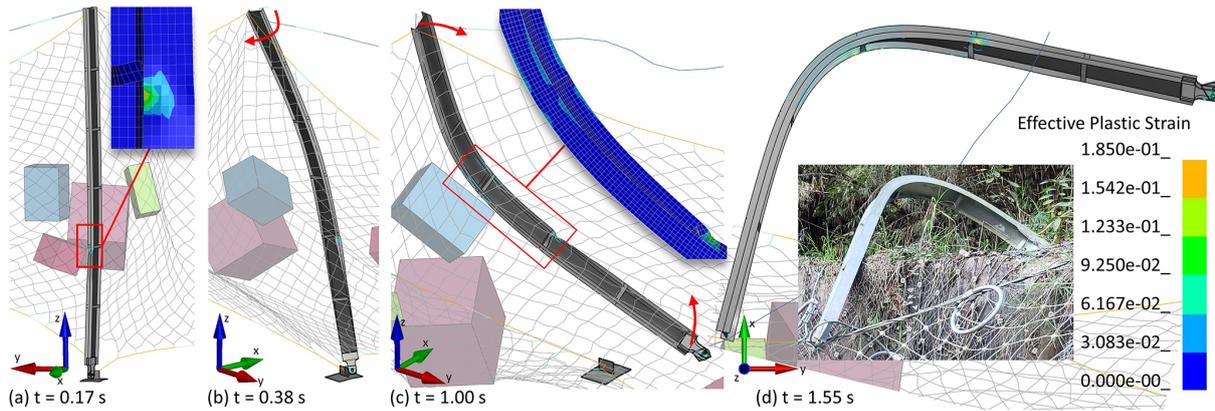
As in the actual project, steel column P2 suffered substantial buckling damage, and the flange also sustained localized damage. The foot damage to border column P1 caused the column to be dumped entirely. Figure 11 depicts the buckling progression of steel column P2 in Act\_Sts: at 0.15 s, Stone 1 impacted steel column P2, causing localized damage at the impact point; at 0.25 s, the stress on both sides of the end of the steel column P2 was out of balance after the failure of the anchorage point connected to the ropes UAR2 and UAR3, while the column foot was restrained and column P2 was twisted; at 0.37 s, the base connection plate of the column P2 weld failed as a result of the column foot twisting, releasing column P2 from the torsional restraint and turning it into

Figure 11. Column P2 deformation development in Act\_Sts.

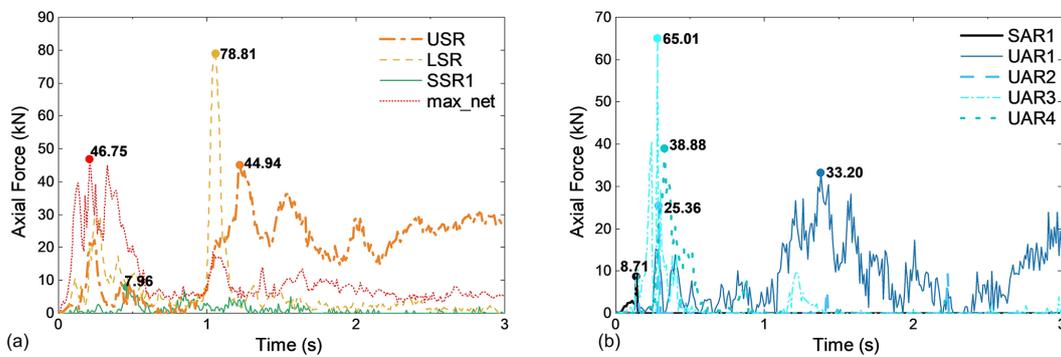
Figure 12. Axial force of the wire ropes in Act\_Sts.

In Opt\_Sts, the transition ropes prevented the net from jamming at the column end and lessened the deflection of the column caused by the tugging of the support ropes (Fig. 19c and d). Due to the system deformation capacity being improved, the internal force of the wire rope increased more gradually (Fig. 19e), and the phenomenon of the pulse force of the wire rope as seen in Act\_Sts did not occur (Fig. 12).

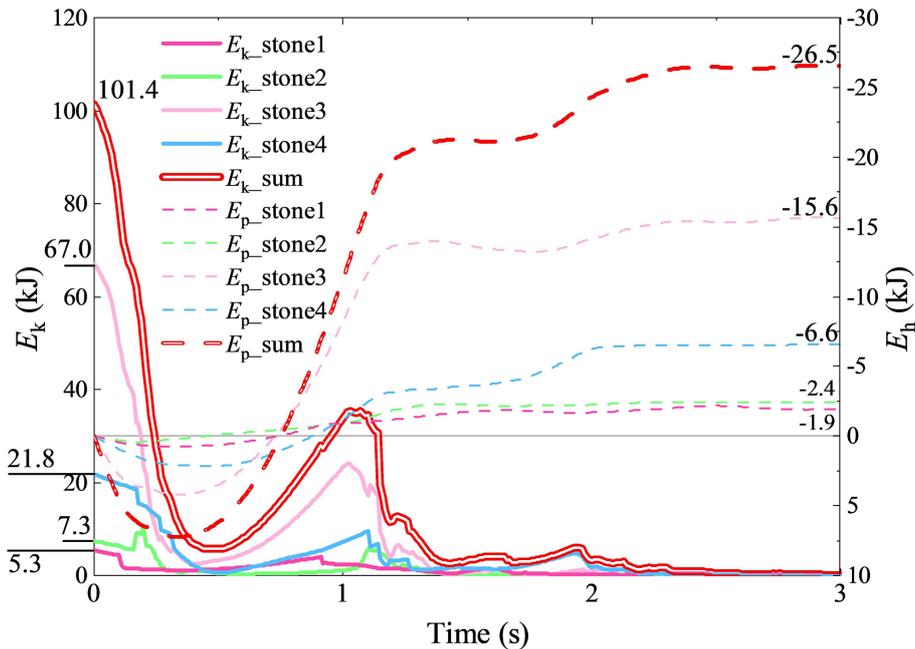
**Figure 13.** Temporal evolution of kinetic energy and potential energy of rockfalls.

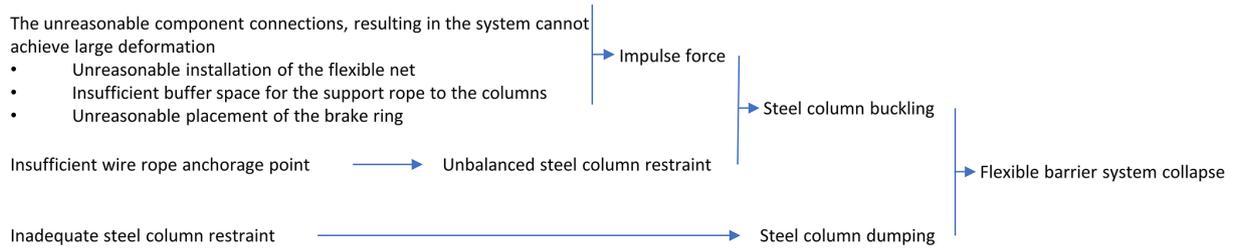
buffer space for the support rope to the columns, and inadequate placement of the brake ring – are the primary causes of the inability of this mitigation project to withstand the rockfall impact. Due to the incorrect component connection form, a sliding system could not be formed, and the buffering mechanism of the flexible rockfall barrier also could not be developed. This resulted in an impulse force at the column end, which eventually caused the steel column to buckle and the system to collapse. Therefore, achieving substantial system deformation requires adequate relative sliding motion between the components, especially the sliding ability of the support rope at the column end (Fig. 14).

Figure 14. Analysis of the system damage mechanism of Act\_Sts.

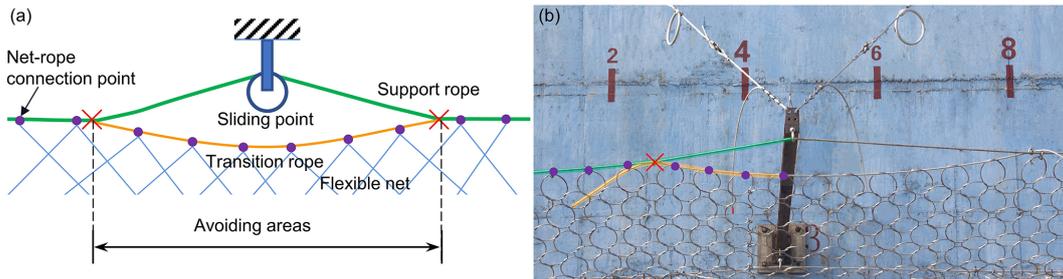
Whether the support rope enables sliding at the end of the steel column depends on the connection mechanism employed between the steel column end, the support rope, and the flexible net. The transition rope should be used in most cases where the design protective energy is 1000 kJ or less and the support rope does not slide a significant distance along the end of the column (Yu et al., 2018b). The transition rope can prevent the lateral force at the column end and the sharp rise in the axial force of the steel column generated by the net jamming, both of which cause the column to buckle (Fig. 15).

Figure 15. The transition rope applied between column ends and support ropes: (a) structure schematic and (b) project photograph.

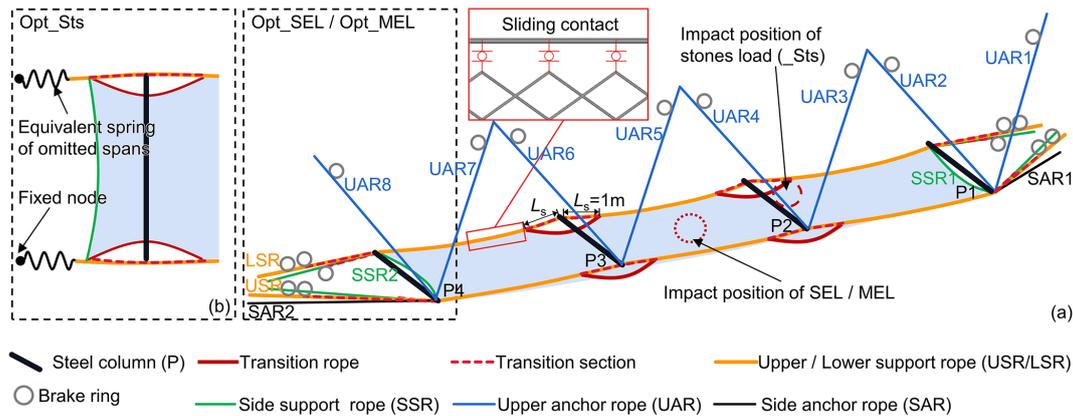
Figure 16. Structure representation of the model Opt\_. (a) Simulation models Opt\_SEL and Opt\_MEL. (b) Simulation model Opt\_Sts.

system components unaltered, and the optimized model is denoted as Opt\_ (Fig. 16). The optimization measures are: (1) removing the brake rings from the flexible net connection portion and replacing them with a single brake ring attached to the support rope and all brake rings positioned at the anchor end of the wire rope; (2) changing the connection between the column end and the support rope to a transition rope whose length of the transition section  $L_s$  is set to 1 m, the maximum elongation of the linked brake ring; (3) extending the support rope from the end of the border column to the slope, and the support rope is in sliding relationship with the border column end; (4) using shackles to link the support ropes to the net or threading the support ropes through the net holes to ensure the relative sliding properties between the net and the support ropes; (5) setting an initial  $x$ -axis angle

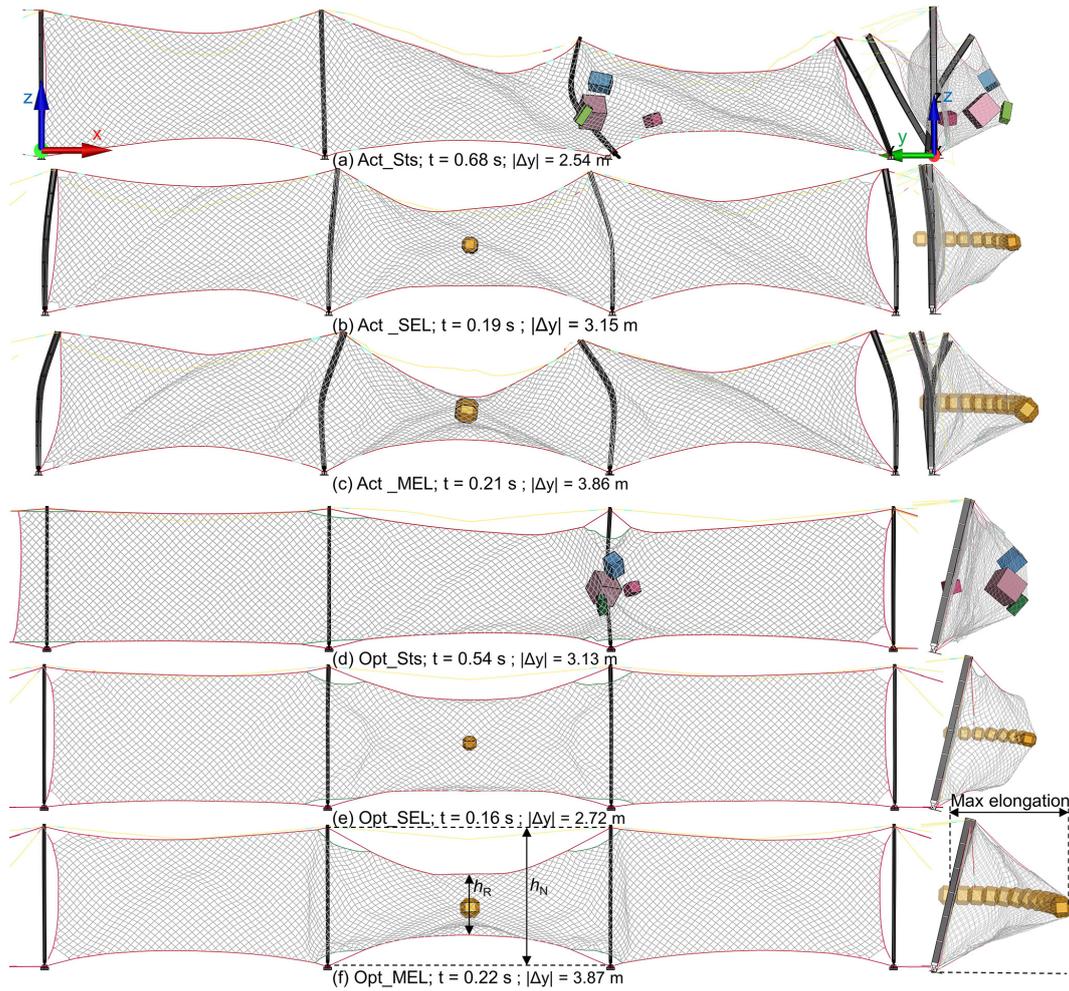
Figure 17. System forms at the moment of maximum y-directional elongation.

Figure 17 and Table 5 display the outcomes and structure states of the six working conditions. The rockfalls were stopped in all simulation conditions. Still, the model Act\_ showed buckling of the steel columns in all impact con-

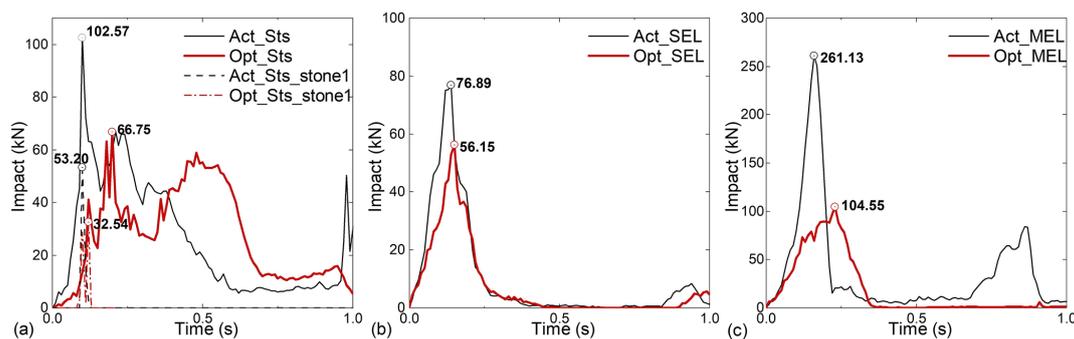
**Figure 18.** Temporal evolution of the impact of rockfalls and barriers.

Stone 1 impacted steel column P2 in Opt\_Sts just as it did in the Act\_Sts case. Still, due to the different system stiffness, the impact force was almost 39 % lower in Opt\_Sts than it was in Act\_Sts (Fig. 18a). Although the Opt\_Sts steel column P2 suffered numerous impacts, none of them seriously damaged it (Fig. 19a). Steel column P2 experienced overall bending at the moment of the most significant system deformation (Fig. 17g). After the impact passed, the steel column recovered, and the entire structure remained stable (Fig. 19a), eventually preventing the system from overthrowing due to the buckling of the steel columns in Act\_Sts (Fig. 19b).

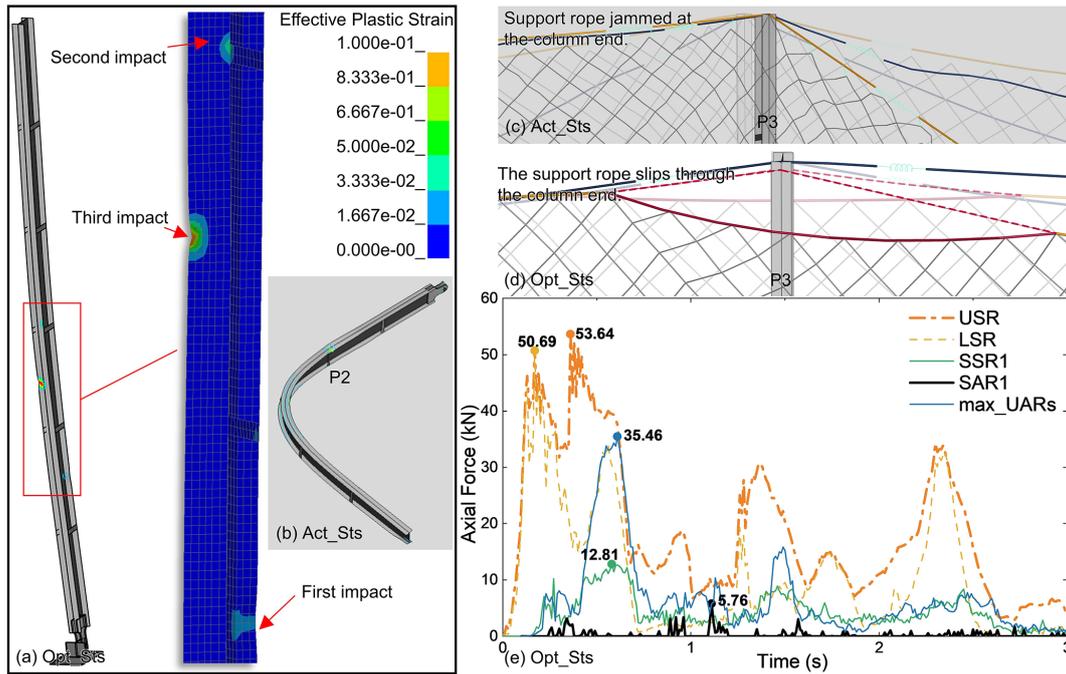
**Figure 19.** Opt\_Sts calculation result: (a) column P2 in Opt\_Sts has local damage after several hits. (b) Column P2 in Act\_Sts is buckling; (c) and (d) are the support rope sliding performance on the end of column P3 in Act\_Sts and Opt\_Sts, respectively (semi-transparent for pre-impact and saturated colour for post-impact). (e) The internal force of part of the wire ropes in Opt\_Sts.
