Characterizing geologic and climatic controls on rockfall hazards using an inventory and integrated kinematic and runout model: Skagway, Alaska, USA

Abstract. Rockfall is common in steep terrain and poses a hazard to nearby communities. While rockfall triggering mechanisms are highly variable and difficult to quantify, the susceptibility of rock slopes to planar, wedge, or toppling failure can be readily assessed using kinematic analysis. As such, valley slopes with favourable joint orientations exhibit high rockfall susceptibility although the potential for rockfall runout to impact infrastructure and public safety depends on the morphology of downslope terrain. Integrating rockfall susceptibility and runout models with maps of talus deposits accumulated from past rockfall events is an effective combination of tools to inform mitigation but can be difficult to accomplish across extensive areas. Here, we combine these methods with a rockfall inventory spanning 2005 to 2022 to assess geologic and climate controls on rockfall activity in the steep and forested postglacial valleys proximal to Skagway, Alaska, where recent rockfall activity has imperilled public safety, infrastructure

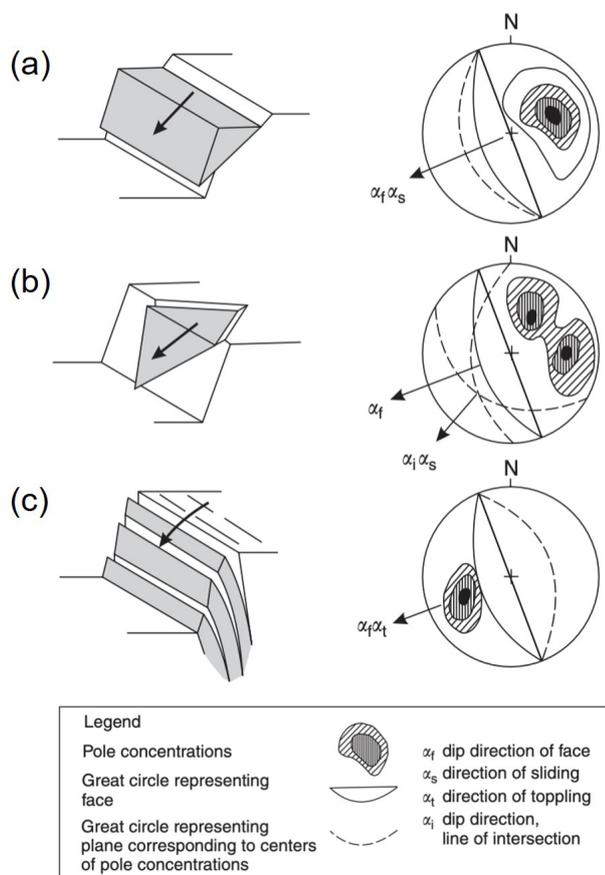
Figure 1. Schematic and corresponding stereonet representations of common rock slope failure modes: (a) planar sliding, (b) wedge, and (c) toppling. On the stereonet plots, the rock slope face orientation is represented by a solid black line, and poles to planar discontinuities that meet conditions for failure are shown in shaded contours. Dashed lines represent planes of these discontinuities. Modified from Wyllie and Mah (2004).

to sliding, toppling, or wedge failure criteria as determined by the geometry of rock slopes and discontinuities (Fig. 1) (Bovis and Evans, 1996; Wyllie and Mah, 2004). Combining high-resolution DEMs with rock structure data can inform kinematic analyses and determine the relative likelihood (often defined as susceptibility) of different failure modes across extensive study areas (Grant et al., 2016; Günther, 2003; Kundu et al., 2023; Meentemeyer and Moody, 2000; Stock and Collins, 2014). Recent applications of kinematic analysis leverage lidar or photogrammetry to extract bedrock discontinuity data and test kinematic failure criteria on complex slope geometries, like overhanging rock quarries (Fanos and Pradhan, 2018; Gigli et al., 2022). Increasingly, the acquisition of discontinuity data is accomplished using automated analysis of point cloud data acquired from terrestrial laser scanning (TLS) (Matasci et al., 2018) or lidar or photogrammetry acquired from uncrewed aerial systems (UAS) (Utlu et al., 2023). These approaches are powerful but can be challenging to implement across large areas characterized by steep, rocky forested slopes where the details of rock structure are often obscured by vegetation.

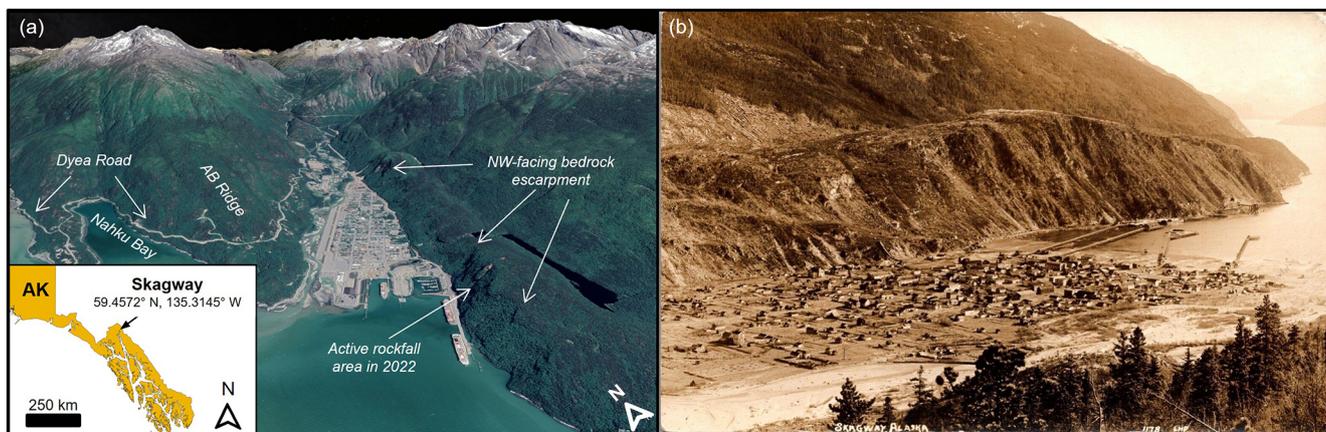
Figure 2. Study area. (a) Oblique view looking N-NE into Skagway River valley, Alaska. Note active rockfall along the NW-facing ridgeline and escarpment above the harbour and cruise ship docks. Use of Imagery © 2025 USGS, Map data © 2025 Google permitted for non-commercial use. (b) Oblique view from AB Ridge looking SE across Skagway towards the NW-facing ridgeline and escarpment. This undated and uncredited historic image postdates the late 1890s construction of the current Skagway City Hall and Museum (photo provided by Andrew Beierly). Local steep cliff faces with fresh bedrock exposure signify active rockfall. Note the lack of vegetation and the sharp bedrock escarpment along the crest of the ridgeline and the abundance of active talus slopes that connect to the harbour.

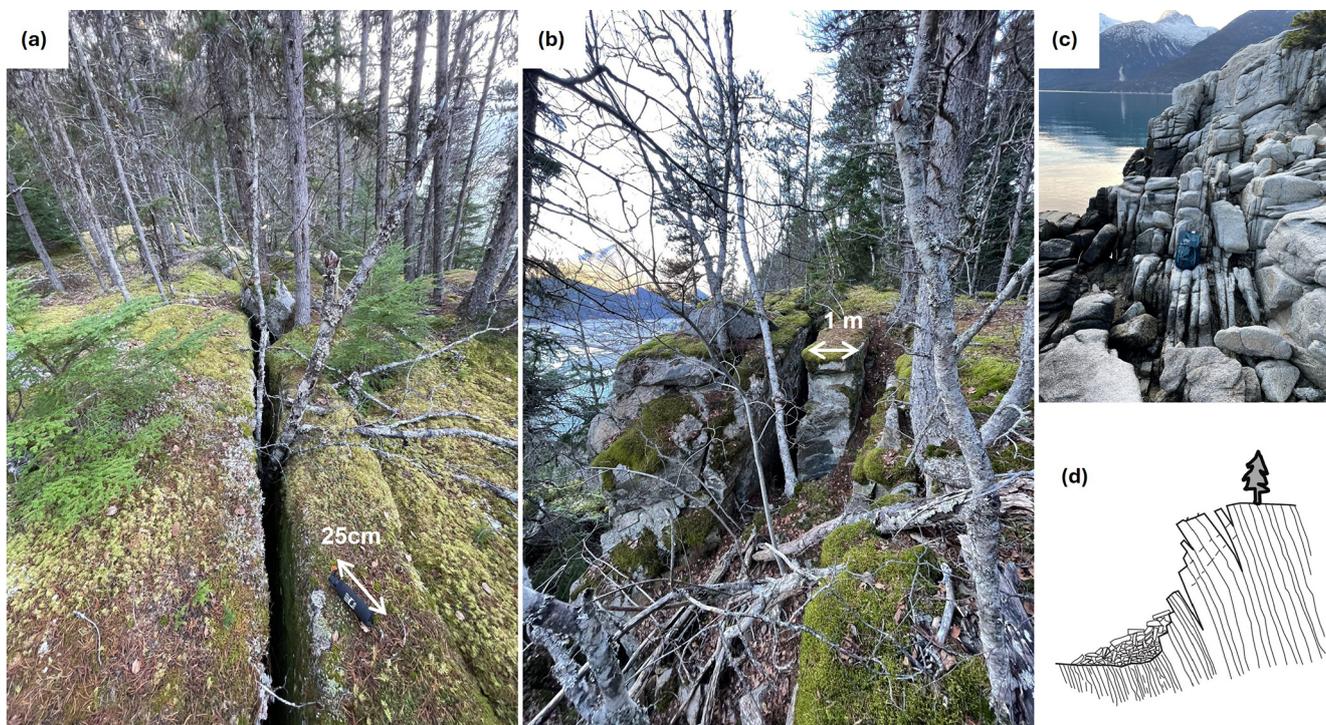
Figure 3. Images (a, b) of open joints and incipient toppling along the bedrock escarpment on the NW-facing ridgeline above Skagway Harbor. (c) Image of joint orientations along shore of Nahku Bay. (d) Schematic of toppling prone hillside with opening joints and talus accumulation modified from Wyllie and Mah (2004). Photos (a), (b), and (c) by Ian D. Wachino and Joshua J. Roering.

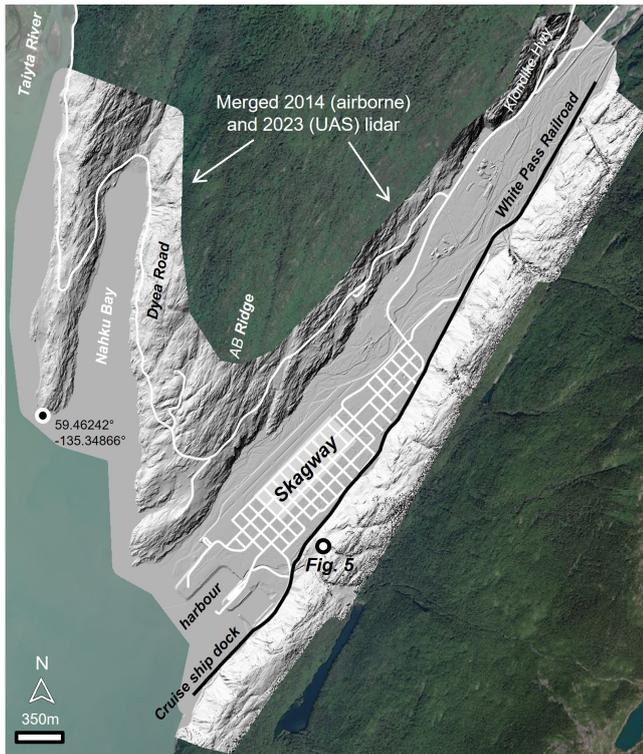
Figure 4. Location map of Skagway, Nahku Bay, and Dyea Road showing a merged hillshade image of the 2014 airborne and 2023 UAS lidar bare earth data. White lines denote roads and the thick black line denotes a section of White Pass Railroad and cruise ship dock used for our rockfall runout susceptibility analyses. The 2023 UAS lidar data was acquired along the ridge southeast of the railroad while the 2014 airborne lidar accounted for the remainder of the study area imagery shown here. Location of Fig. 5 is shown by black/white filled dot. Background image from USGS NAIP (National Agriculture Imagery Program).

The model integration between our kinematic rockfall susceptibility analysis and the RAMMS:Rockfall simulations was accomplished using the following workflow. First, we used our merged lidar DEM, which has a 1×1 m pixels (Fig. 4) to generate rockfall susceptibility index values for toppling and sliding failure. Given that toppling instability dominates our study area, we identify potential source areas as pixels with toppling susceptibility values greater than 5 %. Pixels with > 5 % toppling susceptibility demarcate rocky cliffs situated above our mapped talus deposits as well as areas of recent rockfall activity in the Skagway Harbor (Fig. 5). To link the susceptibility model to our runout model, the pixels with a > 5 % high toppling susceptibility were converted to polygons and only polygons with area greater than 25 m^2 were retained to eliminate small, local high-relief features like boulders and trees that can perpetrate the characteristics of rockfall source zones. Then, rockfall source points for RAMMS modelling were randomly distributed within the resulting polygon coverage with a density of 0.04 m^{-2} and a minimum point spacing of 5 m. The resulting 4945 points

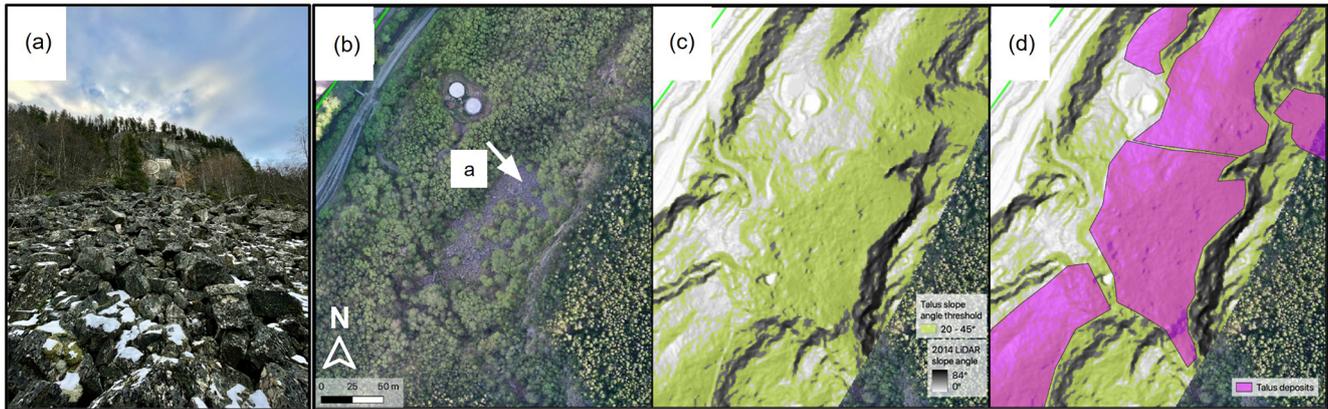
Figure 5. Field images and lidar mapping of talus mantled slopes. **(a)** View looking SE along an exposed talus deposit with boulder sized blocks at the base of a 40 m cliff known as Kirmse’s Cliff (lat: 59.45251, long: -135.31147). **(b)** Aerial imagery from 2023 UAS survey showing a talus deposit and bedrock cliff, white arrow shows view direction for panel **(a)**. **(c)** Terrain within the slope angle range of 20–45° colored in light green, and **(d)** map of talus polygons (pink) generated from lidar slope shade and slope angle maps and orthoimagery. Hillshades in panels **(c)** and **(d)** derived from 2023 UAS lidar data. Background image from USGS NAIP (National Agriculture Imagery Program).

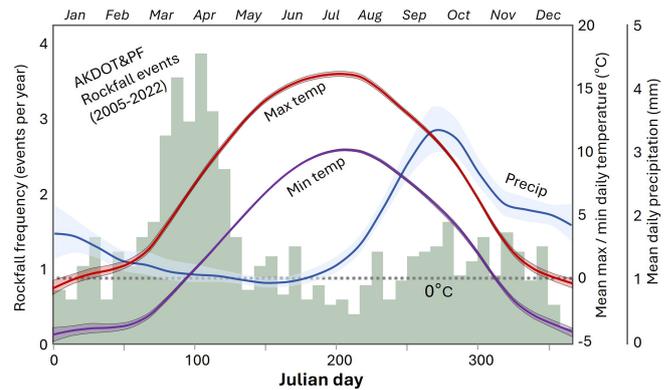
Figure 6. Analysis of seasonal variation in rockfall frequency and climate variables from the AKDOT&PF geoevent database (2005–2022) and daily mean precipitation and daily maximum and minimum temperature from the Skagway Airport (PAGY) for the period 2005–2025. The number of rockfall events (green bars) exhibits seasonal variations that don’t obviously align with precipitation (blue) although maximum temperature (red) and minimum temperature (purple) increase significantly during the typical period of rockfall activity in March and April. The horizontal dashed grey line represents freezing. The confidence intervals for the climate data represent standard error of mean values over the period of record.

within our study area between 2005 and 2022 (Figs. 6, 7). This implies an average rockfall frequency of 50 events yr^{-1} , although this value is an overestimate because some of the reports are redundant given that multiple days are reported in response to a single event. Among the events, 7 resulted in road closures that lasted 3 d or longer in March 2012, October 2012, January 2014, March 2015, February 2016, September 2016, and December 2020.

According to our analysis, rockfall events peak in late March and April, occurring at a pace that is $4 \times$ greater than the remainder of the year (Fig. 6). This substantial uptick in activity corresponds with a seasonal increase in daily temperatures, particularly when the minimum daily temperature exceeds zero. This temporal pattern is consistent with the well-documented observation that thawing of frozen rock slopes promotes the destabilization of blocks through the loss of tensile strength and increases in pore pressure from melting ice and snow (Birien et al., 2024; Imaizumi et al., 2025; Matsuoka, 2019). In the fall, increased daily rainfall associated with atmospheric rivers with a detectable but small increase in activity. The mid-summer period of warm temperatures and dry conditions corresponds with the least active period. Some notable high impact rockfall events correspond with intense rainfall events, including 2 December 2020, when widespread events were preceded by over 3 in. (7.5 cm) of rainfall in the previous 24 h.

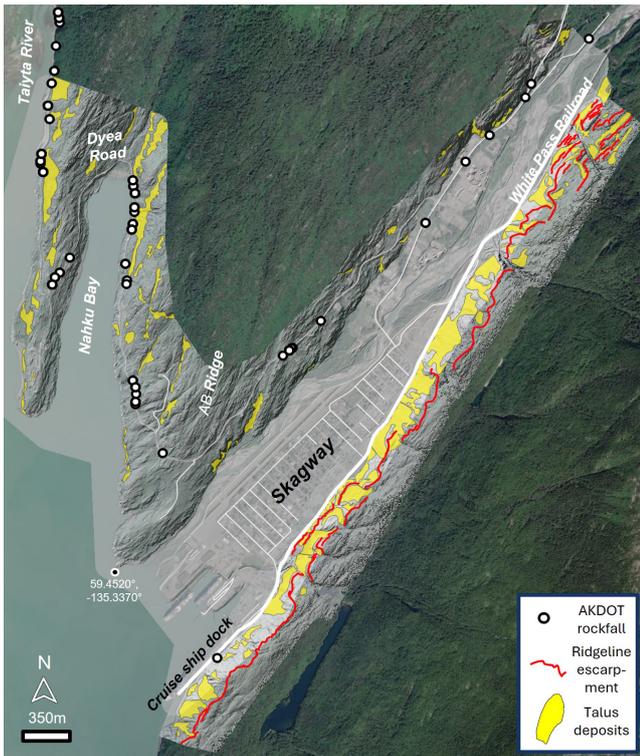
Figure 7. Distribution of talus deposits (yellow polygons), AKDOT&PF rockfall geoevents (2005–2022) (white/black dots), and Eastern ridge bedrock escarpment (red lines). Note the abundance of talus deposits on the NW-facing ridgeline in Skagway and on NW-facing slopes in Nahku Bay and along Dyea Road. Background image from USGS NAIP (National Agriculture Imagery Program). Merged lidar hillshade image has 50 % transparency.

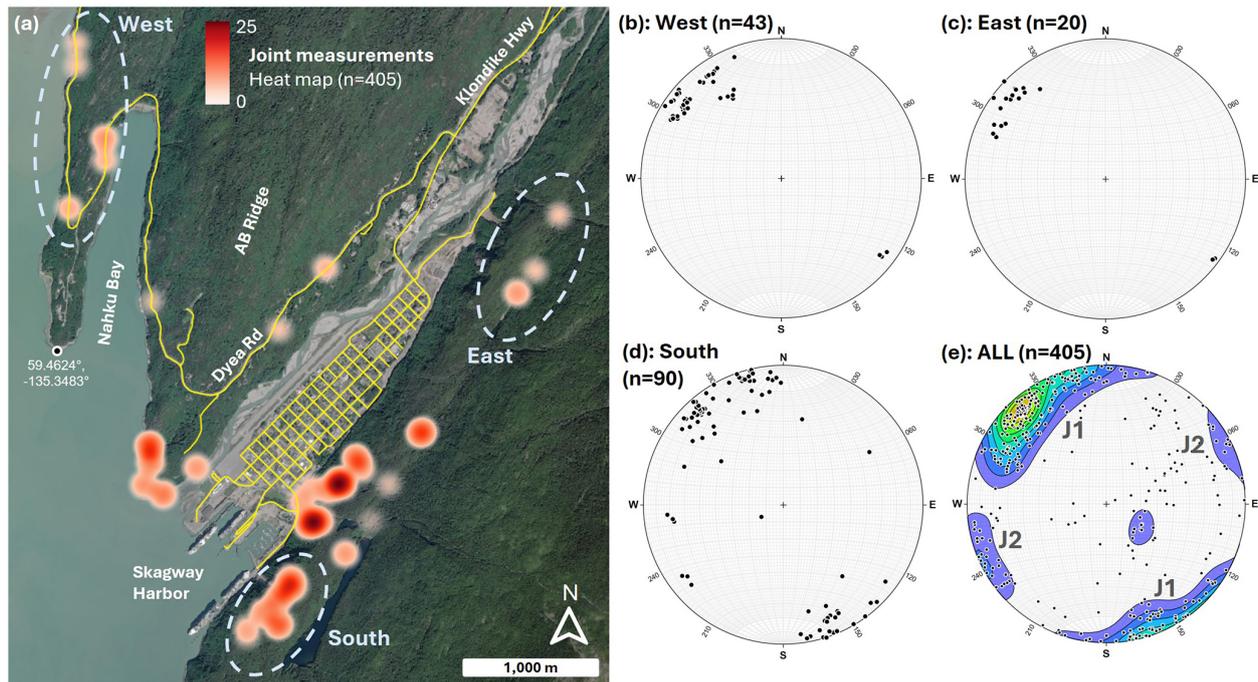
Figure 8. Joint survey data. (a) Location of 405 structural measurements from 48 outcrop locations with heat map showing relative abundance and dashed ellipses showing subsampled data shown in panels (b)–(d). (b–e) Lower hemisphere equal area stereonet plots of joint measurements visualized as poles to planes for West (b), East (c), South (d), and ALL joint data (e). The plot in panel (e) shows Kamb contours to highlight dense clusters of poles (warm colours reflect high density and cool colours convey low density) and two dominant joint sets (J1 and J2) are labelled. Background image in panel (a) from USGS NAIP (National Agriculture Imagery Program).

By combining Eqs. (1) and (2) with our joint orientation data (Fig. 8) and merged lidar dataset (Fig. 4), we mapped susceptibility to planar sliding and block toppling, respectively, across our study area (Fig. 9a, b). Terrain susceptible to planar failure is sparse and 83 % of the terrain has zero values of susceptibility such that none of the measured joint orientations satisfy the planar sliding criteria. Furthermore, the terrain with non-zero planar sliding susceptibility values has very low values with a small fraction exceeding 5 % (Fig. 9c). By contrast, our analysis demonstrates that 29 % of the terrain has non-zero values of block toppling susceptibility and a substantial fraction of the non-zero values exceed 5 % (Fig. 9d). This result emerges because the abundance of consistently oriented joints with vertical or sub-vertical dips promotes block toppling, which is supported by field

observations. Furthermore, given the consistent orientation of sub-vertical joints across our study area (Fig. 8), the primary control on rockfall susceptibility to toppling is the orientation and inclination of rock faces according to Eq. (2). Along the ridge that borders the eastern margin of Skagway River valley, for example, the glacially flattened bench at the ridge crest is not steep enough ($< 20^\circ$) to meet topographic conditions for either failure mode (Fig. 9a, b). Moving to the west side of the crest, however, the gentle ridgetop abruptly transitions to the steep escarpment where overhanging, cliffy bedrock slopes are perched above extensive talus deposits (Fig. 7). In these locations, our analyses show that a substantial portion ($> 20\%$) of observed joints promote toppling failure (see deep red colours in Fig. 9b). Furthermore downslope, we observe patchy zones of high toppling susceptibility, many of which are in close proximity to Skagway township and harbour. Along the southeast-facing rock slopes that border the west side of Skagway, our analyses show few and small patches of terrain with toppling susceptibility approximating 5 %, indicating low susceptibility. This asymmetric susceptibility pattern continues along the sub-parallel ridges west of Skagway along Dyea Road with west- and northwest-facing ridgelines exhibiting abundant patches of terrain with high propensity for toppling failure and east- and southeast-facing slopes showing negligible toppling susceptibility (Fig. 9b).

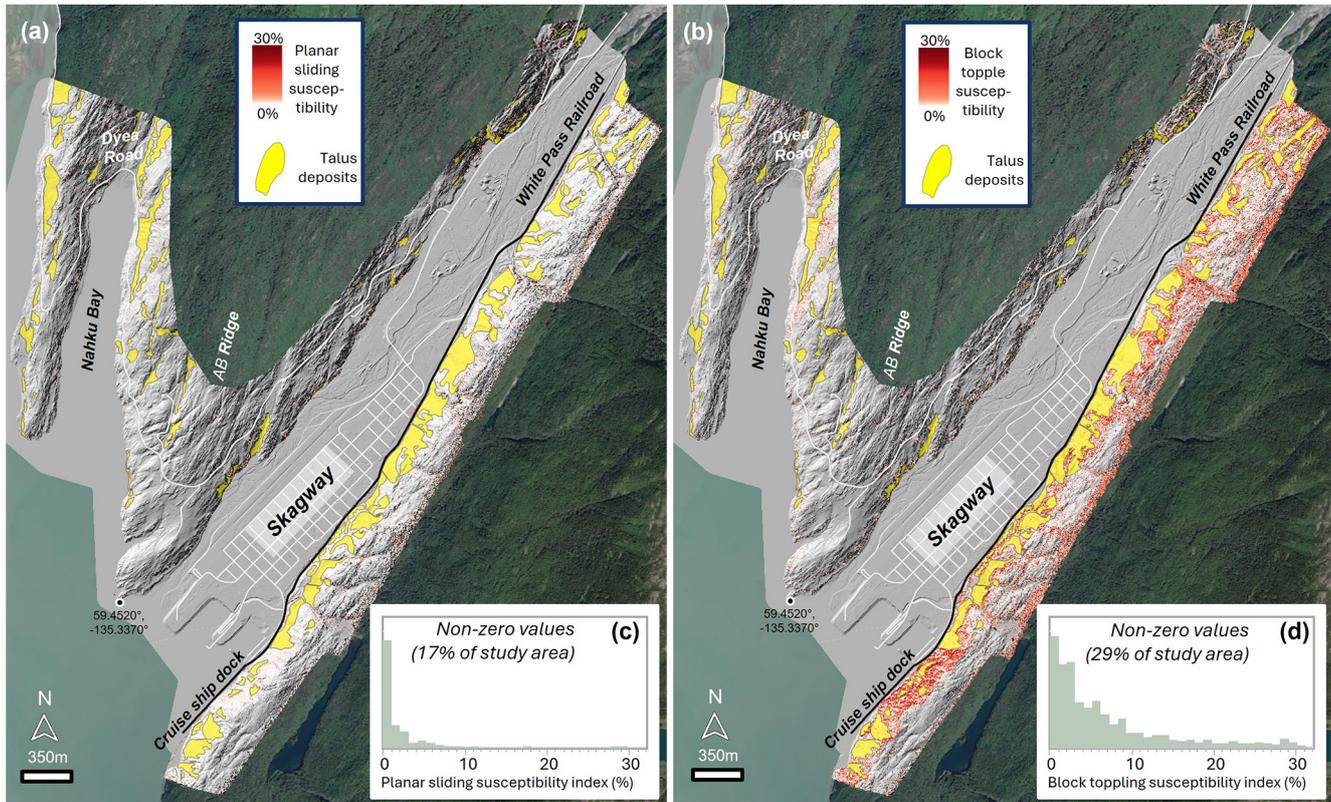
Figure 9. Maps of (a) planar sliding and (b) block toppling susceptibility indices using combined 2014 airborne and 2023 UAS lidar datasets and joint orientation data. Histograms of (c) planar sliding and (d) block toppling susceptibility indices for non-zero values. The mapped and plotted values are the percentage of field-surveyed joints deemed unstable at each pixel according to Eq. (1) (planar sliding) and Eq. (2) (block toppling). Yellow polygons denote talus deposits. Note the abundance of toppling failure zones on NW-facing rock slopes that border Skagway and Nahku Bay as well as the correspondence between toppling susceptibility and talus deposits. Hillshade imagery derived from combined 2014 and 2023 lidar data. Background image from USGS NAIP (National Agriculture Imagery Program).

deposits situated just downslope of zones with high toppling susceptibility (Fig. 9b) is consistent with other studies (Guerriero et al., 2024) and supports the utility of our modelling approach.

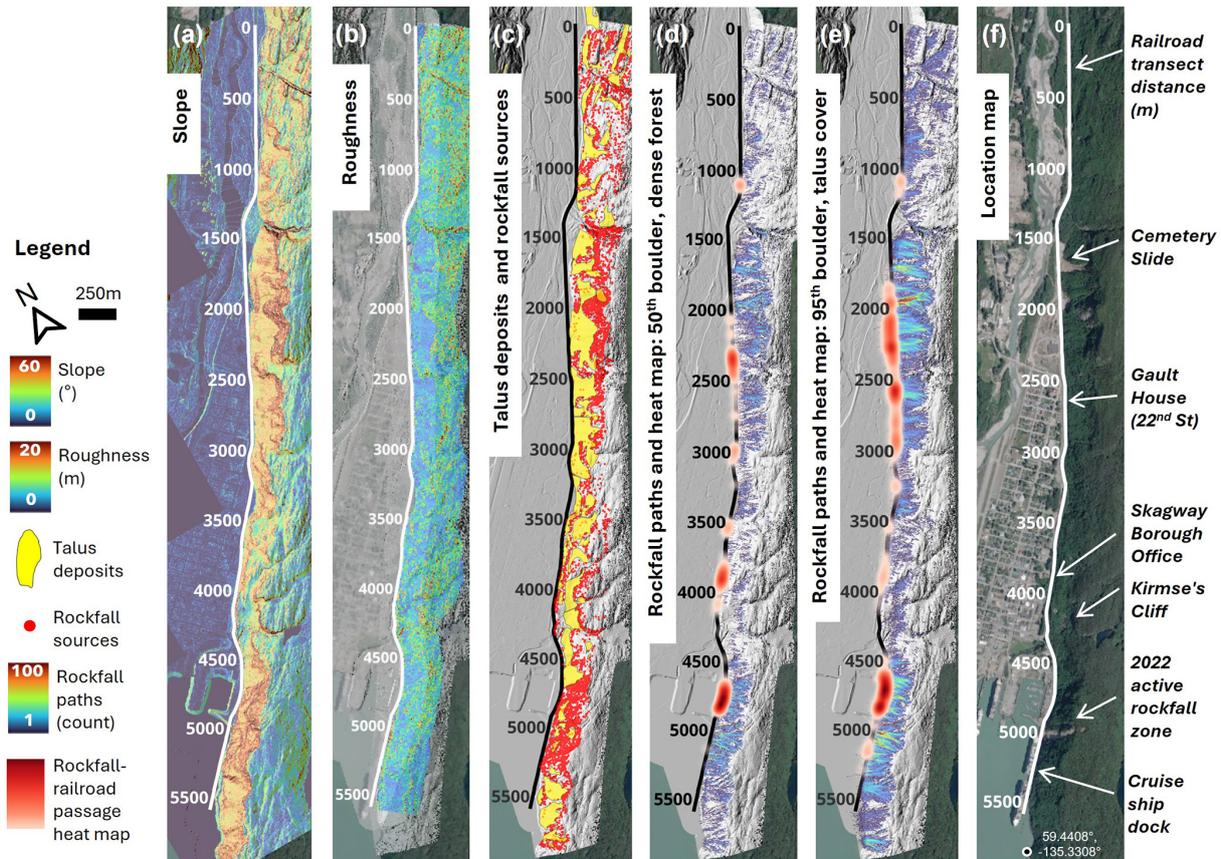
Figure 10. Map of topography and rockfall models along the ridgeline that abuts Skagway township and Harbor. (a) Map of slope angle using merged 2014 airborne and 2023 UAS lidar. (b) Map of roughness defined as the standard deviation of slope angle within a 15 m radius (m). (c) Map of rockfall sources (red points) and talus deposits (yellow polygons). (d, e) Maps of modeled rockfall paths for 2 scenarios with variable block size and land cover. The number of rockfall events that traverse each pixel is indicated by the color ramp. Heat map (red shades) denotes relative density of modeled rockfalls that pass over the railroad. (f) Satellite image from USGS NAIP (National Agriculture Imagery Program) with annotated locations indicated. All maps include railroad transect demarcations. Hillshade images in panels (c)–(e) derived from merged lidar datasets.

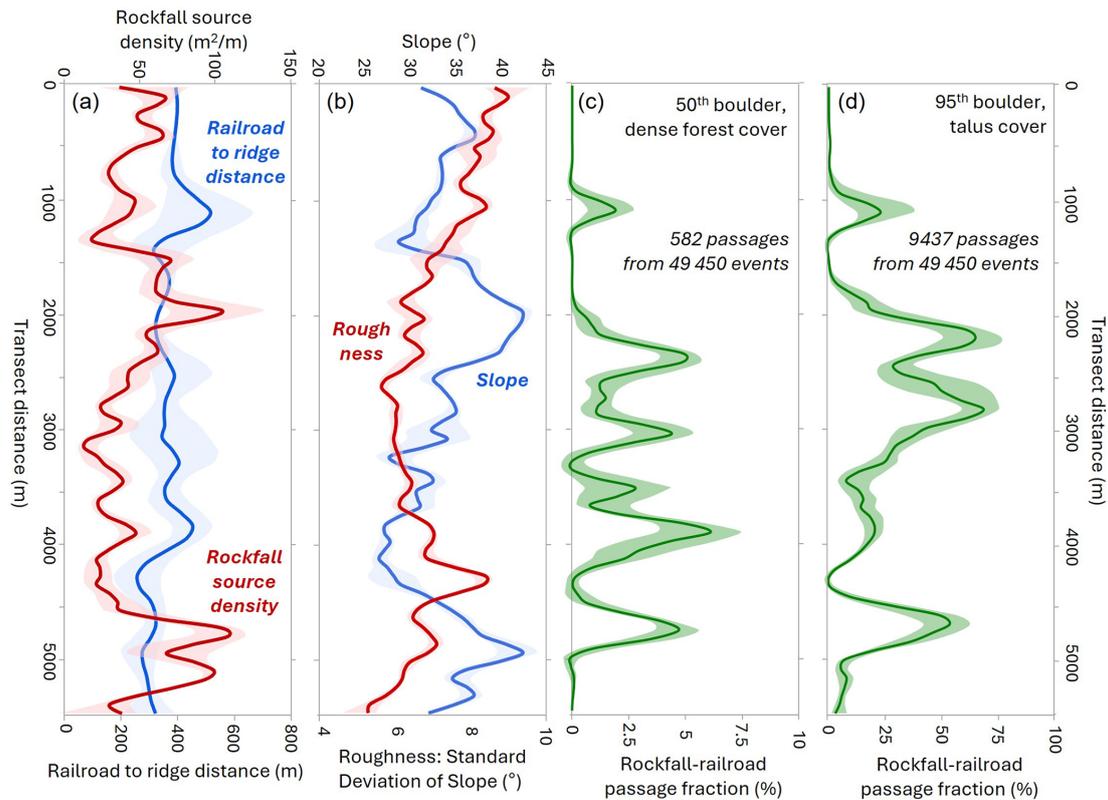
Figure 11. Plots of rockfall model variables and topographic properties along the railroad transect that bisects Skagway and the rockfall prone ridgeline (see Fig. 10 for location). **(a)** Profile of rockfall source density ($\text{m}^2 \text{m}^{-1}$), which depicts the upslope area of toppling-prone terrain (normalized by distance along transect) calculated with Eq. (2) for terrain between the railroad and the ridge crest, and plot of the horizontal distance between the railroad and ridge crest. **(b)** Profile of average slope and roughness (estimated as standard deviation of local slope within a 5 m radius window) for terrain between railroad and the ridge crest. **(c)** Profile of modeled rockfall-railroad passage percentage for the scenario with 50th percentile block size and dense forest cover. **(d)** Profile of modeled rockfall-railroad passage percentage for the scenario with 95th percentile block size and fine talus land cover. Shaded intervals convey standard deviation of values in all plots.
