Development of flood vulnerability functions for cultural heritage buildings and artworks for damage assessment in art cities

Claudia De Lucia and Chiara Arrighi

Department of Civil and Environmental Engineering, Università degli Studi di Firenze, Florence, Italy

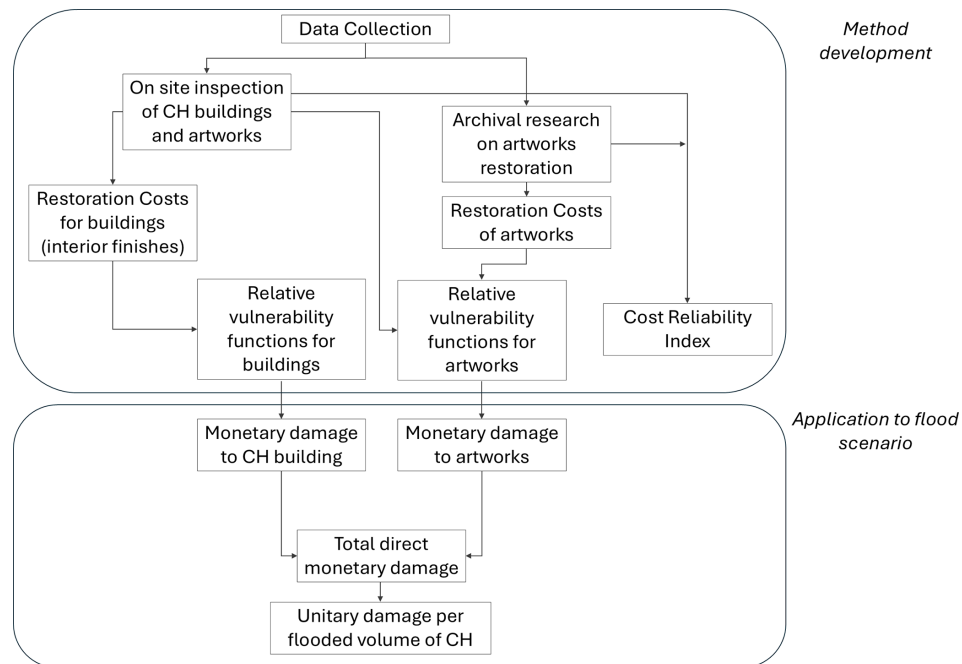
Figure 1. Methodological scheme of the work.

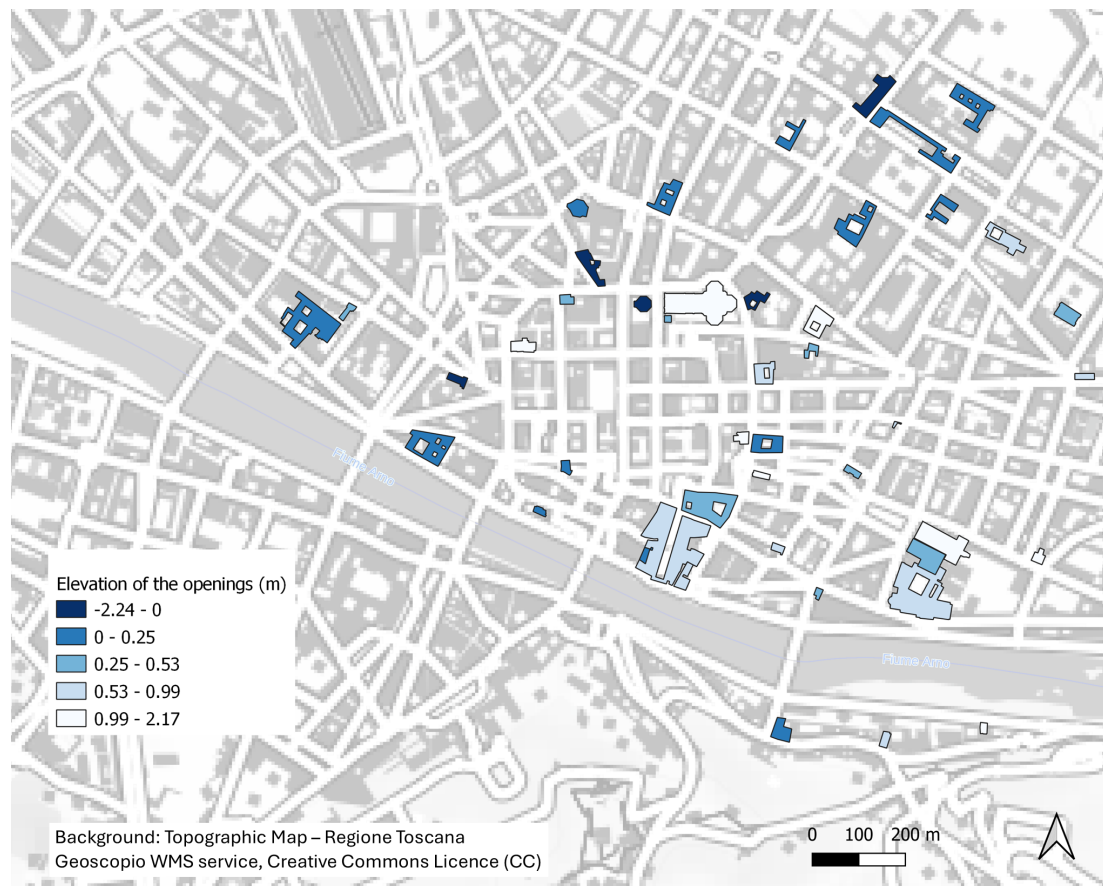
Figure 3. Elevation of the cultural heritage building openings HO above the road pavement after on-site measurements. Background map is based on data from OpenStreetMap. © OpenStreetMap contributors, licensed under the Open Database License (ODbL).

In the majority of the inspected cultural heritage buildings, the ground floor is elevated above street level. On average, the elevation of the main entrance is approximately 0.54 m. This average increases to 0.72 m for places of worship and decreases to 0.33 m for museums. The highest recorded elevation among the surveyed sites is 2.17 m, observed at the Santa Croce Church. Figure 3 presents the measured elevations of building openings above road pavement for the inspected sites.

The elevation of these openings is a critical factor in determining flood exposure, as it directly influences the flood depth threshold used to define zero-damage levels in vulnerability functions.

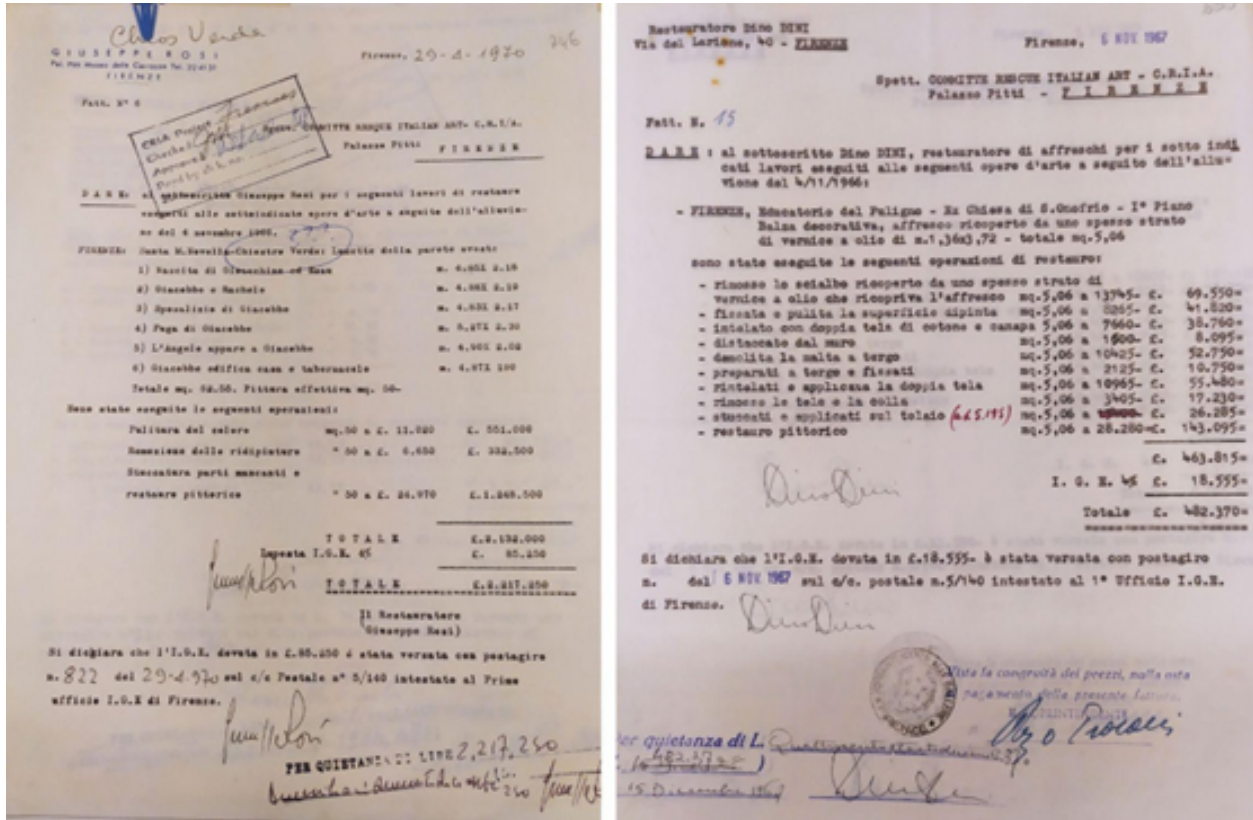
Figure 4. An example of invoices issued by restorers after flooding 1966, stored in CRIA archive.

Following the field investigations, the research focused on a detailed analysis of damage caused by historical flood events. The CRIA archive (Committee to Rescue Italian Art, 2025) contains extensive documentation on the 1966 flood in Florence, including photographs (over 900), videos, and written records. Restoration invoices issued after the event were examined and categorized by artwork type – primarily paintings on canvas, paintings on wooden panels, and wooden sculptures. Figure 4 provides an example of these invoices related to restoration work carried out post-flood. The list of restoration activities documented for flood-damaged artworks was used to update restoration costs to present-day values, enabling the estimation of contemporary repair costs based on historical data.

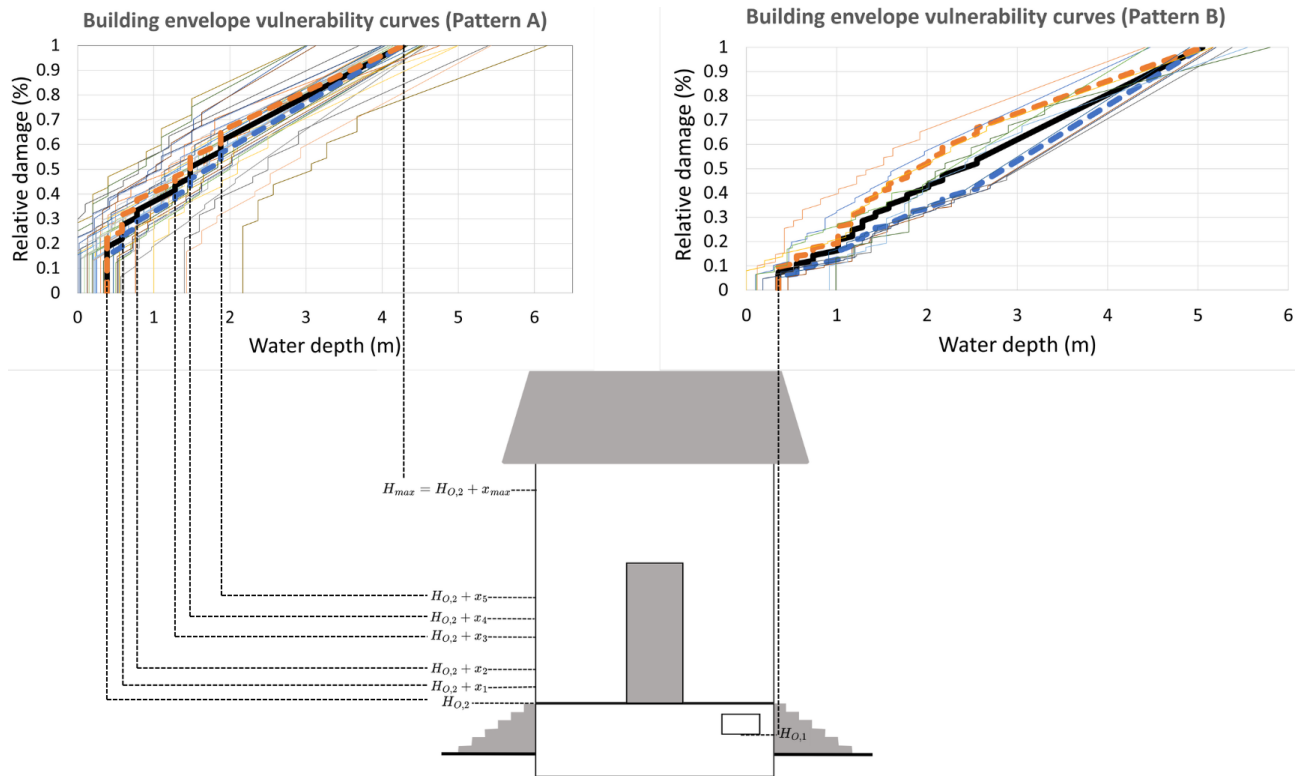
Figure 5. CH Building vulnerability functions: Pattern A (on the left) and Pattern B (on the right). The bold black, orange and blue curves are the average, 75th and 25th percentile vulnerability functions.

Pattern A (left) is characterized by six steps and represents damage scenarios for buildings either without basements or with basements that flood simultaneously with the ground floor. This occurs when basement openings are either absent or positioned above the elevation of the main entrance – typically in buildings with multi-level ground floors. The first step of the function corresponds to the point at which floodwaters reach the lowest opening, thereby affecting the floor. On average, this occurs at a water depth of 0.39 m, resulting in approximately 18 % relative damage to the building. The extent of damage at this initial stage tends to increase with the building's surface area.

Subsequent steps in Pattern A correspond to progressive damage to electrical and plumbing systems. When the electrical system is fully compromised – typically at an average water depth of $w = H_{O,2} + x_5 = 1.88$ m – the relative damage reaches approximately 62 %.

In contrast, Pattern B (right) corresponds to buildings where the basement floods before the ground floor due to basement openings located below the elevation of the main entrance or any ground-floor openings. In this scenario, damage is assumed to occur equally at each level. Accordingly, Pattern B functions are derived by summing two identical stepwise curves, each shifted along the x -axis by $w = H_{O,2} - H_{O,1}$, representing the elevation difference between ground-floor and basement openings. As a result, the vulnerability curve for Pattern B includes twelve steps – six for each level.

As shown in Fig. 5, buildings following Pattern B begin to sustain damage when water reaches the lowest basement opening, at an average depth of 0.36 m. Typically, when water depth reaches 2.55 m, the electrical systems on both levels are entirely compromised, and approximately 54 % of the interior finishes of the building is damaged.

Only 10 CH buildings fall under Pattern B. Due to the low elevation of their basement openings relative to the street level, the first damage step for most of these buildings occurs at water depths below 0.5 m. The sole exception is the National Library of Florence, where the basement windows are located 0.99 m above street level, requiring a greater flood depth to trigger initial damage. The average and percentile vulnerability functions for the CH building are also displayed as Supplement of the manuscript.

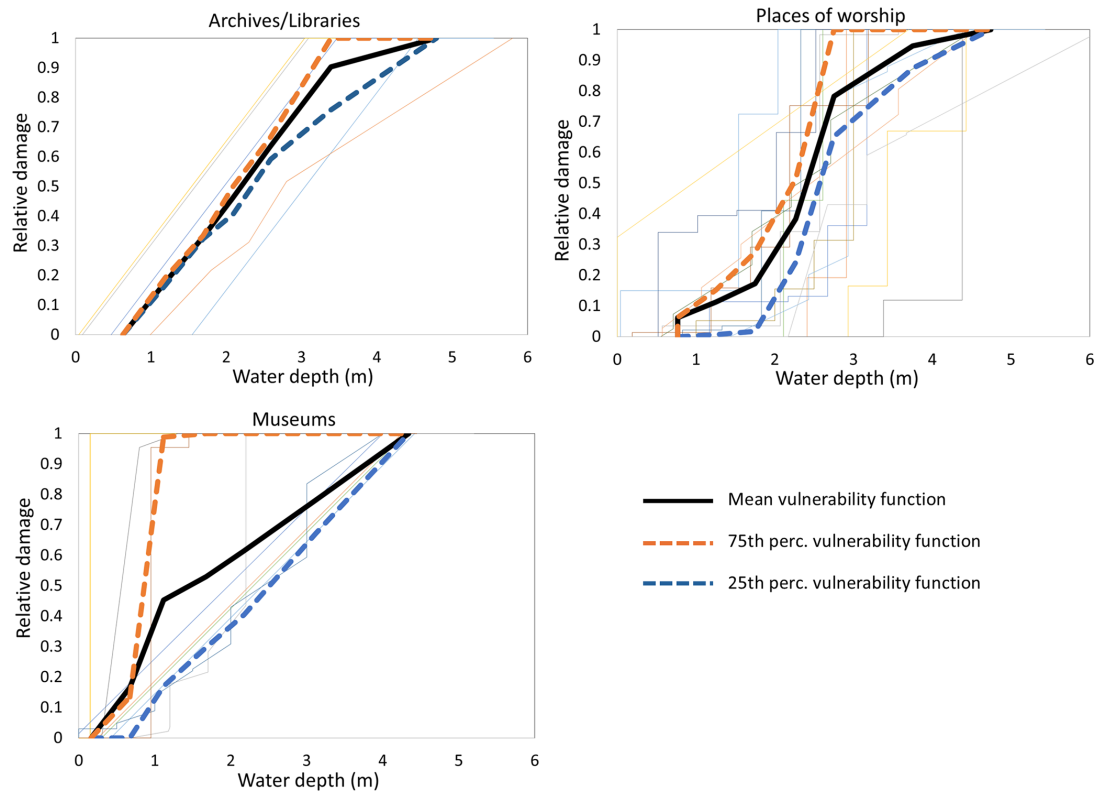
Figure 6. Artworks vulnerability functions for libraries/archives (top left), places of worship (top right) and museums (bottom left). The bold black, orange and blue curves are the average, 75th and 25th percentile vulnerability functions.

Figure 6 (top right panel) presents the vulnerability curves for places of worship in the city of Florence. Approximately 69 % of these curves exhibit a stepwise growth pattern, while the remaining curves display a combined trend of linear progression and stepwise increase. This mixed behavior reflects the coexistence of large-scale artworks, such as frescoes, and smaller movable objects, including paintings on canvas and sculptures. On average, no damage is recorded until the external water depth reaches approximately 0.77 m, after which the relative damage increases rapidly to 6.2 %. A significant inflection occurs at around 1.75 m, where the damage rate increases sharply – from 0.12 to nearly 0.4. Complete damage is observed at a water depth of approximately 4.7 m. This depth–damage behavior aligns with the field data collected and supports findings from previous studies (Salazar et al., 2023; Figueiredo et al., 2021). Initially, elevated ground floors help delay damage; however, once floodwaters breach the entrances, ground-level artworks – such as marble fonts and wooden pews – are immediately affected. When internal water depth reaches around 1 m, artworks located at higher elevations, such as altar paintings, are also impacted, significantly increasing restoration costs.

In the “libraries/ archives” category, only five assets (shown in Fig. 6, top left panel) have a Cost Reliability Index (CRI) below 0.3. Among these, four exhibit a linear vulnerability trend, typical of assets whose interiors are predominantly lined with paper-based materials. Only one asset follows a combined linear and stepwise pattern: the Central National Library of Florence, which includes sculptures and paintings alongside its extensive collection of books, manuscripts, and periodicals.

In the museum category, multiple vulnerability patterns are observed, reflecting the diversity of museum types. This category includes sites ranging from galleries, which display large numbers of paintings or sculptures, to cenacles and historic palaces entirely decorated with frescoes. In galleries, the vulnerability function typically shows a stepwise pattern, while fresco-covered spaces often follow a linear progression. A particularly notable case is represented by the yellow curve, which shows a single-step transition from zero to 100 % relative damage. This curve corresponds to the “Cappelle Medicee” museum, which houses the Medici Crypt, the burial site of the Grand Dukes and their families. Due to the exceptional historical and evidential value of the marble gravestones covering the crypt's floor, the museum is considered completely damaged as soon as floodwaters infiltrate the building (Historic England, 2008). An analysis of average vulnerability functions across the museum category reveals that relative damage increases rapidly up to a water depth of approximately 1.12 m, after which the rate of increase slows,

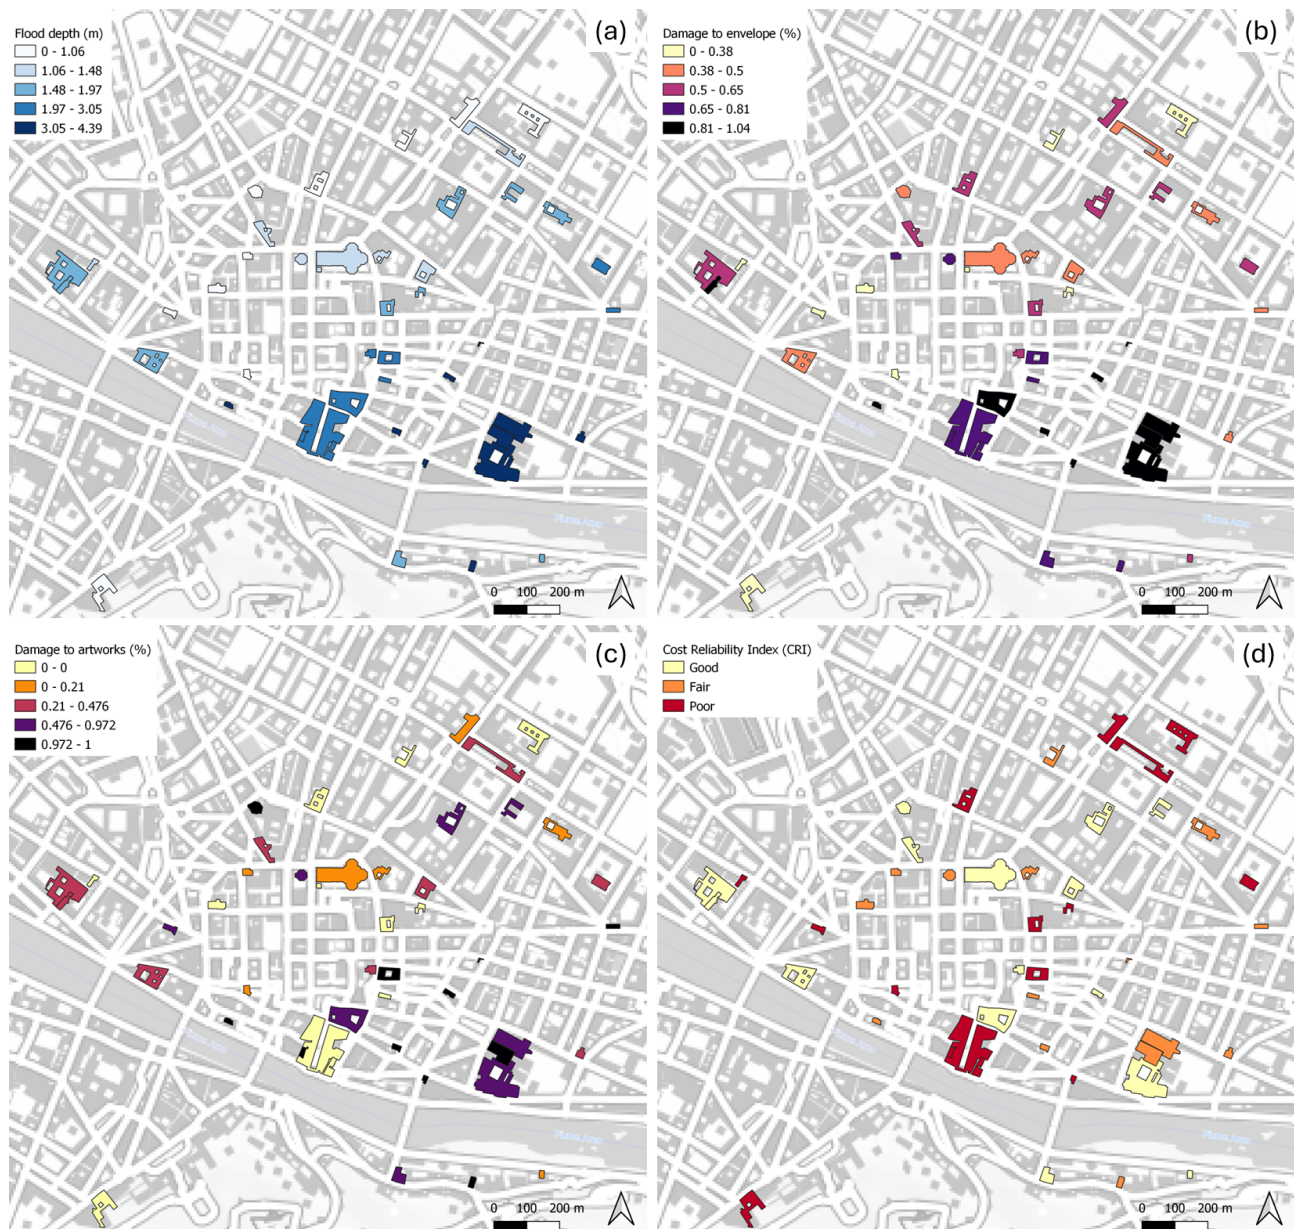
Figure 7. Flood depths for the 500 years return period scenario (a), relative damage to the building envelope (b), relative damage to the artworks (c), Cost Reliability Index for artworks (d). Background maps are based on data from OpenStreetMap. © OpenStreetMap contributors, licensed under the Open Database License (ODbL).

The 2D hydraulic simulation developed by Arrighi et al. (2022) provides flood maps for various scenarios, enabling the estimation of water depth at each CH building. For demonstrative purposes, the 500-year return period scenario is used to assess flood damage. Figure 7a illustrates the flood depth in proximity to buildings. It is evident that cultural heritage (CH) buildings located near the river experience the greatest flood depths – on the order of 3–4 m above the road pavement in the S. Croce district (lower right area of Fig. 7a). Conversely, moving downstream and away from the river, flood depths at CH buildings decrease significantly.

The relative damage to building is shown in Fig. 7b. The most exposed assets, depicted in black and purple, exhibit losses exceeding 65% under the analyzed flood scenario. Notably, the pattern of damage to building does not decrease in direct correlation with flood depth. This discrepancy arises from variations in architectural features, particularly the elevation of openings (see also Fig. 3 for comparison). This observation underscores the importance of on-site inspec-

tions to better determine the zero-damage thresholds of such historically unique buildings. For instance, many buildings close to the river possess elevated ground floors, mitigating damage, while those farther from the river often have entrances at or below road level, increasing their vulnerability.

Regarding the relative damage to artworks (Fig. 7c), the results are more variable due to the heterogeneous distribution of artworks, differences in material susceptibility, and their positioning within CH buildings. Notably, artworks in four cultural buildings – whose ground floors are elevated above street level – remain unaffected, despite their location in flooded areas under the 500-year return period scenario. Nevertheless, the S. Croce district, which hosts libraries, museums, and small churches, emerges as a significant cluster of potential artwork damage.

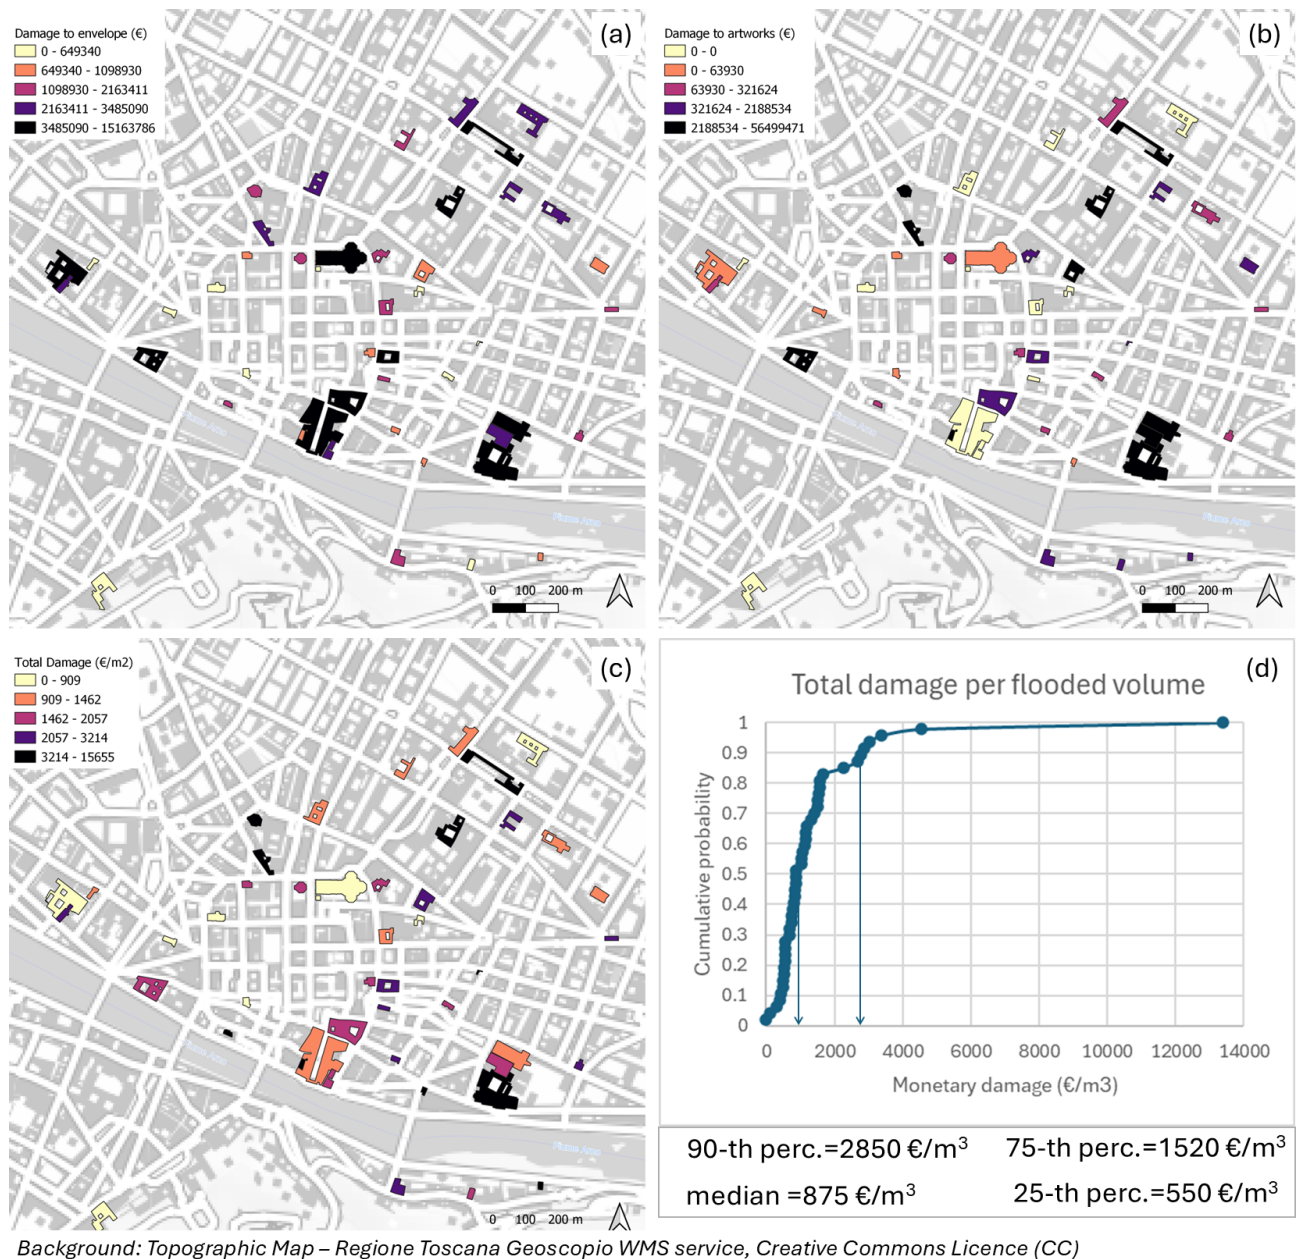
Figure 8. Monetary damage to CH envelope (a), artworks (b), unitary surface damage (c) and unitary volume damage (d). Background maps are based on data from OpenStreetMap. © OpenStreetMap contributors, licensed under the Open Database License (ODbL).

Monetary damages are presented in Fig. 8 for buildings (Fig. 8a) and artworks (Fig. 8b). Damage to the buildings is primarily driven by the larger cultural heritage (CH) buildings in the study area, with the five most affected assets each exceeding EUR 5 million in estimated losses. The average monetary damage to buildings is approximately EUR 2.5 million per building, corresponding to around EUR 1400 m⁻². The total estimated damage to buildings across the 48 assessed buildings amounts to approximately EUR 120 million.

etary damage to artworks in CH buildings is estimated at EUR 3 million per asset, corresponding to approximately EUR 1110 m⁻². The total estimated monetary damage for artworks is approximately EUR 150 million.

Figure 8c illustrates the combined damage (building and artworks) expressed as unit cost per square meter. Unitary total damages range from approximately EUR 500–700 to 2000–4000 m⁻², with localized peaks exceeding EUR 10 000 m⁻², thus spanning two orders of magnitude. By dividing the unitary total damage by the flood depth, a unit monetary damage per flooded volume of CH is obtained. The cumulative probability distribution of this metric is shown in Fig. 8d. The median and 75th percentile values for monetary damage per cubic meter of flooded volume are EUR 875 and 1520 m⁻³, respectively.
