The long-term hazard cascade of an unprecedented wildfire in a tropical mountain ecosystem

Abstract. Climate change is driving wildfires to higher elevations, yet the hazard cascades that follow the burning of pristine tropical mountain ecosystems remain largely unexplored. Here, we analyse the long-term cascade following a February 2012 wildfire that burned 31 km² of forest and wetland in Uganda's Rwenzori Mountains National Park, including sections above 3800 m elevation with no major fire history in 12 000 years. Combining remote sensing, humanitarian records, field surveys and interviews, we document ten major floods since 2012, including two debris floods that required large-scale humanitarian responses. Post-fire increases in erosion and mass movement have widened the River Nyamwamba sevenfold since 2012, breaching copper-cobalt mine tailings and mobilising an estimated 744 000 t of waste into the river. Slow vegetation recovery at high altitudes and positive feedbacks between hazards have prolonged this high-risk state. These findings point to an urgent need to understand where emergent tropical mountain fires can occur, how their impacts cascade downstream, and where early

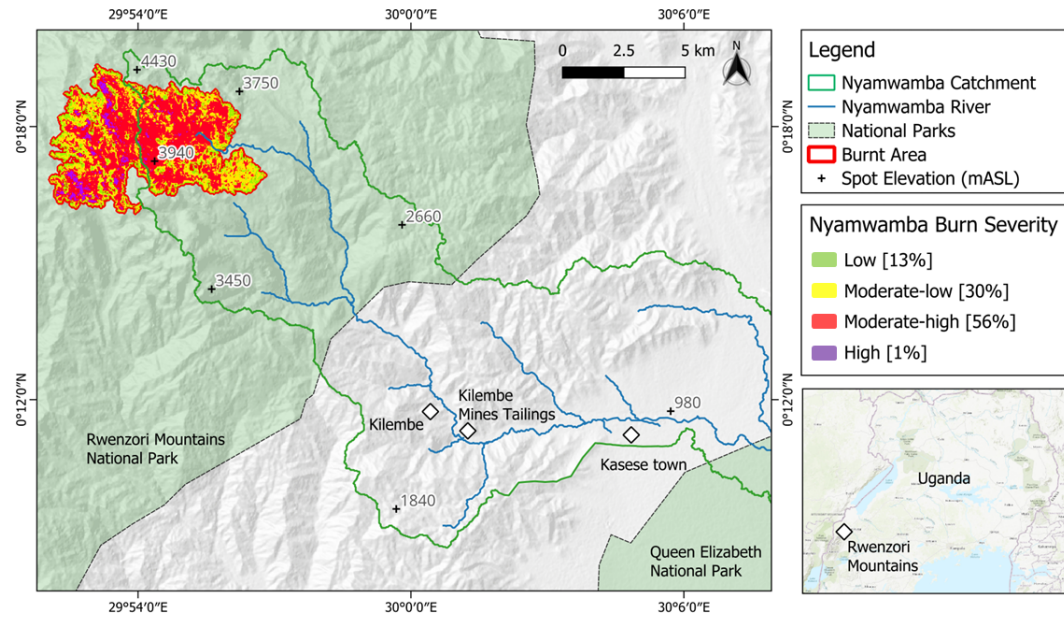
Figure 1. The River Nyamwamba catchment and the delineated wildfire burn area within the Rwenzori Mountains, Uganda. Differenced Normalised Burn Ratio (dNBR) between pre- and post-fire Landsat-7 images were used to delineate the extent and burn severity of the February 2012 wildfire. Severity is classified according to the United States Geological Survey's guide (Key and Benson, 2006). Hill shade background created using DEM distributed by OpenTopography, credit: NASA Shuttle Radar Topography Mission (2013).

The February 2012 wildfire in Uganda’s Rwenzori Mountains National Park burned 31 km² of pristine, uninhabited tropical mountain forest and wetlands (Fig. 1) during a brief meteorological drought measuring -3.5 in a 1-month Standardised Precipitation Index (Appendix A). The ecosystem was mature – the fire was the first to affect elevations exceeding 3800 m above sea level in the Rwenzori Mountains for at least 12 000 years (Mason et al., 2026).

Remote sensing evidence shows a 30.75 km² burn area for the February 2012 wildfire (Fig. 1), with 87% of the area burned to a moderate or high severity. The fire occurred during a meteorological drought, with < 0.2 mm of precipitation in the 4-weeks preceding the fire (Jacobs et al., 2016) and a one-month Standardised Precipitation Index measuring −3.5 for January 2012 (Appendix A). The fire's cause of ignition is still unknown by the water and wildlife authorities [M1; M2; W1].

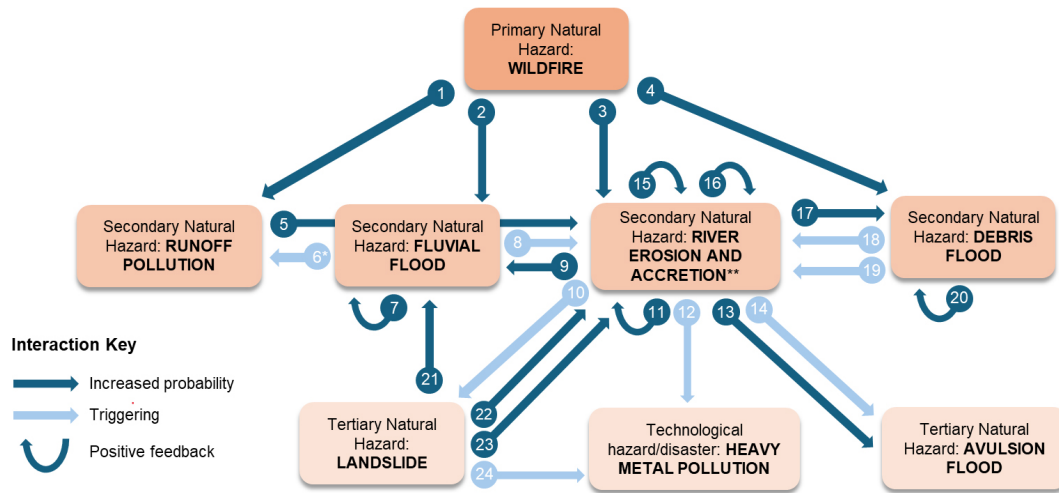
Figure 2. Conceptual model of the multi-hazard cascade following the Rwenzori National Park wildfire in February 2012. Interactions between hazards are classified as being (i) triggering, or (ii) probability increasing, following Gill and Malamud’s (2016) framework, and (iii) positive feedbacks have been identified. There are numerous catalysing/impeding relationships in this context, which we omit from the visualisation for simplicity but describe key examples in the analysis text. Table 1 describes each of the interactions shown. * Interaction (6) also applies for debris floods and avulsion floods as the driving hazard (Table 1), but they are grouped for simplicity in the visualisation. ** River channel erosion and accretion of eroded sediment are treated as one hazard in line with UNDRR’s Hazard Information Profiles (HIPs), with continuously interacting processes and positive feedbacks (15, 16) along the river’s reach (UNDRR, 2025).

We present the multi-hazard cascade caused by the 2012 Rwenzori National Park wildfire (Fig. 2). The following sections describe each of the hazards involved and the interactions they drive, based on evidence from our mixed methods. Results are structured by hazard type: wildfire (Sect. 3.1), flooding (Sect. 3.2), landslides (Sect. 3.3), erosion (Sect. 3.4), and pollution (Sect. 3.5). Identified interactions highlight opportunities where management interventions can impede the cascade, for which we discuss practical solutions at the local and global scales in Sect. 4 (Discussion). The hazard definitions follow the Hazard Information Profiles (UNDRR, 2025) and are clarified in Table D1 (Appendix D). Importantly, here landslides refer to gravitational mass movements directly connected to the river system as shown in Figs. I1 and I2 (Appendix I).

Table 1. Description of the hazard cascade interactions in Fig. 2. The study evidence for each interaction is explained in the text and summarised in Table D2 (Appendix D).

Driving Hazard	#	Description of Interaction	Affected Hazard
Wildfire	1	Wildfire generated ash & exposed soils to surface runoff	Runoff Pollution
	2	Burning increased runoff & river discharge, causing higher peak flows	Fluvial Floods
	3	The higher peak river discharge has increased the river’s erosive power	Erosion and Accretion
	4	The higher peak river discharge has increased its transport competence	Debris Floods
Runoff Pollution	5	Increased sediment loads, more material available for accretion	Erosion and Accretion
Fluvial Floods	6	Floodwaters (fluvial, *avulsion and debris floods) transport contaminants	Runoff Pollution
	7	Each flood damages natural banks & flood defences	Fluvial Floods
	8	Higher flow velocities & turbulence during floods increase erosion	Erosion and Accretion
River Channel Erosion and Accretion	9	Eroded material fills the channel, reducing its discharge capacity	Fluvial Floods

Table D2. Description of the hazard interactions in Fig. 2 and supporting evidence.

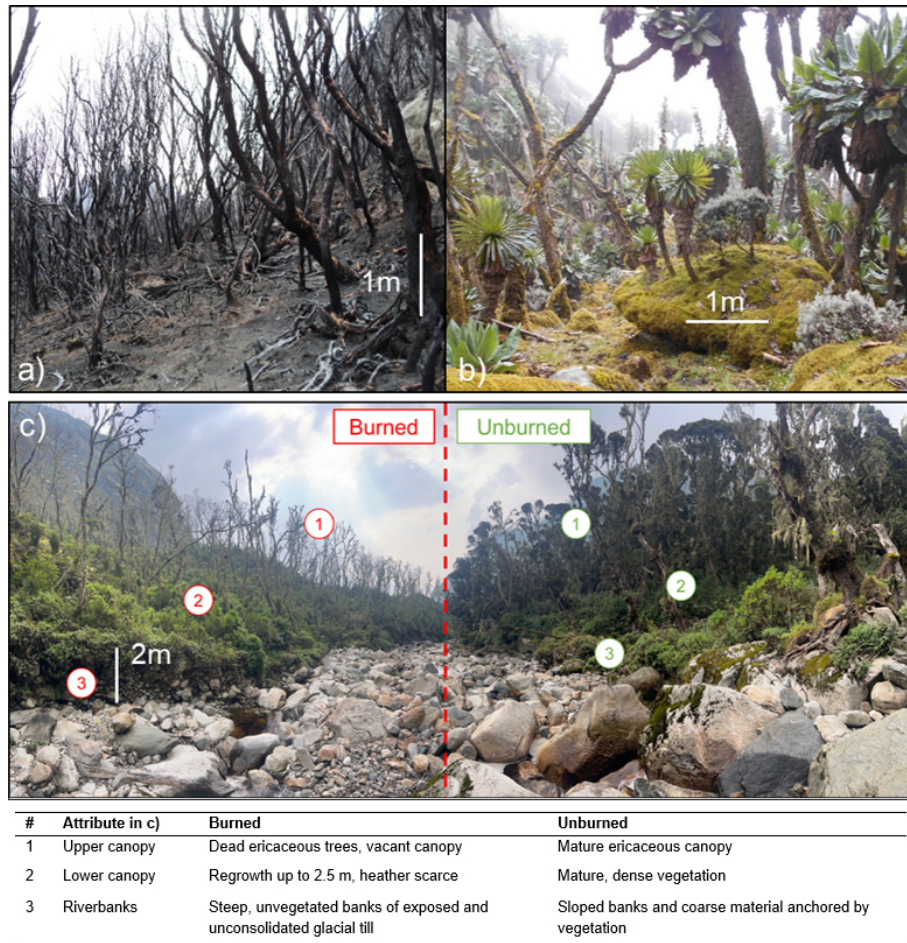
Figure 3. (a) Burned ericaceous “heather zone” vegetation 1-month after the wildfire in March 2012; (b) Mature Afroalpine moorland vegetation prior to the wildfire (March 2011); (c) upper course of the River Nyamwamba at 3380 m elevation in July 2024, where the river had acted as a firebreak to provide direct comparison between unburned and recovering burned sections of the ericaceous forest. Scale bars correspond to the tree trunk in (a), the boulder in (b) and the riverbank in (c). The associated table describes the ecological properties of the burned and unburned areas.

The fire burned between 3360–4400 m above sea level, burning climax “heather zone” forest, “spongy” [R1] Afroalpine moorland, and methane-rich bogs [M1] with no recorded history of wildfires (Fig. 3a; Mason et al., 2026; UNEP, 2022). Photographs from March 2012 show indicators of high burn severity (Fig. 3b), while images from July 2024, twelve years later, reveal regrowth limited to a maximum of 2.5 m, with the upper canopy still vacant (Fig. 3c). These slow growth rates and an observed scarcity of heather in the regrowth succession indicate that natural recovery will require several decades (Wesche et al., 2000).

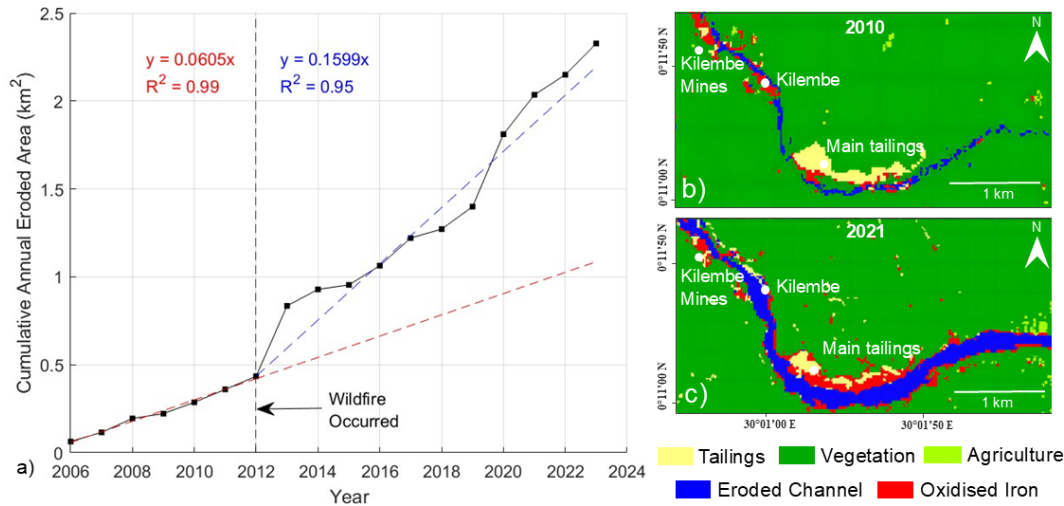
Figure 4. (a) Annual cumulative eroded area in a 20 km mid-lower course section of the River Nyamwamba, calculated as the increase in eroded channel area between each year’s supervised classification; (b) supervised classification of a February 2010 Landsat-7 image; (c) supervised classification of a February 2021 Landsat-8 image.

7	Fluvial flood	Fluvial flood	Increased probability. Fluvial floods damage engineered flood defences, increasing the probability of future breaches.	Photos of damaged flood defences (Appendix H).
8	Fluvial flood	River channel erosion	Triggering. Higher flow velocities and turbulence during fluvial floods exert shear stress, abrasion and hydraulic action to erode riverbanks.	GIS analysis shows the years of highest erosion occurred in 2013 and 2020, the years of the largest debris and fluvial floods [M1, R1] (Fig. 4).
6*	Fluvial flood	Runoff pollution	Triggering. Fluvial floods transport materials across the urban and agricultural landscape. If pollutants are present, this results in a runoff pollution event.	Respondents describe post-flood contamination of urban and agricultural landscapes [M1, M2]. Field photographs of contaminant transport into urban areas (Appendix L, Fig. L1).
9	River channel erosion and accretion	Fluvial flood	Increased probability. Eroded material fills and reduces the channel’s carrying capacity for discharge. Erosion has also relocated active channels closer to residential areas.	Change in river morphology to a sediment-laden braided system indicating increased deposition and channel switching (Fig. 4b).

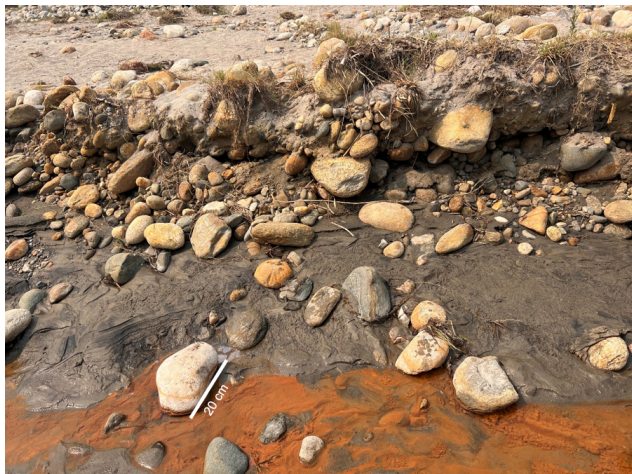
Figure E1. Acid mine drainage at location 0.18599° N, 30.01951° E, 25 July 2024.

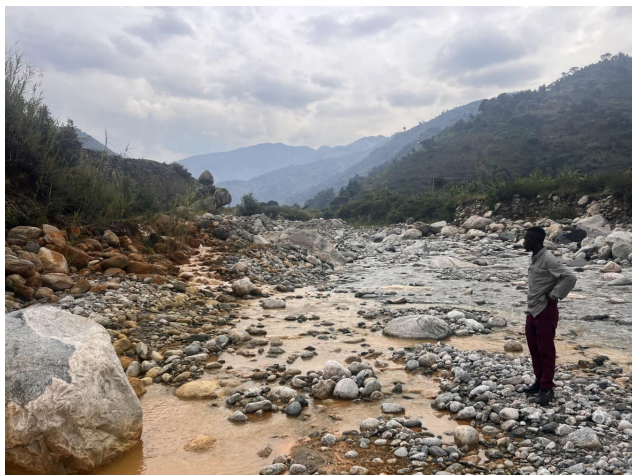
Figure E2. Acid mine drainage at location 0.19879° N, 30.01139° E, 3 August 2024.

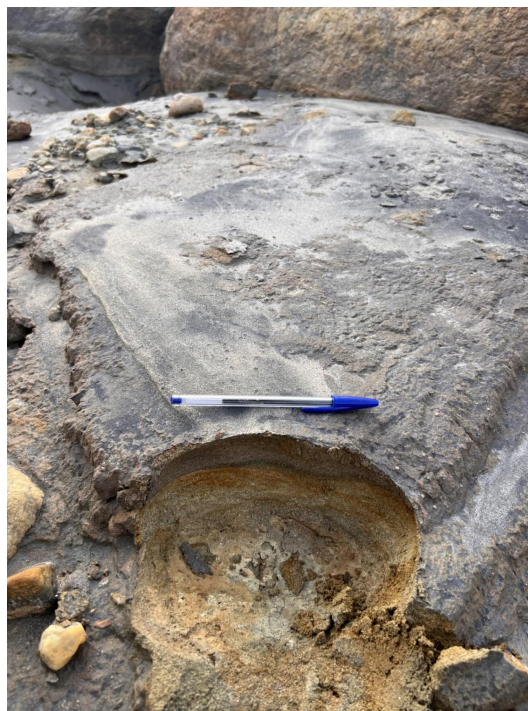
Figure E3. Tailings sedimentation in the Nyamwamba channel, 0.18652° N, 30.01986° E, 25 July 2024.

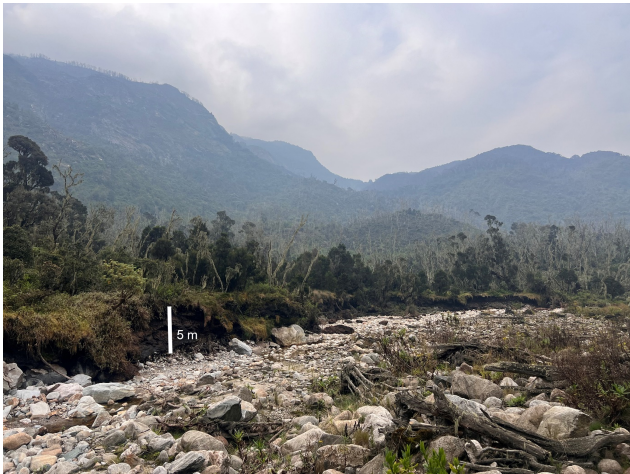
Figure F1. Riverbank exposure at 0.29291° N, 29.93596° E – 28 July 2024.

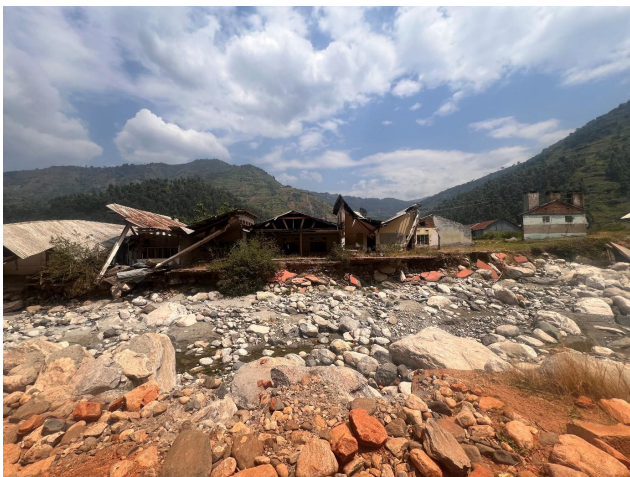
Figure F2. Riverbank style erosion of house foundations in Kilembe, 0.20603° N, 30.00822° E – 24 July 2024.

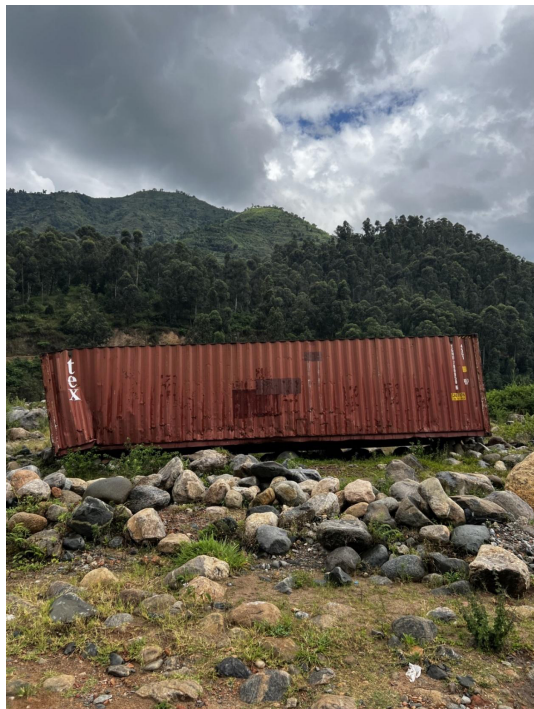
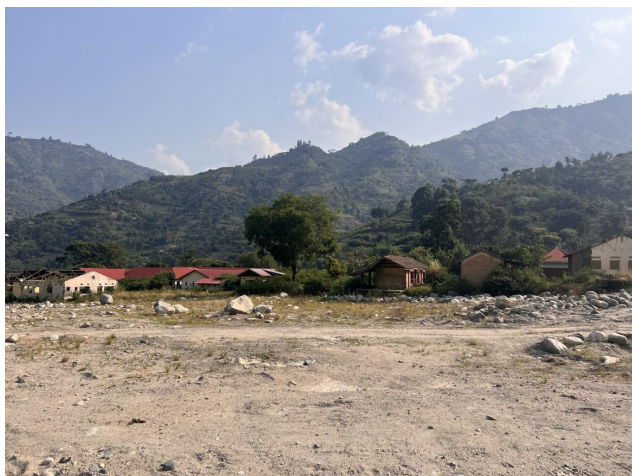
Appendix G: Flood Plain Boulder Deposition Photographs

Figure G1. 0.20285° N, 30.00908° E – 7 June 2023.

Figure G2. 0.19528° N, 30.01544° E – 25 July 2024.

3	Wildfire	River channel erosion	Increased probability. Wildfire’s burning of vegetation and erosion of soil has increased runoff, peak river discharge, and therefore the erosive power of the river. Initial erosion and mass movement also exposed riverbanks, which is increasing the probability of (and catalysing) further erosion in a positive feedback process.	GIS analysis calculating an erosion rate increase by a factor of 2.64 due to the wildfire (Fig. 4). Photographs of exposed riverbanks within wildfire affected areas (Fig. 3c and Appendix F).
4	Wildfire	Debris flood	Increased probability. Wildfire has increased peak river discharge by the burning of vegetation and soil which modulate discharge. It has also increased sediment generation through augmented erosion and mass movement, improving the conditions for debris flood development.	Two interview respondents explain and show camera footage of 2013 and 2020 debris floods, described as unprecedented before the fire [M1, R1] (Table 1). Jacob’s et al.’s (2016) reconstruction of debris flood during the May 2013 flood. Field photographs of boulder deposition on the delta and distal flood plain (Appendix G).

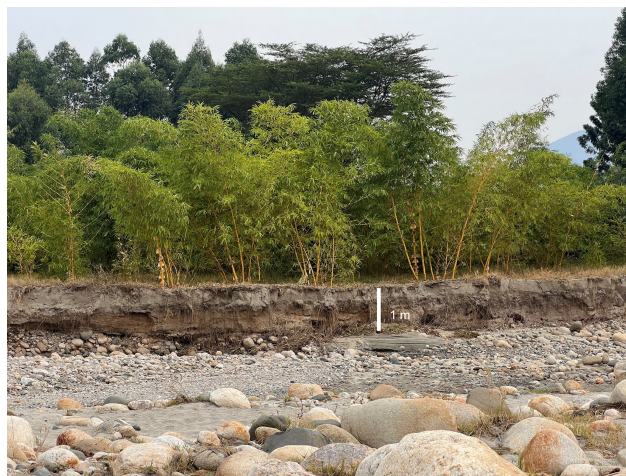
Figure H1. 0.18981° N, 30.07408° E, 26 July 2024 (damaged bamboo nature-based solution).

High flows during fluvial and debris floods damage engineered flood defences, increasing their own probabilities of future breaches in self-perpetuating positive feedback (#7; #20; Appendix H). At the same time, their elevated veloci-

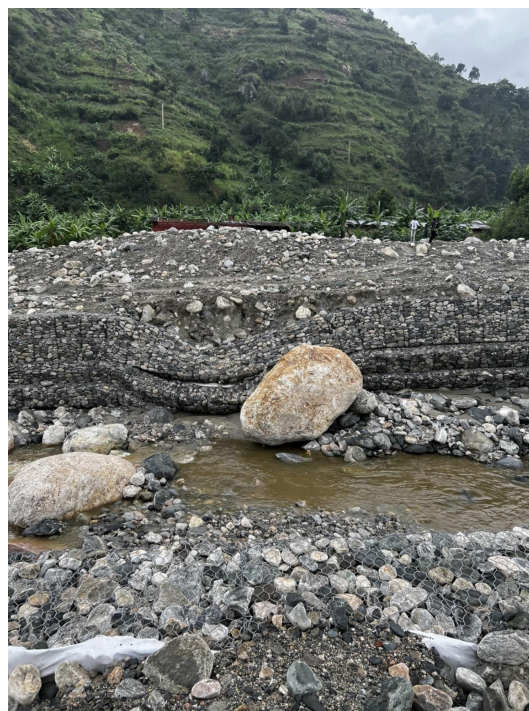
Figure H2. 0.21387° N, 30.00558° E, 7 June 2023 (damaged gabions).

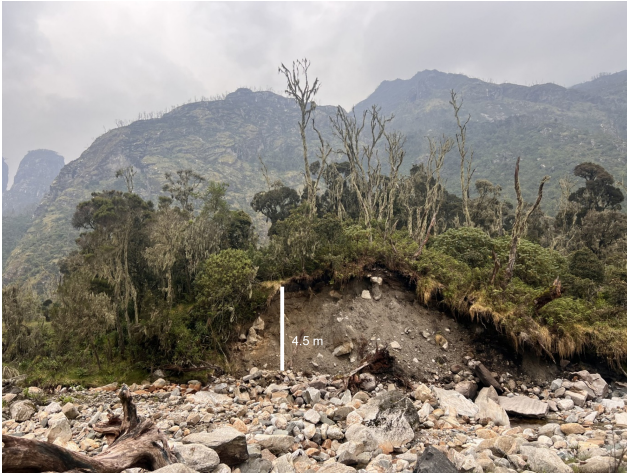
Figure I1. 0.29291° N, 29.93596° E – 28 July 2024.

Appendix I: Landslide Talus Entering the River Photographs

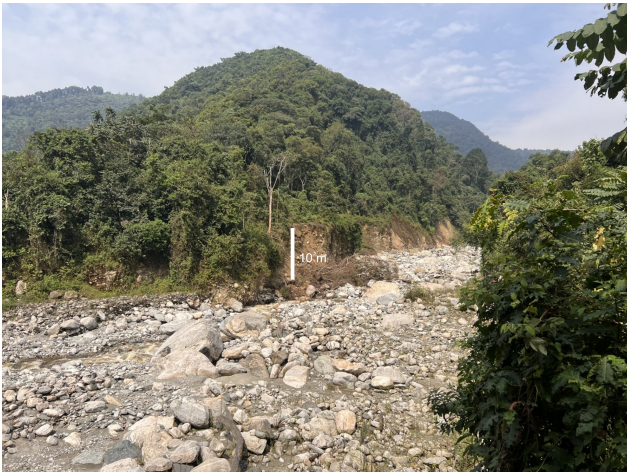
Figure I2. Landslide scar at 0.23758° N, 29.97570° E – 1 August 2024.

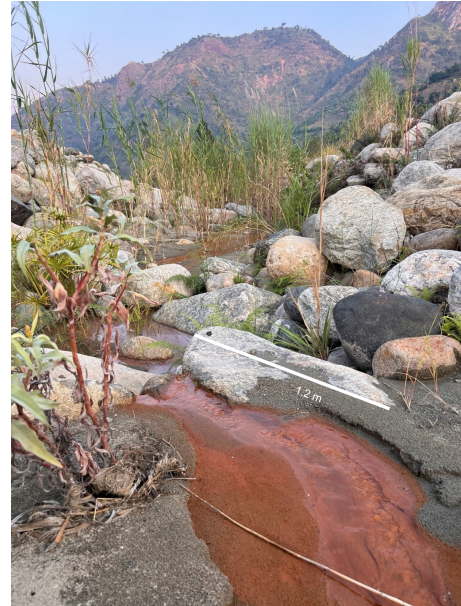
Figure J1. Deposition and acid mine drainage downstream of Kilembe Mines 0.19385° N, 30.082355° E, 26 July 2024.

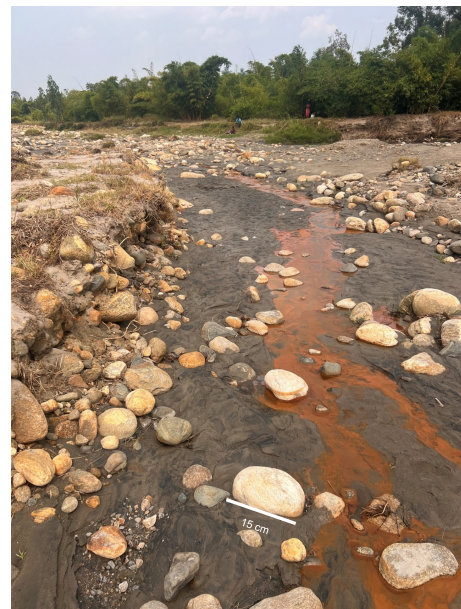
Figure J2. Acid mine drainage from deposited solid tailings at location adjacent to Kasese town, 26 July 2024.

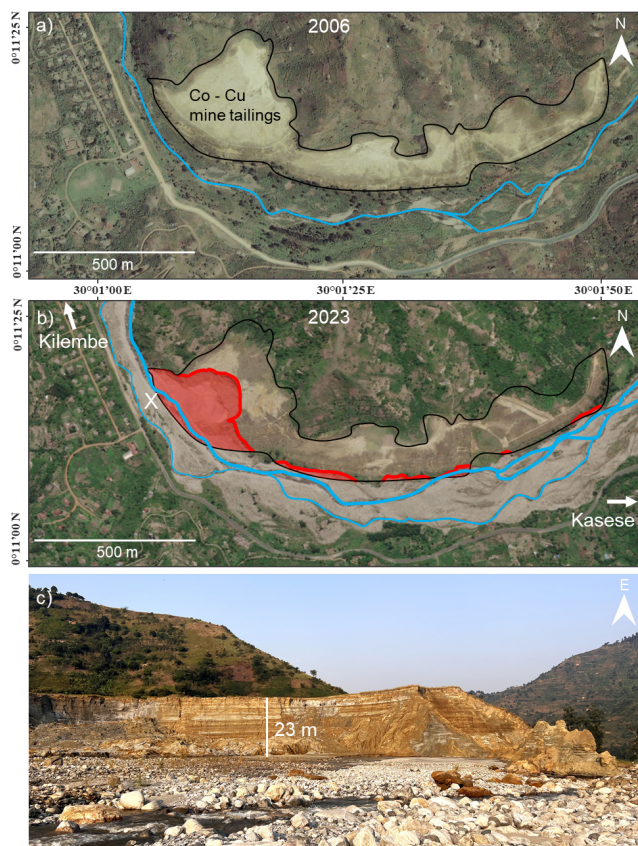
Figure K1. (a) Kilembe Mines tailings on 24 March 2006 (Maxar Technologies, 2024a); (b) the same location on 10 Apr 2023 (Maxar Technologies, 2024b) where an estimated 744 000 t of solid waste have eroded into the river. The black polygon outlines the original surface area of mine tailings, and the red polygon shows the area partly or fully eroded; (c) photograph of a section of the eroded tailings taken in July 2024 at position X (b), facing east towards Kasese town.

Beyond this diffuse pollution, accelerated river erosion (#12) and landslides (#24) have inputted an estimated 744 000 t of a 15 Mt Kilembe Mines Co-Cu tailings deposit directly into the River Nyamwamba (mapped in Appendix K). Satellite imagery and field photographs show erosional banks, slump scars and new channels within tailings areas, and evidence of acid mine drainage from distinctive iron oxide precipitation (Fig. 3c; Appendix E). Elevated Co, Ni, Cu, Fe, Al, S, Zn, As, Cd and Mn river contamination has previously been attributed to leaching of the Co-Cu mine (Abraham and Susan, 2017; Mwesigye et al., 2016; Mwesigye and Lawrence, 2024; Mwongyera et al., 2014).

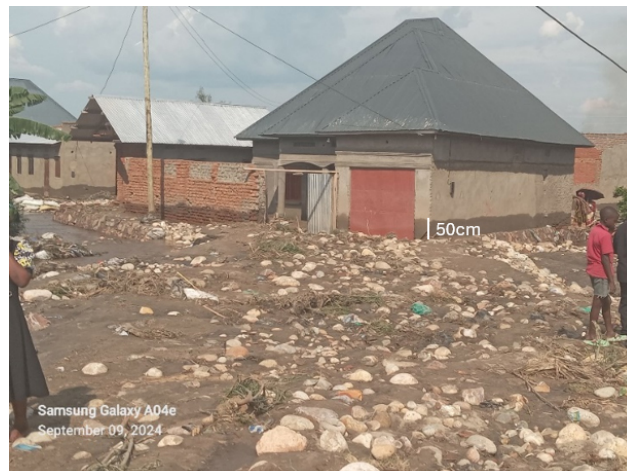
Figure L1. Photograph following flooding in Kasese town evidencing the inundation level and post-flood ground contamination. Photograph provided by the Ministry of Water and Environment.

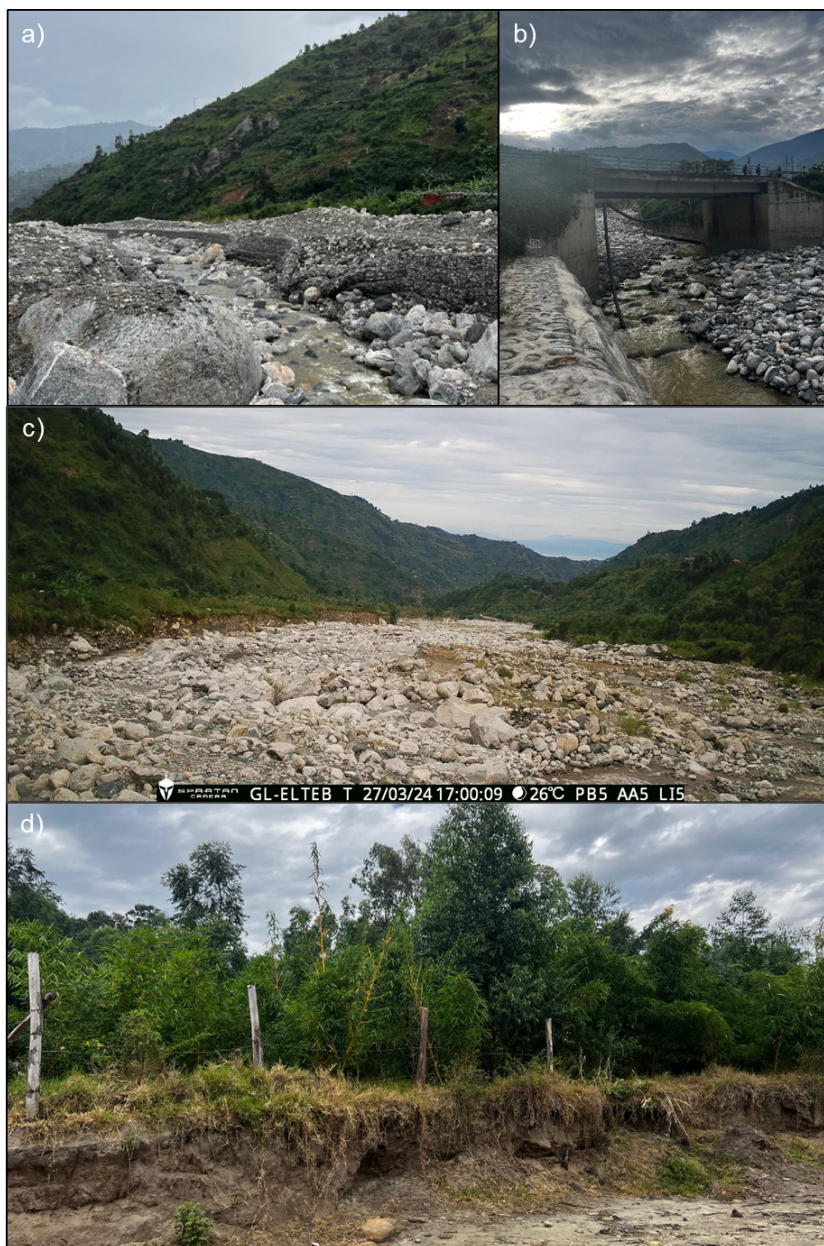
Figure M1. Photographs taken during June 2023 field reconnaissance: **(a)** collapsed gabions adjacent to Kilembe town (for scale: 8 m channel width); **(b)** channelisation using concrete embankments in Kilembe town centre (10 m channel width under bridge); **(c)** photo from a camera transmitting photos at 1 min intervals 5 km upstream of Kilembe town centre for flood early warning; **(d)** riverbank stabilisation adjacent to Kasese town including asper bamboo (4 m fencepost spacing).

Strategy		Description	Evaluation
Nature-based Solutions (NbS)	Riverbank Stabilisation (Fig. M1d)	As part of a 2021 World Bank funded project (World Bank, 2022), a 10 km length of the Nyamwamba riverbanks have been planted with 30 m thick vegetation buffers to mitigate further lateral erosion. Seedlings planted included 35 000 Asper bamboo, 2000 mango and 4000 Mahogany, situated within a fenced zone to deter trespassing, logging, theft and interference by animals (World Bank, 2022).	An existing pilot in Mubuku has demonstrated 20 years of successful bank stabilisation [M1], however 2021 Nyamwamba planting has faced challenges of droughts, floods, termites [W1], death of seedlings due to heavy metal contamination by mine tailings, logging, and reluctant participation by some land owners. Rapid initial growth in patches require long term monitoring and evaluation, but bamboo planting is perceived as the most promising solution for landslide and erosion mitigation in the wildfire-affected zone and around the mine tailings [R1, M1, M2, I1, I2, W1]
