Dynamics and conceptual model of the Rossena castle landslide (Northern Apennines, Italy)

This paper describes an interesting landslide, failed during the night of 28 February 2004, that involved the village of Rossena: the failure damaged the village (Fig. 1), the road and the fields down to the stream but, fortunately, the castle just upslope the village was not involved at all.

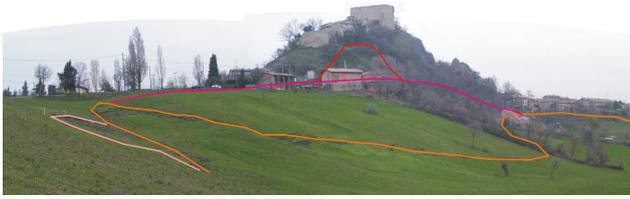
Fig. 1. Panoramic view of the higher part of the Rossena Landslide. Keys: orange line = main body (rotational), purple line = earth slide (translational), red line = rock slide, pink line = secondary landslide.

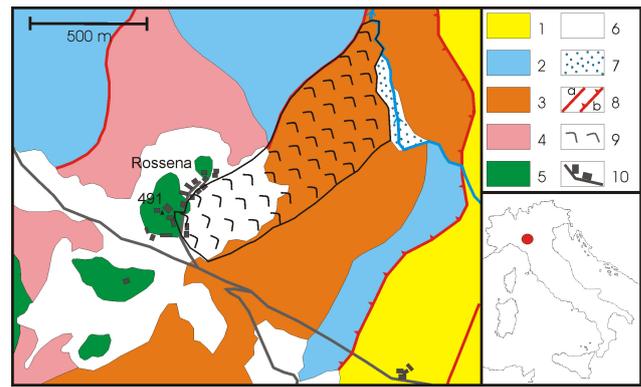
Fig. 2. Location of the Rossena landslide and geological sketch of the surrounding area. Keys: 1) clayey breccias, 2) limestone in shales, 3) varicolored shales, 4) tectonic *mélange* (clay with blocks), 5) ophiolites, 6) slope deposits, 7) alluvial deposit, 8) faults (a) and trust (b), 9) Rossena landslide, 10) roads and buildings.

In the Rossena area two main rock units outcrop (Fig. 2): mainly dismembered and tectonically fatigued clay and shale formations and a more or less fractured and weathered ophiolitic sequence (Papani et al., 2002).

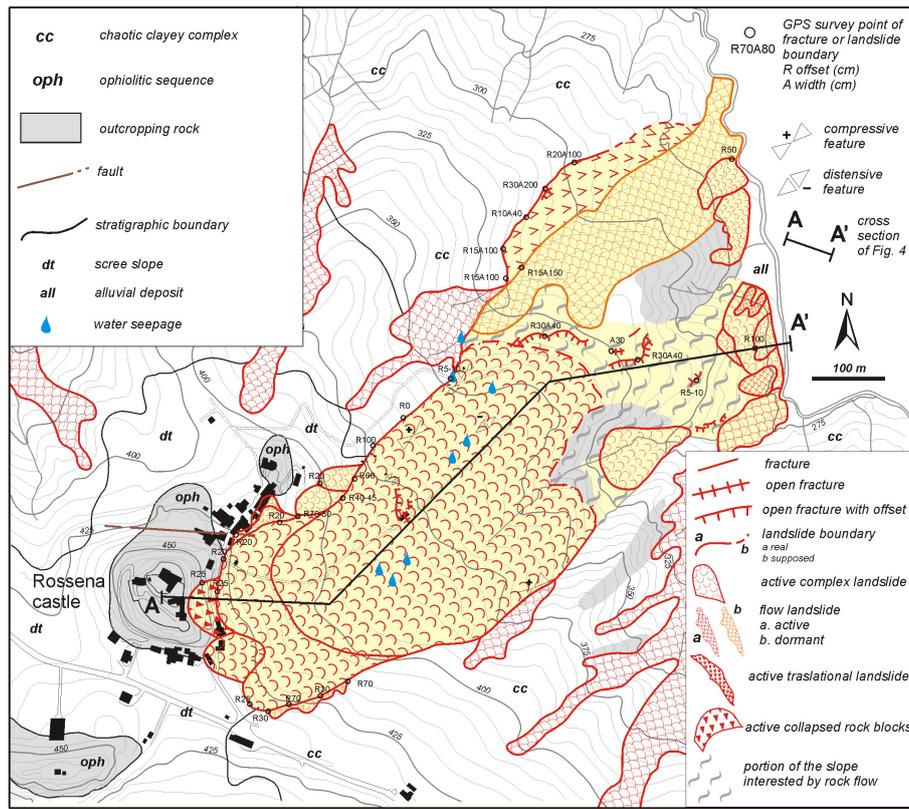
Fig. 3. Geological-geomorphologic sketch of the Rossena Landslide (highlighted in pale yellow) and surrounding area.

A detailed geomorphologic and geologic survey allowed us distinguishing the different landslides that shape the north-eastern slope of the Rossena area (Fig. 3). The Global Positioning System (GPS) device was employed to map the boundaries of the landslide bodies and to place the morphologic indicators of the different movements. In particular, it was possible to distinguish the portions of the landslides where there are spreading movements from the others where compressive ones appear, therefore it was possible to map the different landslide bodies and, mainly, solve the complex situation that characterized the middle-lower portion of the slope.

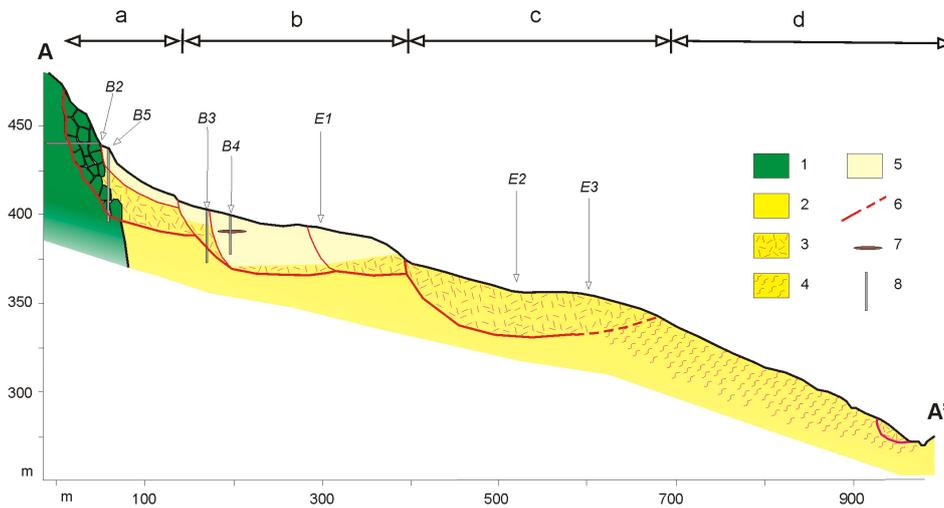
Fig. 4. Cross section of the Rossena Landslide. Keys: 1) ophiolites, 2) varicoloured shales, 3) idem, involved in the landslide, 4) idem, involved in the rock creep, 5) slope deposits, 6) slip surface, 7) organic layer of 10000 y b.p., 8) boreholes (B) and vertical electrical soundings (E). Letters at the top of the picture show the four morphological units in which the landslide can be divided.

From the top to the bottom of the slope different types of landslides were identified, with each one involving different parts of the slope (sectors A, B, C, D in Fig. 4).

The cliff of the Rossena castle (sector A) is crossed by many families of fractures, which cut the basaltic mass in different directions. They allowed the disjuncting of the mass in huge blocks that underwent differential movement in the eastern part of the cliff. During the 28 February event some blocks collapsed, with about 1 m of vertical offset (Fig. 5), just below the wall of the old building, while topplings involved the outer blocks (Fig. 6). Small rock falls and debris flows occurred respectively on the front of the cliff and in the covers that surrounds it, made of debris in a clayey matrix. A rotational-translational landslide involved the slope below the cliff, developing in the oldest part of the village. Several fractures, with offset between 1 and 2 m, widened in the ground and many small landslides occurred just after the main event, enlarging the crown and the flanks of the main landslide, and contributing to damaging the village.

The top of sector B is at about 390 m a.s.l., where there is a gentle concave area that is the morphological expression of the head of a rotational landslide. Different springs appear in this area: they likely mark the boundary between an upper layer made by material deriving from the wasting of the basaltic cliff, in which a water seepage can develop, and a lower one made up by a mainly clay-rich material, mainly

impermeable, deriving from the varicolored clay formation (both levels are involved in the landslide). The type of movement changes in the middle-lower part of the landslide, turning into a flow type and, on the whole, this part of the landslide may be classified as a complex phenomenon (rotational slide-flow).

Sector C is characterized by another concave surface where some other springs appear. On the right side of the surface, there is a very steep scarp where varicolored clay outcrops. Downslope, many series of fractures, some of them showing decimetric offset, appear in the ground, developing from the center of the slope towards northeast. On the basis of their distribution, the fractures seem to be the expression of an initial failure of this part of the slope rather than a well-defined landslide body.

An extended well-stratified and preserved outcrop of the varicolored clay formation is in correspondence of the foot of the slope (sector D). It seems to contrast the development of the landslide, playing the role of a buttress. Actually, the landslide divides into two tongues in correspondence of the change in acclivity: the first one, on the right of the outcrop, is affected by many fractures and secondary landslides, whilst the second one, on the opposite side of the varicolored clay outcrop, reaches the torrent at the foot of the slope. The features of this last part of the landslide allow to state that it is an earth-flow, but no evidence of recent movement was found. This fact proves that this specific part of the landslide was not involved in the event of 2004 and it is, at present, in a dormant state of activity. Moreover, some small landslides, mainly of complex (rotational slide-flow) type, and debris-flow affected the foot. They developed concomitantly

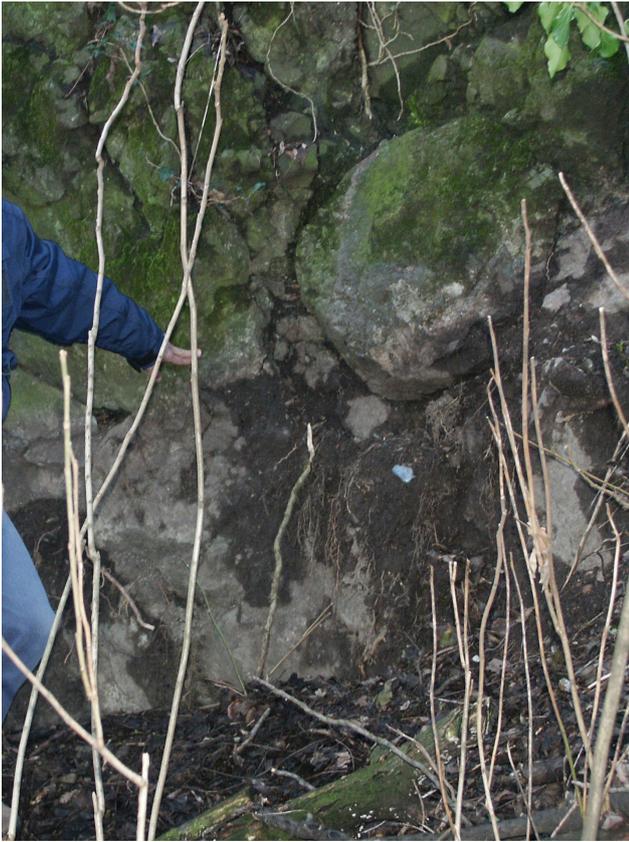
Fig. 5. Vertical offset between stable basaltic cliff and dismembered blocks.

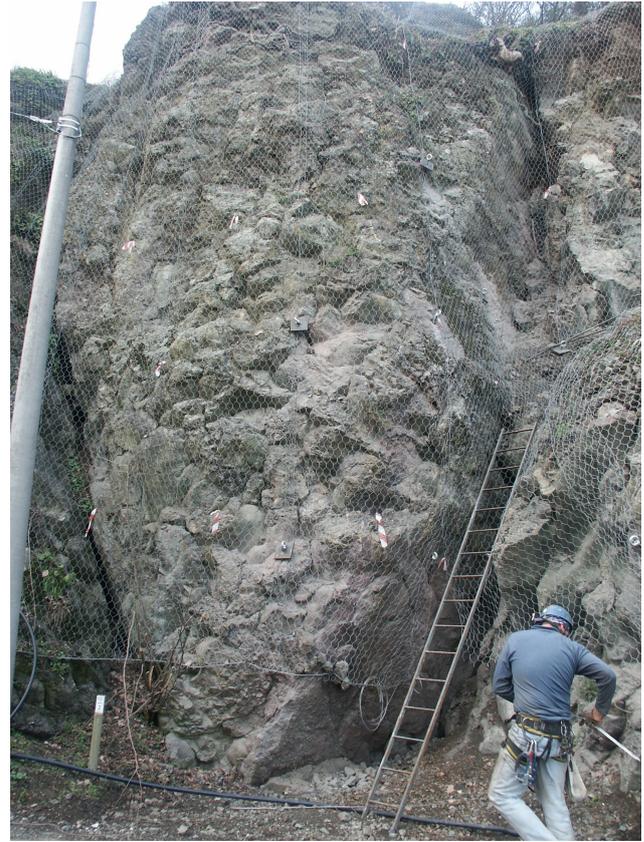
Fig. 6. Unstable basaltic block at the base of the cliff.

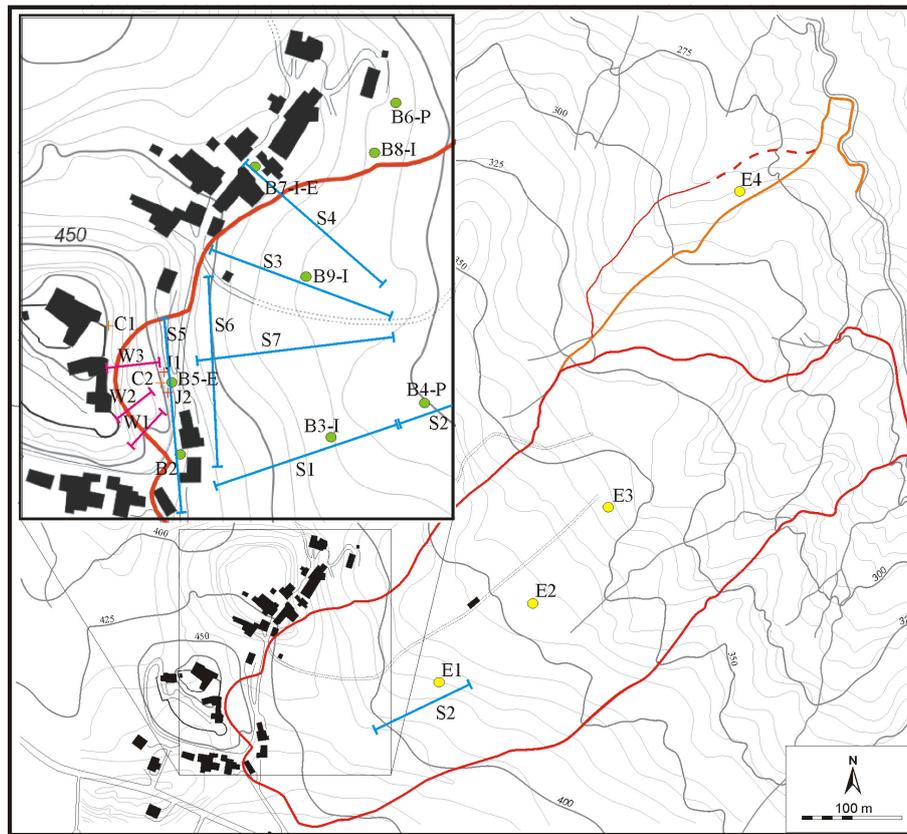
Fig. 7. Location of the subsurface observations, field instrumentations and monitoring system. Keys: B = boring (used as I = inclinometer, E = extensometer, P = piezometer), S = seismic survey, E = electrical survey, C = clinometer (tiltmeter), W = wire extensometer, J = jointmeter.

First, a simple system of monitoring (3 wire extensometers and 1 inclinometer) was built up immediately after the event in February 2004 (Fig. 7). It was progressively substituted, in the following months, by a more complex one in which tiltmeters (2), jointmeters (2), inclinometers (2), incremental extensometers (1 vertical and 1 horizontal) and piezometers (2) play an important role. Most of this equipment are fitted with data loggers, collecting many measurements per day.
