Site investigation and modelling at “La Maina” landslide (Carnian Alps, Italy)

G. Marcato¹, M. Mantovani¹, A. Pasuto², S. Silvano¹, F. Tagliavini², L. Zabuski³, and A. Zannoni¹

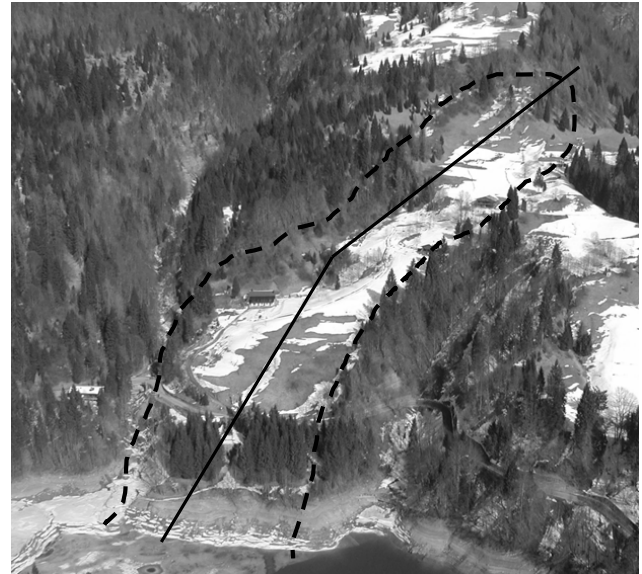
Fig. 2. The “La Maina” landslide. Modelling cross section is highlighted.

The “La Maina” landslide (Fig. 2) is located some kilometers uphill from the dam, bordered by Poch stream on the right hand side, just before the Sauris villages. The phenomenon involves both the Quaternary terrains and Werfen Formation which were mobilised after a period of high intensity rainfall occurred in October 2002. The landslide represents a risk for some houses located in the unstable area and on its foot as well as for the underlying provincial road (unique road from Sauris to Ampezzo) and for the lake whose basin might be involved if a collapse occurs.

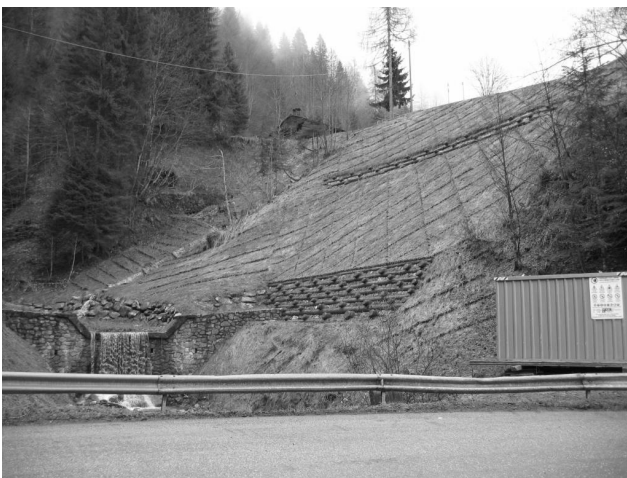
Fig. 8. Lower part of the “La Maina” landslide after the consolidation.

The high risk caused by “La Maina” landslide forced a type of investigation that could provide reliable results in short time. The monitoring system was important both to evaluate the hazard of the landslide and to collect data for the model. The survey and modelling allowed to recognize that at present there are two distinct landslide’s bodies. Since an increasing of the water table seems to be unreasonable with the data collected, a sudden failure of the slope is not expected. The good agreement between the model and the geological and morphological evidences outlined the proper mitigation measures. The urgent consolidation was focused on the lower part of the landslide where the elements at risk are located. Using naturalistic engineering the Corpo Forestale dello Stato has installed a system of superficial drainage and has consolidated the slope in order to avoid the erosion by the Poch stream (Fig. 8). For the upper body of the landslide a complex drainage system is planned for the future.
