The disastrous 17 February 2006 rockslide-debris avalanche on Leyte Island, Philippines: a catastrophic landslide in tropical mountain terrain

S. G. Evans, R. H. Guthrie, N. J. Roberts, and N. F. Bishop

Landslide Research Program, Department of Earth Sciences, University of Waterloo, Waterloo, Ontario, N2L 3G1, Canada

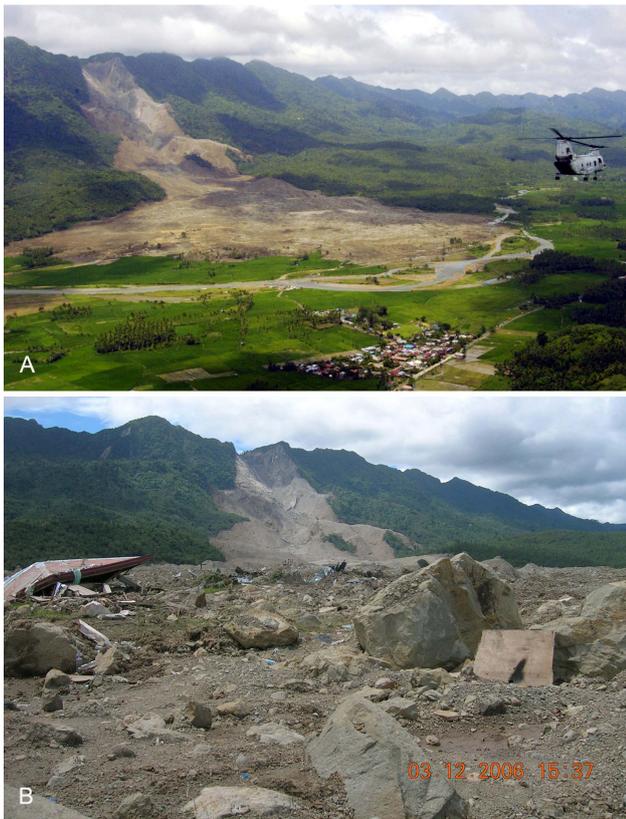
Fig. 1. (A) Oblique aerial view (to the northwest) of the Guinsaugon landslide taken on 19 February 2006. (U.S. Navy photograph by M. D. Kennedy). The Himbangao River flows from right to left. (B) View of debris toward the source area of the rockslide-debris avalanche (Photograph taken 12 March 2006).

The landslide (Figs. 1, 5) occurred between 10:30 a.m. and 10:45 a.m. on the morning of 17 February 2006. An eyewitness interviewed during field work said that the landslide started with a shaking of the ground, followed by the sound

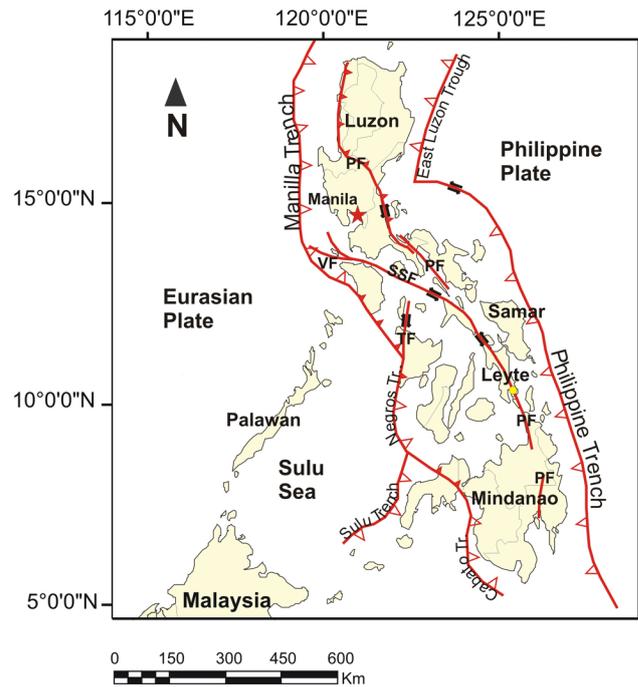
Fig. 2. Map of the Philippine archipelago showing plate tectonic setting, trace of the Philippine Fault (PF), other main active faults (the Sibuyan Sea Fault (SSF), the Verde Passage Fault (VF), Tablas Fault (TF)), and the location of Leyte Island (modified after Barrier et al., 1991).

Leyte Island is located in the central part of the Philippine islands (Fig. 2). The archipelago is located in one of the most active geologic settings on earth. Three major tectonic elements characterize this complex oblique convergence environment; the Philippine Sea Plate, the Eurasian Plate and the Philippine Fault (Fig. 2). The westward moving

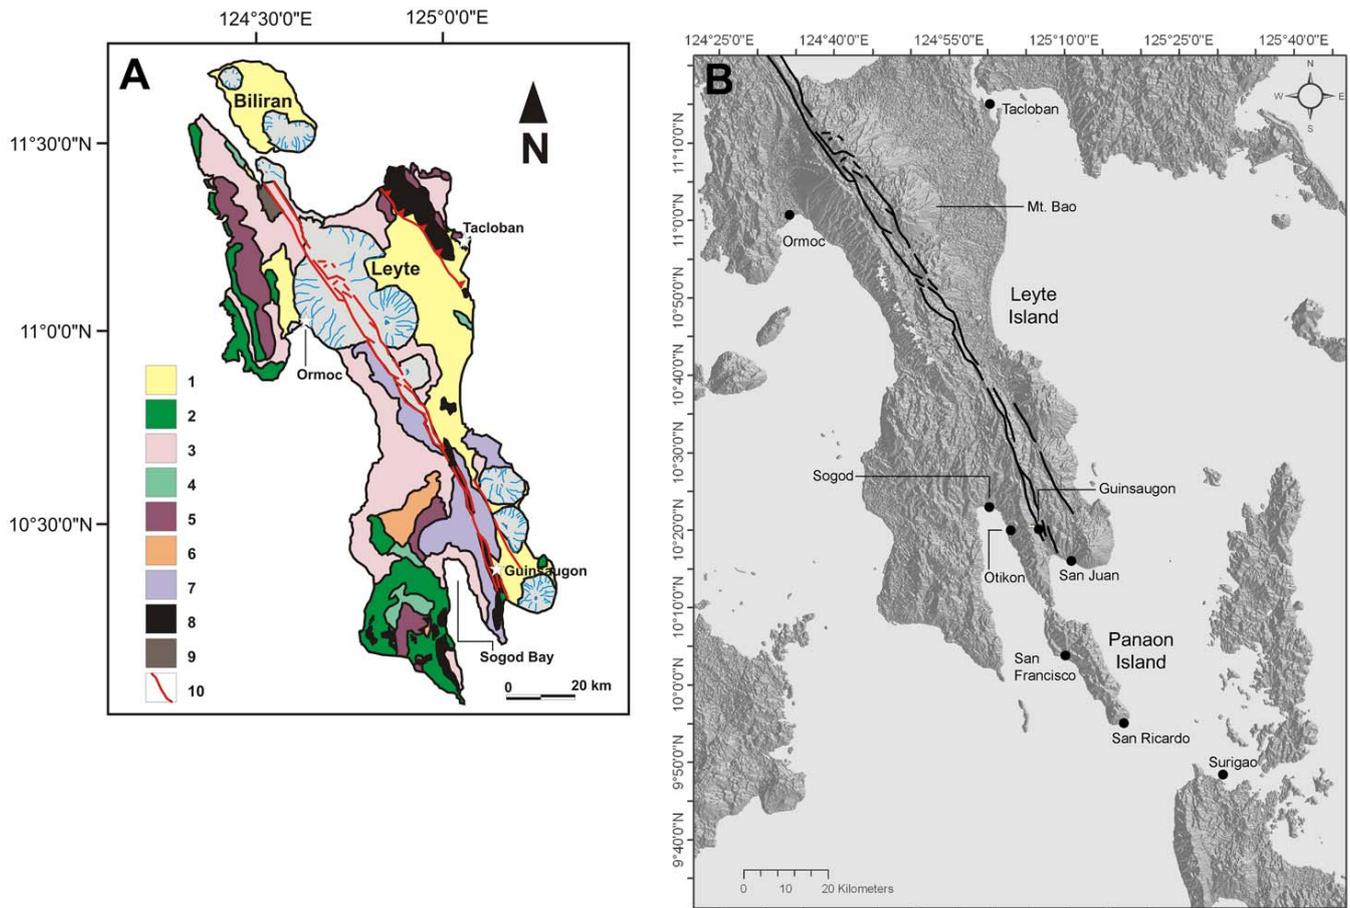
Fig. 3. (A) Geology of Leyte Island (modified from Aurelio, 1992). Key to geological units: 1 – alluvium; 2 – Pleistocene limestone; 3 – Late Miocene to Early Pliocene sediments; 4 – Middle Miocene Limestone; 5 – Late Oligocene to Early Miocene sediments; 6 – Eocene volcanics; 7 – undifferentiated volcanics; 8 – ophiolite; 9 – marshland; 10 – Trace of Philippine Fault that bisects Leyte Island. (B) Shaded relief map (based on SRTM data – for technical details see Appendix) of Leyte Island showing the location of 17 February Guinsaugon landslide and the trace of the Philippine Fault (thick black lines). Locations of communities mentioned in the text are also shown.

northeast and southwest sectors of the ancestral Mount Bao volcano in the northern part of Leyte Island by a distance of 8 km over a period of 450 000 years (Figs. 3a, b; Duquesnoy et al., 1994; Lagmay et al., 2000).

Creep movement along the fault in the Leyte area has been measured at about 2.5 cm/year (Aurelio et al., 1997; Barrier et al., 1991; Duquesnoy et al., 1994). In Leyte Island the creep is largely aseismic. An analysis of the shear partitioning along the fault suggests that oblique convergence is decomposed into a component perpendicular to the Philippine Trench and another parallel to the Trench and thus parallel to the Philippine Fault (Aurelio, 2000). GPS measurements in the central Philippines (Duquesnoy et al., 1994; Aurelio, 2000), suggest left-lateral displacement although an extensional component perpendicular to the strike of the fault was also detected which may represent non-brittle deformation of surface rocks, perhaps in response to slope movement. The topographic expression of the fault includes fault line scarps, side-hill ridges, pressure ridges parallel to the fault and associated narrow elongate depressions (Allen, 1962; Duquesnoy et al., 1994; Fig. 3b).

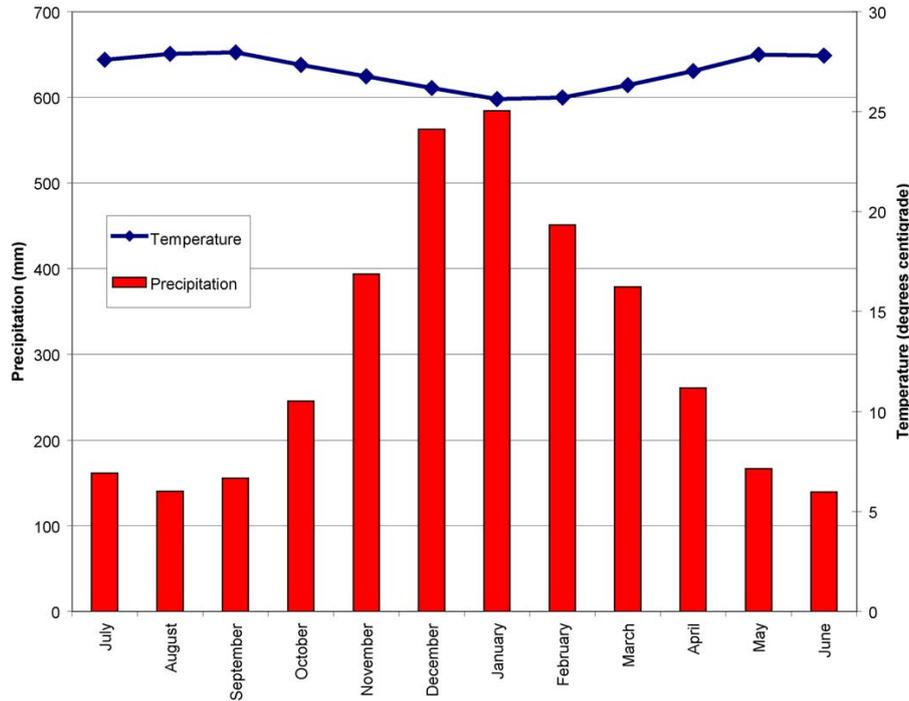
Fig. 4. Climatic data (mean monthly precipitation and mean monthly temperature) typical of Philippine Climate Zone Type II from Surigao, Mindanao (located on Fig. 3b). Data is summarized for the period 1902–2005 (Data obtained from Global Historical National Climate Network).

The climate of Leyte Island is characterized by high total annual rainfall, episodic very heavy rains associated with tropical cyclones and almost constant warm temperatures (Fig. 4). Southeastern Leyte is characterized by Type II climate under the Philippine Climate Classification (the Coronas Classification), i.e., no dry season and a very pronounced maximum rainfall from November to January (Fig. 4). Climate data for the period 1902–2005 were obtained for Surigao, located within the same Type 2 zone at the northern

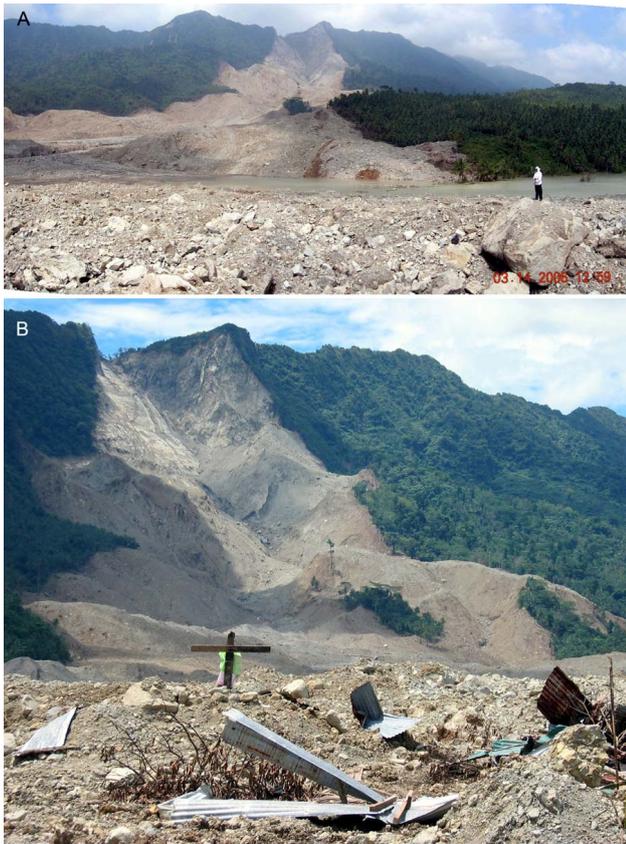
Fig. 5. (A) View to the west toward the source area from northern boundary of landslide of debris. (B) View from the surface of the debris toward the source area of the rockslide-debris avalanche. Characteristics of the source area are well illustrated. Particularly evident is the planar sliding surface that corresponds to a splay of the Philippine Fault. Note wreckage of buildings in foreground and the nature of the debris.

8) and it appears that a splay of the fault formed the steep sliding surface of the initial rock slope failure (Figs. 5b, 8).

The debris began to be deposited as it traveled over rolling hummocky topography below el. 300 m a.s.l. which, on the basis of roadcut exposures immediately adjacent to the landslide, is interpreted to represent the surface of a previous landslide deposit (cf. Fig. 1a). The thickest part of the deposit occurs between el. 200 and el. 50 m a.s.l. (Fig. 6b). In this part of the debris, which averages 10 m in thickness, the material appears to be predominantly block-supported in nature with matrix material being less dominant than in the distal part of the debris (Fig. 5a).

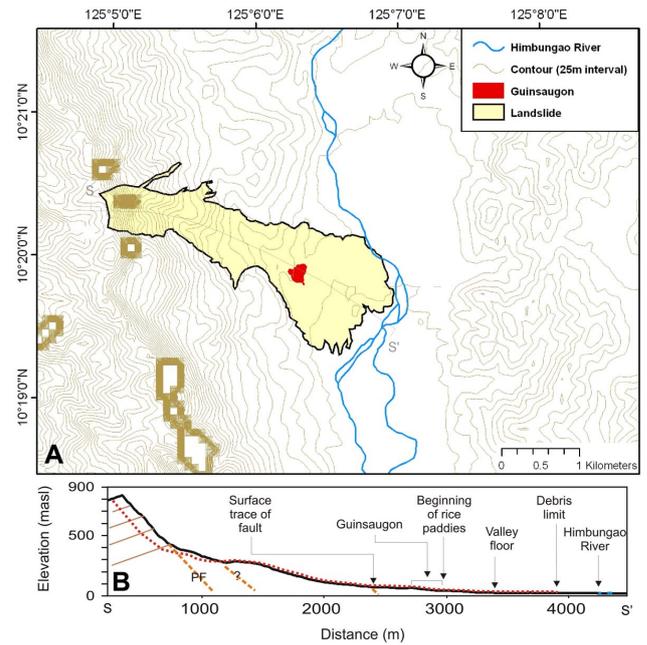
Fig. 6. (A) Map of area of Guinsaugon landslide based on SRTM data. Holes are apparent in the digital terrain data along the ridge line (see Appendix for discussion). Outline of the landslide is based on interpretation of ASTER image collected on 1 March 2006 and GPS-controlled field traverses in March 2006. (B) Profile of rockslide-debris avalanche based on SRTM data and field measurements in March 2006. Line of profile is marked in Fig. 6b (S-S').

The topographic map generated from SRTM data (see Appendix A) for this paper (Fig. 6) indicates that the rockslide-debris avalanche traveled a horizontal distance (L) of about 3.8 km (Figs. 6, 7) over a vertical height difference (H) of about 810 m (Fig. 6). This yields a *fahrböschung* of 12° , a value that is identical to the field measurement of 12° . Based on field estimates of debris depth and an analysis of digital terrain data (Fig. 6) the volume of the landslide debris is

In the Guinsaugon case, we analysed the travel path in Fig. 6b. The initial failure geometry was specified as indicated in Fig. 6b and we assumed the immediate disintegration of the initial failure mass. This assumption was based on the brecciated nature of the source rock mass in the damage zone of the Philippine Fault and the field evidence of flowage high up in the source area as mentioned above (Fig. 6a). This assumption enabled the simulation to be carried out with a single rheology from initiation to el. 72 m a.s.l. where the debris encountered flooded paddy fields. At this point the rheology determining basal resistance was changed to simulate the undrained loading of the paddy field mud by the debris sheet.

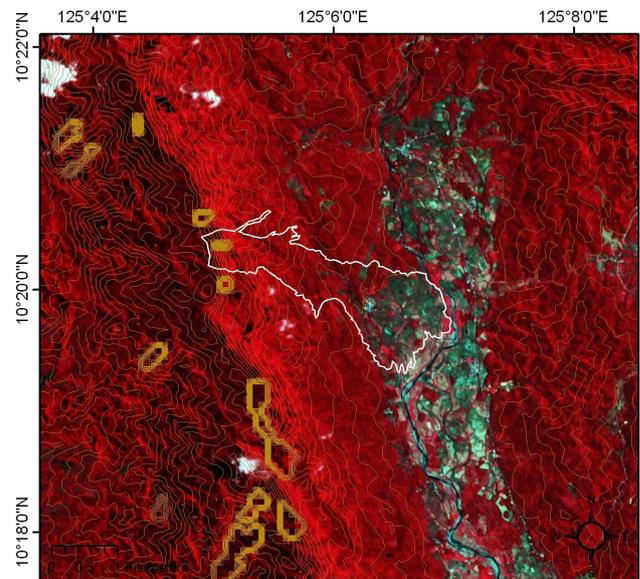
Fig. 7. Satellite image of the landslide site (SPOT image, June 2003) with outline of the rockslide-debris avalanche (from Fig. 6a) showing pre-event conditions on the source slope and in the Himbangao river valley.

As noted above the initial failure involved a steep (48°) forested rock slope that forms the east facing slope of a NNW-SSE trending ridge (Figs. 7, 8). Satellite imagery and helicopter observations indicate that this sharp-crested ridge has undergone notable slope displacements (Figs. 7, 8). This is manifested in slipped masses and tension cracks along the crest of the ridge (Fig. 8). The source of the rockslide-debris avalanche is located within the damage zone (Kim et al., 2004) of the Philippine Fault; the site of the landslide is traversed by the main trace of the Philippine Fault (Figs. 6, 7,

Pre-disaster imagery (Fig. 7) was a SPOT scene provided by the European Space Agency. The high resolution (10 m multispectral, 5 m panchromatic) orthorectified SPOT 5 image (030601_00148057004) was imaged on 1 June 2003. Visual analysis of pan-sharpened colour infrared composites provided best interpretation results.

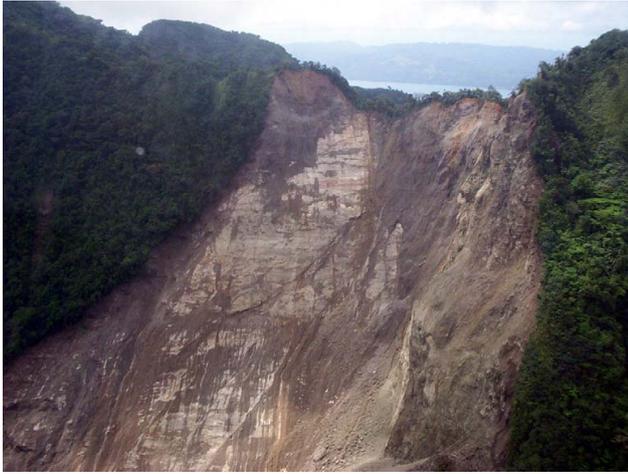
Fig. 8. Aerial view of the sliding surface showing horizontal striations consistent with strike-slip fault movement. Note also rock mass characteristics on the right of the source area resulting from movement of Philippine Fault (Photograph courtesy of Mines and Geosciences Bureau, Government of the Philippines).

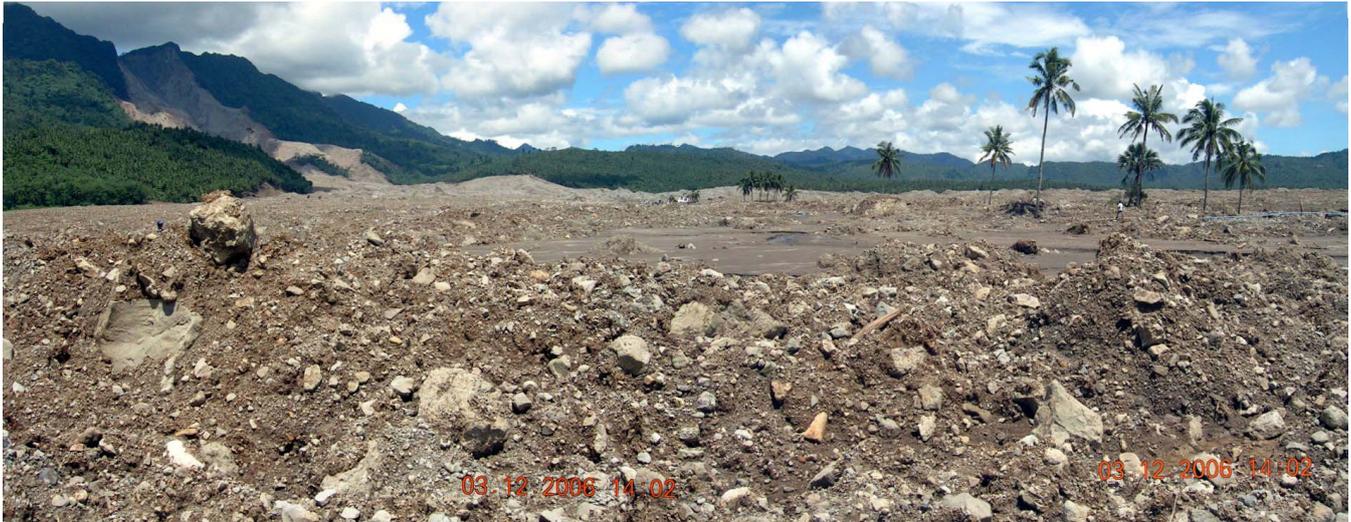
Fig. 9. View from near the distal limit of the debris toward the source area. Note matrix supported nature of the debris at this distal location and flat surface, corresponding to rice paddy fields, over which the debris ran in the distal part of its path. Debris thickness here is about 2 m.

Debris deposited on the valley floor is dominated by finer grain sizes which forms a matrix-supported deposit (Figs. 9, 10), despite the fact that large boulders are present (Fig. 11a). This may reflect the entrainment of finer-grained colluvium by the leading edge of the rockslide-debris avalanche from the base of the source slope and/or the mixing of the rockslide-debris avalanche debris with the saturated sediments from paddy fields on the valley floor. The distal limit of the debris consists of series of irregular lobes on the flat valley floor, (Figs. 10a, b) which are rimmed by a zone of dark mud. This represents the fine muds ejected from beneath the moving debris sheet during the final part of its travel over the paddy fields. In some places we noted that trees and buildings were destroyed by the ejected mud beyond the limit of the coarser debris (Fig. 11b).

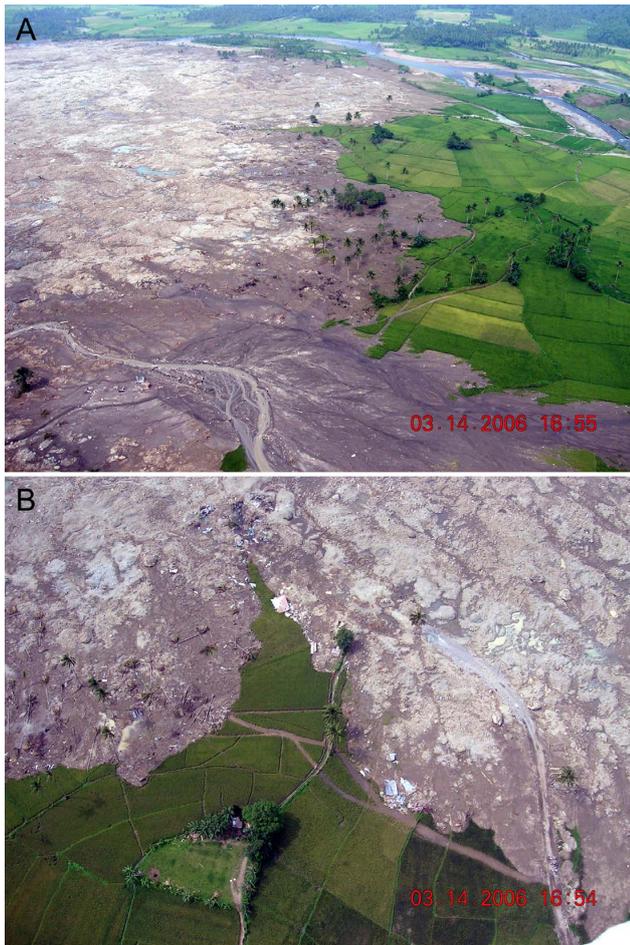
Fig. 10. Aerial views of distal limit of debris. (A) View east along southern edge of debris showing muddy lobes extending out from main debris deposit onto the paddy fields on the valley floor. (B) Close-up view of distal limit of debris and wreckage of buildings. Note paddy fields. (Photograph taken on 14 March 2006).

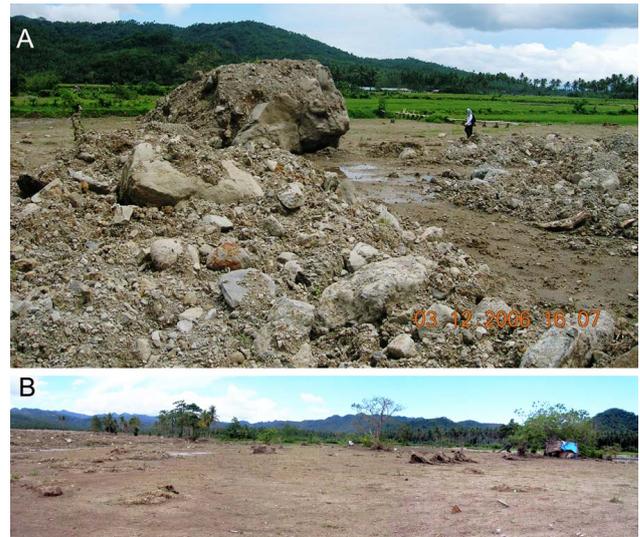
Fig. 11. Distal limit of rockslide-debris avalanche. (A) characteristics of debris, including large boulder (B): damage to trees and houses by fine mud ejected from base of debris sheet, the limit of which is seen at left.

The debris contains large boulders up to 5 m in diameter, transported in some cases to the distal limit of the debris (Figs. 1b, 11a). As noted above, a significant part of the debris is made up of a fine-grained matrix including significant amounts of silty sand, sandy silt, and low plasticity clay (Liquid Limit = 48 and Plasticity Index = 22), reflecting the composition of the sheared source rock mass and the colluvium entrained from the base of the rock slope.

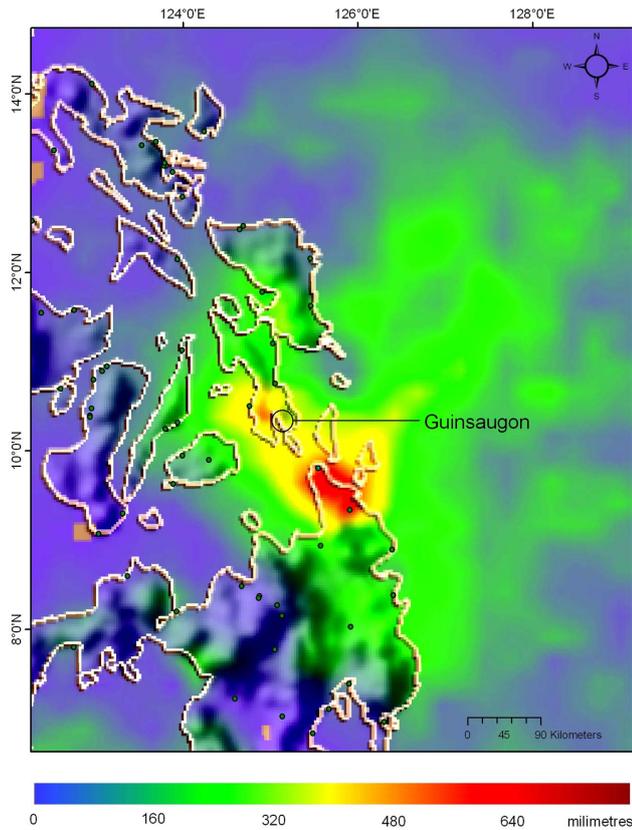
Fig. 12. Tropical Rainfall Measuring Mission (TRMM) data showing accumulation of rainfall between 4 February and 17 February 2006 in the Central Philippines. (Image based on data supplied by NASA). Rainfall in Southern Leyte during this time is seen to exceed 500 mm.

No direct trigger exists for the Guinsaugon landslide. The rockslide-debris avalanche was preceded, however, by excessive rainfall during the period 8–12 February 2006 (Fig. 12). Rainfall was measured at Otikon, Libagon, on the western (lee) side of the mountain ridge (for location see Fig. 3b) affected by the landslide. At this station, in the 5 day period

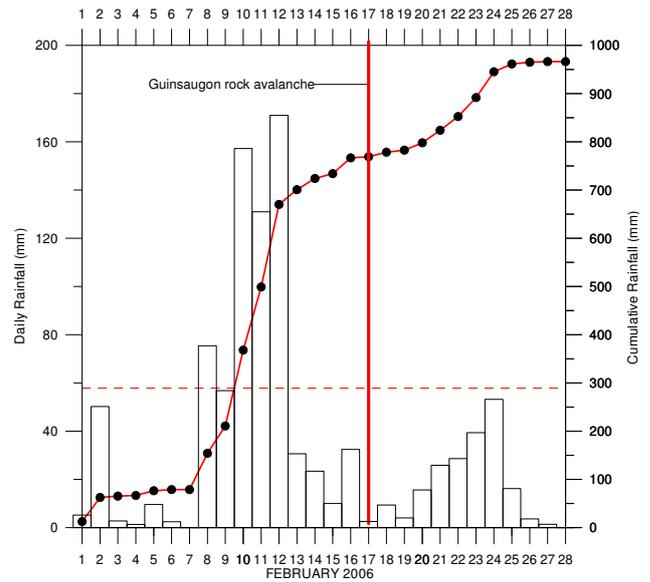
Fig. 13. Daily rainfall and cumulative rainfall measured at Otikon, Liagon (for location see Fig. 3b) for the period 1–28 February 2006. Horizontal dashed line is monthly mean rainfall. Data courtesy of Philippine Atmospheric, Geophysical, and Astronomical Services Administration.

between 8 February and 12 February 2006 cumulative rainfall reached 571.2 mm, with an average of 114 mm per day (Fig. 13). This exceeds the monthly average rainfall measured both at Libagon (by a factor of two) and Surigao (by a factor of 1.2). There was, therefore, a lag time of four days between the end of the 5 day period of heavy rainfall and the occurrence of the landslide of 17 February. No analysis of the frequency of the February rainfall magnitude has been carried out but rainfalls of this magnitude and intensity are not uncommon in the Philippines, especially those related to tropical storms (typhoons) (Hart et al., 2002).

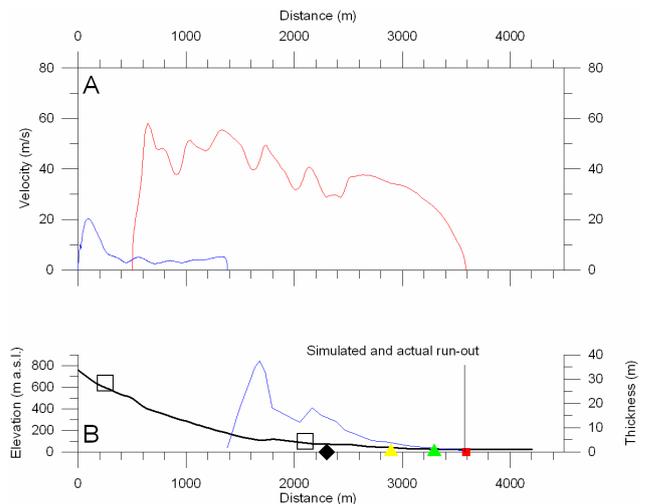
Fig. 14. Results of dynamic analysis using DAN simulation model. (A) Plot of velocity along the path showing the velocity of the front (red) and rear (blue) of the moving mass. (B) Profile is shown in black. Squares are the centres of gravity of the initial slide mass (pre-event) and of the deposit (post-event). Thickness of deposit is shown in blue. Simulated run-out distances without presence of paddy field (yellow triangle) and without entrainment (green triangle) are also shown. The location of the beginning of the paddy fields is shown with a black diamond corresponding to the point where the basal resistance of the moving mass is changed from a Voellmy rheology ($f=0.12$; $\xi=400 \text{ m/s}^2$) to a frictional one ($\phi=30^\circ$) with pore pressure ($r_u=0.8$) (for discussion see text).

The results of the DAN simulation are seen in Fig. 14. The run-out is precisely duplicated with Voellmy parameters of $f=0.12$, and $\xi=400\text{ m/s}^2$ and with a value of r_u of 0.8 for the materials in the paddy field section of the path. The maximum frontal velocity (58 m/s) occurred at a path distance of 942 m (Fig. 14). The duration of the movement is esti-

mated at 102 s for a mean velocity of 35 m/s. This compares with estimates of velocity estimates in the range 27–38 m/s noted by Lagmay et al. (2006) based on eyewitness accounts. Further, the length of the deposit, the location of maximum thickness, and the distal thinning of the debris are simulated quite well, the pattern of deposition corresponding generally to that observed in the field (Fig. 14). It is noted, however, that the maximum debris thickness obtained in the simulation is 37 m at a path distance of 1670 m (Fig. 14b). This is in considerable excess of the field estimate. The DAN simulation clearly overestimates the deposit thickness at the beginning of deposition in the path, possibly a model response to the effect of irregularities in the surface profile (Fig. 6b). However, further downslope, the depth of burial of Guinsaigon is estimated to be 4–7 m, which corresponds to field estimates. It is also noted that the simulation indicates that the centre of gravity of the deposit is quite high up in the path (Fig. 14b), reflecting the spreading and thinning of the distal part of the debris as it encountered the flooded paddy fields.

gave a runout distance 291 m less than the observed case (Fig. 14b), a reduction of 8%. A second DAN simulation, using a Voellmy rheology for the entire path (i.e., without the presence of the flooded paddy field), but including entrainment as specified above, indicated a run-out 692 m shorter than the real case, a run-out reduction of about 20% (Fig. 14b). We suggest that these simulation results demonstrate the importance of the flooded rice paddy fields as a major contributor to the enhanced run-out of the Guinsaugon rockslide-debris avalanche.

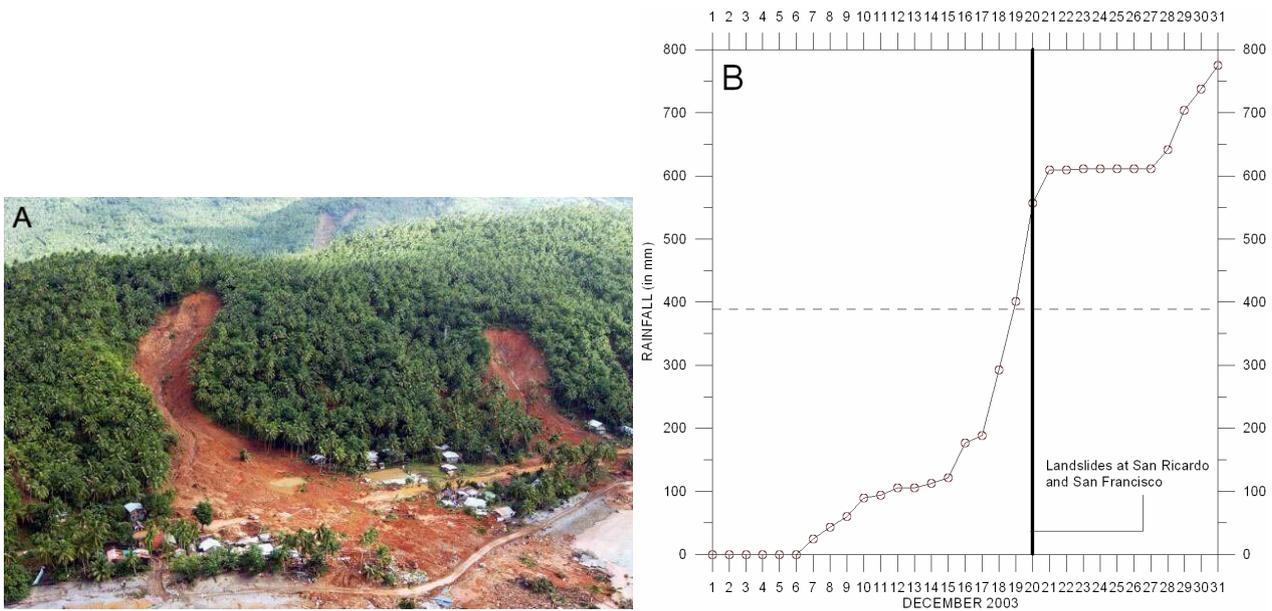
Fig. 15. (A) Rainfall-triggered debris avalanche in residual soils that destroyed the village of Pinut-an, Township of San Ricardo, Panoan Island, Southern Leyte Province (For location see Fig. 3b) on 23 December 2003. 209 people lost their lives in the landslide (Photograph courtesy of PCPO/PNS). (B) Cumulative rainfall for December 2003 landslide disaster in Southern Leyte Province. Rainfall measured at Otikon, Liagon (for location see Fig. 3b). Horizontal dashed line is monthly mean rainfall. Data courtesy of Philippine Atmospheric, Geophysical, and Astronomical Services Administration).
