Inundation mapping – a study based on December 2004 Tsunami Hazard along Chennai coast, Southeast India

Abstract. Tsunami impact study has been undertaken along Chennai coast starting from Pulicat to Kovalam. The study area Chennai coast is mainly devoted to prepare large scale action plan maps on tsunami inundation incorporating land use details derived from satellite data along with cadastral data using a GIS tool. Under tsunami inundation mapping along Chennai coast an integrated approach was adopted to prepare thematic maps on land use/land cover and coastal geomorphology using multispectral remote sensing data. The RTK dGPS instruments are used to collect elevation contour data at 0.5 m intervals for the Chennai coast. The GIS tool has been used to incorporate the elevation data, tsunami inundation markings obtained immediately after tsunami and thematic maps derived from remote sensing data. The outcome of this study provides an important clue on variations in tsunami inundation along Chennai coast, which is mainly controlled by local geomorphologic set-up, coastal zone elevation including coastal erosion protection measures and near shore bathymetry. This study highlights t

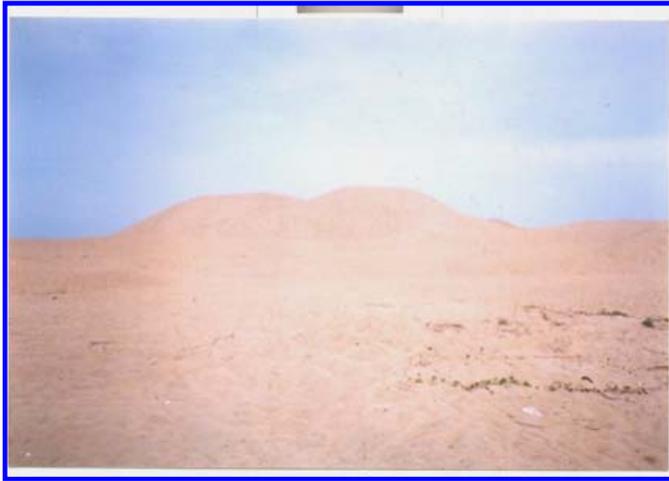
Fig. 7. Natural coastal protection measures (sand dune) present in north Chennai area.

The North Chennai coastal zone was found to be slightly protected due to the presence of shoreline erosion protection measures (Figs. 7 and 8). Some coastal stretches are experiencing acceleration of erosion due to the violent action of the ocean waves, which breaks well within the landmass in the coastal area and carry away the sand mass resulting in severe erosion. Heavy damages are caused to the coastal environment and livelihood due this erosion (Sundar and Sundaravadivelu, 2005). Several options for the protection of the coast were discussed and finally a groin has been suggested by them for the north Chennai coast. The groin structure is serving not only as coastal protection measures for the coast but also act as mini fishing harbors.

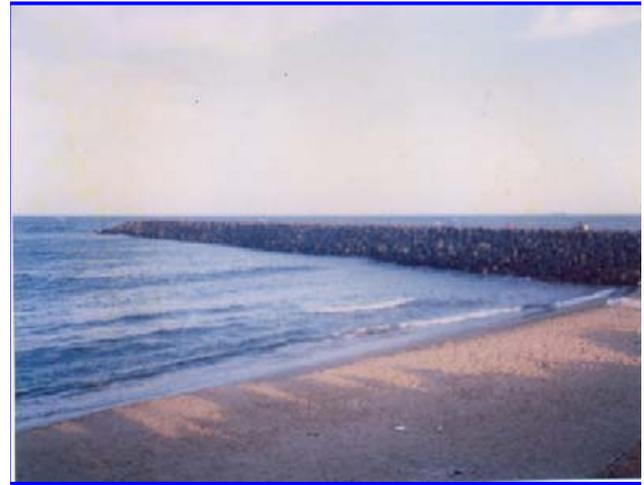
Fig. 8. Man made coastal protection measures gryans prevented tsunami inundation in north Chennai area.
