Intercomparison and validation of building damage assessments based on post-Haiti 2010 earthquake imagery using multi-source reference data

G. Lemoine¹, C. Corbane^{1,2}, C. Louvrier¹, and M. Kauffmann¹

¹European Commission, Joint Research Centre Via E. Fermi 2749, 21027 Ispra (VA), Italy

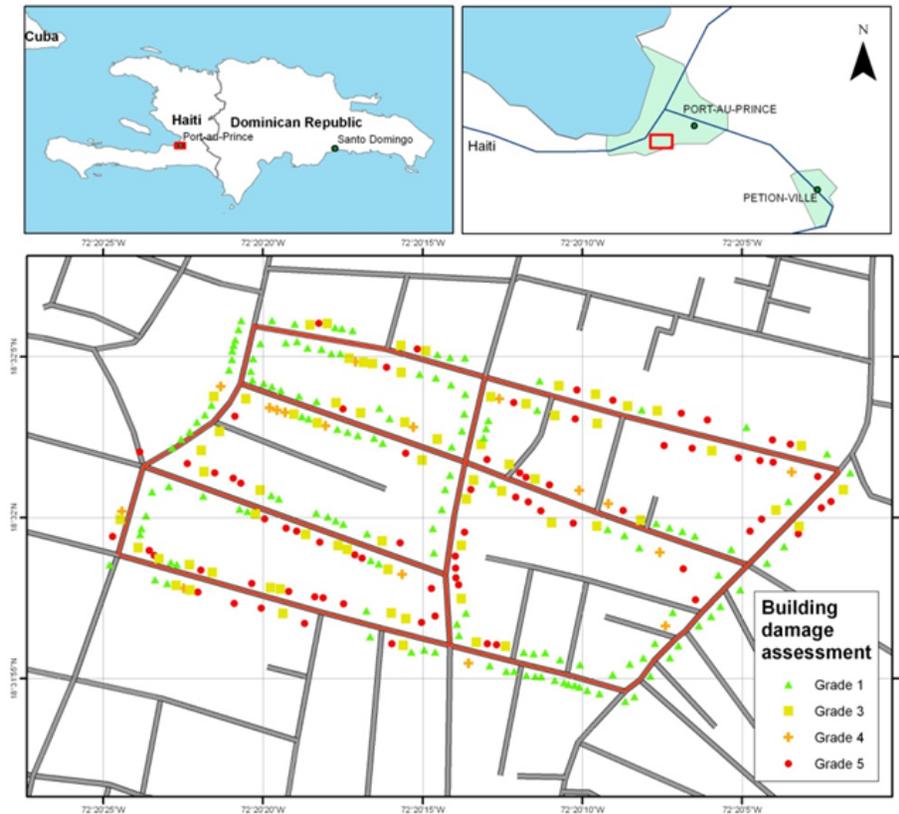
Fig. 1. Car survey ground track (red lines) and building damage assessment (based on high resolution aerial imagery) considered for the validation test (Ajmar et al., 2011).

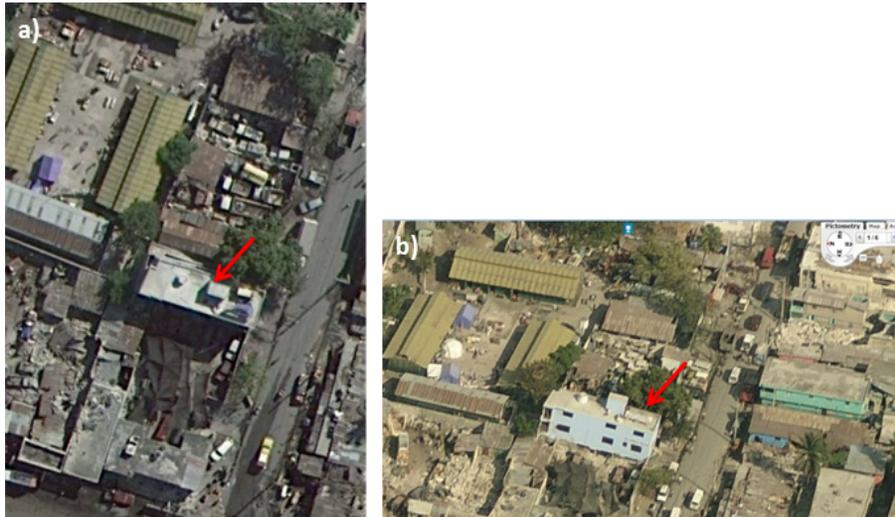
Fig. 2. Example of a building suffering from a soft storey failure observed on the aerial imagery **(a)** and on the oblique Pictometry image **(b)**. The lateral view provided by Pictometry data allows a better detection of this type of damage.

directly on to the first or bottom story. They are common when the upper stories are constructed to be much stiffer than a more open or softer bottom story. In the nadir images, these types of failures are difficult to identify (Fig. 2a) without the use of oblique imagery or ground survey data (Fig. 2b). In addition, more minor or moderate damage to buildings that does not result in building collapse are also difficult to identify in the nadir images. Accordingly, the damage levels used for marking the individual buildings on the aerial photographs were limited to the higher grades of the EMS-98 scale, e.g. substantial to heavy damage (EMS grade 3), very heavy damage (EMS grade 4), and destruction (EMS grade 5). All building centroids were marked including those that did not exhibit visible damage (EMS grade 0, 1 and 2). The overall point data set consists of more than 300 000 labeled points.

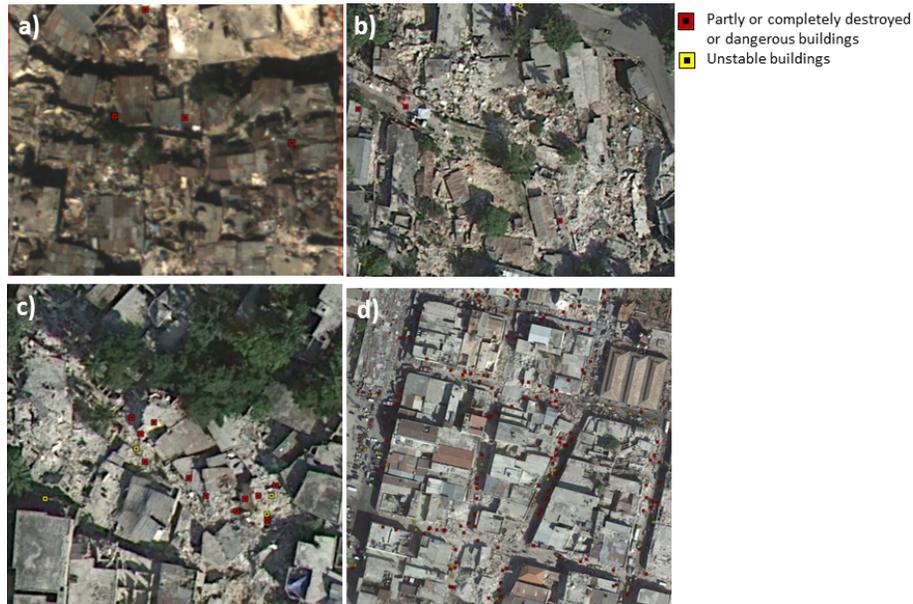
Fig. 3. Examples illustrating the quality problems identified in the extensive field survey. Red squares correspond to partly or completely destroyed or dangerous buildings; yellow squares correspond to unstable buildings. **(a and b)** Overlooked heavily damaged houses; **(c)** Inconsistency in the labeling within the same area, with several labels assigned to the same building close to unlabeled buildings; **(d)** Buildings surveyed from the road. Each image fragment corresponds to an area of approximately 200 by 200 m (projection: UTM 18 North (WGS84)).

This inventory has however some quality problems that must be taken into account when using this dataset as a reference for validation purposes. Some typical examples of quality issues were encountered in the informal neighbourhoods where the inventory seems to have overlooked heavily damaged houses (Fig. 3a and b). Among the reasons for the underestimation of the damage we could possibly cite, the presence of rubble that prevented access to field visits. On some other occasions, several labels were assigned to the same building while neighboring buildings were not assessed (Fig. 3c). Apparently some visits were only conducted from the outside or from the road (Fig. 3d).

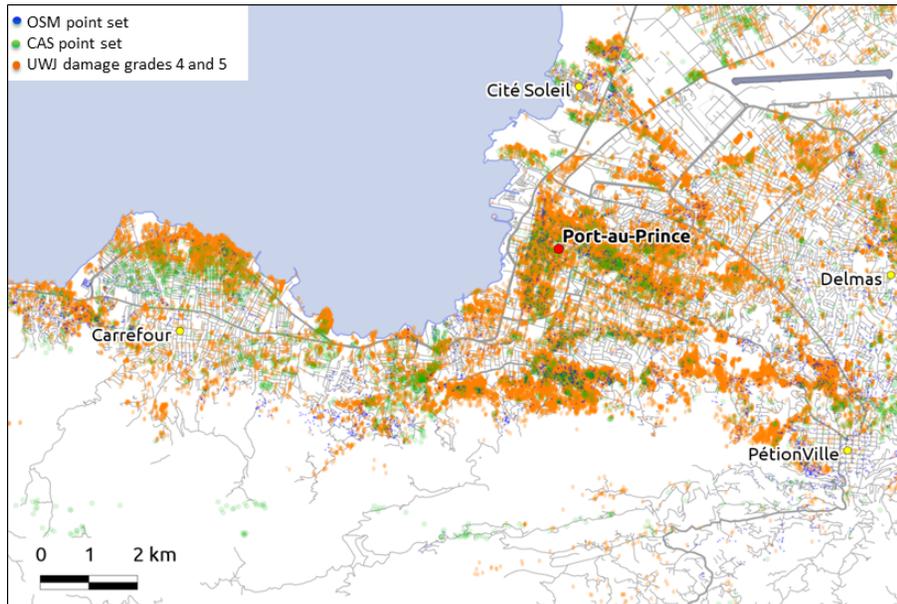
Fig. 5. Spatial distribution of the two satellite derived damage assessments (OSM and CAS point sets represented with blue and green dots respectively) and the aerial derived damage assessment (UWJ -damage grades 4 and 5 represented with orange dots) (© OpenStreetMap contributors, CC-BY-SA).

The purpose of the intercomparison is to provide an objective measure of the quality of the satellite based damage assessments and to develop an understanding of the validity and comparability of the satellite (OSM and CAS datasets) and aerial (UWJ) derived damages to buildings. Given that the three datasets have different coverage, it was decided to focus the analysis on a subset comprising all the three assessments and covering an area of approximately 25 × 15 km, which is enclosing the area depicted in Fig. 5.

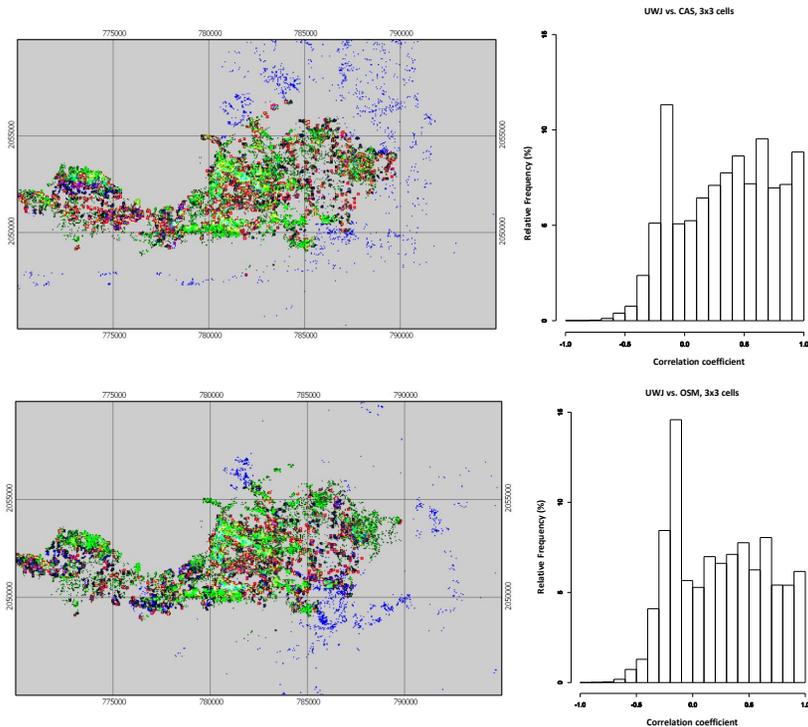
Fig. 6. Graphical representation of the correlation results. The images (projected to UTM 18 (WGS84) North) on the left overlay the local 3×3 normalised correlation coefficient (in red) with the UWJ density (in green) and (top) CAS density and (bottom) OSM density (in blue), respectively. Highly correlated grid counts show up as red (if isolated), white and yellow colours. Green colours show areas where UWJ damage points are not matched with either CAS or OSM damage points. Blue colours show the opposite. The histograms on the right show the distribution of the correlation coefficients for both set comparisons.

A graphical impression of the overall correlation is shown in Fig. 6. The images on the left provide a simple tool to inspect pattern matching directly. They are colour composites, in which the correlation coefficient is combined with the grid densities for the two sets that we compare, in the red, green and blue colour planes, respectively. Where green colours dominate, the UWJ damage densities are not matched with corresponding pattern in either the CAS or OSM data sets. Similarly, blue colours show

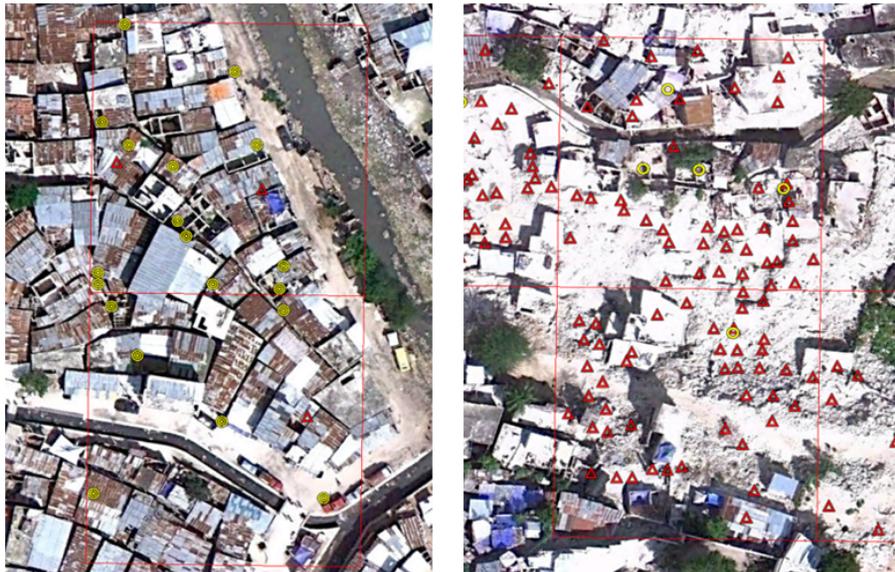
● UNOPS surveyed points (partly or completely destroyed or dangerous buildings)

▲ UWJ damage points (damage grades 4 and 5)

Fig. 7. Examples of (left) overestimation of MTPTC surveyed points (yellow circles) versus UWJ damage points (red triangles) for the highly damaged and destroyed categories and (right) underestimation. The background image is © Google Earth, 2010.

Two examples are given in Fig. 7. On the left side of the figure, the example shows an overestimation of MTPTC surveyed points, with damage categories 60–100 % and 100 % with respect to UWJ damage points for categories 4 and 5. The main reason for this deviation is, apparently, that the damage artefacts registered in the MTPTC survey are likely to be related to internal damage, which is not shown in the aerial view, as little external signs of damage are visible. In the right figure, the opposite effect is shown. This is an area with extensive total destruction, visible as wide swaths of rubble. The MTPTC survey is aimed at an inventory of remaining structures, and has obviously not counted pre-existing structures that no longer exist.

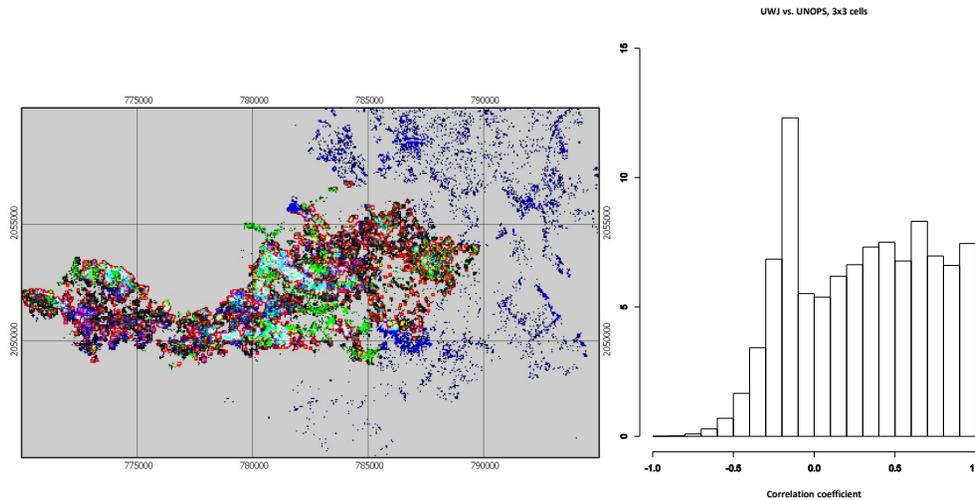
Fig. 8. Graphical representation of the correlation results between the UWJ and MTPTC sets. For an explanation, see Fig. 6.

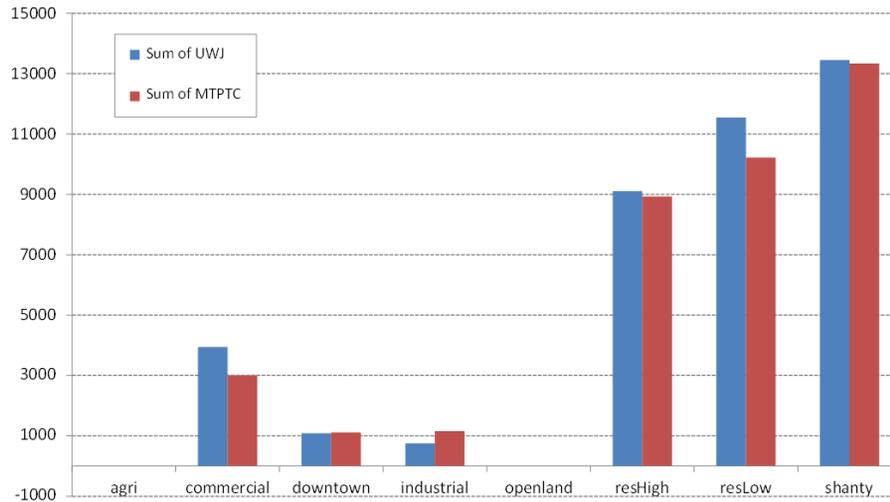
Fig. 9. Overall number of heavily affected and damaged buildings per category of land use for both datasets considering all the 50×50 m cells under analysis (30 922 in total).

Figure 9 shows the overall number of heavily affected and damaged buildings per category of land use for both datasets considering all the 50×50 m cells under analysis (30 922 in total). From this graph, it can be seen that despite the high level of disagreement detected in the previous table for shanty zones, especially for the cases of underestimation (2090 cells), in terms of absolute values, the number of heavily affected and damaged buildings in the aerial point set is slightly higher than that obtained from the field survey (13 449 against 13 334). Besides, in almost all major land use categories, except in the industrial areas, the assessment from aerial imagery detects more damaged building than the field inventory. In the downtown, there is an agreement in the absolute number of damaged buildings between the two datasets ($\Sigma\text{Count}_{\text{MTPTC}} = 1112$ and $\Sigma\text{Count}_{\text{UWJ}} = 1082$).
