Public participation in recovery after earthquakes in Friuli (NE Italy) and the Upper Soča Valley (NW Slovenia) in 1976, 1998, and 2004

P. Pipan and M. Zorn

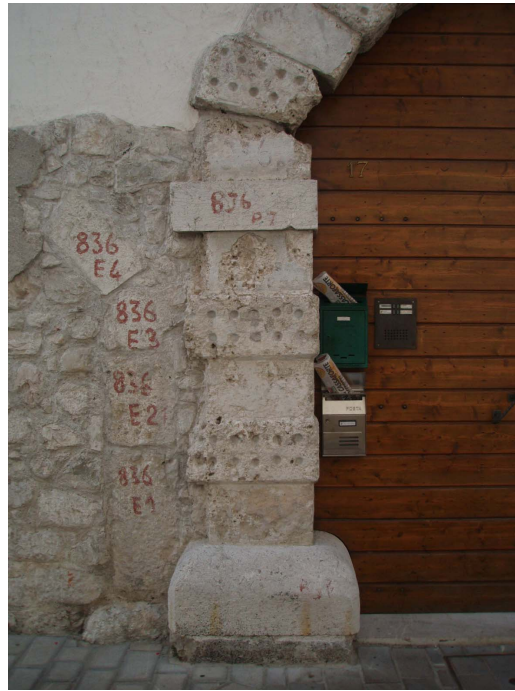
Fig. 3. Markings based on which parts of the buildings were reconstructed after the two earthquakes are still visible on many buildings in the old town of Venzone (photo: Primož Pipan).

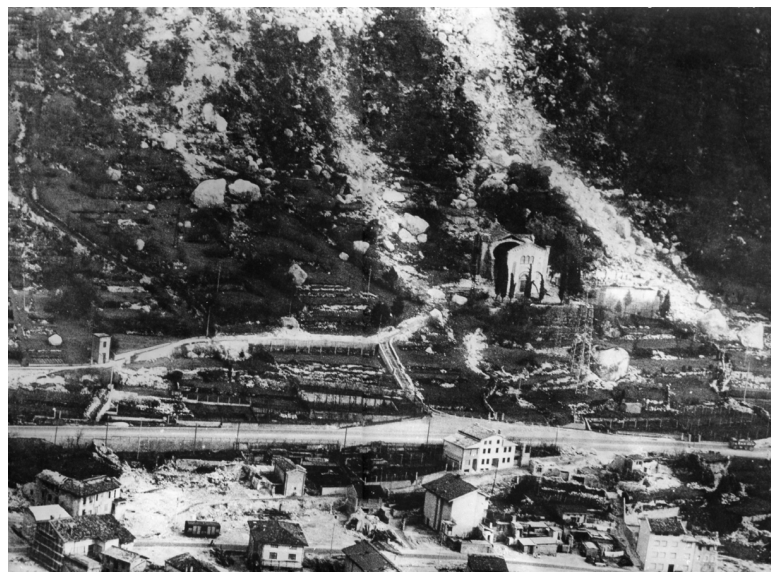
Fig. 4. Portis after the September 1976 earthquake. Rockfalls, which were the main reason for relocating the settlement, can be seen in the background (Archive of Ezio Gollino).

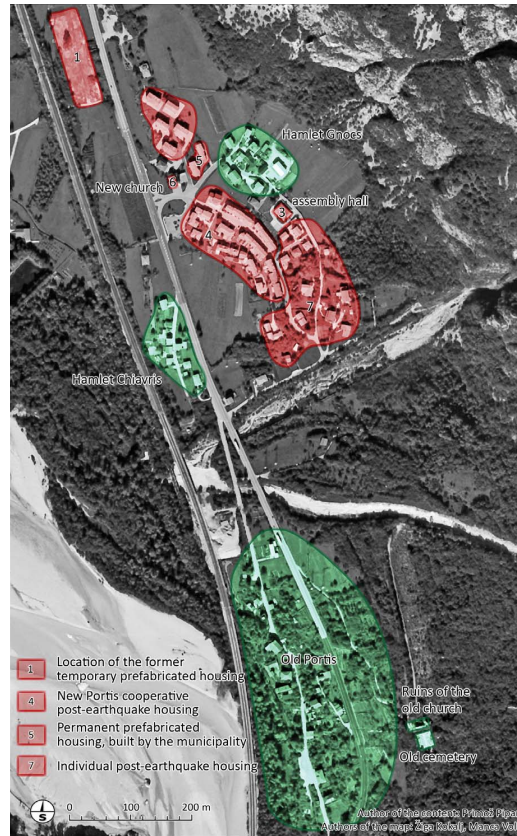
Fig. 5. Relocation of Portis following the 1976 earthquakes.

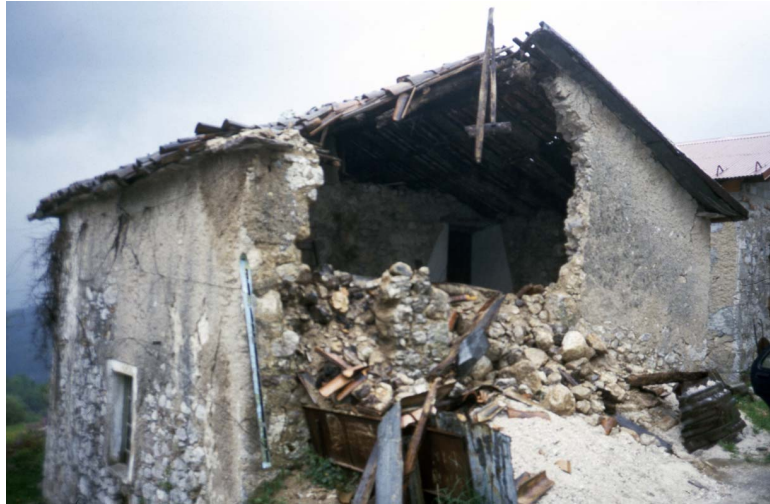
Fig. 7. Damage to buildings in Drežniške Ravne after the 1998 earthquake (photo: Matija Zorn).

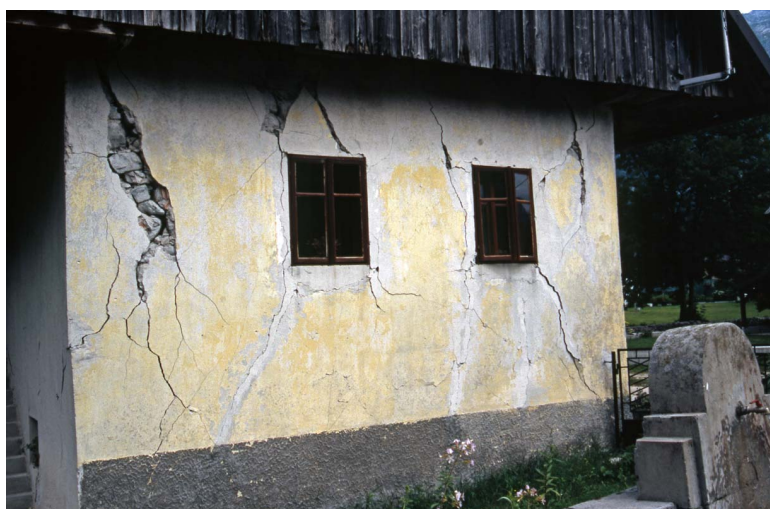
Fig. 8. Damage to buildings in Čezsoča after the 2004 earthquake (photo: Matija Zorn).

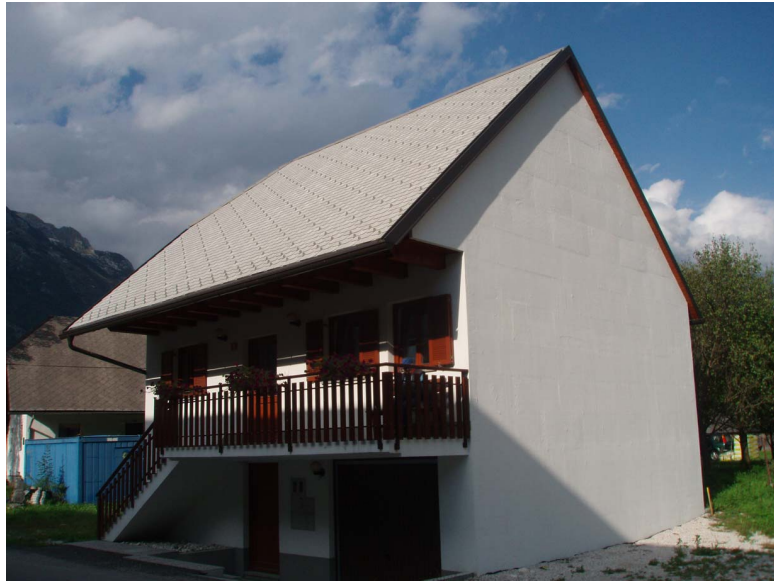
Fig. 9. New house build in Čezsoča after the 2004 earthquake (photo: Primož Pipan).
