Landslides and slope stability evaluation in the historical town of Kruja, Albania

Y. Muceku and O. Korini

Faculty of Civil Engineering and Architecture, Epoka University, Tirana, Albania

Received: 15 February 2013 – Accepted: 23 June 2013 – Published: 13 July 2013

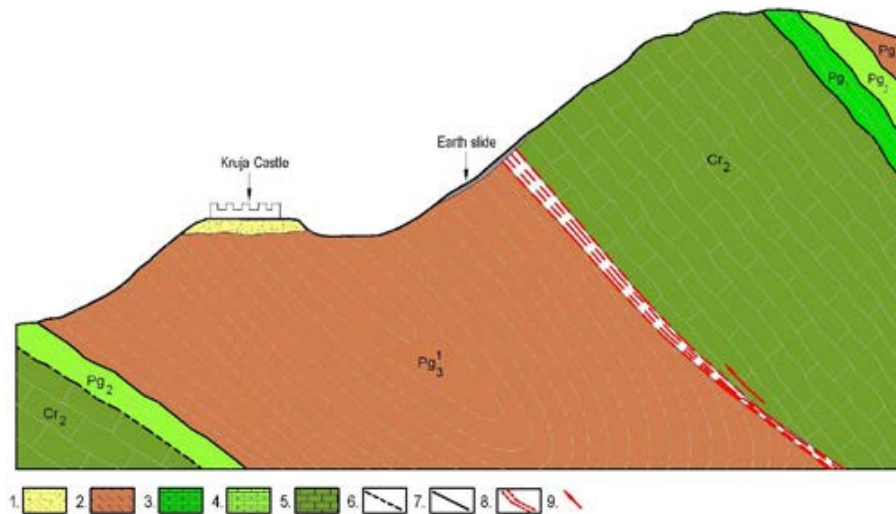
Fig. 2. Geological profile of Kruja region (Xhomo et al., 2002; Muceku, 2008). (1) breccia's rocks, (2) flysch rocks, (3) limestone rocks of Paleocene (Pg₁), (4) limestone rocks of Eocene (Pg₂), (5) limestone rocks of Upper Cretaceous (Cr₂), (6) stratigraphic break's boundary, (7) normal boundary, (8) overthrust tectonics, (9) mass movement direction.

The upper part of the landslide body-crown is situated directly on the tectonic fractured zone (Figs. 2 and 7), which is one of the main factors favoring this phenomenon (Muceku, 2008, 2009), whereas the medium and lower part of the slide plane is situated on weathering crust of flysch rocks, which is 1.4–2.2 m thick (Figs. 3, 4 and 5). The slide's body consists of silts and clays with fine sands. The other (smaller) earth slide is 220.0 m long, 120.0 wide and 2.8–5.5 m thick (Fig. 7). On this slide a traffic road and green park are built, which are often damaged from its moving. Several geo-factors favor this mass movement. They are the soft rocks-flysch (interbed of the siltstone's, claystones and sandstone's layers), which are intensively disturbed by tectonic activity, as well as rainfall and underground waters. The tectonics zone works as a collector of the karstic water of limestone's rocks of Skanderbeg Mountain. These waters flow out in the form of spring water at the point of contact of soil and flysch rocks on landslide's crown, influencing the lowering of geotechnical properties of the soils and rocks. Furthermore, this area is very much affected by rainfall averaging 1800–20 000 mm yr⁻¹ (Themeli and Mustaçi, 1996). The rainfall reached its climax in 1959 (3160.6 mm) and 1960 (3569.9 mm) (Naçi, 1974). The man-made works (foundation's excavation) have also affected the earth slide occurrences. Also, the morphology of the steep slopes on this area can also increase susceptibility to landslide events. Based on geotechnical investigations (Muceku, 2008) engineering's measures are taken on upper part

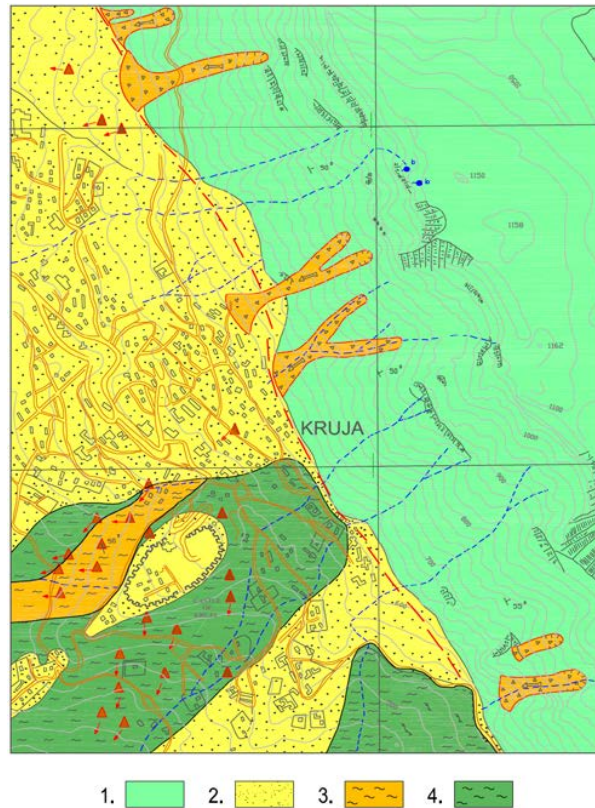
Fig. 15. Slope stability zonation map of Kruja town in case of arid period, scale 1 : 5000. (1) engineering geology zone with basement of limestones rocks, stable, (2) engineering geology zone with basement of breccia's rocks, stable, (3) engineering geology site in critical state, (4) engineering geology site in stable state.

- a. In most of slopes' areas that are built from breccia's and limestone's rocks the mass movements have not occurred, therefore they are considered stable areas (Figs. 15, 16, 17 and 18).
- b. The hills slopes that are located on the southern part of urban area, covered by inorganic silts and clays with very fine sands, which are situated on flysch rocks and characterized by shallow underground water tables (0.8–2.0 m), are considered unstable (Figs. 15, 16, 17 and 18).

- c. Some areas of the hill's slope (east of urban area) on which are deposited the diluvium soils (gravels-cobbles mixture with no fines), over limestone's rocks are evaluated unstable (Figs. 15, 16, 17 and 18).

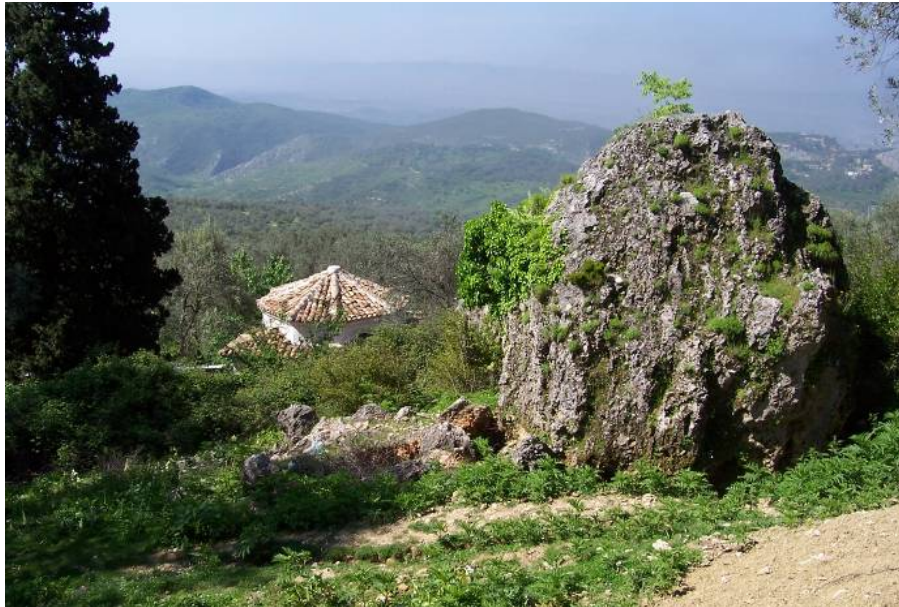
Fig. 19. A breccia's block in unstable state condition.

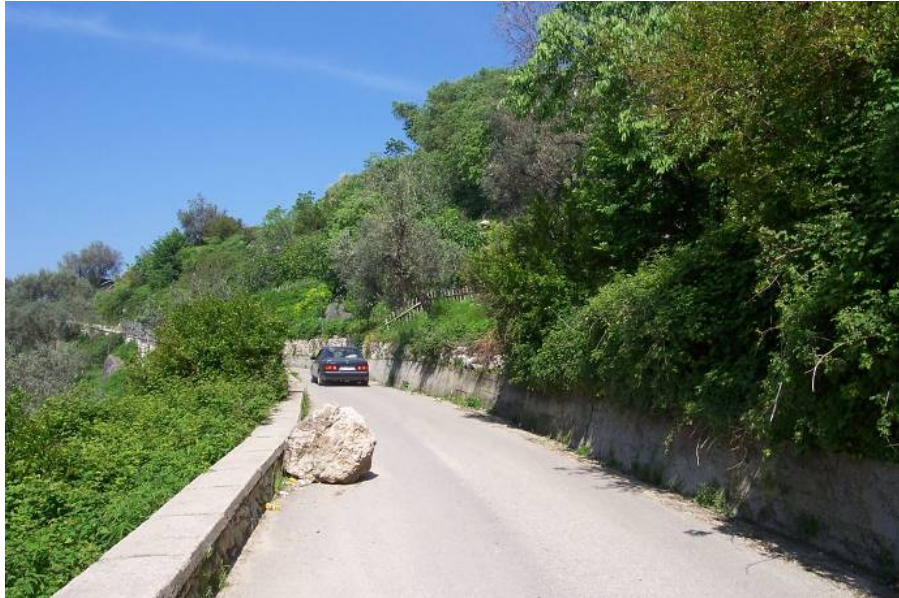
Fig. 20. A limestone block fell on Kruja urban area during heavy rain on 2010.
