# Analysis of sea cliff slope stability integrating traditional geomechanical surveys and remote sensing

S. Martino<sup>1,2</sup> and P. Mazzanti<sup>1,2</sup>

<sup>1</sup>Department of Earth Sciences, University of Rome “Sapienza”, P.le Aldo Moro n.5, 00185, Rome, Italy

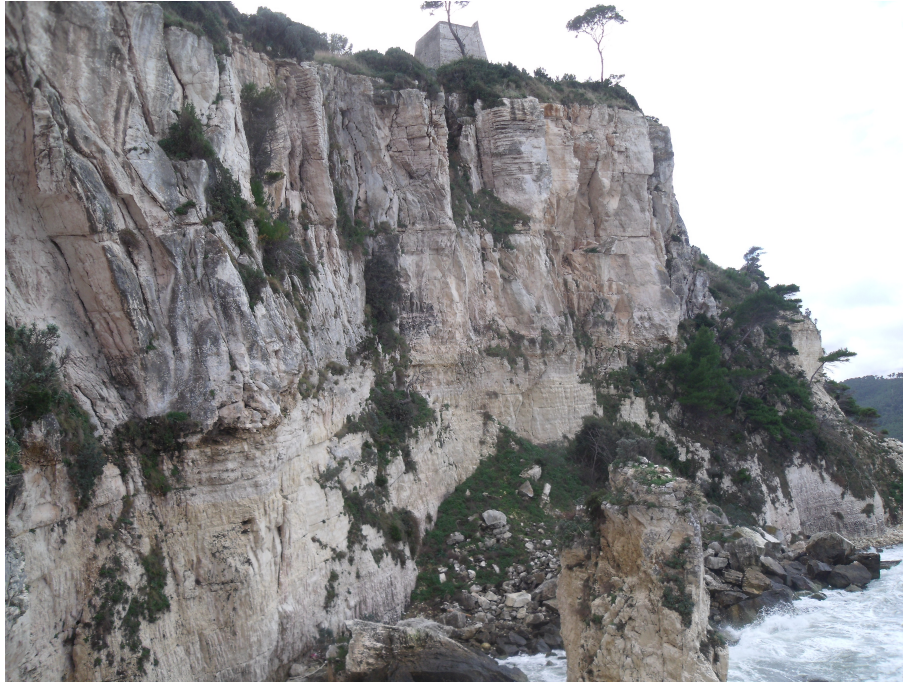
**Fig. 3.** Photo view of the Mt. Pucci cliff slope from the remote sensing point shown in Fig. 2.

Field evidence reveals that the Mt. Pucci coastal cliff is widely involved in rockslides responsible for a clearly visible talus at the bottom of the slope (Fig. 3). The main predisposing conditions for these instabilities are the subvertical face of the cliff and the intense erosion processes due to the sea, which continuously excavates the base of the cliff. Moreover, the visible weathering processes can be primarily related to intense

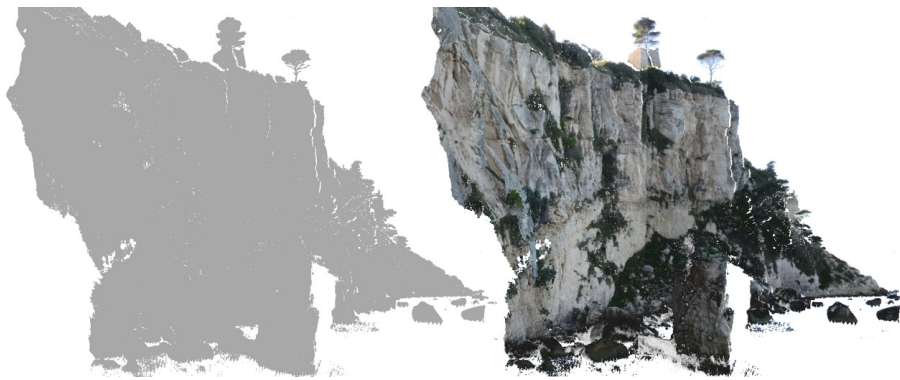
**Fig. 5.** TLS point cloud of the Mt. Pucci cliff: left: the standard point cloud; right: the point cloud colored by the optical photos.

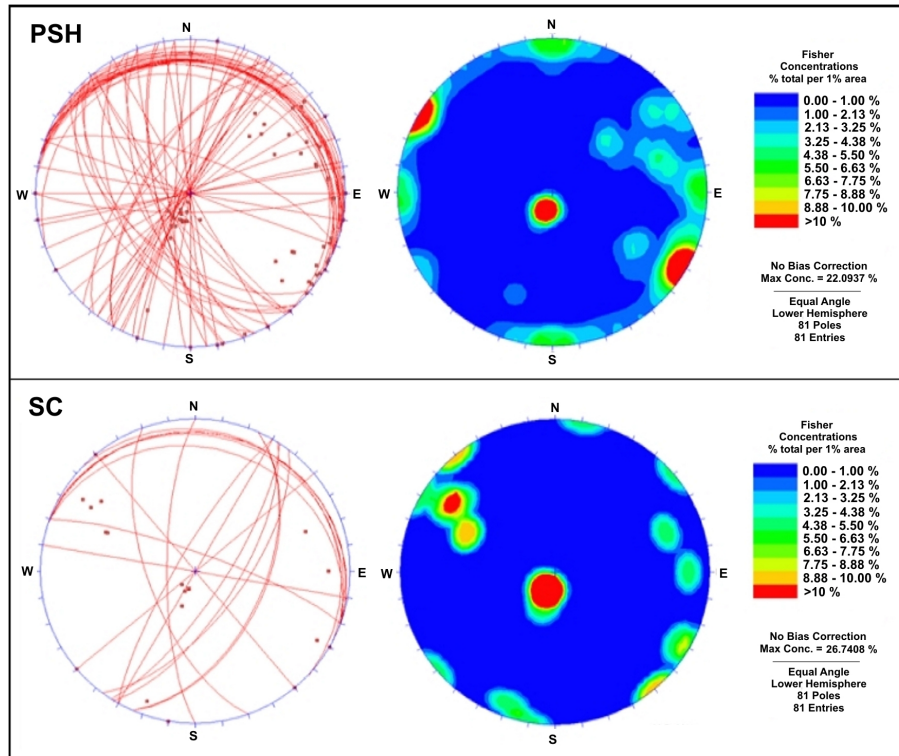
Fig. 7. Great circles and stereo-plots for PSH Fm. and SC Fm. referenced to the geomechanical measurements from direct and remote surveys.
