Reconstruction of the 1945 Wieringermeer Flood

O. A. C. Hoes¹, R. W. Hut¹, N. C. van de Giesen¹, and M. Boomgaard²

Received: 19 February 2013 – Accepted: 22 February 2013 – Published: 11 March 2013

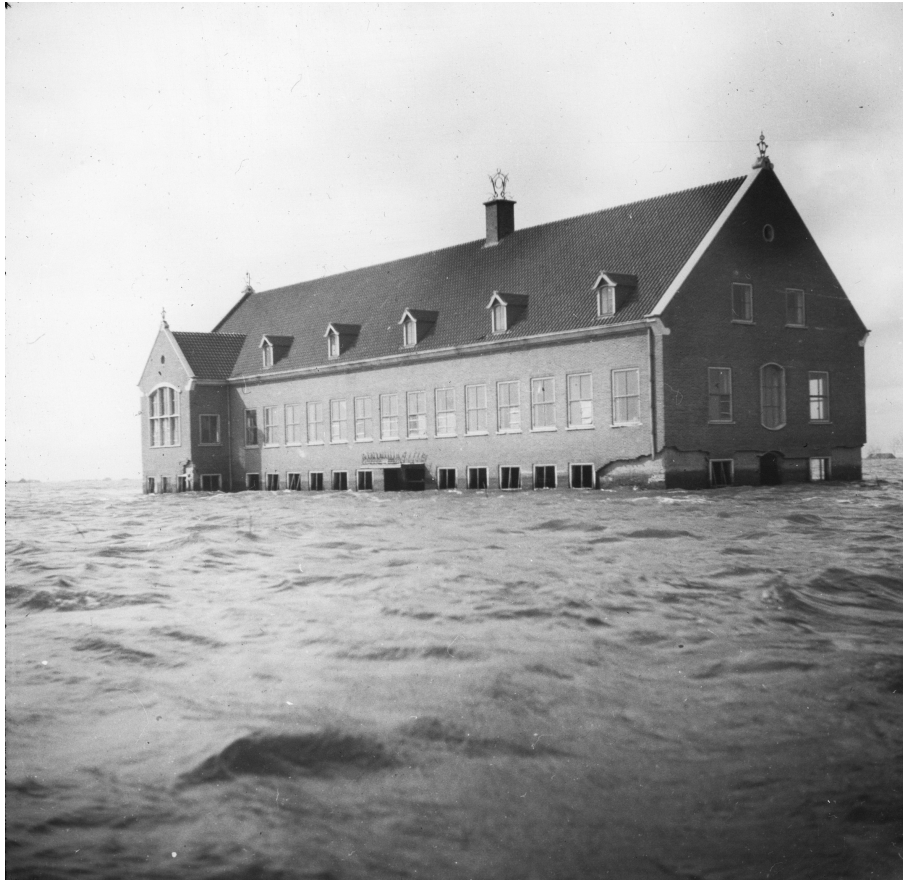
Fig. 1. Office building in Wieringerwerf during the inundation. Around 30 people sheltered 3 weeks in this building until the capitulation on 5 May 1945.

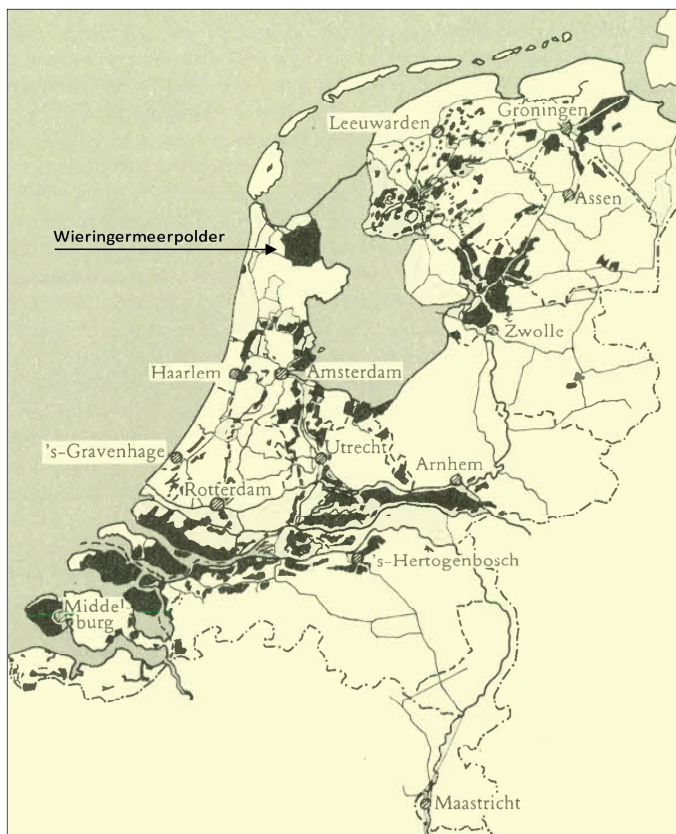
Fig. 2. Around 220 000 ha were inundated in May 1945 (de Jong, 1982).

Between February and September the German army inundated around 120 000 ha by blocking the discharge of excess water (see also Fig. 2). A telegram from the resistance on the 16 February 1944 to the Dutch government in exile in England stated that the German army wanted to raise the water level of Lake IJssel (Waalewijn, 1985).

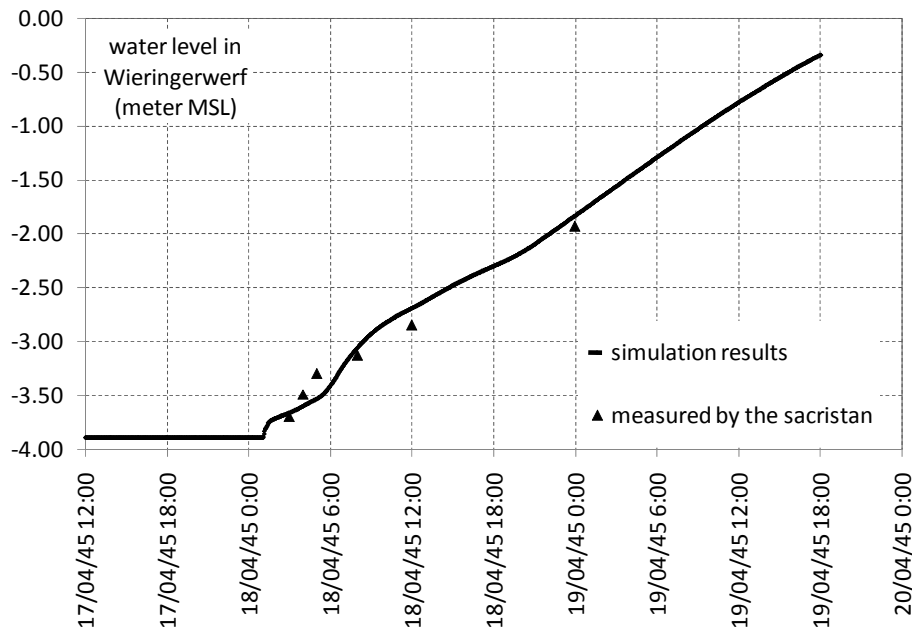
Fig. 6. Simulated water level rise in Wieringerwerf and historical measurements by the sacristan in the vicarage.

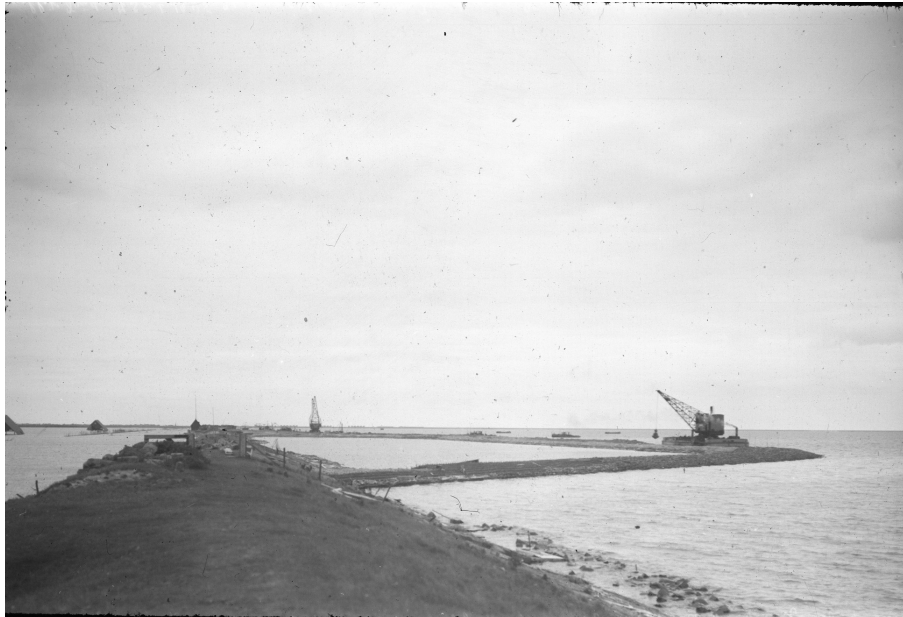
Fig. 7. Reconstruction works around the breach in August 1945. The polder is on the left with some roofs of farm houses visible in this picture and Lake IJssel is on the right.

Immediately after the liberation on the 5 May 1945, the Public Works department worked on a plan to close the dike. They decided to build a 940 m long new dike in Lake IJssel around the deep scour holes. This solution was preferred over filling the scour holes, as this would have required much more sand and also the subsidence would be uncertain. The location and shape of the scour holes made that a new dike in the polder itself would have required more sand and boulder clay. The first sand was dumped on the 21 June 1945; on the 5 August the dike was closed.

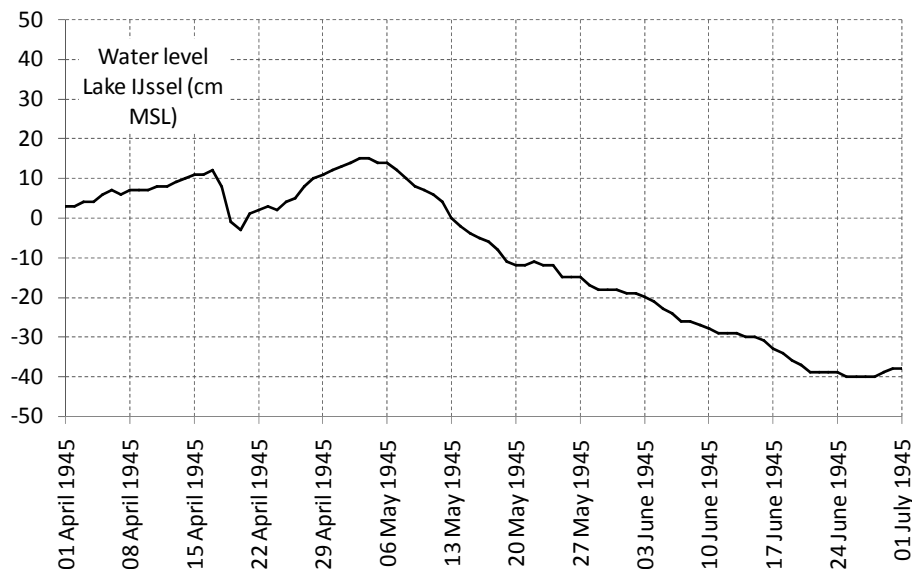
Fig. 8. Water level at Lake IJssel April–June 1945. On 17 April the water level was +12 cm m.s.l. The water level dropped 15 cm between the 17 and the 20 April.
