# A new approach to flood loss estimation and vulnerability assessment for historic buildings in England

**V. Stephenson and D. D’Ayala**

Civil, Environmental and Geomatic Engineering, University College London, London, UK

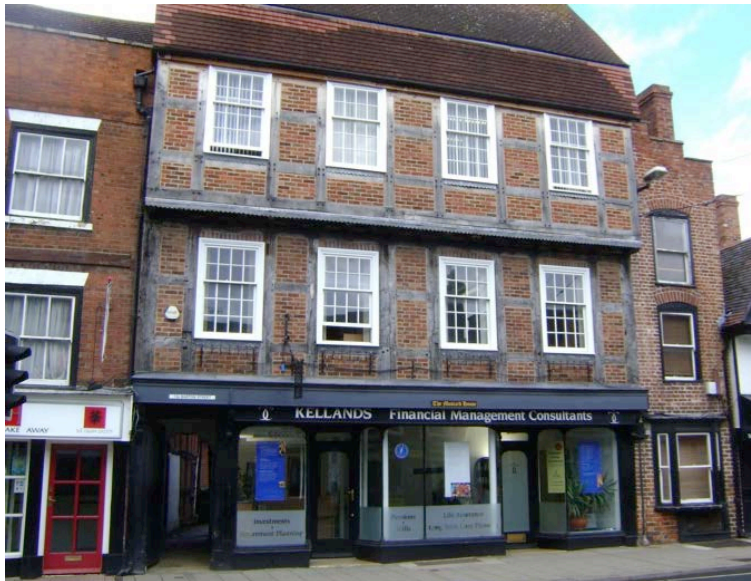
Fig. 4a. Barton Street, Tewkesbury.

Barton Street, Tewkesbury	
Not Listed	10
3 Storeys	70
Timber Frame with BI	70
Georgian	55
Excellent Condition	10
Vulnerability Index	215/500
Mill Bank, Tewkesbury	
Grade II	40
3 Storeys	70
Timber Frame with BI	70
Medieval/Tudor	100
Excellent Condition	10
Vulnerability Index	290/500

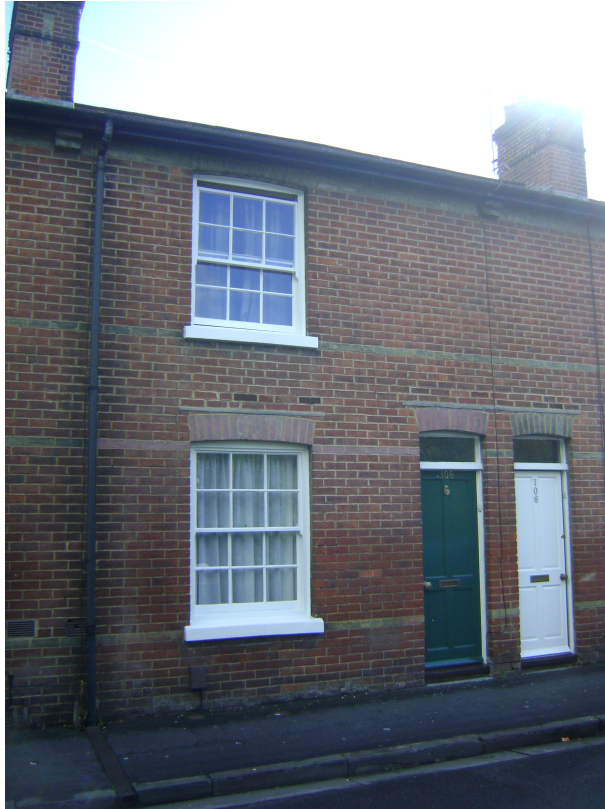
**Fig. 5a.** Water Lane, Winchester.

Water Lane, Winchester	
Not Listed	10
2 Storeys	40
Brick Masonry	40
Victorian	32.5
Good Condition	55
Vulnerability Index	177.5/500
Kingsgate Street, Winchester	
Grade II	40
3 Storeys	70
Brick Masonry	40
Jacobean	77.5
Poor Condition	100
Vulnerability Index	327.5/500

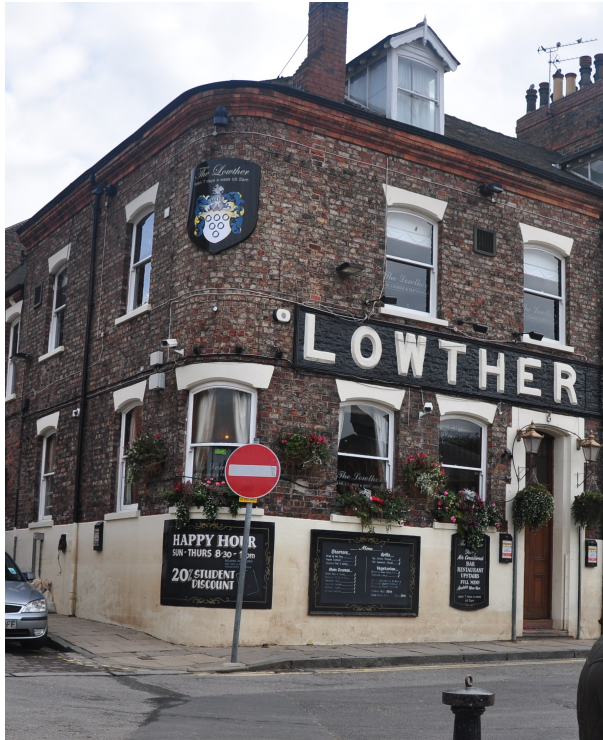
Fig. 6a. Riverfront, York.

Riverfront, York	
Not Listed	10
3 Storeys	70
Brick Masonry	40
Georgian	55
Excellent Condition	10
Vulnerability Index	185/500
Fishergate, York	
Grade II	40
3 Storeys	70
Brick Masonry	40
Georgian	55
Poor Condition	100
Vulnerability Index	305/500
