Results of the post flash-flood disaster investigations in the Transylvanian Depression (Romania) during the last decade (2001–2010)

V. Arghiuş, A. Ozunu, I. Samara, and G. Roşian

Babeş-Bolyai University, Faculty of Environmental Science and Engineering, Cluj-Napoca, Romania

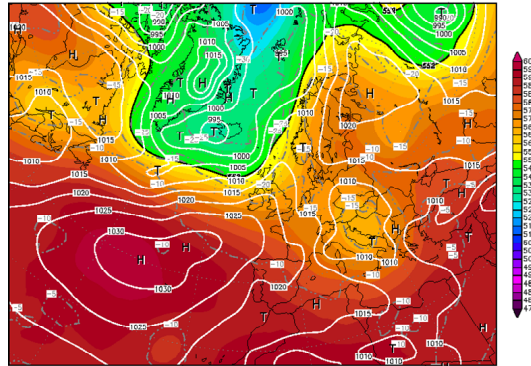
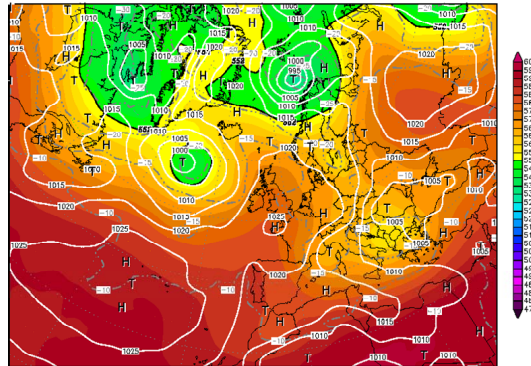
Fig. 2. Sea level pressure (hPa), 500 hPa geopotential height (gpm) and temperature (°C) on Feernic 2005 (a) and Ciunga 2010 (b) flash-flood events (<http://www.wetterzentrale.de/topkarten/fsavneur.html>).

(Arghiuș, 2008; Stăncălie et al., 2010) (Fig. 2). The same situation was observed in the studied areas. In this context the height cold nucleuses maintain the cyclonic activity at ground level and increase the atmospheric instability in the lower and middle troposphere, leading to the rapid and massive condensation processes and to short-lived heavy rainfalls (Arghiuș and Maloș, 2009). The situation at the sea level shows a distribution of the baric systems that include a field of high atmospheric pressure (The Azores High) developed from south-western to central Europe, and a Mediterranean cyclone in the south-western part of Romania. In these conditions, the ground-level air circulation is predominantly southern.

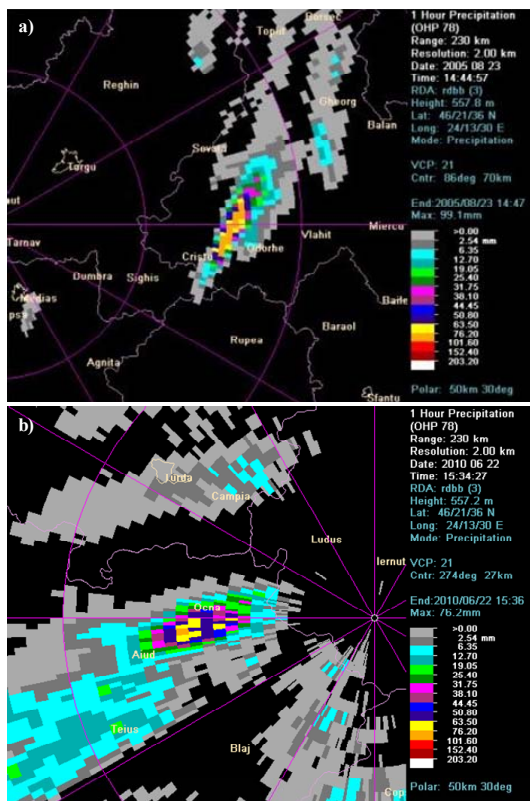
Fig. 3. The estimation of rainfall rates (mm h^{-1}) with the Doppler radar on **(a)** Feernic and **(b)** Ciunga basinal areas (source of radar images: Regional Meteorological Center “Transilvania Nord”).

The precipitation reconstruction based on radar images showed maximum rainfall rates varying from 102 mm h^{-1} (Feernic basin) to 76 mm h^{-1} (Ciunga basin) (Fig. 3), while the total storm event recorded values that reached up to 175 mm in the eastern side of the Feernic basin, 160 mm in the north-east of the Ilișua basin and 90 mm in the southern part of the Ciunga basin.

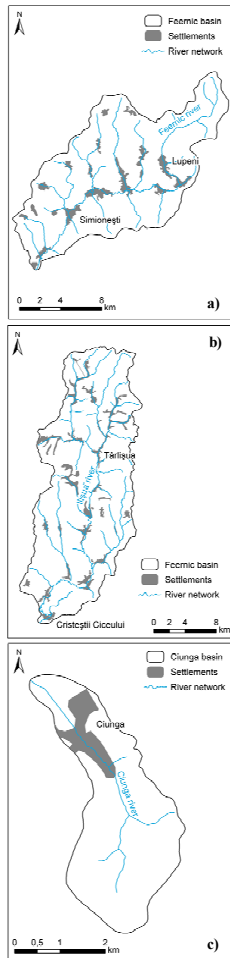
Fig. 4. The studied watersheds: **(a)** Feernic basin, **(b)** Ilişua basin and **(c)** Ciunga basin.

Extreme rainfall falling on saturated soil, especially in the upper part of the basins, resulted in severe flooding in the Feernic, Ilișua and Ciunga watersheds (Fig. 4). The main characteristics related to the selected basins are listed in Table 2. Streamgauge station data and observations from post-event surveys, combined with hydraulic modeling from another related studies, were used to examine hydrologic response to the storm.

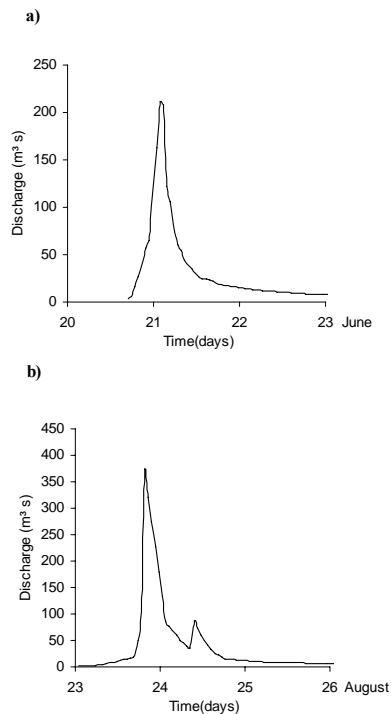
Fig. 5. Flash-flood hydrographs recorded at: **(a)** Cristeștii-Ciceului streamgauge station – June 2006 Ilișua event; **(b)** Șimonești streamgauge station – August 2005 Feernic event (source of data: Romanian Waters National Administration, RWNA).

Unfortunately, just two streamgauge stations are located in the study basins (Feernic river – Șimonești streamgauge station; Ilișua river – Cristeștii Ciceului streamgauge station), both being located near by the mouth of the rivers. The flash floods recorded at these two streamgauge stations are shown in the Fig. 5.

Analysing the hydrographs, a sudden peak rising can be observed that indicates features related to flash floods. Along with the heavy rain rates in the upper basins, the sudden rise of the peak discharges was influenced by the failure of a series of temporary wooden debris dams which were formed in narrow valley sections. Four important dams were reported in Ilișua watershed and one in Feernic river basin. Another study in the Feernic basin confirms the above mentions. Thus, the recorded discharge values at Șimonești streamgauge station show a sudden peak rising, while the simulated hydrograph in the same section follow a milder curve. As the author has observed the impulsivity of the registered hydrograph could depend from the blockage-release effect due to wood and solid material passing through narrow cross sections, while this dynamic is not considered by the model (Sangati, 2009).

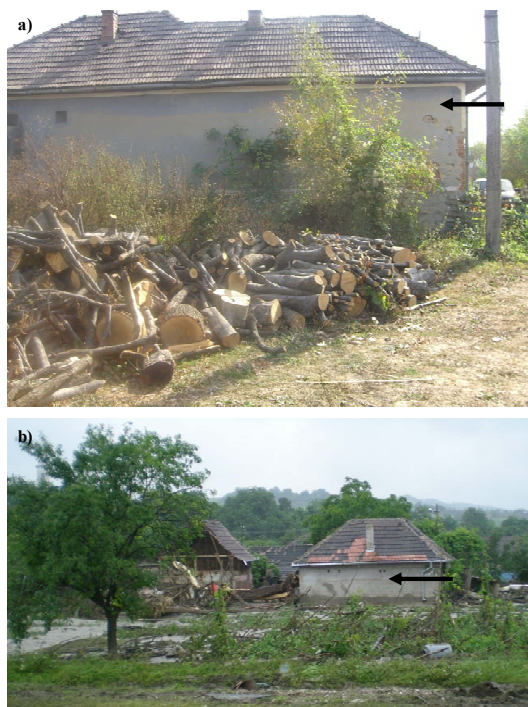
Fig. 6. The flash-floods marks in the affected areas: **(a)** Lupeni village – Feernic basin; **(b)** Uioara de Jos village – Ciunga basin.

Based on flood marks, has been found that the maximum water level ranged from 5.0 m (Lupeni village – Feernic event) to 4.8 m (Târlișua village – Ilișua event) and 4.0 m (Uioara de Jos village – Ciunga event) (Fig. 6).

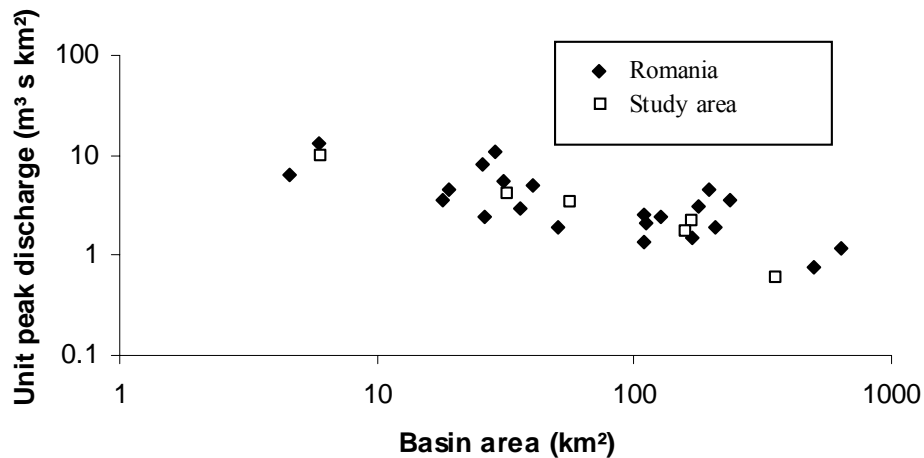
Fig. 7. Relation between basin area and unit peak discharge for the studied events and other significant flash floods in Romania.

By comparing the unit peak discharges from the studied region with other specific peak discharges related to the significant flash floods from Romania, it was noticed that the flash flood events from the Transylvanian Depression have moderate to low intensity (Fig. 7). Nevertheless, in some areas from this region even low-intensity flash floods can trigger disasters considering that the floodplains are generally associated with high demographic density.
