## 2 Site considerations

**Table 1.** Geographic information and landslide erosion data for the seven road segments surveyed in northwestern Yunnan.

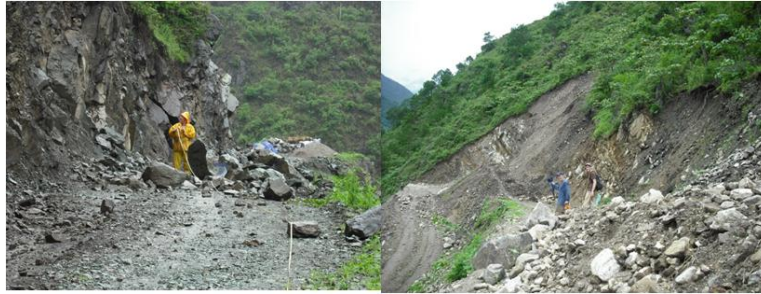
**Figure 2.** The highest landslide erosion occurred along a 1 yr old road (DXD) leading to a remote village and a future hydropower plant just south of Daxingdi, Yunnan, China.

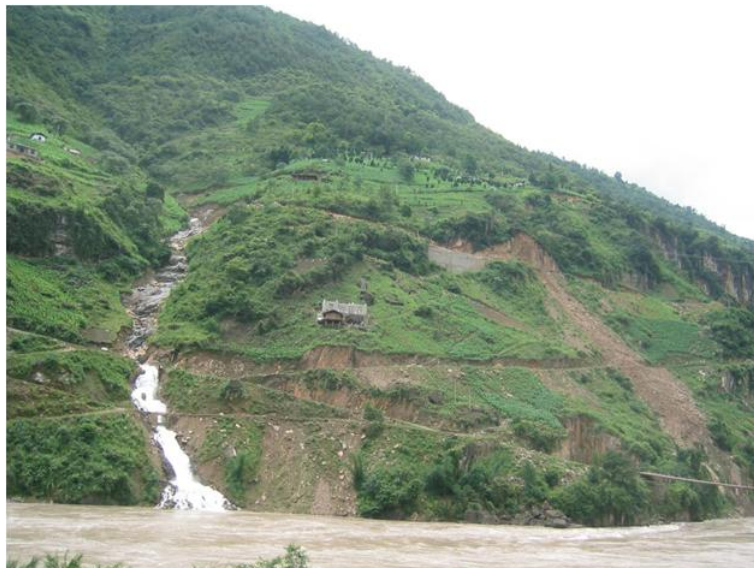
**Figure 3.** Road leading to a mountain village on the west side of the Salween River about 45 km south of Fugong. Upper portion of the road had (SFG1) the lowest landslide erosion of all surveyed segments, while the lower portion of the road (SFG2) had fewer numbers of, but larger, cutslope failures. Landslide erosion rates were significantly higher at SFG2 compared to SFG1 – 3.5 times higher for fillslope and 4.4 times higher for cutslope failures. Access bridge across the river is in the lower right corner of the photo.

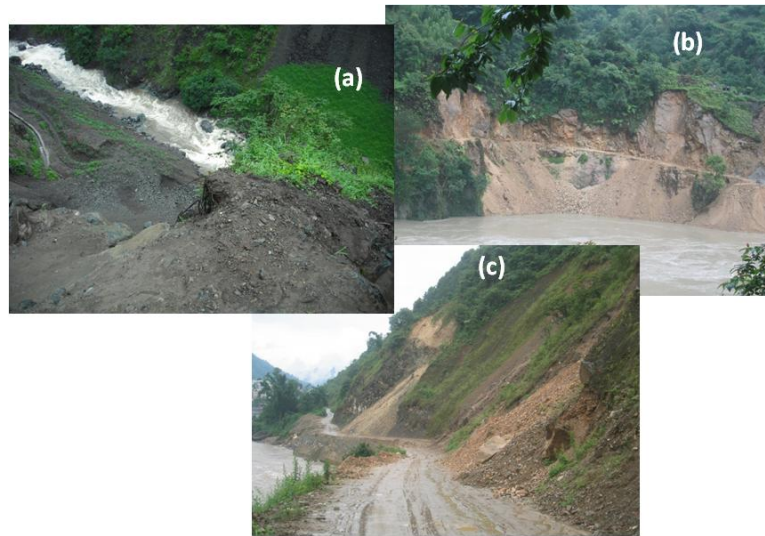
**Figure 4.** High rates of landslide sediment delivery to the Salween River from the: **(a)** DXD; **(b)** WTW and **(c)** FG1 road segments.

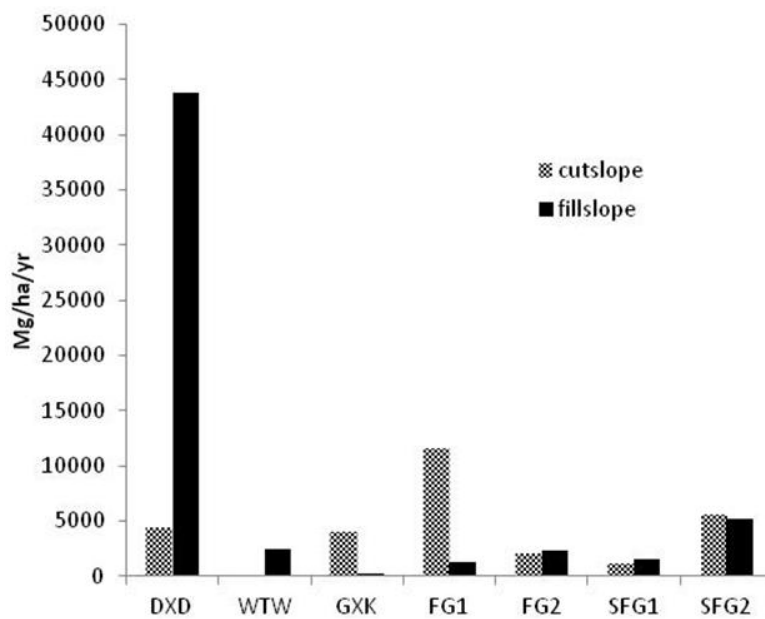
**Figure 5.** Landslide erosion from cutslopes and fillslopes for the seven surveyed road segments.

The relative proportion of landslide erosion along cutslopes and fillslopes varied among sites and was strongly influenced by terrain characteristics, depth of road cuts into the hillside, and disposition of fill material. Overall more landslide sediment was produced from fillslopes (38 170 Mg) compared to cutslopes (29 055 Mg) even though cutslope failures outnumbered fill failures by 235 to 77 (more than a 3 : 1 ratio). Three examples stand out as having disproportionately higher cutslope or fillslope landslide erosion. The DXD road had a large number ( $> 31.3 \text{ km}^{-1}$ ) and the highest rate ( $43\,789 \text{ Mg ha}^{-1} \text{ yr}^{-1}$ ) of roadfill landslides (Table 2; Fig. 5). Of the 27 fill failures that occurred along this road segment, the average gradient below the road was  $44.4^\circ$ . As such, when unconsolidated rock and soil material from the blasting and excavation was deposited on these steep side slopes, it sometimes failed immediately or shortly thereafter during a large storm. In contrast, two other road segments (FG1 and G XK) had significantly higher (about 9 to 16 times higher) landslide erosion along cutslopes compared to fillslopes (Fig. 5). These differences can be partially attributed to the gentler slope gradients immediately downslope of the road which contributed to the low numbers and volumes of fillslope landslides. The G XK road segment had only 2 fill failures with an average volume of  $58 \text{ m}^3$ , while the FG1 road had 12 failures with an average volume of  $124 \text{ m}^3$ . The WTW road segment, and especially the FG2, SFG1 and SFG2 segments, each had similar levels of cutslope and fillslope landslide erosion (Fig. 5). The greater than 4-fold increase in cutslope landslide volume in SFG2 (lower segment) compared to SFG1 (upper segment) is attributed the deeper road cuts into fractured bedrock in the lower segment (Fig. 3). Much fewer, but larger (mean mass =  $96.6 \text{ Mg}$ ), failures occurred along rocky cutslopes of SFG2, while more, but much smaller (mean mass =  $10.4 \text{ Mg}$ ) soil failures occurred along cutslopes of SFG1 (Table 2).

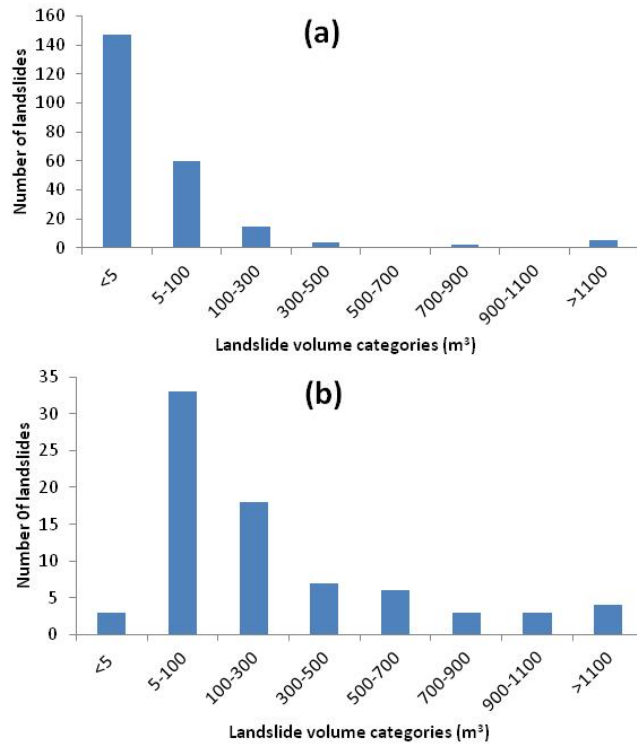
**Figure 6.** Size distribution for all surveyed landslides from **(a)** cutslopes ( $n = 235$ ) and **(b)** fill-slopes ( $n = 77$ ).

The distribution of all cutslope landslides ( $n = 235$ ) was heavily skewed to small failures ( $< 5 \text{ m}^3$ ) (Fig. 6a). More than 88 % of all cutslope failures were  $< 100 \text{ m}^3$ . In contrast, fillslope landslides ( $n = 77$ ) followed a more Gaussian size distribution that was

only somewhat skewed towards smaller failures (Fig. 6b). About 66 % of all fillslope failures were in the range of  $> 5$  to  $100 \text{ m}^3$  and less than 4 % were  $< 5 \text{ m}^3$ . Very large ( $> 1100 \text{ m}^3$  or  $> 1430 \text{ Mg}$ ) landslides along cut and fillslopes comprised only 2 % and 5 % of the respective landslide numbers for these sites (Fig. 6). Nevertheless, the small number of very large ( $> 1430 \text{ Mg}$ ) landslides along cut and fillslopes contributed similar sediment mass ( $16\,507$ – $16\,645 \text{ Mg}$ ), constituting 56.8 % and 43.6 % of the total respective landslide mass. All five of the very large cutslope failures occurred along FG1.

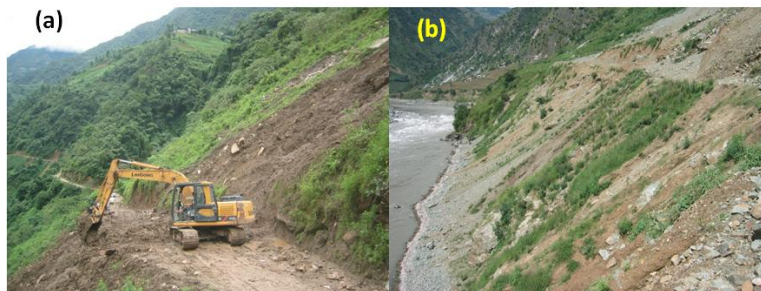
**Figure 7.** **(a)** A section of the FG2 road several kilometers north of Fugong that was temporarily closed by a landslide; and **(b)** secondary road to a small mountain village near Daxingdi (not included in our landslide survey) that was abandoned during construction because of excessive landslides.

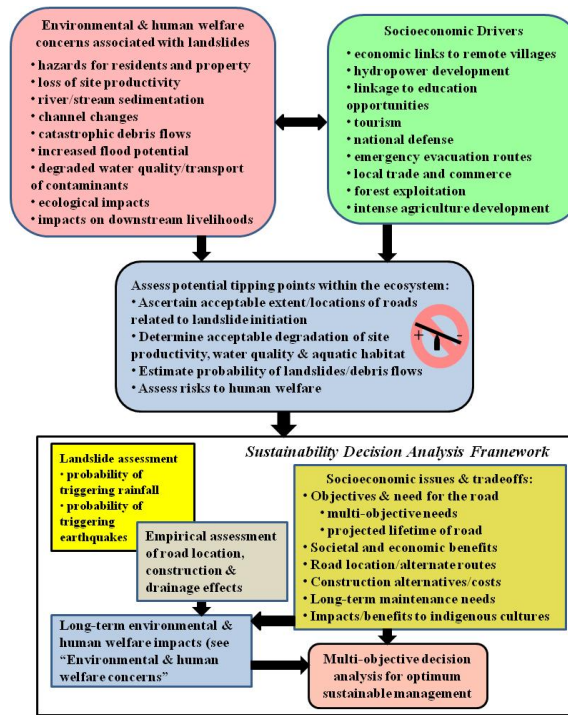
**Figure 8.** Decision framework for sustainability assessment of mountainous terrain in north-western Yunnan, China, where extensive road construction is being proposed (modified extensively from Sidle et al., 2013).

Moving forward, there is an urgent need to develop a systems-based approach for more sustainable mountain road development before tipping points are reached in these ecosystems. In northwestern Yunnan, this would include detailed landslide hazard assessments prior to road planning and construction activities. Ideally, such analyses should identify the probability of exceeding landslide trigger thresholds (in this area, largely rainfall) coupled with estimates of decreased slope stability associated with different road locations and construction techniques (Fig. 8). This approach would allow

for trade-offs between socioeconomic development and long-term environmental and human welfare impacts by articulating acceptable levels of landslide erosion, with an eye towards avoiding tipping points where site productivity, human welfare, ecological attributes, flooding, and aquatic habit are not compromised in the long term. Trade-offs for road development could include alternative locations and construction techniques, assessing “storm-proofing” roads vs. continual widening and maintenance, considering multiple road uses, incorporating climate change impacts, and reevaluating the necessity of the road. In particular, road location strategies can go a long way towards ameliorating landslide problems; these include: (1) optimize the expected lifetime of the road with uses; (2) ensure a balance of minimizing road length and minimizing steep gradients; (3) avoid deep cuts into unstable substrate (especially bedrock dipping parallel to the hillslope); (4) utilize valley bottom and ridge-top roads whenever feasible; (5) avoid seasonally wet areas (e.g., hollows); (6) reduce the width of midslope roads; (7) avoid crossing old landslides, particularly undercutting the toe or loading the head of dormant failures; (8) roll roads to fit hillslope contours and across drainage culverts; and (9) minimize stream crossings (Megahan et al., 1978; Sidle and Ochiai, 2006). Such a systems-based approach that considers all possible road uses and benefits against environmental and human welfare costs (Fig. 8) offers a much more robust and sustainable alternative.

landslides on settlements, sediment loads in rivers, water quality, and aquatic habitat; (3) loss of site productivity on hillslopes affected by landslides; (4) impacts of relatively clean and contaminated sediments in downstream water supplies; (5) effects on channel conveyance, flooding and potential debris flows; (6) siltation of existing reservoirs; and (7) environmental consequences of unintended forest exploitation (Fig. 8).
