Epic landslide erosion from mountain roads in Yunnan, China – challenges for sustainable development

R. C. Sidle¹, M. Ghestem², and A. Stokes³

Received: 10 April 2014 – Accepted: 7 May 2014 – Published: 3 June 2014

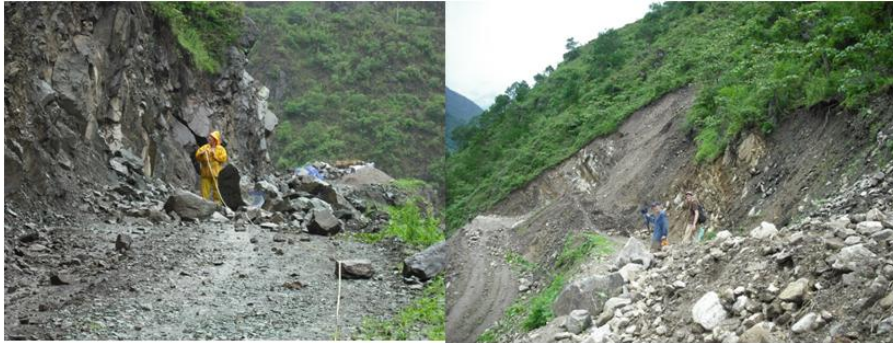
Figure 2. The highest landslide erosion occurred along a 1 yr old road (DXD) leading to a remote village and a future hydropower plant just south of Daxingdi, Yunnan, China.

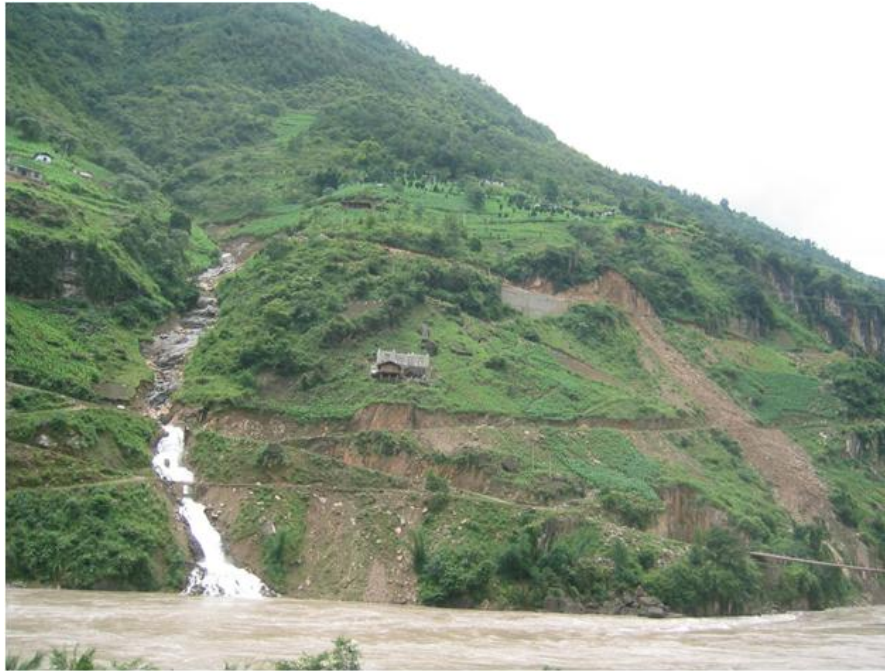
Figure 3. Road leading to a mountain village on the west side of the Salween River about 45 km south of Fugong. Upper portion of the road had (SFG1) the lowest landslide erosion of all surveyed segments, while the lower portion of the road (SFG2) had fewer numbers of, but larger, cutslope failures. Landslide erosion rates were significantly higher at SFG2 compared to SFG1 – 3.5 times higher for fillslope and 4.4 times higher for cutslope failures. Access bridge across the river is in the lower right corner of the photo.

Overall there were about three times more cutslope compared to fillslope landslides, and cutslope landslides were more frequent than fillslope failures at all seven road segments (Table 2). SFG1 had the largest number of cutslope failures, but, as noted, these were small and constituted the second smallest landslide erosion rate of all seven road segments; DXD had a rather large number of sizable cutslope failures. WTW and GXX both had high numbers of landslides along cutslopes, but with small to intermediate mean masses (Table 2). Both DXD and WTW had the largest numbers of fillslope failures together with the highest sediment delivery estimates (Tables 1 and 2) – these sites were both proximate to a tributary and the main stem of the Salween River, respectively. Few fillslope failures occurred in FG1 and FG2, and especially in GXX. GXX was situated away from the river and the slope below the road was gentle containing rice paddy fields.

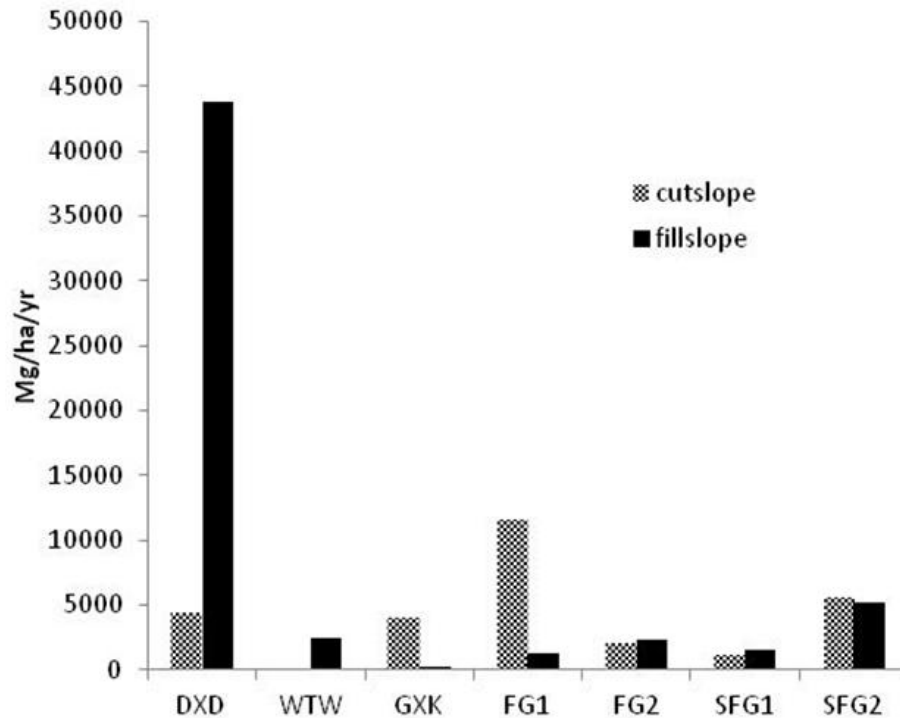
Figure 5. Landslide erosion from cutslopes and fillslopes for the seven surveyed road segments.

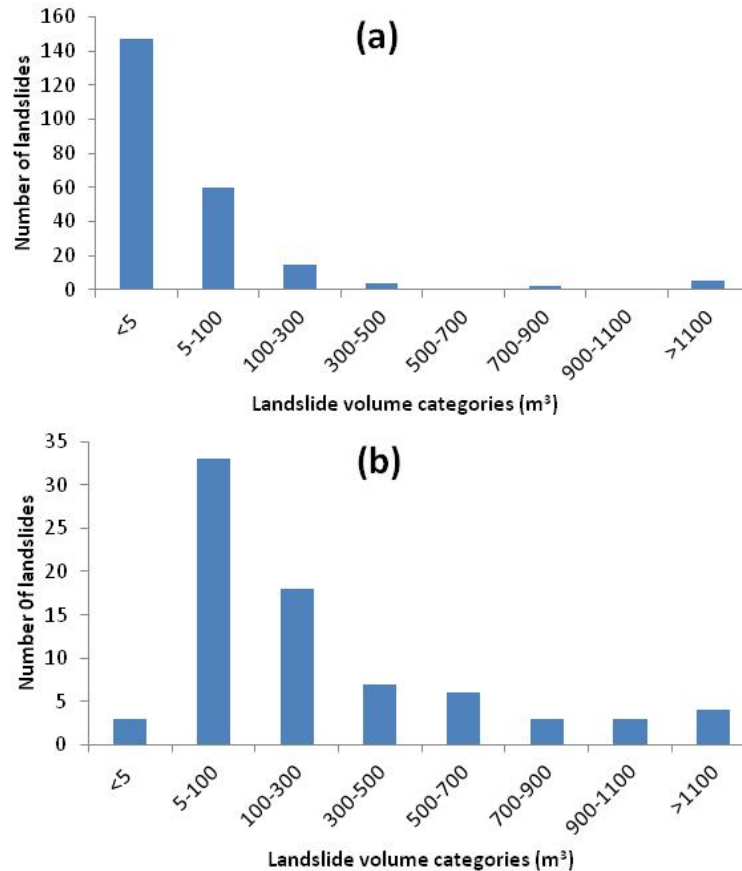
Figure 6. Size distribution for all surveyed landslides from **(a)** cutslopes ($n = 235$) and **(b)** fill-slopes ($n = 77$).

only somewhat skewed towards smaller failures (Fig. 6b). About 66 % of all fillslope failures were in the range of > 5 to 100 m^3 and less than 4 % were $< 5 \text{ m}^3$. Very large ($> 1100 \text{ m}^3$ or $> 1430 \text{ Mg}$) landslides along cut and fillslopes comprised only 2 % and 5 % of the respective landslide numbers for these sites (Fig. 6). Nevertheless, the small number of very large ($> 1430 \text{ Mg}$) landslides along cut and fillslopes contributed similar sediment mass ($16\,507$ – $16\,645 \text{ Mg}$), constituting 56.8 % and 43.6 % of the total respective landslide mass. All five of the very large cutslope failures occurred along FG1.

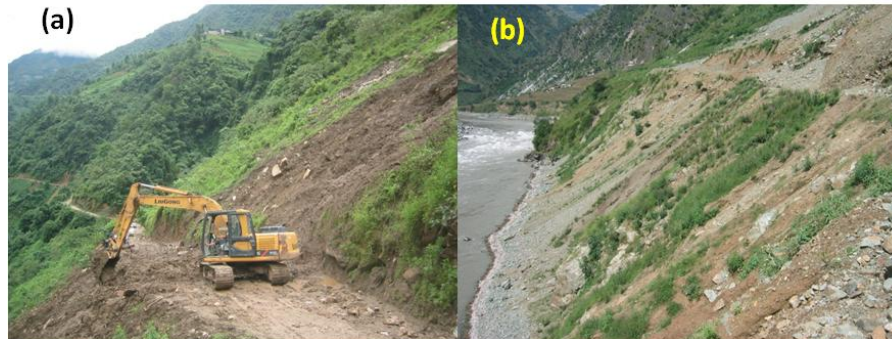
Figure 7. (a) A section of the FG2 road several kilometers north of Fugong that was temporarily closed by a landslide; and (b) secondary road to a small mountain village near Daxingdi (not included in our landslide survey) that was abandoned during construction because of excessive landslides.

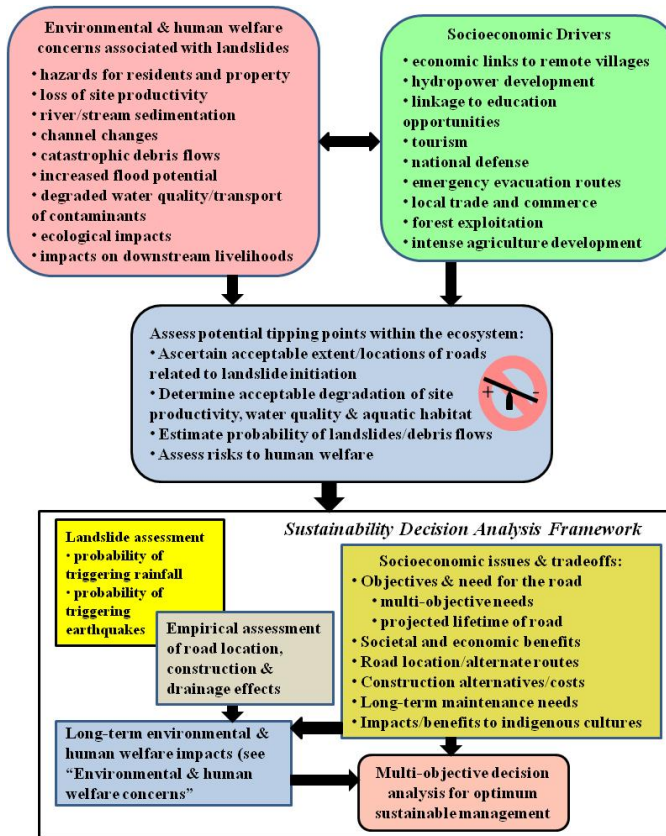
Figure 8. Decision framework for sustainability assessment of mountainous terrain in north-western Yunnan, China, where extensive road construction is being proposed (modified extensively from Sidle et al., 2013).

Moving forward, there is an urgent need to develop a systems-based approach for more sustainable mountain road development before tipping points are reached in these ecosystems. In northwestern Yunnan, this would include detailed landslide hazard assessments prior to road planning and construction activities. Ideally, such analyses should identify the probability of exceeding landslide trigger thresholds (in this area, largely rainfall) coupled with estimates of decreased slope stability associated with different road locations and construction techniques (Fig. 8). This approach would allow

landslides on settlements, sediment loads in rivers, water quality, and aquatic habitat; (3) loss of site productivity on hillslopes affected by landslides; (4) impacts of relatively clean and contaminated sediments in downstream water supplies; (5) effects on channel conveyance, flooding and potential debris flows; (6) siltation of existing reservoirs; and (7) environmental consequences of unintended forest exploitation (Fig. 8).
