Laboratory and 3-D-distinct element analysis of failure mechanism of slope under external surcharge

N. Li and Y. M. Cheng

Department of Civil and Environmental Engineering, The Hong Kong Polytechnic University, Hong Kong

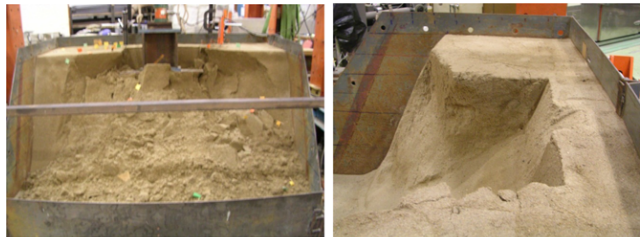
(a) intermediate process state

(b) sideview of intermediate process state

(c) Final failure state after failure mass (d) global failure surface after failure mass is removed

(e) Cracks developed at slope surface and crest originated from the loading plate

Figure 6. Failure process of soil slope under increasing loading.

The intermediate and final failure states of the model slope were illustrated in Fig. 6, and the results from the five transducers were given in Fig. 7. From Fig. 6a and e, we could see that cracks developed firstly around the steel loading plate and extended towards each corner side of the slope crest with an angle 45° which were basically in accordance with the classical theory. During the test, flags with different colors were used to locate the time of appearance and the location of cracks during loading which could also be seen in Fig. 6. From Fig. 6d, it was noticed that the failure surface was approximately a triangular zone at top plus a log-spiral zone similar to the Prandtl mechanism for a bearing capacity problem with an inclined surface below the top triangular zone (Cheng and Au, 2005). The inclination of the failure surface to the horizontal direction in Fig. 6d was also close to 74.3° ($45^\circ + \phi/2$) which was a good illustration of the general shear failure for the present test. The soil mass actually failed gradually instead of a sudden failure in the loading process. As the steel plate kept going down, the inclined slope face was covered with vertical cracks and diagonal cracks which were directed towards the steel plate (see Fig. 6e). The soil mass at the slope surface was drawn down layer by layer to the slope toe by the action of the loading steel plate, and this was the typical face failure phenomenon for cohesionless soil. After four-hours of loading, the sand at the middle top of the slope was highly compressed and a cavity was formed underneath the steel plate which could be noticed after the removal of the steel plate, while the largest cracks were generated at the critical failure surface within the slope body for the global failure (Fig. 6d). The global soil mass was pushed down to the toe of the slope gradually, and the complete physical slope model collapsed eventually which was shown in Fig. 6.

For this test, there were several interesting phenomena worth discussing. The failure profile and cracks first initiated beneath the footing as shown in Fig. 6e, which was a typical bearing capacity failure with a triangular failure zone. This could also be observed from the upper part of the failure profile as shown in Fig. 6c and d. As the load increased, the failure zone extended and propagated towards the toe of the slope and the final failure surface was shown in Fig. 6d. It was observed that the failure mechanism of the physical model test is a local triangular failure beneath the bearing plate, and the failure surface propagates towards the slope surface with a curved surface similar to a logspiral curve until a failure mechanism is formed. This type of problem could be considered as a bearing capacity problem as well as a slope stability problem, which was demonstrated to be equivalent by Cheng et al. (2013).

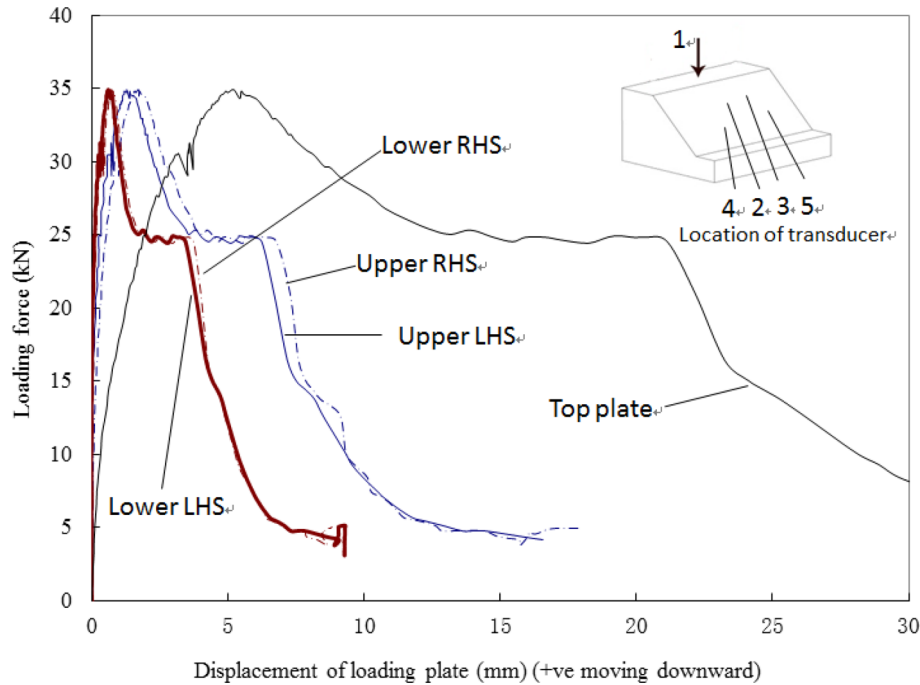
Figure 7. Loading force against the displacement of slope surface.

An ultimate load of 35 kN had been attained at a displacement of about 6 mm as shown in Fig. 7. For the slope surface, the corresponding displacement at the maximum pressure was about 2 mm and 1 mm at top and bottom of the slope respectively as shown in Fig. 7, which were much lower than the corresponding displacement at the loading plate. Beyond the peak load, the applied load decreased with increasing jack displacement. From the displacements for the left and right LDTV at upper and

lower level, it was clear that the displacements of the slope were basically symmetrical. In Fig. 7, after the maximum load has been achieved, the loading force decreased with increasing displacement until a displacement of about 13 mm for which the load maintained constant for about 9 mm. At the beginning of this constant load stage, the local triangular failure zone was fully developed while the failure zones at the two ends of the plate were still not clearly formed. At the end of this constant load stage, the failure zones at the two ends became visually apparent. When the displacements were further increased, the applied load decreased further and the failure zone propagated towards the slope surface until the failure surface as shown in Fig. 6c and d is obtained, which is the typical global failure as considered in classical stability analysis. At last, the residual load of the test was around 5 kN.

laboratory test results as shown in Fig. 7, the trend of three curves are basically similar, and the final failure loading of 35 kN from the laboratory test was also close to the value 37 kN from the DEM analysis. DEM can hence give a relative good quantitative assessment about the slope failure process up to the initiation of the failures.

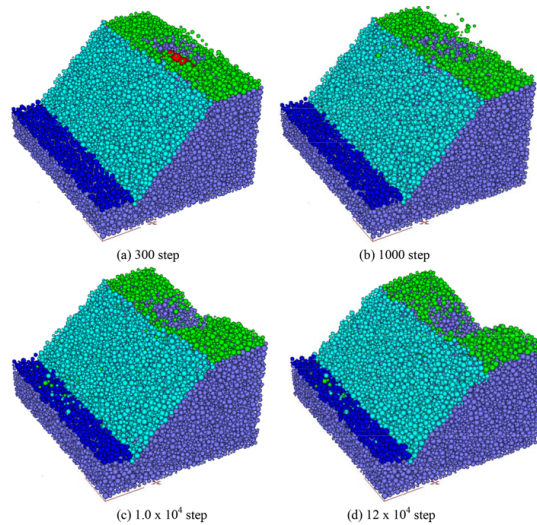
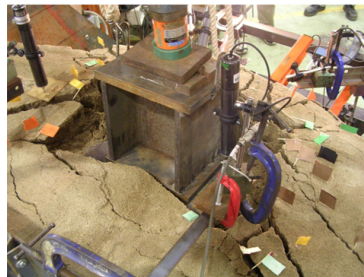
(e) Penetration of base plate into the soil

Figure 9. Failure process of numerical slope model under Loading Raft.

The numerical failure process development under loading is illustrated in Figs. 9 and 10. It is noticed that on top of the slope crest, the region below the loaded surface has deformed to form a depression zone from the DEM modeling which is also observed from the test as shown in Fig. 9e. Sand particles are triggered to move down the slope, dragging more and more sands downward. The depression zone develops larger and deeper, accompanying with considerable settlement at the top of the slope, and the inclined slope face moves forward with an upheaval at the slope toe as shown from the XY direction view in Fig. 10d.

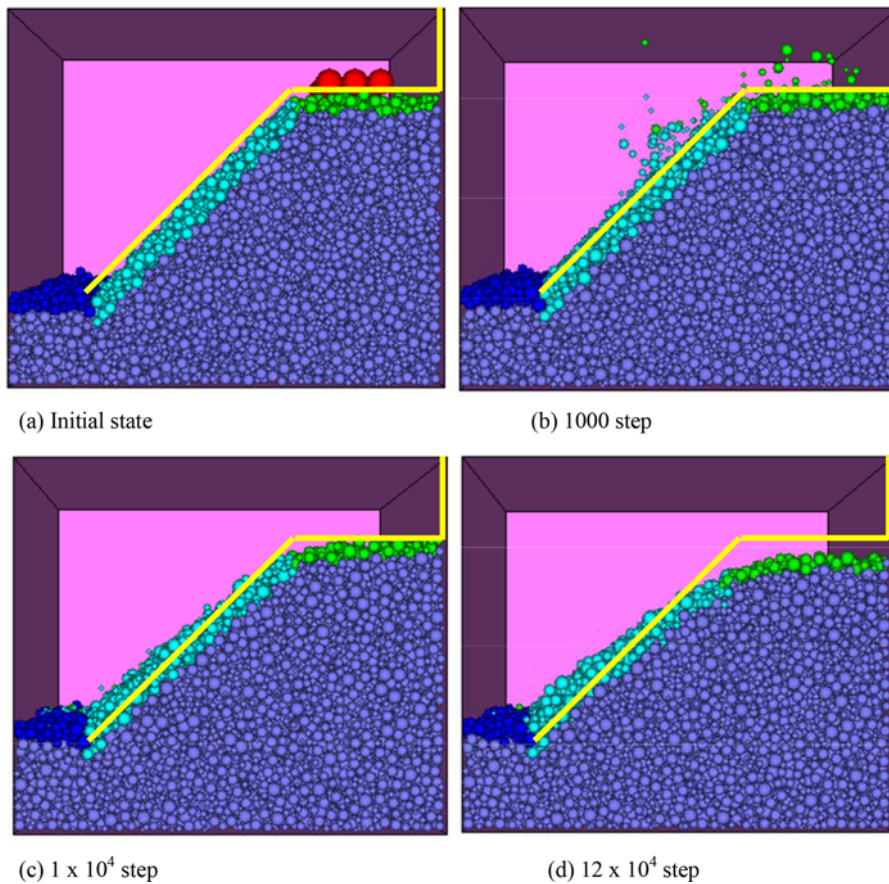
Figure 10. Failure process of numerical model under loading raft in XY direction.

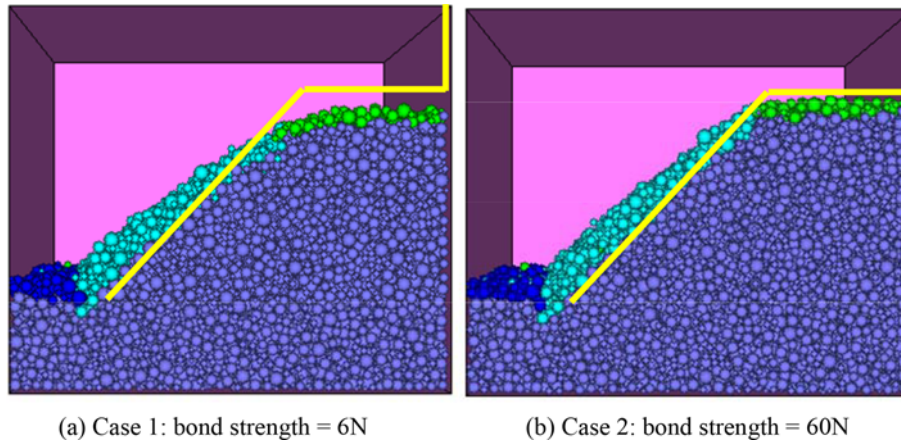
Figure 11. Eventual failure of two modeling cases under loading raft in XY direction.

Slope with soil particles under higher bond strength is also simulated, where the normal and shear contact bond strength of particles value are increased to 60N, which is ten times larger than that in the former case. The results of the comparison are shown in Fig. 11. It is observed that noticeable collapse has taken place in Case 1 with forward movement of slope body and extruding slope toe. On the contrary, the soil movement in Case 2 is not major and the slope is actually stable under the loading as shown in Fig. 11b. It is demonstrated that larger bond strength between soils is followed by slower and smaller failure, or the soil is more stable under the external load.

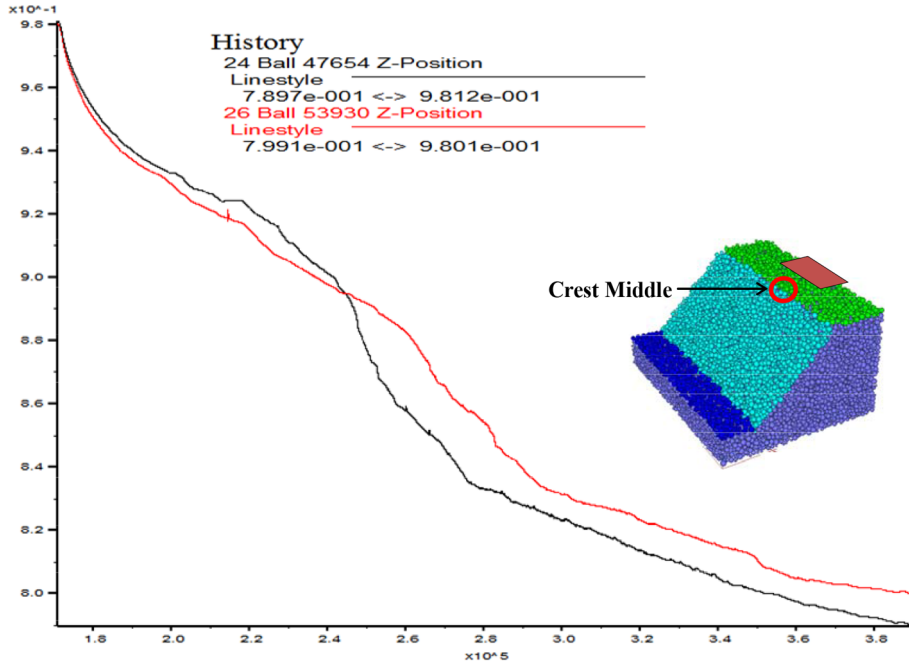
Figure 13. Vertical position history for the balls at the crest middle.

At the middle of the crest of the slope as shown in Fig. 13, the situation is different in that a more rapid and less moderate trend can be noticed. The displacement reaches to more than 0.2 m at the middle of the crest compared with a displacement of almost 0.17 m at the crest corner. However, the particles at the corners move faster than those in the middle in the beginning, which are demonstrated by the sharp increase of the settlement in Fig. 12. Figure 13 shows that the loading at the middle of the slope top has pushed the sands at the middle of the slope crest downward and accumulated at the toe of the slope.

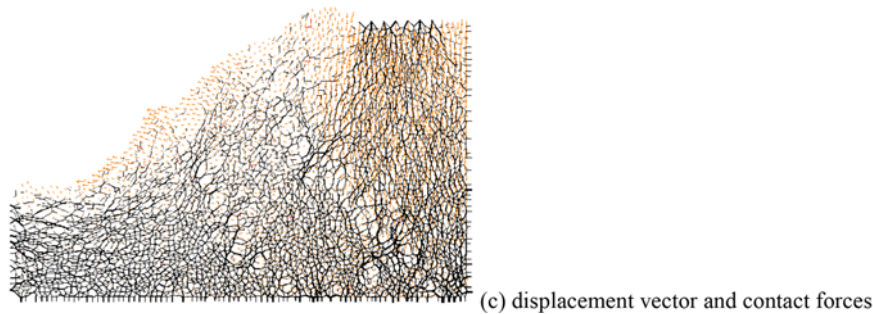
(a) Laboratory test of slope

(b) DEM displacement vector

(c) displacement vector and contact forces

Figure 15. Side view for the final failure from laboratory test and DEM modelling.

The front and side view for the final failure of the laboratory model test and DEM modeling are shown in Figs. 14 and 15. A steeply inclined failure surface (triangular failure zone underneath the loading plate) which is followed by a curved failure surface can be observed from Fig. 15b and c, and the failure profile of the physical test matched reasonably well with that as predicted from the present simulation as shown in Figs. 14 and 15a. At the beginning of the laboratory test, cracks firstly appear along each crest corner in the laboratory test which is the effect due to the side plate of the model. In the particle flow simulation, the loading plate is applied with a small velocity of $5 \times 10^{-5} \text{ m step}^{-1}$. Besides the triangular failure zone underneath the loading plate, there is

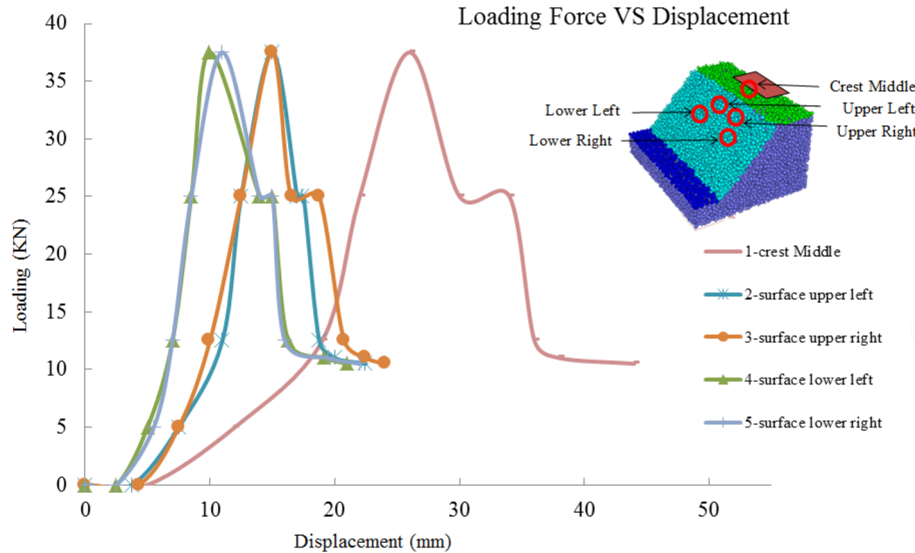
Figure 16. Loading force against displacement curves of the slope at different measuring points.

The relation between the applied load and the displacement of the loading plate from DEM is illustrated in Fig. 16. Three groups of curves were generated from the measuring points of lower position, upper position of slope surface and middle crest respectively. For the soils at the lower position of the slope surface, there is a rapid increase in the loading applied before the displacement has reached 10 mm, which can be noticed in green and light blue curves in the figure. The applied load reaches the peak value of 37 kN at about 10 mm settlement, and then the loading firstly drops to around 25 kN, followed by the second drop down to around 10 kN till eventual failure. For the soil at the upper position of the slope surface, the trend is similar to that of lower surface points, but the settlement largely develops to approximately 14 mm under maximum loading. For the soil at the middle of the slope crest, the maximum load is achieved at larger displacement of 26 mm as compared with the slope surface measuring points, and soil particles experience longer-time settlement with significant displacement value in the whole failure process.
