Interactive comment on “UAV-based urban structural damage assessment using object-based image analysis and semantic reasoning” by J. Fernandez Galarreta et al.

J. Fernandez Galarreta et al.

Received and published: 15 January 2015

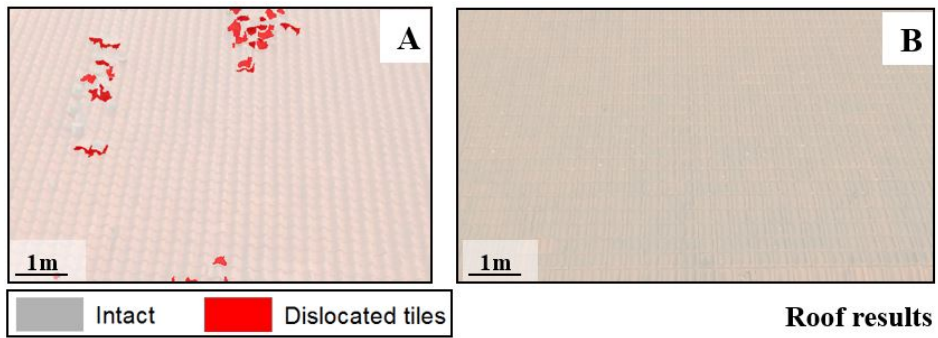
Fig. 1. Corresponds to Fig. 7 in the original document.

Author response: The color in the legend for intact roof has been slightly changed. However, notice that the color will never be the same since the transparency of the classification layer on top of the real image changes with the background's main color. Figure 1 (note that the numeration here does not coincide with the original document)

- In figure 7, the legend could be misunderstood, as the color of intact roof in figure 7(a) is different from the one in figure 7(b).

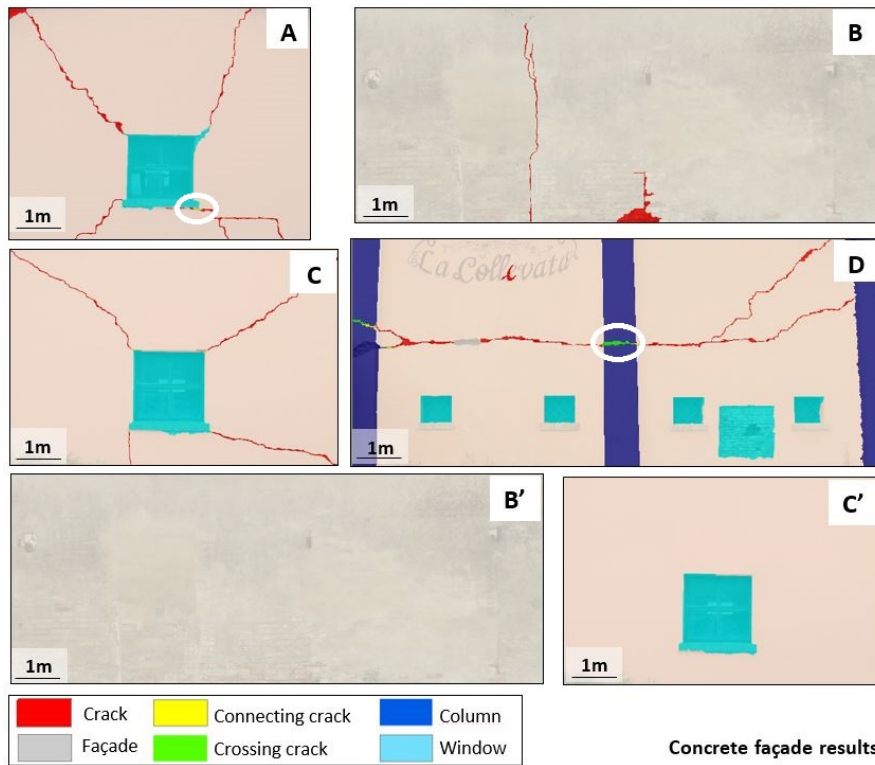
Fig. 2. Corresponds to Fig. 8 in the original document.

3.3 section II. Additionally, the caption of figure 8 has been extended to include a better explanation of such phenomena: "Fig. 8. Results of applying the concrete ruleset on 6 concrete façade images B' & C' were edited in order to remove the damage feature. Images A & B illustrate cases of cracks connecting with windows, shown as yellow objects on the corners of the windows (highlighted by circles). Façade image D illustrates a crack crossing a column (in green). Scale approx." Figure 8 now also includes two circles to highlight mentioned phenomena Figure 2 (note that the numeration here does not coincide with the original document)

- In figure 8, please also explain some phenomena on connecting crack, crossing crack and inclined column in the right hand of figure 8(D).

Author response: The phenomena of connecting and crossing cracks is explained in
