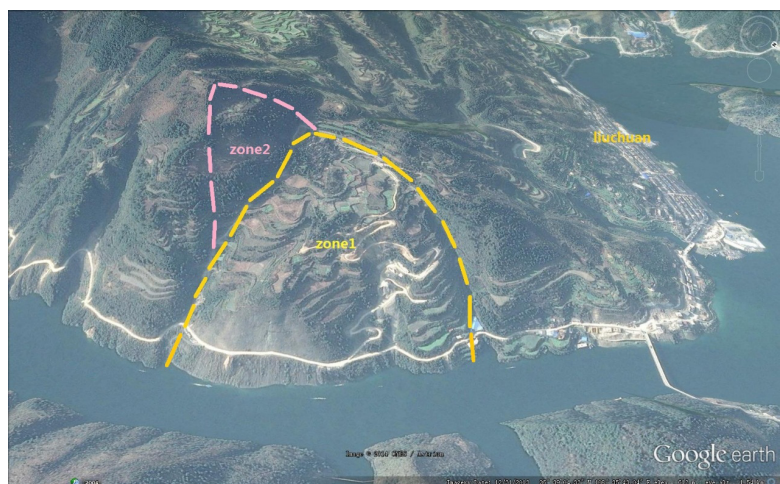
Figure 2. The Donglingxin landslide facing the Qingshui River (taken form Google earth).

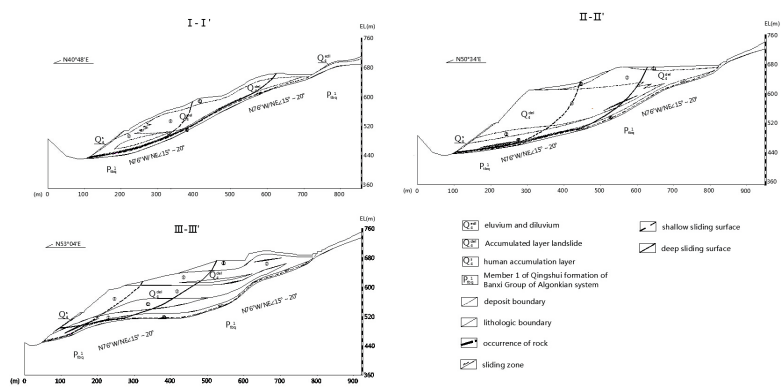
Figure 5. Geological profile of the landslide deposit.

Three representative engineering profiles: preflies I-I', II-II', and III-III' (Fig. 5) were selected for stability analysis by modified Janbu method under three different conditions: a natural state, a rainfall and an inundation with rainfall. The safety factors of two sliding surfaces were calculated, as given in Table 2.

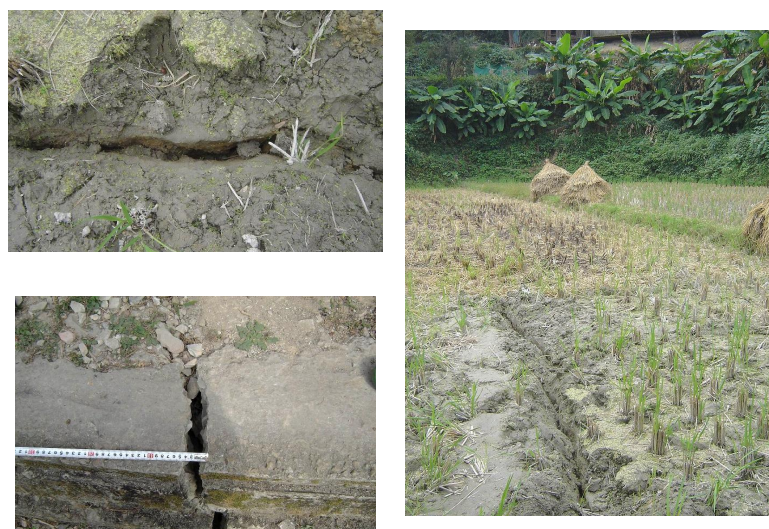
Figure 6. Photo of cracks in farmland at elevation 692 m.

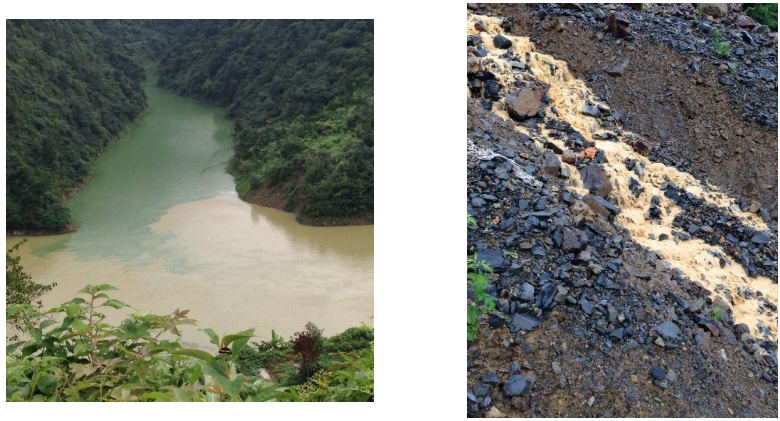
Figure 7. The phenomenon of muddy water coming from the landslide.
