Movement of the Donglingxin landslide, China, induced by reservoir inundation and rainfall

J. Yu^{1,2}, R. B. Wang^{1,2}, W. Y. Xu^{1,2}, L. Yan^{1,2}, J. C. Zhang^{1,2}, and Q. X. Meng^{1,2}

¹Research Institute of Geotechnical Engineering, Hohai University, Nanjing, China

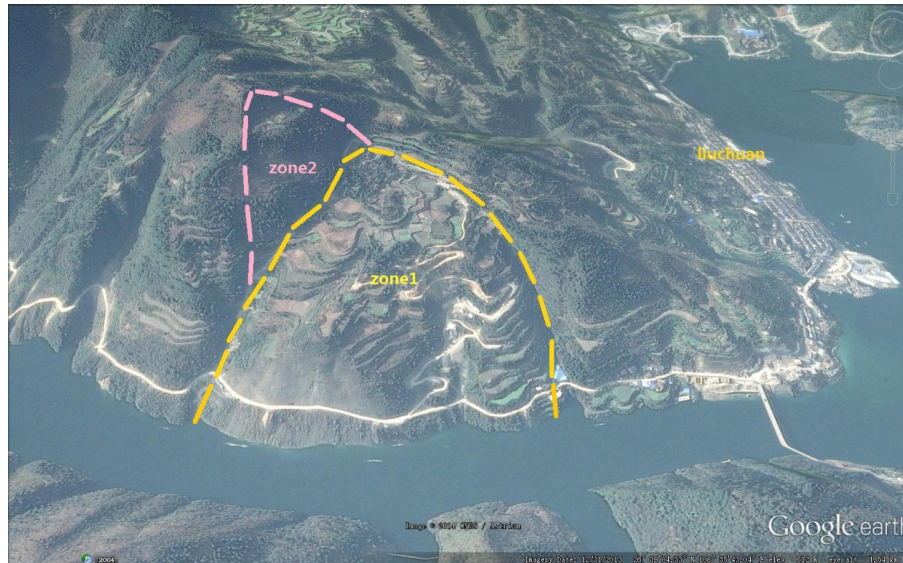
Figure 2. The Donglingxin landslide facing the Qingshui River (taken form Google earth).

excavation slope and the central ridge. The landslide can be divided into two zones, Fig. 2 shows the topography and zoning of the Donglingxin landslide (Google earth), (i) zone 1 extends along the Qingshui River with approximately 280 m in height and 310 km² in area, it is 800 m wide and lies between the riverbed and elevation 700 m, and the landform looks like a round-backed armchair (ii) zone 2 is located in the upper southern region of zone 1 with 120–220 m in height and 68 km² in area it is 200 m wide and lies between elevation 600 and 825 m. Borehole data indicate that the landslide is generally between 18 and 96 m thick, the thickest being about 140 m. The landslide volume is about 20 million m³. The slope of zone 1 ranges from 22° in the upper part to 40° in the lower part. The slope of zone 2 ranges from 17 to 35°. Houses are built at elevations of 670–702 m. Figure 3 shows the local village and rice paddies at an elevation of 692 m.

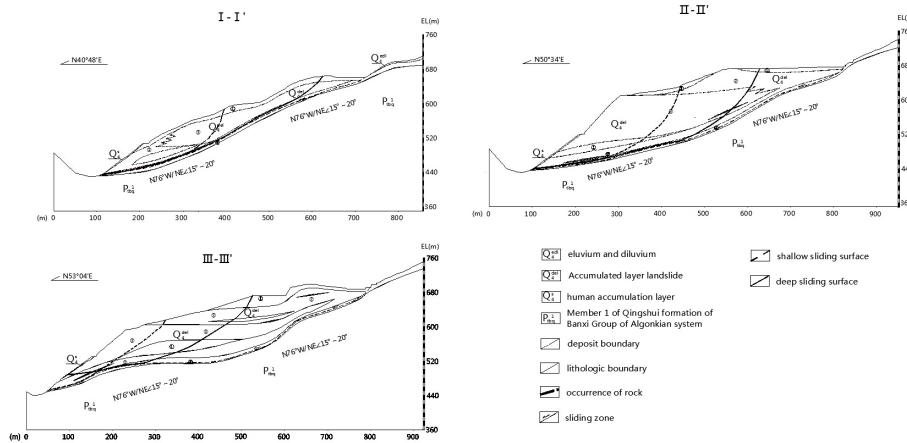
Figure 5. Geological profile of the landslide deposit.

The stratum outcropped in this region are Banxi group of Algonkian system and Quaternary. The lithology at the landslide is illustrated in three profiles presented in Fig. 5 along the sections marked by I-I', II-II', and III-III' in Fig. 4. Stratigraphic geo-materials differ in compositions and characteristics as described in detail below.

20 The field investigation suggested that there are two sliding surface in the slope (Fig. 5). One is shallow located within the lower accumulated layer landslide, which has a rotational slide mode. The other is deep through the sliding zone. It is a translational slide, and the slope may appear bedding landslide. The deformation characteristics show: the landslide belongs to thrust load caused landslide, the landform and material

Three representative engineering profiles: profiles I-I', II-II', and III-III' (Fig. 5) were selected for stability analysis by modified Janbu method under three different conditions: a natural state, a rainfall and an inundation with rainfall. The safety factors of two sliding surfaces were calculated, as given in Table 2.

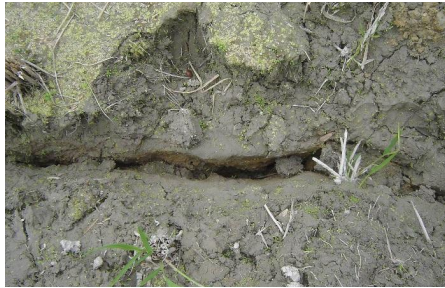
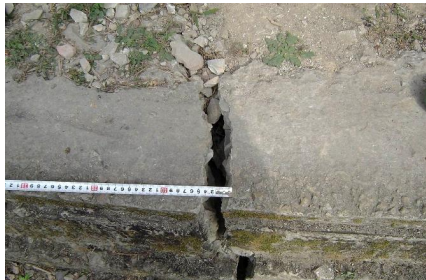
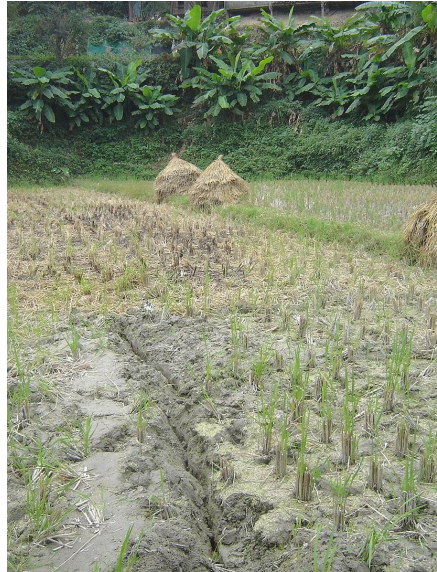
Figure 6. Photo of cracks in farmland at elevation 692 m.

1. In the eastern gully, where the landslide is covered by quaternary overburden, a few cracks 1–5 cm wide and about 2 m long were observed along N 10° W–N 20° E.
2. In the rice paddies at elevation 692 m, along N 10° W–N 5° E, a tension crack was
15 observed; it was 15–20 cm wide, more than 2 m long, and 10–30 cm in visible depth (Fig. 6).
3. The landslide experienced prolonged periods of intense rainfall, muddy water was observed coming out of the toe of zone 1 (Fig. 7).

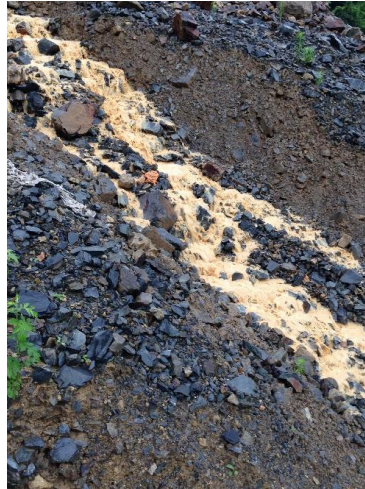
Figure 7. The phenomenon of muddy water coming from the landslide.

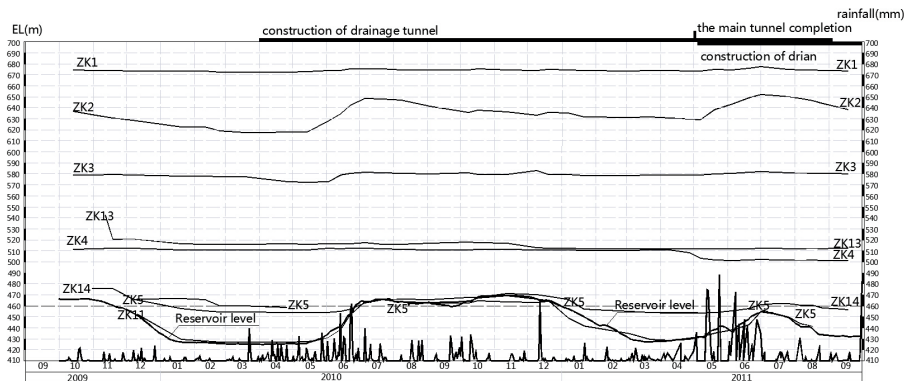
Figure 10. Monitoring results of groundwater levels at boreholes ZK1–ZK5, ZK11, ZK13, and ZK14 for the period October 2009 to September 2011 in the Donglingxin landslide. Rainfall for this period and water level in the Sanbanxi reservoir are also shown.

The data of groundwater level from the eight boreholes and the reservoir, rainfall data are plotted in Fig. 10. Looking at the groundwater level of boreholes ZK11 and ZK14 located in the lower part of landslide, four fluctuations can be identified.

1. From November 2009 to February 2010 the groundwater level at ZK11 and ZK14 dropped from 452.32 and 475.83 to 428.19 and 455.70 m, respectively. In this period, rainfall was low and the reservoir drainage system had been operating for three months; hence, these decreases in groundwater level are related to reservoir drainage.

2. From May 2010 to July 2010, the groundwater level at ZK11 and ZK14 rose by 36.17 and 8.89 m, respectively, because of increased reservoir water level. This was a period of heavy rainfall in the region, which also affected the groundwater level of boreholes ZK11 and ZK14.

3. From December 2010 to March 2011, the groundwater level at ZK11 and ZK14 dropped from 466.14 and 470.37 to 434.67 and 455.23 m, respectively. The decreases in groundwater during this period were induced by reservoir drainage.

4. From April 2011 to July 2011, the groundwater level at ZK11 and ZK14 increased from 428.52 and 453.48 to 454.57 and 461.08 m, respectively. The influence of the heavy rainfall on the groundwater level is more noticeable, because although the water level of the reservoir decreased during this period, the groundwater level increased.

At the upper part of the landslide (borehole ZK2; Fig. 10), three distinct phases can be identified in the groundwater level curve of KZ2, with May 2010 and May 2011 being the demarcation points.

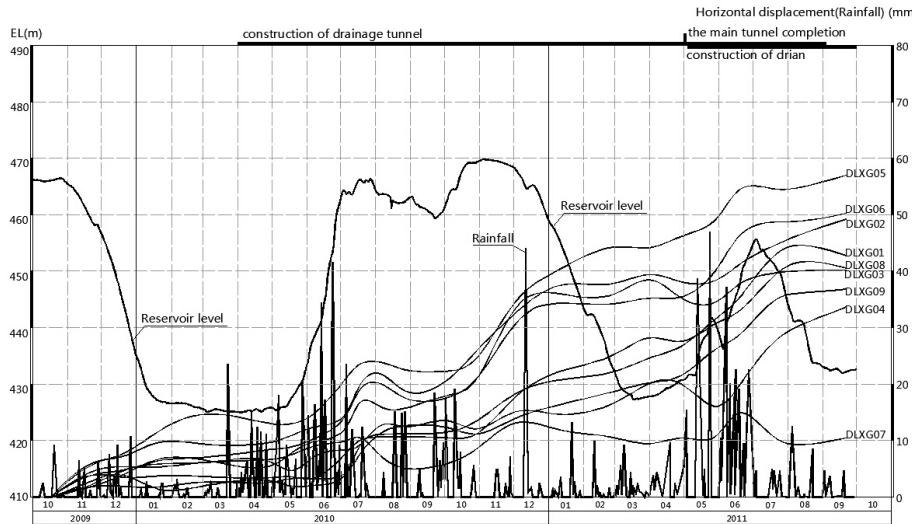
Figure 11. Monitoring results of displacements for the period from October 2009 to September 2011 in the Donglingxin landslide. Rainfall for this period and the water level in the Sanbanxi Reservoir are also shown.

reservoir water level during this period and great increases in the displacements of DLXG02, DLXG03, DLXG05, and DLXG06 from May 2010 to July 2010. The biggest displacement increment was about 12.08 mm. From July 2010 to September 2010 the reservoir water level gradually dropped by 6 m, but the deformation of these four observational points decreased by 5.77, 4.10, 2.17, and 4.22 mm, respectively. There were two increases in the displacements of DLXG01, DLXG08, and DLXG09 located in the upper part of the landslide; one occurred after the rainfall events in June 2010 and the other occurred after the rainfall events in September 2010.

3. After March 2011 the displacements of DLXG02, DLXG03, DLXG05, and DLXG06, induced by fluctuations of the reservoir water, increased; the displacements of DLXG01, DLXG08, and DLXG09 increased sharply after rainfall events.

Before this period, the displacement of DLXG04 increased slowly; after April 2011, once the main drainage tunnel was completed, the displacement of DLXG04 decreased by 7.32 mm in May 2011 and rapidly increased after May 2011.

1. Creep deformation: before April 2010, as shown in Fig. 11. The rate of this creep movement of landslide was increased slowly and gradually with a movement rate of 0.72–2.12 mm month⁻¹.
2. Instantaneous deformation: roughly since April 2010. The execution of work and inundation were the two principal triggers which activated the landslide, furthermore, rainfall induced the shallow rotational slide.
