Why the 2014 Ludian, Yunnan, China M_s 6.5 earthquake triggered an unusually large landslide?

The 3 August 2014 Ludian, China M_s 6.5 earthquake has spawned a mass of severe landslides. Of them the biggest occurred at Hongshiyuan near the epicenter, which has $1200 \times 10^4 \text{ m}^3$, clogging the Niulanjiang River, and creating a large dammed lake. Post-event field investigations yield detailed data on following aspects: rock structure of landslides, lithology, and geometry of the dam, composition and grain sizes of debris avalanches. Based on these data, this work further analyzes the geology and topography of the Hongshiyuan area, and explores the mechanism for occurrence of such an unusual big landslide at this place. Our analysis suggests the following conditions are responsible for this catastrophic event: (1) during the M_s 6.5 earthquake, the special terrain and site conditions led to abnormally strong ground shake. (2) Hongshiyuan lies nearby an active fault, where intense crustal deformation resulted in rock fractures and weathering. (3) Intense incision on the river increased topographic relief with steep slopes and scarps. (4) Combined structures, including unloa

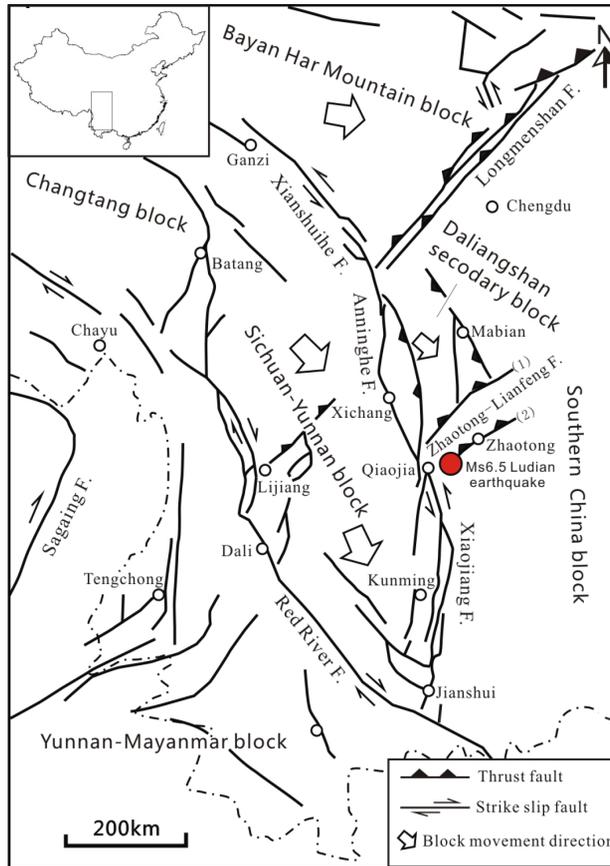
Figure 1. Sketch map showing tectonic and dynamics setting of the 2014 Ludian M_s 6.5 earthquake. (1): Lianfeng fault; (2): Zhaotong-Ludian fault.

The Ludian M_s 6.5 event took place in northeastern Yunnan Province of China, between the southeastern margin of the Tibetan plateau and South China block (Fig. 1). This area is characterized by intense neotectonic movements, numerous active faults and frequent major earthquakes (Allen et al., 1989; Song et al., 2002; Zhang et al., 2004; Xu et al., 2005; Guo et al., 2013). Field investigations suggested that the Ludian quake was generated by the southwest segment of the NE-trending thrust-dominating Zhaotong-Lianfeng fault that lies at the east flank of the Sichuan-Yunnan block (Fig. 1). This fault zone consists of two faults: the Lianfeng fault and Zhaotong-Ludian fault, dominated by thrusting (Wen et al., 2013), which serves as the south boundary of the secondary active Daliangshan block (Fig. 1). In this block, there exists also the nearly

As stated previously, the Ludian seismic area lies between the Sichuan-Yunnan block and Daliangshan block, southeast of the Tibetan plateau (Fig. 1). The Hongshiyuan seismic dam is nearby the Zhaotong-Ludian fault zone that consists of many NE- and NW-trending faults dominated by thrusting (Fig. 2). Influenced by the intense fault activity, fractured rock and strongly weathering surface characterize this region, particularly along faults or compressive fractured zones. Thickness of the weathering layer is controlled by lithology and topography. In general, dolomite, limestone, quartz-sandstone and siltstone have relatively stronger capability of resistance to weathering, while shale and argillaceous rocks are weak in this aspect. On the ridges and gentle slopes, weathering beds are thick, while they are thin in cols, gullies, and steep slopes. Previous data and the field investigations after the 2014 Ludian M_s 6.5 quake reveal that the weathering reaches down to depth 20–25 cm beneath the surface on either bank of the Niulanjiang River in the vicinity of Hongshiyuan. The horizontal extensions of weathering are

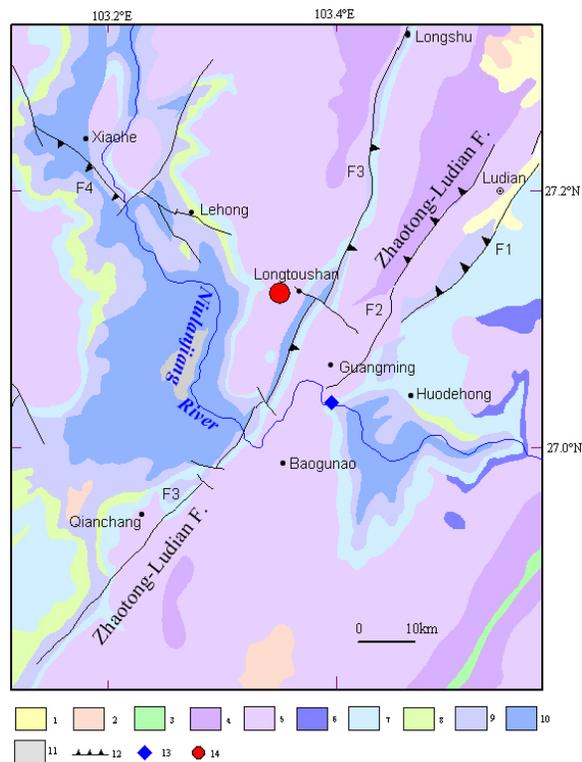
Figure 2. Geologic map of the Ludian seismic area (modified from Geological and Mineral Bureau of Yunnan Province, 1990). 1 Quaternary. 2 Neogene. 3 Jurassic. 4 Triassic. 5 Permian. 6 Carboniferous. 7 Devonian. 8 Silurian. 9 Ordovician. 10 Cambrian. 11 Sinian. 12 fault (triangles indicate dipping directions). 13 Seismic dam at Hongshiyuan. 14 Epicenter of Ludian M_s 6.5 event. F1: Sayuhe fault. F2: Zhaotong-Ludian fault. F3: Longshu fault. F4: Xiaohe fault.

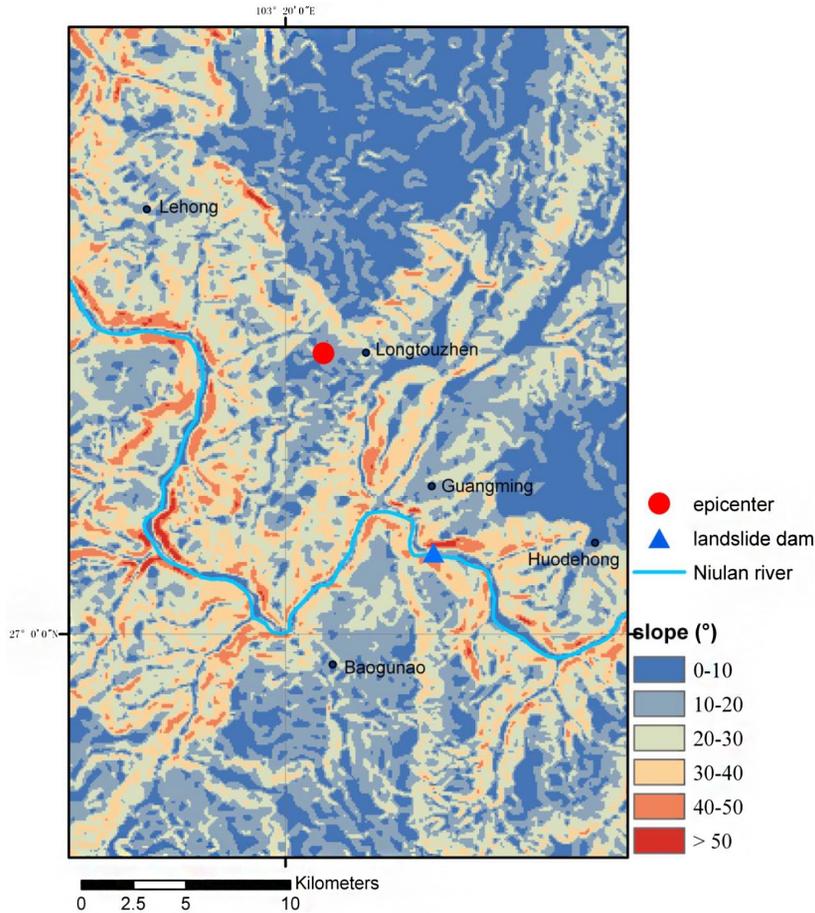
Figure 3. Map showing slope angles in the Ludian seismic area.

flows from southeast to northwest through the Ludian seismic area, with incision depth up to 1200–3300 m forming V-shaped valleys. On either bank of this river, the slope is usually very steep. Almost 80 % of the slopes steeper than 40° concentrate along either bank of the Niulanjiang River. While in the north and east of the seismic area, the terrain are relatively gentle, dominated by middle-height and low hills with steepness generally less than 20° (Fig. 3).

The valley of the Niulanjiang River is deeply incised with very steep slopes on either bank (Fig. 3). Under extensional stress, numerous unloading fissures developed in the rock of the slopes. Near the Hongshiyuan seismic dam, either bank of the river is of steep slopes, on which the rock contains particularly evident unloading cracks. On the surface, a mass of medium to steeply dipping unloading fissures, that are parallel to the river, are seen. For instance, at the slope behind the Pearl spring at the upstream right bank about 1.8 km to the seismic dam near Hongshiyuan, there exists a long unloading crack (Fig. 13). It dips almost vertically, parallel to the bank, with maximum opening width 15 cm by eyesight (Fig. 13). Cut by this crack, the rock surrounding it is nearly separated from the slope, forming a dangerous rock mass that is 30–40 m high, 15 m wide and 5 m thick, with a volume of 3000 m³. Beneath this rock mass, thin-beds of rock dip gently downstream. Gentle terrain appears below the steep slope, where the upper portion of the rock mass has partly broken off and hangs in the air locally (Fig. 13).

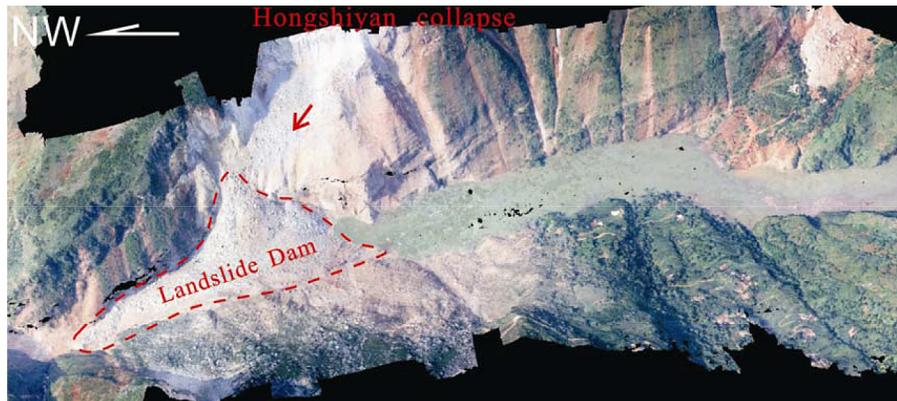
Figure 4. Unmanned Aerial Vehicle photo showing the seismic dam on the Niulanjiang River (Provided by Institute of Geophysics, China Earthquake Administration).

The Ludian M_s 6.5 earthquake has triggered a huge landslide on the right bank of the Niulanjiang River nearby the Hougshiyuan village (27.035° N, 103.397° E). Meanwhile it also partly reactivated the old landslide on the opposite left bank, part of which thrust down into the river. Both produced a huge barrier that clogged the river, resulting in a dammed lake (Fig. 4).

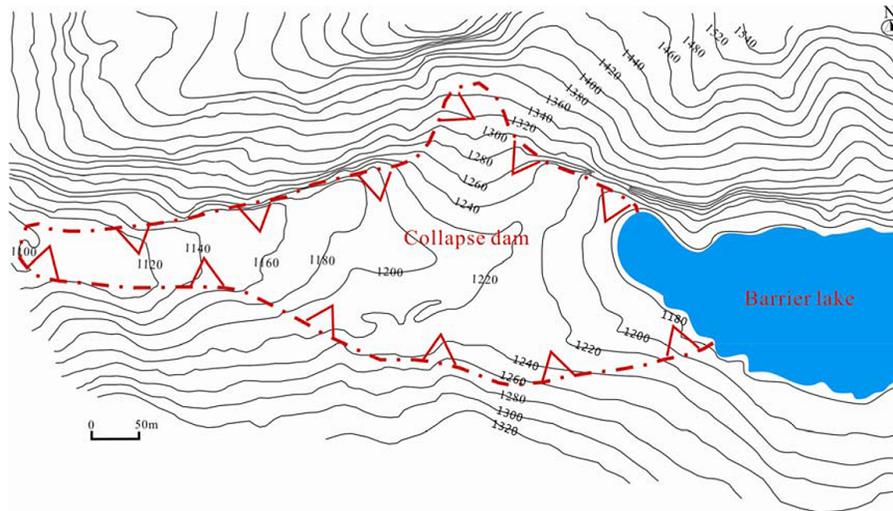
Figure 5. Planar distribution of the seismic dam on the Niulanjiang River at Hongshiyuan (Contours are elevations above sea, modified from Institute for Earthquake Engineering Survey of Yunnan Province, 2014).

The seismic dam at Hougshiyuan clogs in the V-shaped valley of the Niulanjiang River. From planar projection, it is up to 1000 m long and 270 m wide, with average width 262 m along the river and 301 m across the river, respectively, and a total projection area 80 000 m². The elevation is 1216 m at the top, and 110 m at the base, with dam height 120 m (Fig. 5). The total volume of the dam is estimated to be about 1200 × 10⁴ m³ (Institute for Earthquake Engineering Survey of Yunnan Province, 2014).

Overall, the dam top is higher on the right bank and lower on the left bank, and the culminations are 1270 m on the left bank and 1349 m on the right bank, respectively. Avalanche accumulation of the new landslide is present on the edge of the right bank. Upstream the dam, the slope is relatively steeper with an average slope ratio 1 : 2.5, while downstream the dam, the slope is relatively gentle with an average slope ratio

is 1 : 5.5. The dam top is 17 m wide at elevation 1222 m, and the base is 910 m wide along the river. And the length along the dam axis of elevation 1222 m is 307 m (Fig. 5).

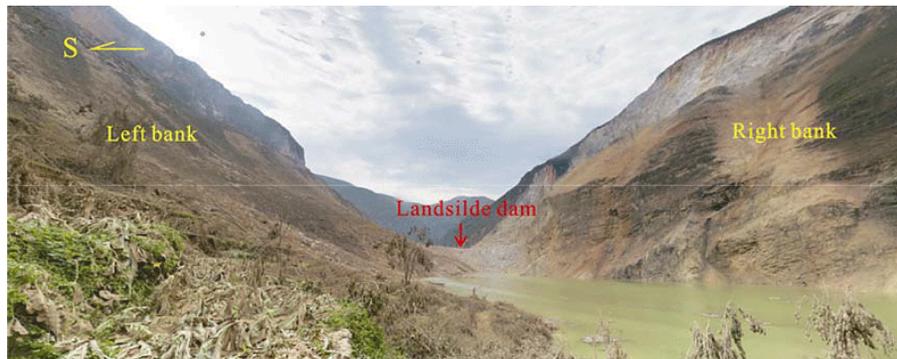
Figure 6. Overall look of the seismic dam (view toward west).

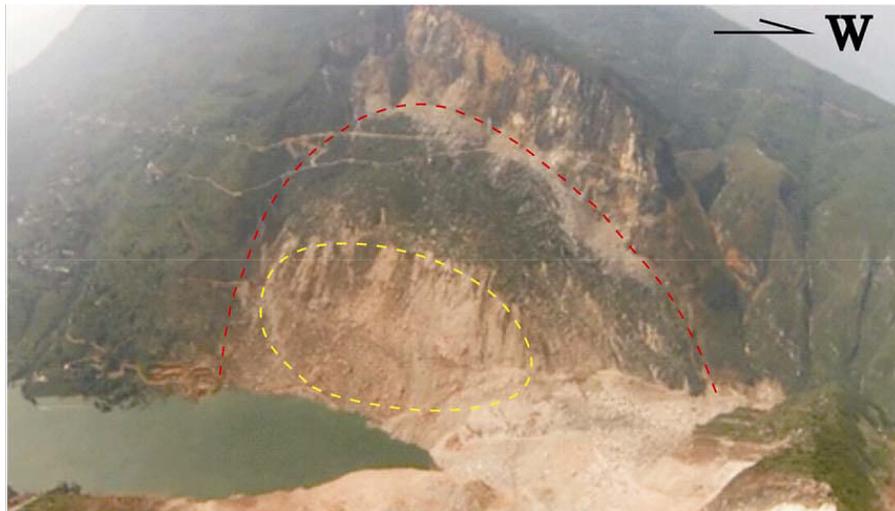
Figure 7. Photo showing the old landslide on the left bank of the Niulanjiang River. Red dashed line denotes old landslide. Yellow dash line shows the frontal part that collapsed during the 2014 Ludian event (view toward south).

The old landslide aforementioned lies at the southern end of the seismic dam. It is 1200 m wide at the base, 900 m from the top to the bottom in planar projection, with average thickness 80 m and volume $7920 \times 10^4 \text{ m}^3$ (Fig. 5). It is upper steep and lower gentle, with slope angles 36° and 18° above and below elevation 1400 m, respectively. Relevant data reveals 25–40 m thick cover on the river bed at this place, of which the muddy soil is thick up to 18–24 m. The river valley of this stretch convexes slightly to the right, implying a possible landslide-damming event in history. Because the front of this old landside was deposited on the original river bed, the right bank has been eroded by the river.

Affected by the 2014 Ludian M_s 6.5 quake, the rear edge scarp of the old landslide, which is 300 m high (elevations of rear and frontal edges are 1850 and 1550 m, respectively), suffered from local collapse (delineated by red dashed line in Fig. 7). Consequently, part of its front slipped into the river (delineated by yellow dashed line in Fig. 7). Meanwhile, the surface layer of this old landslide became loose, causing big massive boulders and pebbles to slide into the river, which joined the avalanches from the right bank to create the dam on the river. Nevertheless, the whole body of this old landslide remained stable during the shock, only a lot of cracks appeared on its surface. The triggered failures are composed of pebbles and massive stones intercalated with silt and clay, of which the largest boulder is up to 5 m in diameter.

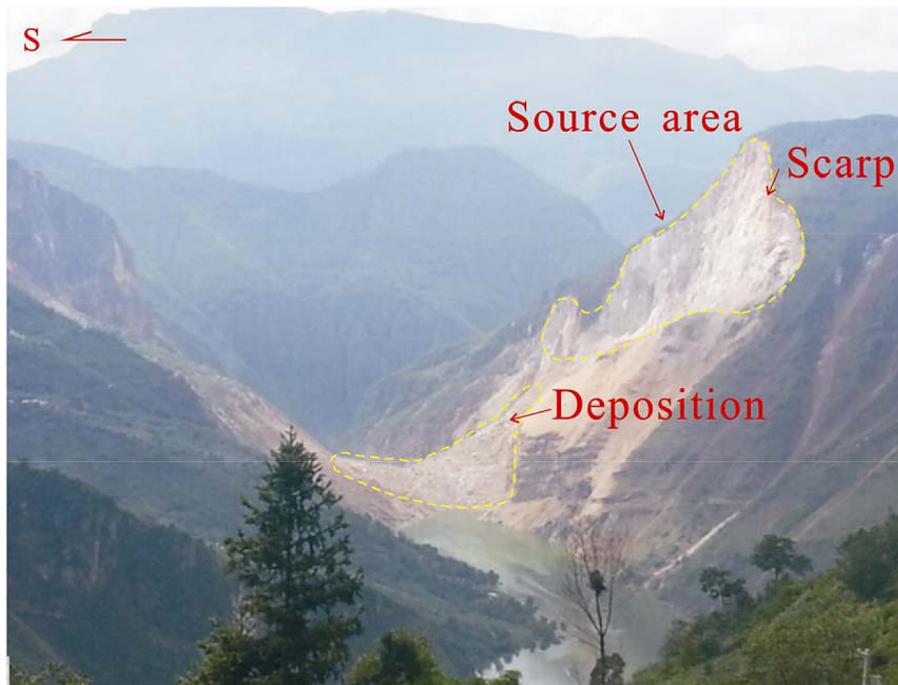
Figure 8. New landslide induced by the 2014 Ludian quake on the right bank of the Niulanjiang River (view toward west).

The avalanche on the right bank of the Niulanjiang River triggered by the Ludian event is the primary part of the seismic dam at Hongshiyuan. Its source is at elevation 1680 m. Upstream the river, this avalanche is 890 m long and the highest rear edge wall is up to 500 m. Total volume is estimated about $1000 \times 10^4 \text{ m}^3$ (Fig. 8). Field investigations indicate that the avalanche consists of medium-bedded dolomitic limestone and dolostone intercalated with sandstone and shale of Ordovician, Silurian, Devonian and Permian systems. These rocks are laced with numerous joints and fissures. In particular, unloading cracks and broken rocks characterize the upper landslide body. Detailed descriptions of this landslide are in the next section.

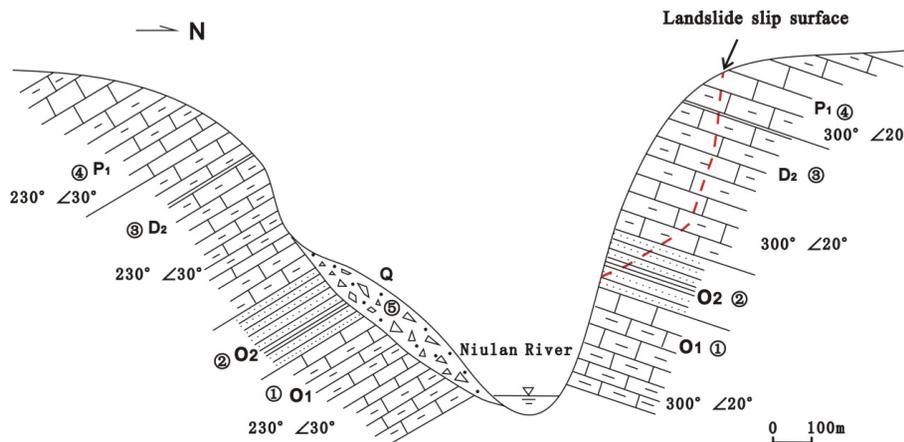
Figure 9. Cross section at the dammed lake before the 2014 Ludian quake. 1 – Dolomitite and limestone of lower Ordovician. 2 – Sandstone with shale and mudstone of middle Ordovician. 3 – Dolomitite and limestone with argillutite of middle Devonian. 4 – Massive limestone and dolomitite of lower Permian. 5 – Quaternary diluvium deposit.

On either bank of the river around the seismic dam, rocks strike in different directions, while all dipping gently. On the right bank, rock attitudes are NW 20–30°/SW 15–30°; and on the left bank, rocks dip toward downstream with attitudes NE 20–60°/NW 10–30° (Fig. 9).

At this place, upper portion of the slope is dolomitite that is relatively tough, while sandy mudstone and shale constitute its lower portion, which are relatively soft (Figs. 9 and 11). In this case, the rock of lower portion of the slope is steadily deformed under the gravity load of the upper portion rock. Consequently, the brittle rock in the upper portion of the slope is prone to fracturing, while the soft rock in the lower portion of the

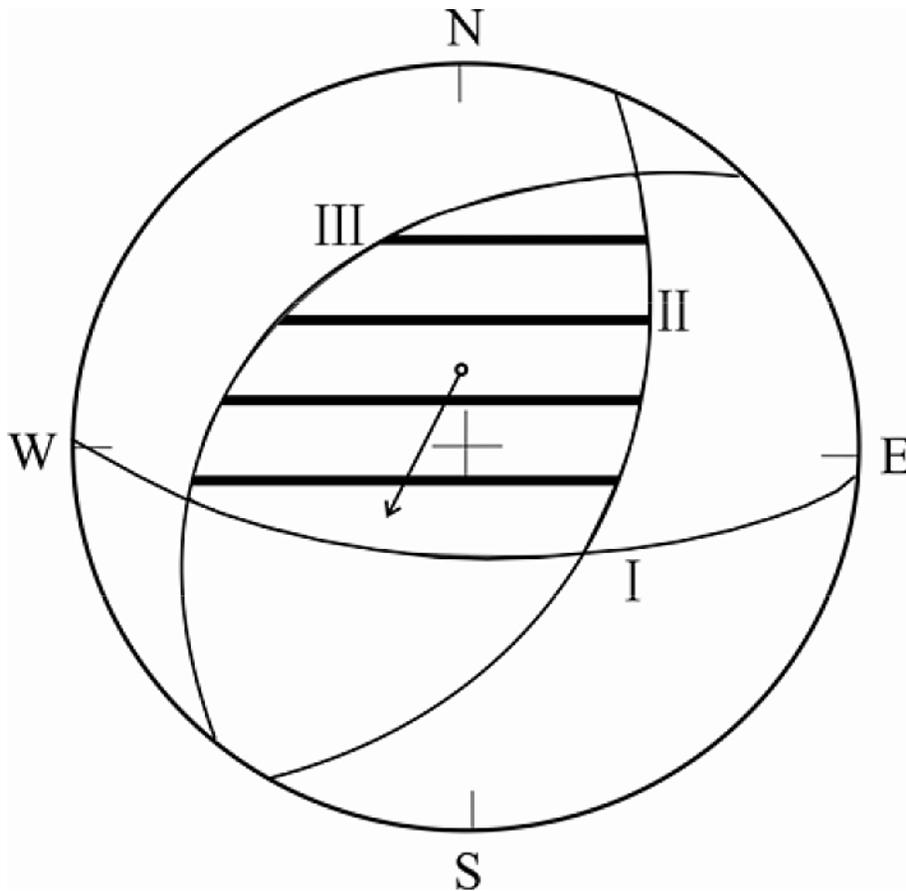
Figure 10. Wolf projection of joints in individual avalanches at Hongshiyan (projection of lower hemisphere). I: steep joint parallel to river, II: steep joint normal to river, III: interbed joint (see Table 2).

According to attributes of three kinds of joints, we use the projection on the equator plane of the Wolf net to describe the structure of the rock on the slope around the landslide (Fig. 10). It can be assumed that the steep joint normal to the river (i) and that parallel to the river (ii) cut the rock body into a small mass. Plus the gentle dipping joint (iii), they will generate an unstable block (shaded area in Fig. 10). Under seismic motion, this block will be prone to slip toward the open side of the slope (along river flow) (arrow in Fig. 10).

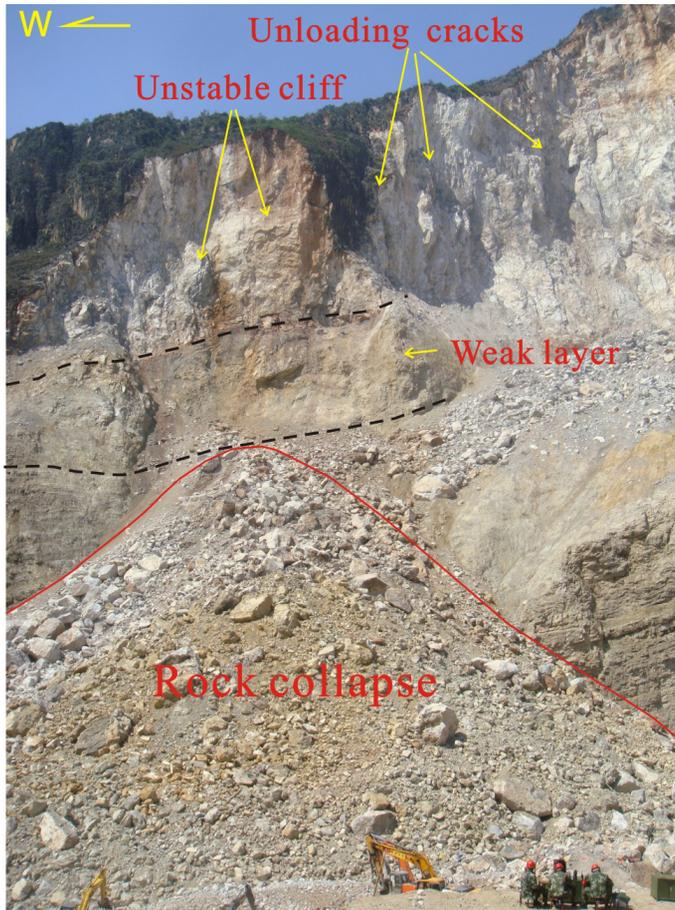
Figure 11. Rock structure that unleashed rock avalanches at Hongshiyuan during the Ludian earthquake.

slope will become potential slip surfaces. When an earthquake occurs, the fractured rock will slide down along the unloading fissures parallel to the river or other structural surfaces (such as interbed joints), leading to landslides. As the soft rock is present in a large area, and fissures and joints developed well in the touch rock of the upper portion of the slope, the resulting avalanches will also cover a big area (Fig. 11).

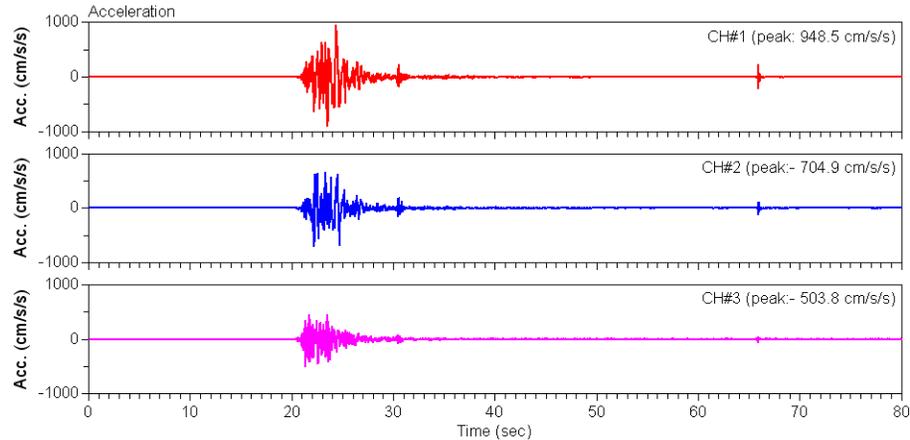
Figure 12. Peak ground accelerations recorded by the Longtoushan seismic station during the 2014 Ludian M_s 6.5 earthquake. Red: EW component. Blue: NS component. Pink: vertical component.

Although the 2014 Ludian earthquake is a moderate event, the Longtoushan station nearby the epicenter recorded high acceleration values of ground motion. The peak ground accelerations of NS, EW and vertical components are 948.5, 704.9, and 503.8 Gal, respectively (Fig. 12). The intensity of the most heavily affected area is IX degree according to Chinese seismic intensity (Seismic intensity zoning group et al., 1990), where lies the Hongshiyuan seismic dam near which is only 10 km distant to the epicenter. It means a rather strong effect of the Ludian quake.

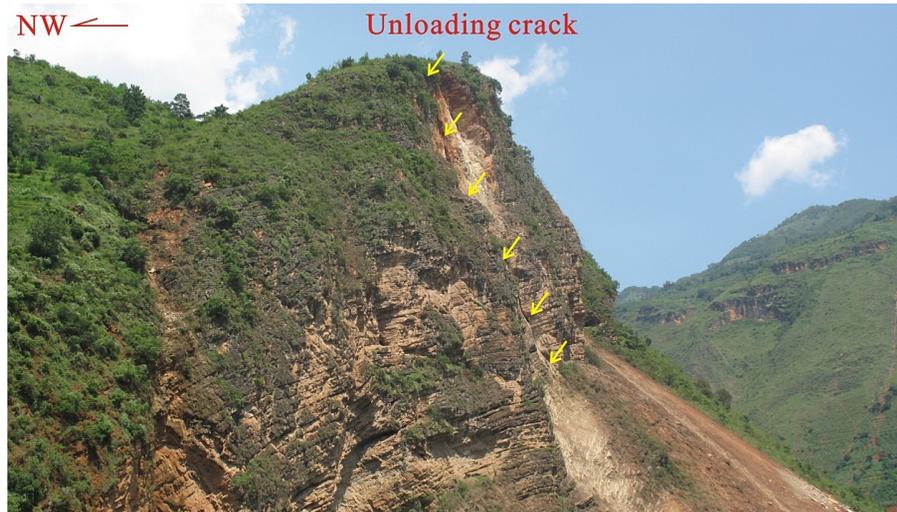
Figure 13. Unloading fissures (shown by yellow arrows) on the rear edge of slope at Pearl spring.

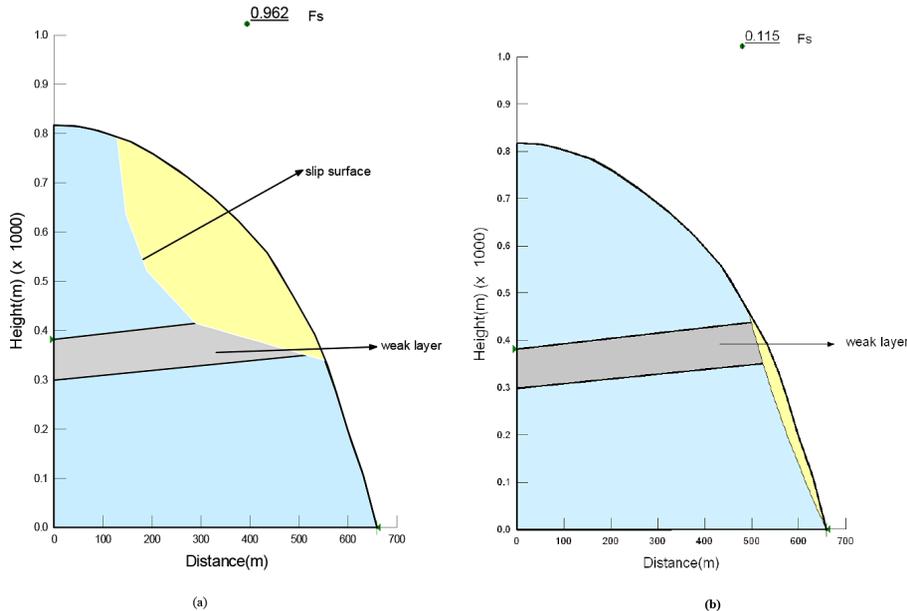
Figure 14. F_s of the Hongshiyuan slope under seismic loading (Yellow parts represent the slope failures; **(a)** with a slip surface; **(b)** without a slip surface).

The results show that t F_s of the slope is 1.450 before the event, implying a safe state. While it drops to 0.962 after 300 gal of seismic motion is loaded (Fig. 14a), which means this slope enters an unstable state. Although this numerical calculation is preliminary, its results demonstrate that the seismic motion can lower F_s of the slope, leading to its instability. In other words, the Ludian earthquake should be the direct cause for the landslide at Hongshiyuan. On the other hand, however, if there was no existing slide plane, the scale of the seismic landslide would have been very small under the same seismic motion, at least not so large as the real case we see now (Fig. 14b). Thus we suggest that the existing potential slide plane or its formation should be another critical reason for the unusually big landslide at Hongshiyuan.

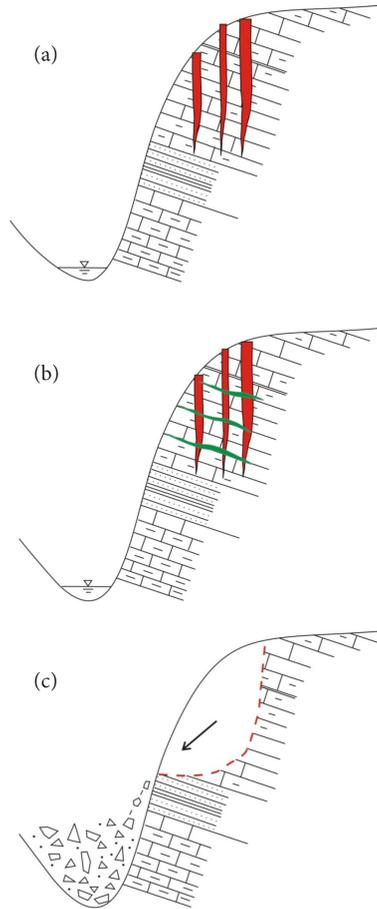
Figure 15. Schematic diagram showing assumed forming process of rock avalanche at Hongshiyuan. (Red bars are unloading cracks, green lines are joints along beds.)

- *Stage 1*: Under strong ground shaking, the joints parallel to and normal to the river and unloading cracks (red bars) are opened and connected (Fig. 15a).

- *Stage 2*: Joints along beds (green lines) develop further, resulting in rock masses that intersect each other (Fig. 15b).
- *Stage 3*: Rock masses lose stability, sliding downward, collapsed, and moved over a short distance along the sliding surface to the inside of the valley. This stage is a process of rapid motion as well as rock-mass colliding each other and fracturing. Finally, it creates masses of varied sizes and powder-like piles, which block the river course coupled with the old landslide on the left bank, resulting in a dammed lake (Fig. 15c).

Of these stages, the first and second may proceed simultaneously, hardly being distinguished. When the earthquake occurs, because of intense tensile stress at the slope, the first stage may be slightly ahead the second one. And during the second stage, extensional split of vertical fissures happens from the beginning to the end.
