# Structurally controlled hazard mapping of Southern Leyte, Philippines

P. K. Luzon<sup>1,2</sup>, K. P. Montalbo<sup>1,2</sup>, J. A. M. Galang<sup>1,2</sup>, J. M. Sabado<sup>1,2</sup>,  
C. M. Escape<sup>1,2</sup>, R. P. Felix<sup>1,2</sup>, and A. M. F. Lagmay<sup>1,2</sup>

Received: 1 September 2015 – Accepted: 7 September 2015 – Published: 1 October 2015

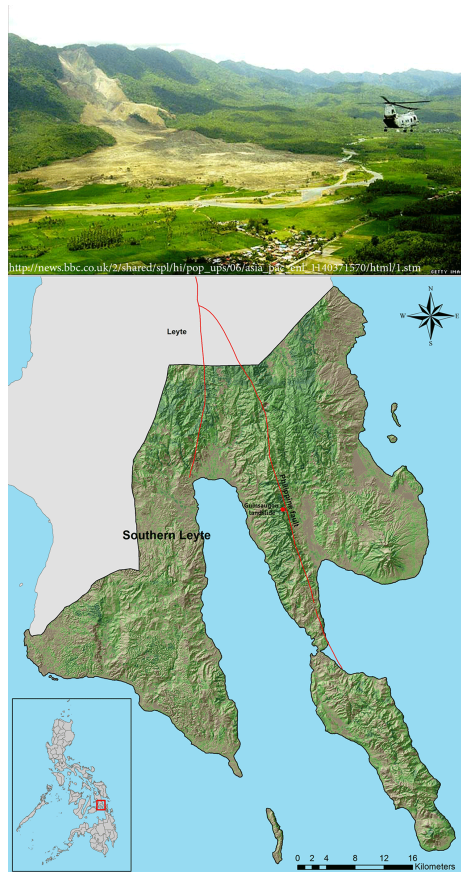
**Figure 1.** Location of Southern Leyte in the Philippine map with specifics of the Guinsaunon landslide (photo shown on top from BBC News UK) and Philippine fault segment in the province.

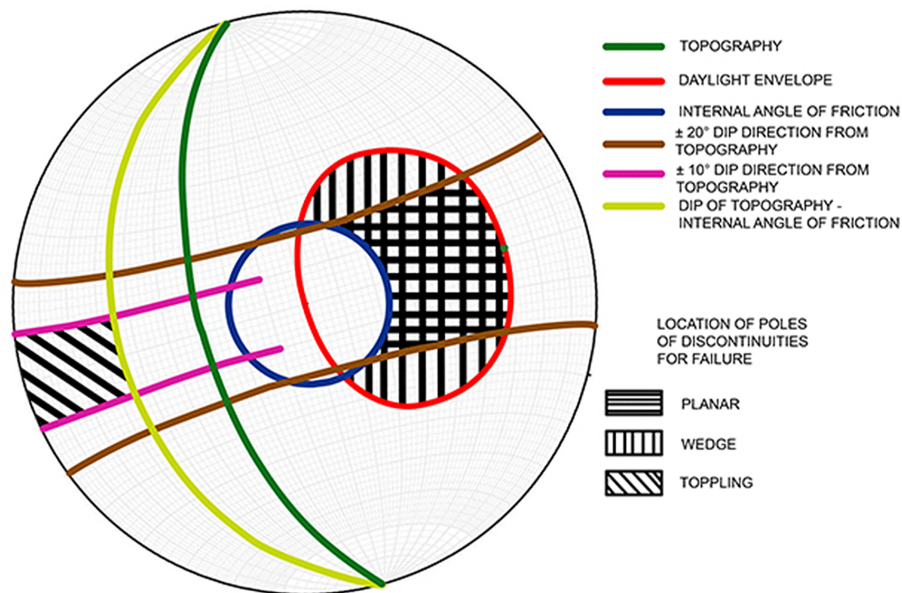
**Figure 3.** Criteria for discontinuities to cause failure (planar, wedge or toppling) on a given slope (Wyllie and Mah, 2004).

1. the sliding plane must strike parallel or nearly parallel to the slope face;
2. the sliding plane must have its plane dip less than the dip of the slope face;
3. the dip of the sliding plane should be greater than the angle of friction of the sliding plane;
4. the upper end of the sliding plane should intersect the upper slope or where the tension crack terminates;
5. lateral boundaries of the slide should be defined by the negligible resistance to sliding provided by the release surfaces.

2. The line of intersection plunge should be less steep than the dip of the slope face and steeper than the friction angle of the two sliding planes. The slope face inclination is determined by the view at right angles to the intersection line. The true dip of the slope face would only be determined if the dip direction of the intersection line is the same as the dip direction of the slope face.

These concepts can be simply illustrated as shown in Fig. 3. Matterocking applies these in an iterative manner to the entire DTM and computes the slopes which satisfy the criteria for instability. It generates a map of potential rock slide zone which is used as landslide source for propagation.

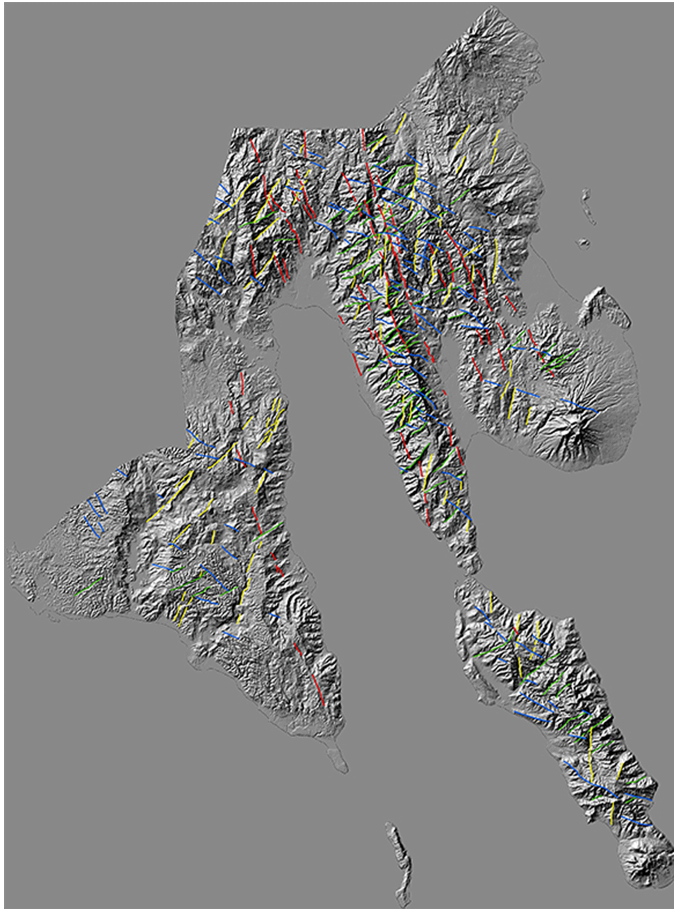
**Figure 4.** Lineament Analysis for Southern Leyte.

In this study we use high-resolution imagery derived from Interferometric Synthetic Aperture Radar (IfSAR) to identify structural features for use in hazards mapping of landslides using numerical models. The IfSAR used is from a 2012 nationwide digital terrain model (DTM) and digital surface model (DSM) dataset with 0.5 m vertical accuracy and 5 m pixel resolution. Shaded relief images generated from these DEMs provided high resolution and shaded relief images that reveal well-defined lineaments and distinct changes in the face of mountains slopes. Four sun azimuth directions were used to highlight geological structures in the province of Southern Leyte (Fig. 2).

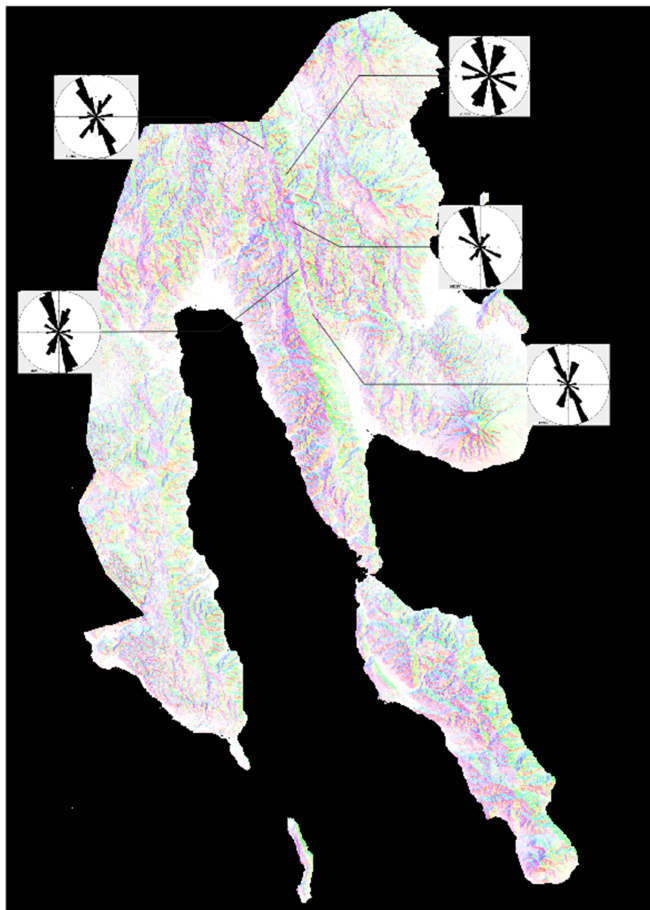
**Figure 5.** Different rose diagrams for a segment of the Philippine fault.

Selections of discontinuities along the Philippine fault are also presented in rose diagrams. Shown in Fig. 5 are different segments of the lineament. The diagram is consistent with the usual rose diagram appearance of a left lateral strike slip fault with a main long axis parallel to the master fault (i.e. Philippine Fault) and 2 other minor orientation directions that represent associated faults such as Riedel shears.

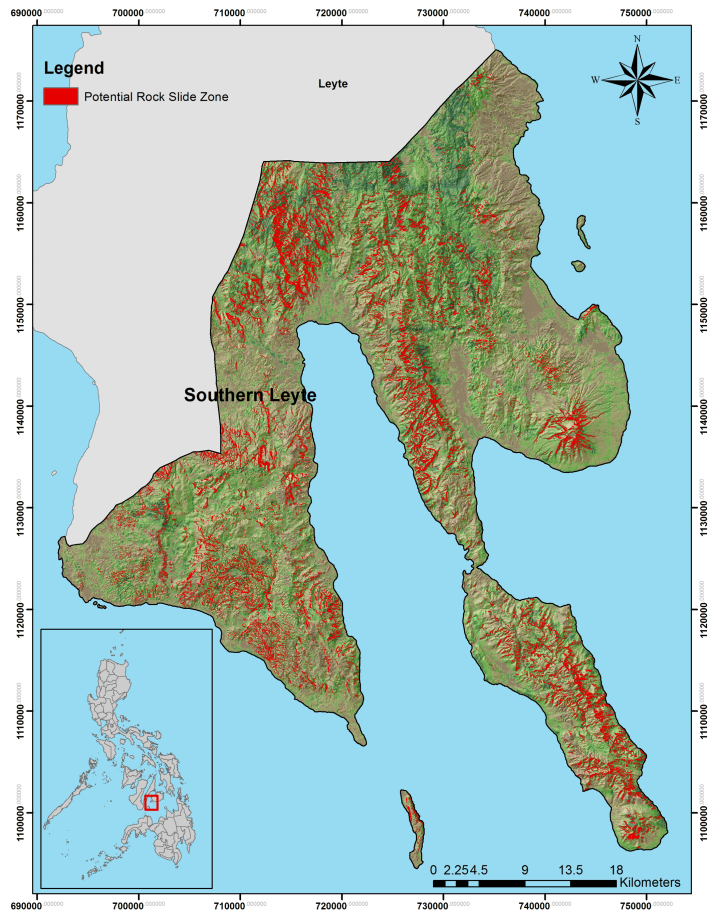
**Figure 6.** Area of potential rockslide zones in Southern Leyte using Matterocking.

Failure zones generated by Matterocking are shown in Fig. 6. The province of Southern Leyte is highly susceptible to structurally controlled landslide as obviously presented. This includes the analysis for a planar and wedge failure that may occur due to discontinuities considered. Generally steep slopes in the region and presence of discontinuities due to the segment of PF caused this high susceptibility. Looking closer on the Guinsaun Landslide area, we can expect more failure as for the presence of the scarp before the mass movement happened. It is the case of wedge failure that could trigger most rock slide. This is due to the persistence of intersecting discontinuity sets in the area. About 10 % of the slopes in the province have failure potential according to the model.

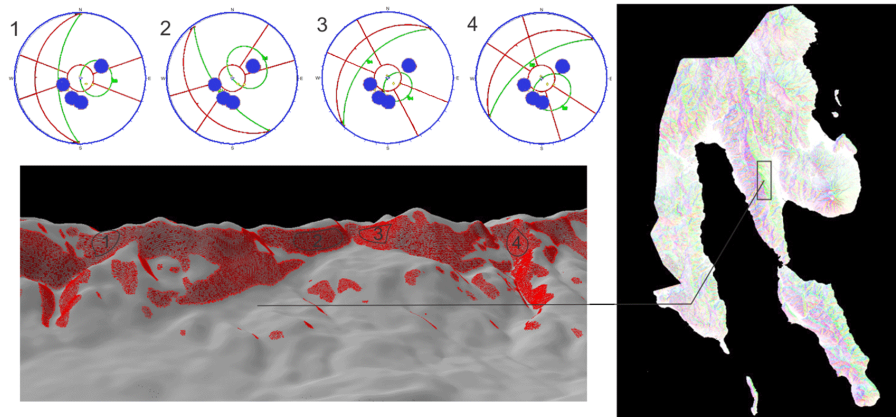
**Figure 7.** Kinematic analysis of selected slopes in Mt. Can-abag.

Kinematic analysis was performed for several slopes of the Mt. Can-abag east facing facade as shown in Fig. 7. Slopes covered in red are those that were identified as rockslide source. These were chosen just to verify and further analyze the mode of failure that could occur as shown in Table 3. Present discontinuity sets in the area were used in the analysis. Results have shown the probability of wedge and planar failure in almost all cases. Intersection of Discontinuity sets 41/61 and 41/185 most probably would cause wedge failure on this side of the mountain. Toppling failure couldnt be

taken into account in this case due to lack of very steep recorded discontinuity. We considered the limitation of DEM's resolution that dip angles would always be less than the actual values on the field. Planar slide in S1 follows the configuration slide in one slip plane of the Guinasugon landslide.

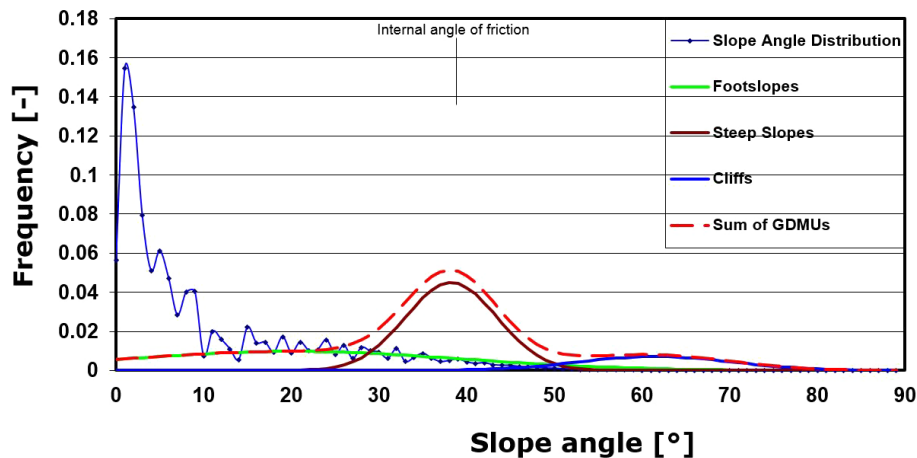
**Figure 8.** Slope families method using Histofit for the slope angle distribution of Southern Leyte, Philippines.

It should be noted that this method assumed structurally homogeneous areas in regional scale as scope (precision) (Jaboyedoff et al., 1999). To put into scope the parameter used in determining the friction angle for the region, the slope family concept presented by different studies by (Strahler, 1954), Baillifard et al. (2005), Jaboyedoff et al. (2004), Loye et al. (2008) and Michoud et al. (2012) is a suitable tool due to prominent slope families produced by active movement in large part of the province (Cole et al., 1989; Duquesnoy, 1997). Result of Histofit (Loye et al., 2009; Michoud et al., 2012), a program for computing Gaussian fittings for a slope angle distribution shows a threshold value for a family of steep slopes of 38° (Fig. 8) which corresponds to the internal angle of friction. Direction of discontinuities produced by this movement are also as prominent. Thus, an incorporated effect of critical slope and discontinuity sets is enough for identifying potential source of failure.

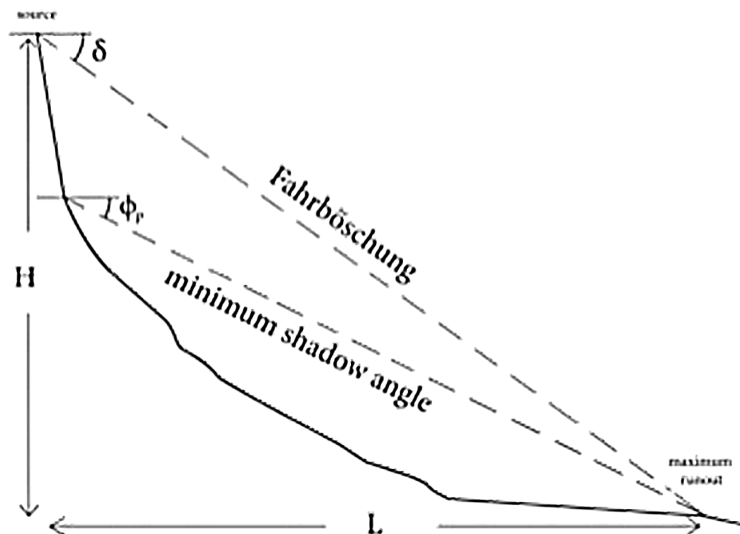
**Figure 9.** Simplified scheme using an empirical approach to determine runout projection.

A number of models use an angle from source to extent of a landslide to determine possible runout within the area of interest (Dorren, 2003). Studies differ on what the H/L ration to use in determining this limit angle as shown in Fig. 9, either the highest portion of the foot slope or the top failure plane. Evans and Hungr (1993) suggested that the minimum shadow angle is preferable (H is the lowest portion of the failure block). To come up with an acceptable value of this angle, a certain amount of landslide events' runout should be considered. A study by Onfri and Candian (1979) used 98 rockfalls to suggest a minimum Fahrboshung in Italy from structural instability to be 28.34°. Evans and Hungr (1993) used 16 profiles of rockfall paths suggesting a minimum shadow angle of 27.5° in British Columbia. Several studies also reported lower values (i.e. 22–24°) for shadow angles in smooth surfaces such those in snow and grass covered areas (Evans and Hungr, 1993). The use of this approach is widely accepted in terms of capturing real events scenarios.

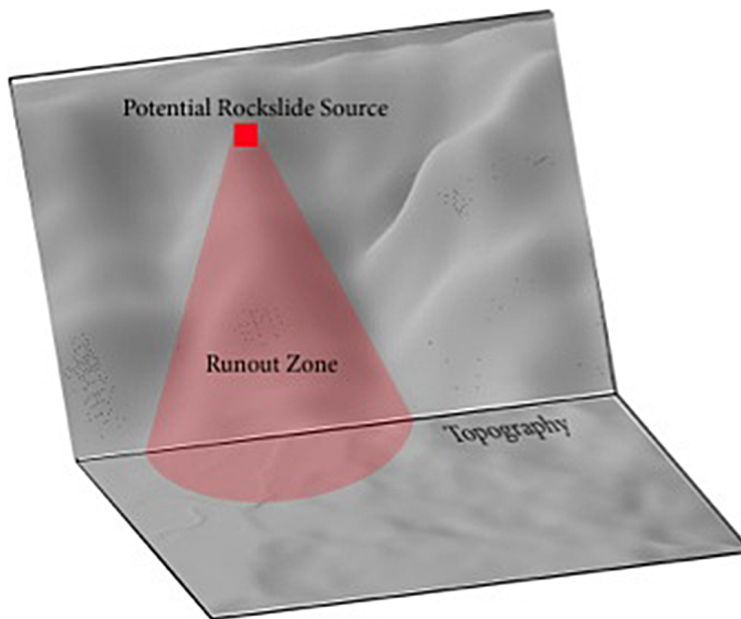
**Figure 10.** The cone method applied to simple topography in estimates of the runout zone using Conefall modified from Loye et al. (2008).

where  $z$  must be less than the surface height. The estimated runout in 3-D is the cone envelope (Fig. 10) covered by the aperture angle from the source point (Loye et al., 2008).

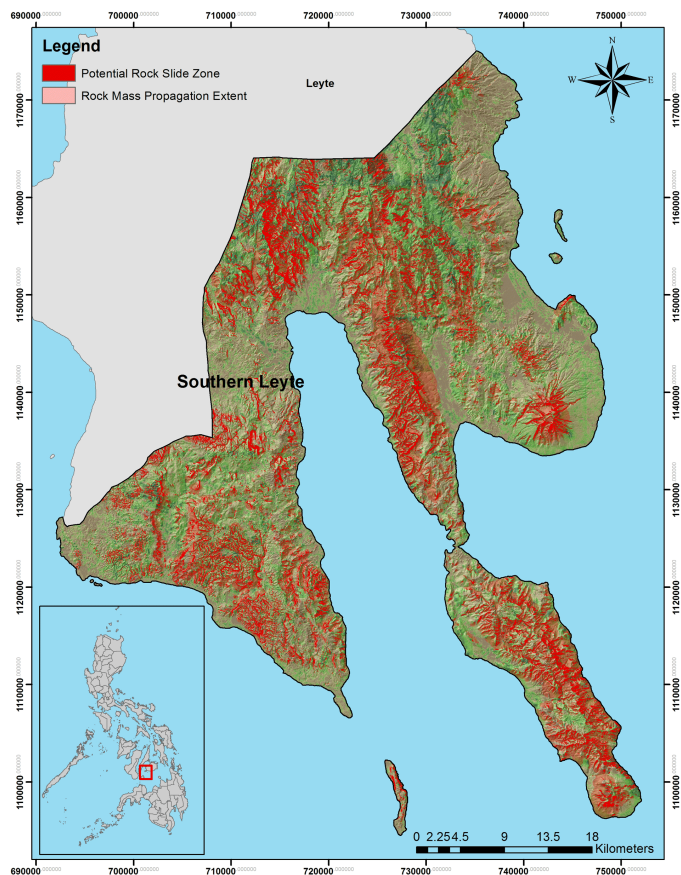
**Figure 11.** Combined map of potential rock slide zone sources and propagation extent for Southern Leyte.

Since the sources of rockfall/slide were already identified, zones where it will propagate were also mapped using Cone-fall. The study utilized a runout angle of 20° as discussed above. Ratio of “safe” zones from structurally controlled landslide to high susceptibility area is 2 : 1. Shown in Fig. 11 is the combined map for the source and propagation extent of Southern Leyte.
