A huge deep-seated ancient rock landslide: recognition, mechanism and stability

M. G. Tang^{1,2}, Q. Xu¹, Y. S. Li², R. Q. Huang¹, and G. Zheng¹

¹State Key Laboratory of Geohazard Prevention and Geoenvironment Protection, Chengdu University of Technology, No. 1 Erxianqiao Rd, 610059, Chengdu, China

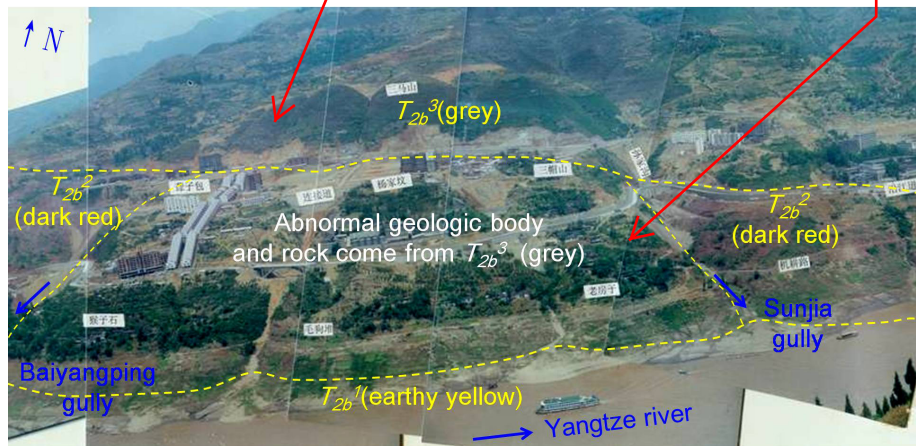
Figure 2. The abnormal geomorphologic and geological phenomenon at Sanma Mountain in the new city of Fengjie (photograph taken in 1998).

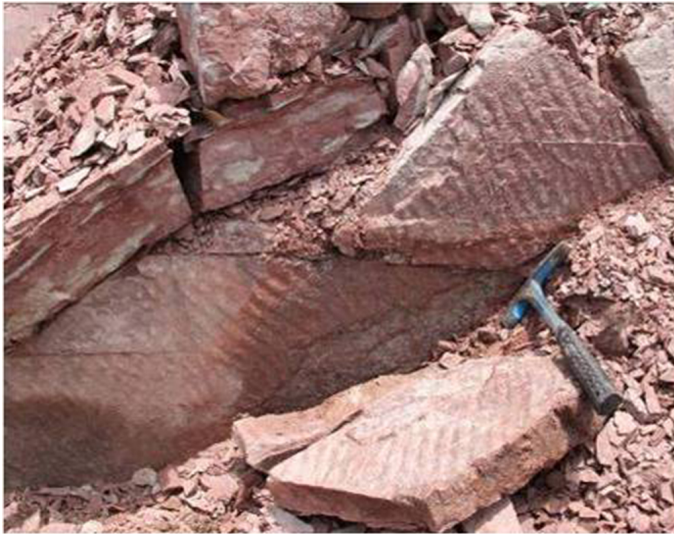
Figure 9. Ripples displaying reversal rock.

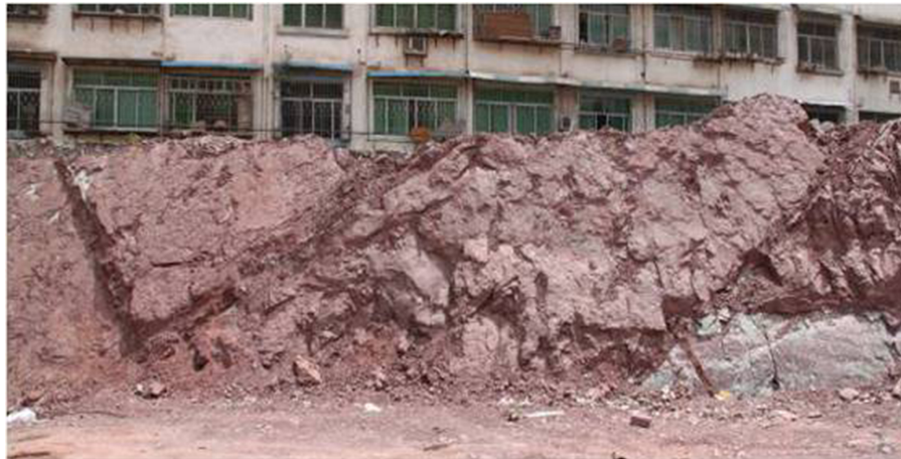
Figure 10. Conjugate shear jointing.

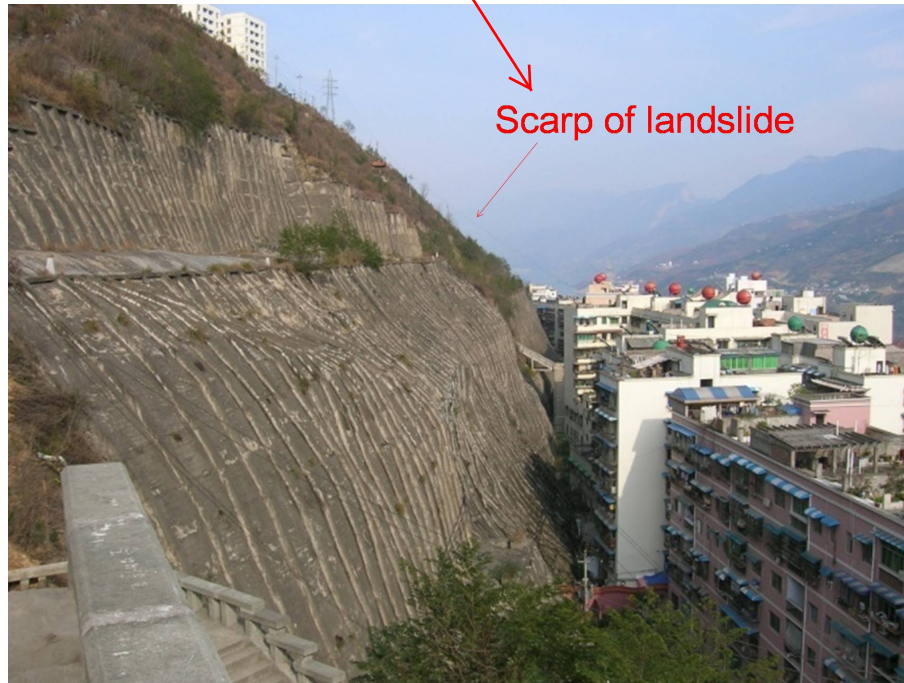
Figure 14. The scarp of the Sanmashan landslide (March 2006).

- 15 Crown or head scarp (Fig. 14): there is unclear (elevation above sea level or height difference ?); elevation of 300–410 m. During an foundation investigation, the sliding face and scar in the end of the landslide were exposed (Fig. 15).

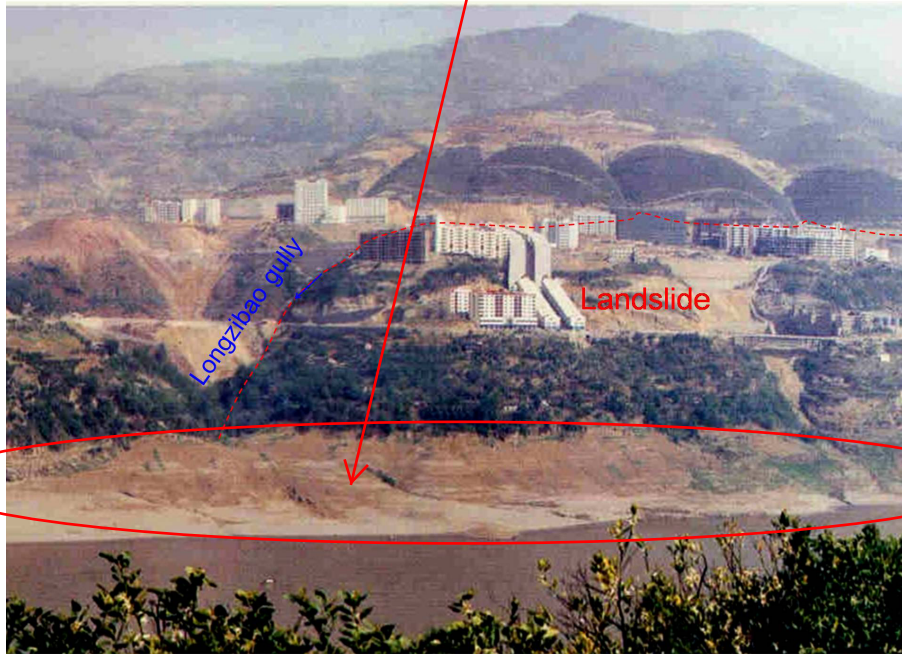
Figure 18. The western lateral edge of the Sanmashan landslide.

Western lateral edge: there is a shallow groove called Longzibaogou leading into Yangjiaping gully (Fig. 18). Sliding scratches were observed during level drilling (Fig. 19).

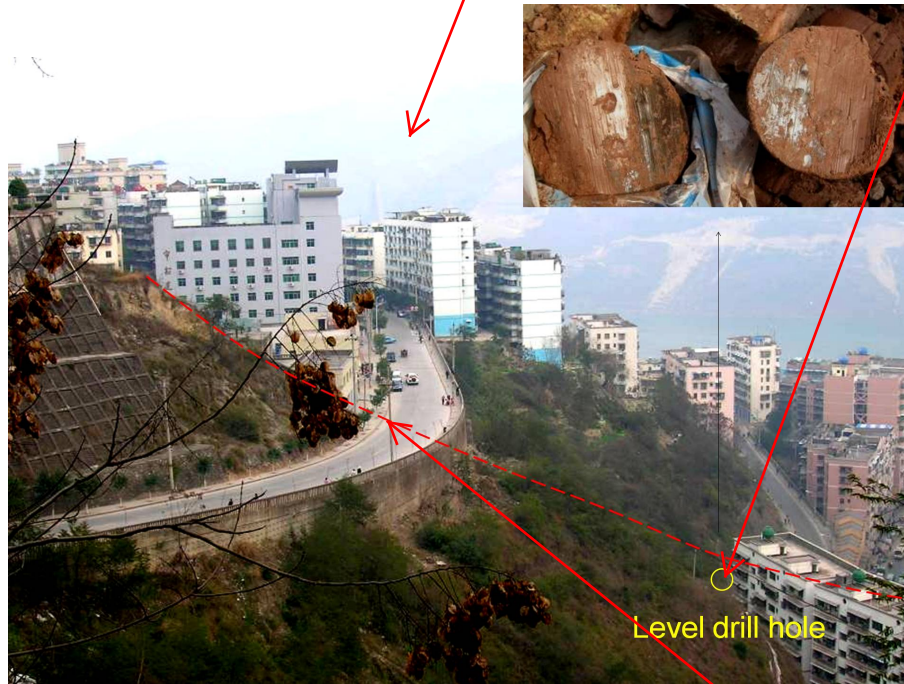
Figure 19. The sliding scrape in level drill hole near by the western lateral edge.

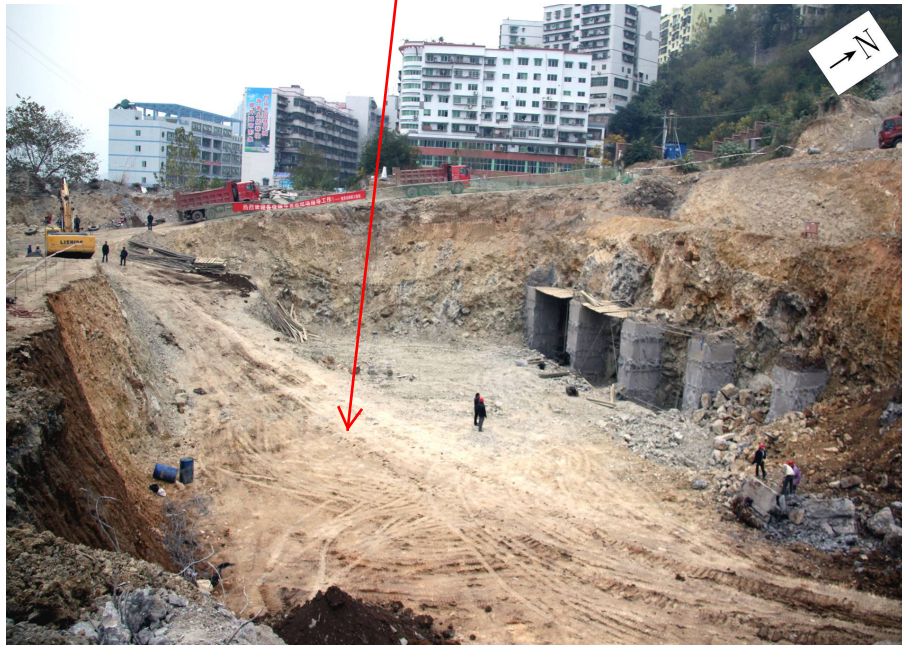
Figure 22. Overview of the foundation pit (photograph taken in 2013).

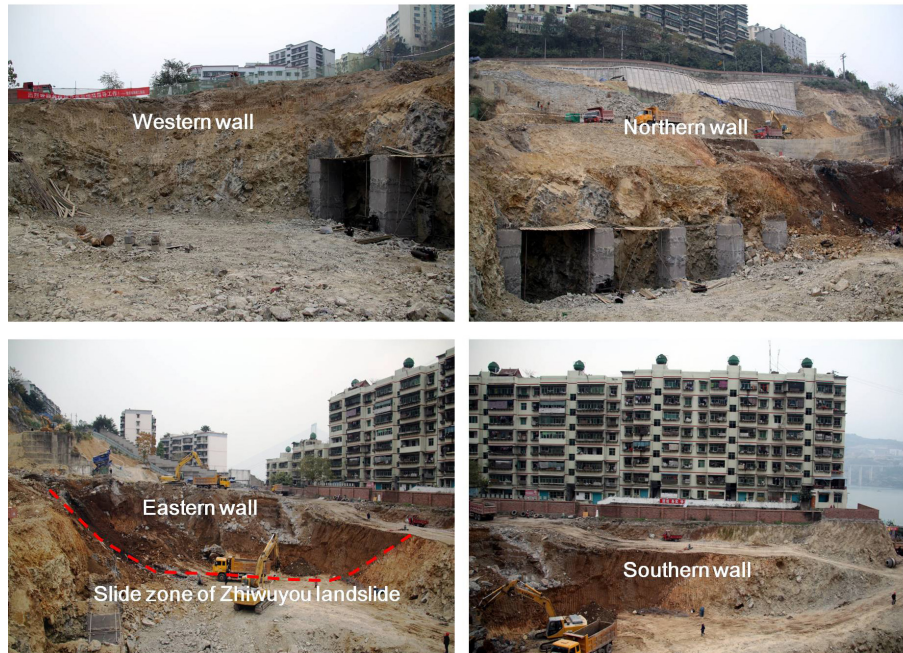
Figure 23. The geologic structure of four walls in the foundation pit.

Landslide deposits (Q^{del}): including three units followed. (1) The first unit is dense to denser, and contains gray or dark gray crushed stone, within silty clay and sand. The crushed stone is derived from limestone and marlite (T_{2b}^3). A large foundation pit was constructed in the center of the landslide during field surveys (Figs. 21 and 22). The slide zone of the Zhiwuyou secondary landslide is exposed in the eastern wall (Figs. 23 and 24), and the rock masses in the western wall have anomalous attitudes

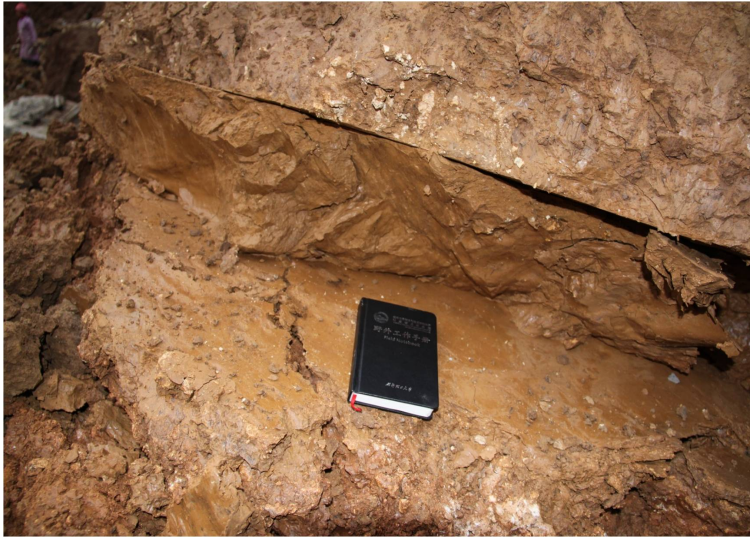
Figure 24. Close-up view of the slide zone of the Zhiwuyou secondary landslide.

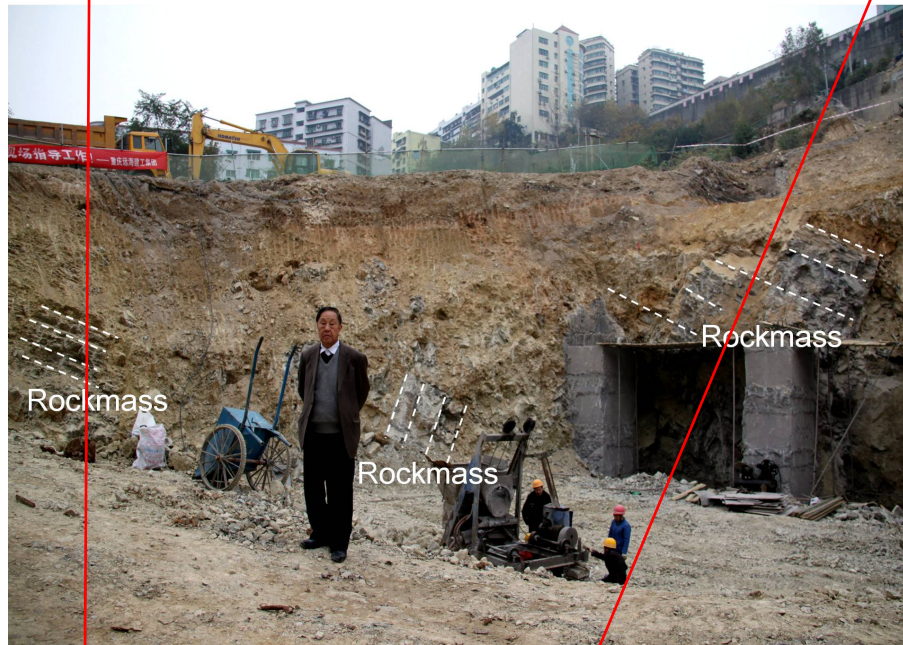
Figure 25. Rockmass showing their anomalous attitudes each other in the western wall of the foundation pit, and this kind of geologic structure is only generated by landslides.

their anomalous attitudes each other in the western wall of of geologic structure is only generated by landslides. The results of this study have confirmed that the Sanma Mountain in the new city of Fengjie is a **large-scale ancient deep-seated landslide**. From analysis of the slope deformation process and failure in centrifuge experiment model, it is **reasonable to summarize the deformation and failure**

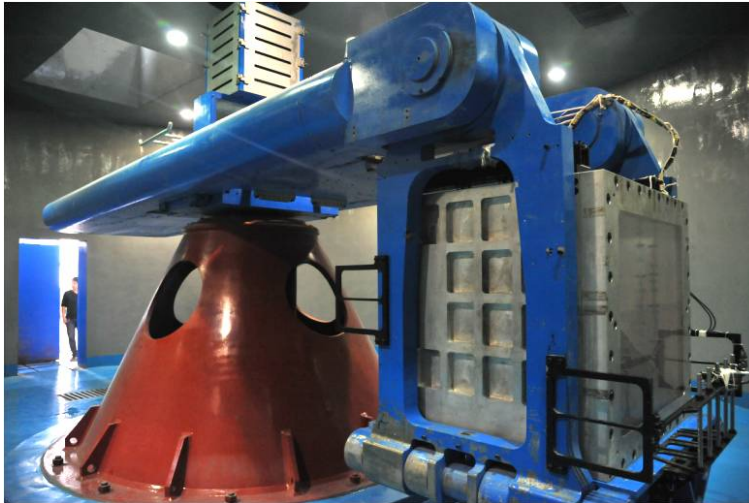
Figure 26. The geotechnical centrifuge used in experimental modeling.

A centrifuge is a piece of equipment that puts an object in rotation around a fixed axis (spins it in a circle), applying a potentially strong force perpendicular to the axis of spin (outward). Geotechnical centrifuge modeling is used for physical testing of models involving soils and rock. Centrifuge acceleration is applied to scale models to scale the gravitational acceleration and enable prototype scale stresses to be obtained in scale models. Problems such as building and bridge foundations, earth dams, tunnels, and slope stability, including effects such as blast loading and earthquake shaking. Large centrifuges are used to simulate high gravity or acceleration environments. This experimental modeling used a centrifuge at the State Key Laboratory of Geohazard Prevention and Geoenvironment Protection in China (Fig. 26). Its maximum acceleration is 500 gt, and it is the largest geotechnical centrifuge in Asia.

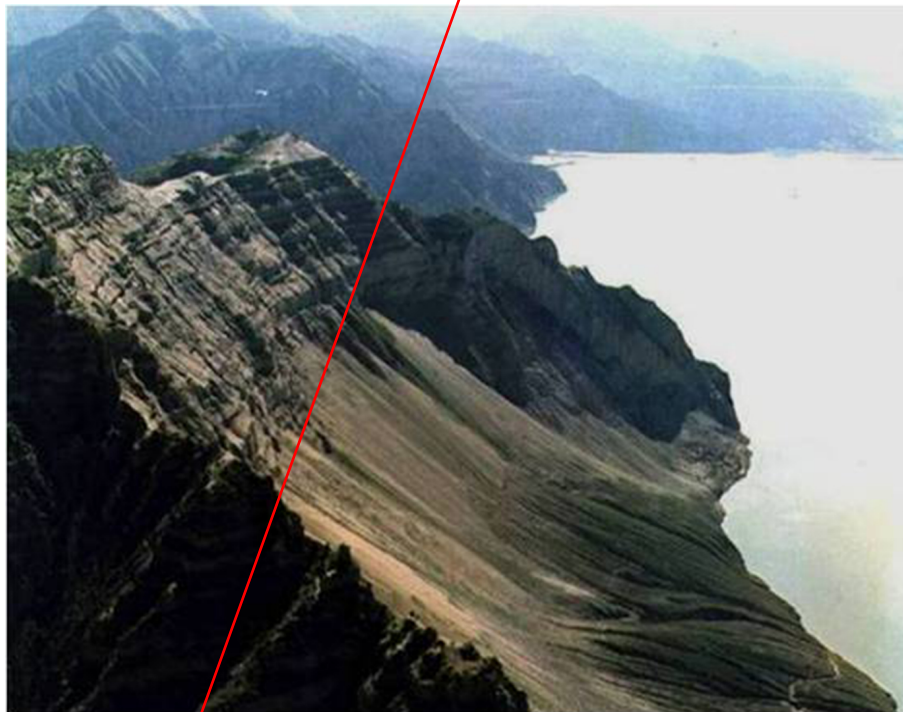
Figure 33. The Chana landslide, Longyangxia, China.

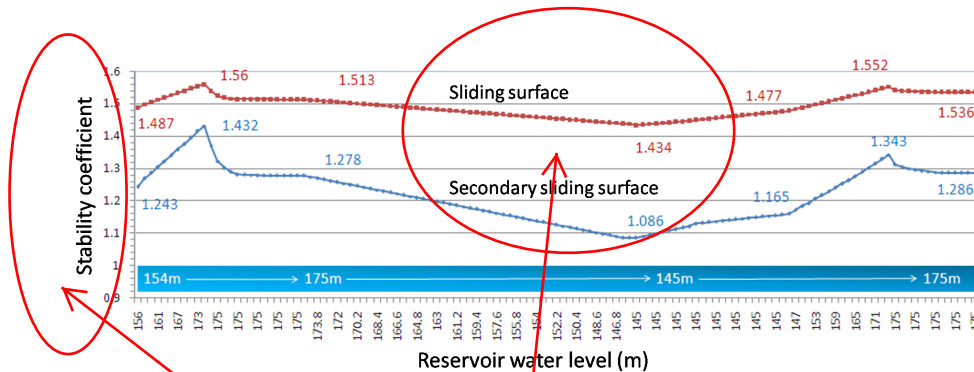
Figure 35. Stability changes with water level of the Three Gorges reservoir.

level of the reservoir to 175 m, landslide stability will begin to decrease with further rises in groundwater level. If the reservoir water level is reduced from 175 to 145 m, at the current rate of reservoir scheduling, the resulting decline in the groundwater level behind the water level of the reservoir will cause landslide stability to decrease. After reduction of the water level of the reservoir to 145 m, further decline of the groundwater level will cause landslide stability to increase gradually. (Fig. 35).
