# Landscape analysis for multi-hazard prevention in Orco and Soana valleys, North-Western Italy

A Civil Protection Plan has been drafted for a 600 km<sup>2</sup> mountainous region in NW Italy Consisting of Orco and Soana Valleys. It is a part of the oldest natural park in Italy and attracts several thousand tourists every year. The work is concerned with the analysis of relevant physiographic characteristics of this Alpine landscape having extremely variable geomorphology and possess a long history of instability. Thousands of records as well as digital maps (involving overlay and comparison of up to 90 GIS layers) have been analyzed and cross-correlated to find out the details of the events. The study area experienced different types of natural hazards, typical of the whole Alpine environment. Thus, the present area has been selected for such multi-hazard research in which several natural processes have been investigated, concerning their damaging effects over the land. Due to 36 different severe hazardous events at least 250 deaths have been recorded in the area since 18th Century, in the occasion of.

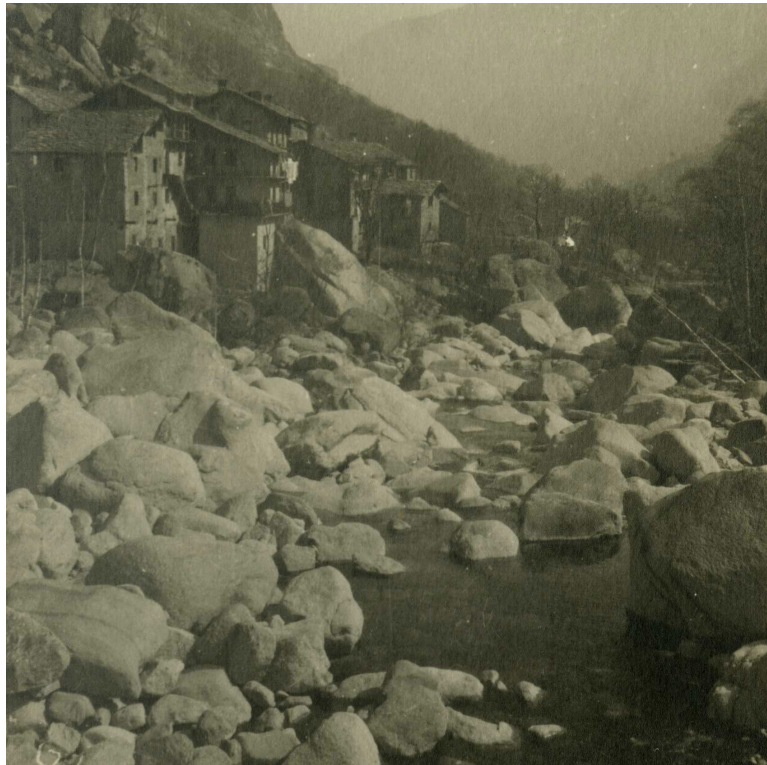
**Figure 2.** A village in the high Orco basin: very coarse deposits in the main channel as depicted in an old photograph (year 1952).

The hazard damage database have been generated from bibliographic sources, newspaper articles, unpublished documents of CNR-IRPI and several public archives, Communes of the Orco valley (e.g. Fig. 2) and from the online archives of Regione Piemonte. A systematic attempt has been made to examine the historical evidence of instabilities (largely from field and aerial photographs) and to verify numerous descriptions of ancient slope failures (many of which date back to the middle of the 17th Century). It includes old nomenclature of stream channels that might have changed in morphology and description of protection works (Fig. 2). To analyze the effects of the events we have exploited the detailed historical research of the CNR-IRPI and other researchers, from documents in national archives, libraries and other public bodies, and correlated them through interviews with local residents and eye-witnesses. A sub-

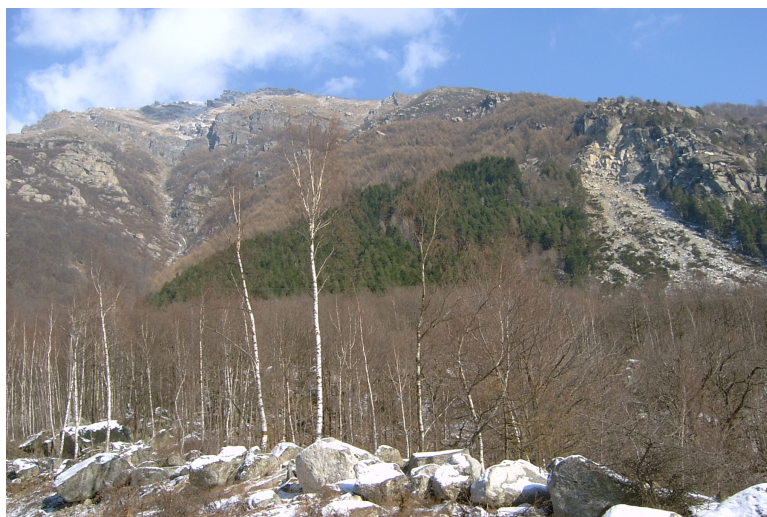
**Figure 3.** Frontal view of a minor catchment left to the Orco stream in which slope instability processes can be seen towards right; these have been re-activated in October 2000. In the foreground, mountain birches can be seen, on the left side of the catchment, in a 75 year old reforested area (Photo 25 February 2005).

the Rio Frera catchment, which was widely populated by larches until a half century ago, still appears in fairly good condition with regard to plant health, in spite of wildfire damage (Fig. 3).

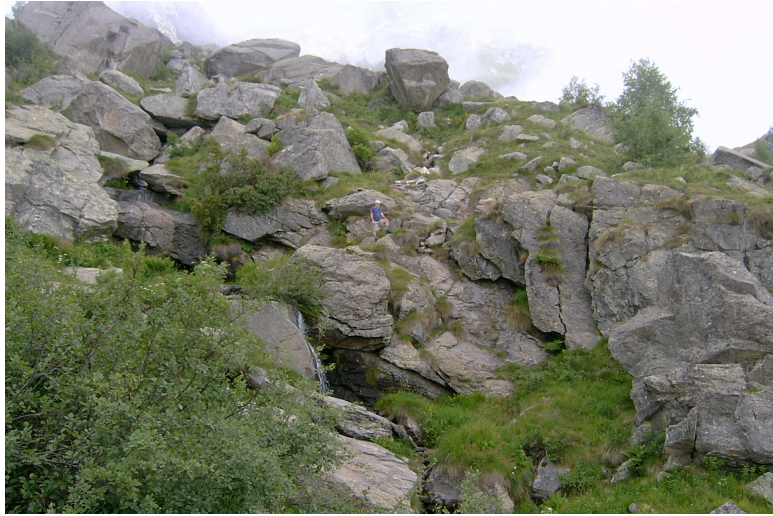
**Figure 6.** In a steep-sloping sub-catchment in the upper Orco Valley, the right slope, affected by a deep-seated gravitational process, is underlain by disjointed earth blocks and extremely uneven ground surface (Photo 12 July 2004).

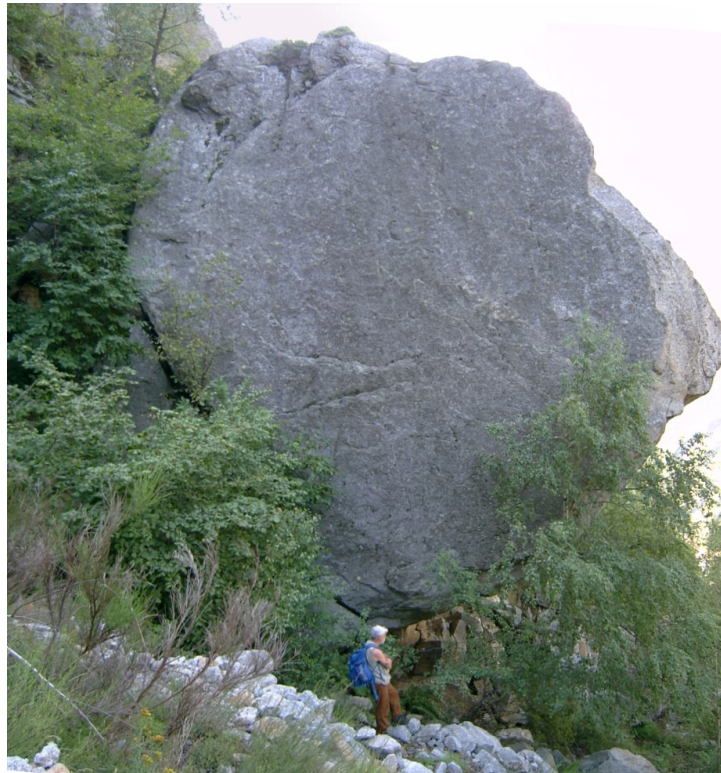
**Figure 7.** An example of the huge, disjointed stony blocks outcropping on the left slope of the Orco Valley, behind a settled area few hundreds meters downslope (Photo 21 July 2004).

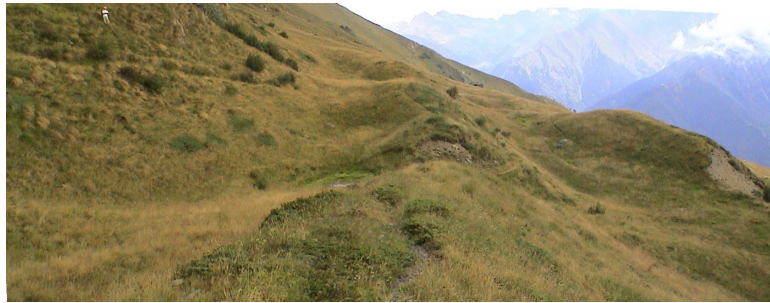
**Figure 8.** Watershed of tributary of the Soana stream, incised in a deep-seated slope collapse deposit; typical features include trenches and counterslope surfaces, often with emergent water (Photo 31 July 2003).

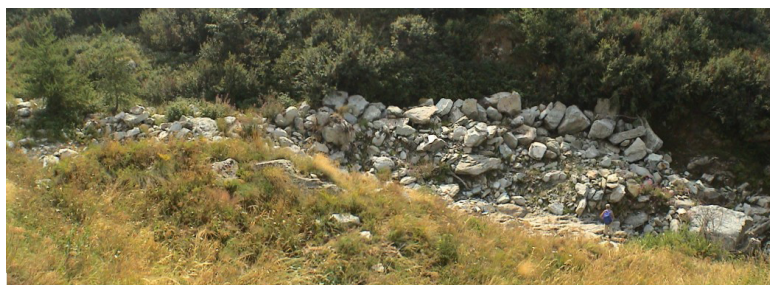
**Figure 9.** Residual deposit of a debris flow (October 2000), which shows typical inverse gradation, along a left tributary of the Soana stream (Photo 8 August 2003).

This has been sub-divided into three classes (TR1, TR2 and TR3) according to their increasing probability of occurrence. Few examples of torrential hazard are provided in  
20 Fig. 9.
