1 **Landscape analysis for multi-hazard prevention in Orco and Soana valleys, North-Western**
2 **Italy**

19 The study area (600 km²), consisting of Orco and Soana Valleys in the Western Italian Alps,
20 experienced different types of natural hazards, typical of the whole Alpine environment. Some of
21 the Authors have been requested to draw a Civil Protection Plan for such mountainous region. This
22 offered special opportunity 1) to draw a lot of unpublished historical data, dating back several
23 centuries mostly concerning natural hazard processes and related damages, 2) to develop original
24 detailed geo-morphological studies in a region still poorly known, 3) to prepare detailed thematic
25 maps illustrating landscape components related to natural conditions and hazards, 4) to check
26 thoroughly in the area present-day situations compared to the effects of past events and 5) to find
27 adequate natural hazard scenarios for all sites exposed to risk. Method of work has been essentially
28 to compare archival findings with field evidences in order to assess natural hazard processes, their

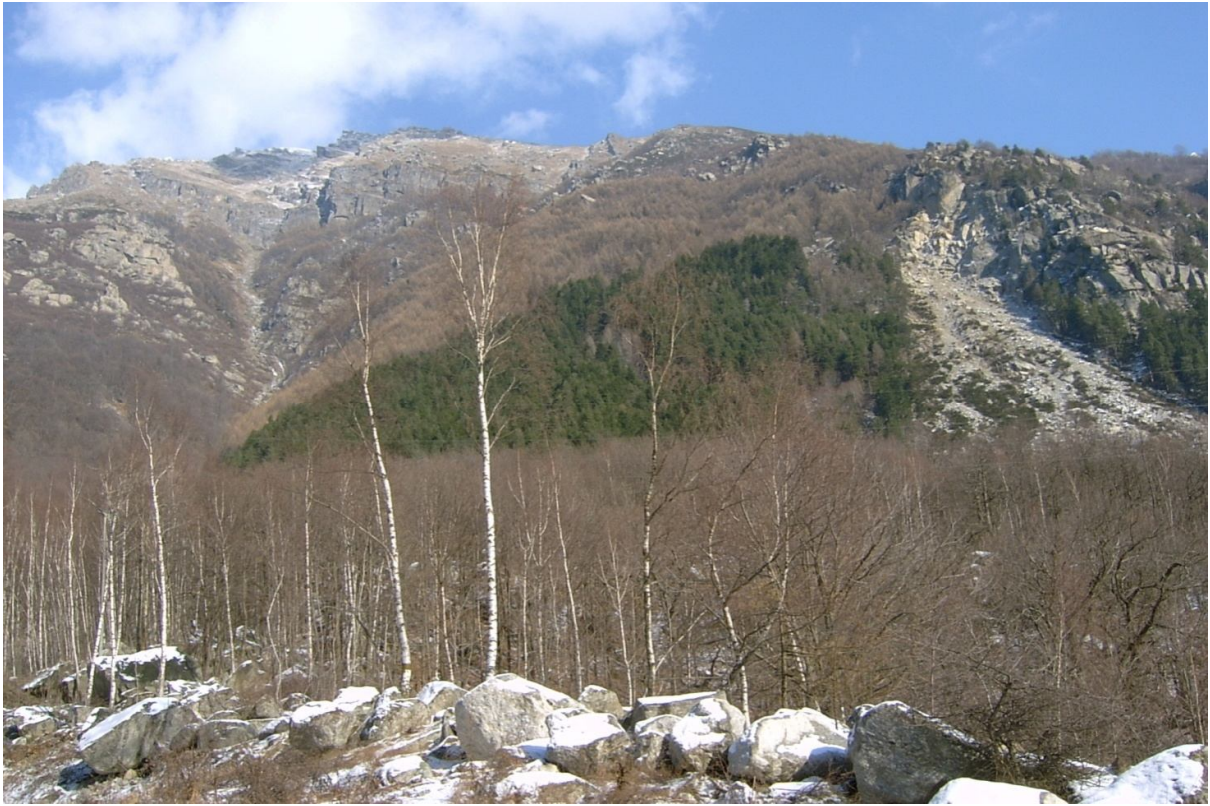
556 Fig. 2

53 Forest management in the Orco and Soana Valleys began in the 1900s, even on slopes which are
54 difficult to manage and unsuitable for rapid root establishment. On 7th September 1925, the
55 National Forestry Corporation began a general restoration programme to prevent slope degradation
56 and flooding in several sub-catchments of the region. Such work continued up to and after the
57 Second World War, but ceased in the early 1970s (according to CNR-IRPI archives). For example,
58 the Rio Frera catchment, which was widely populated by larches until a half century ago, still
59 appears in fairly good condition with regard to plant health, in spite of wildfire damage (Fig. 2).

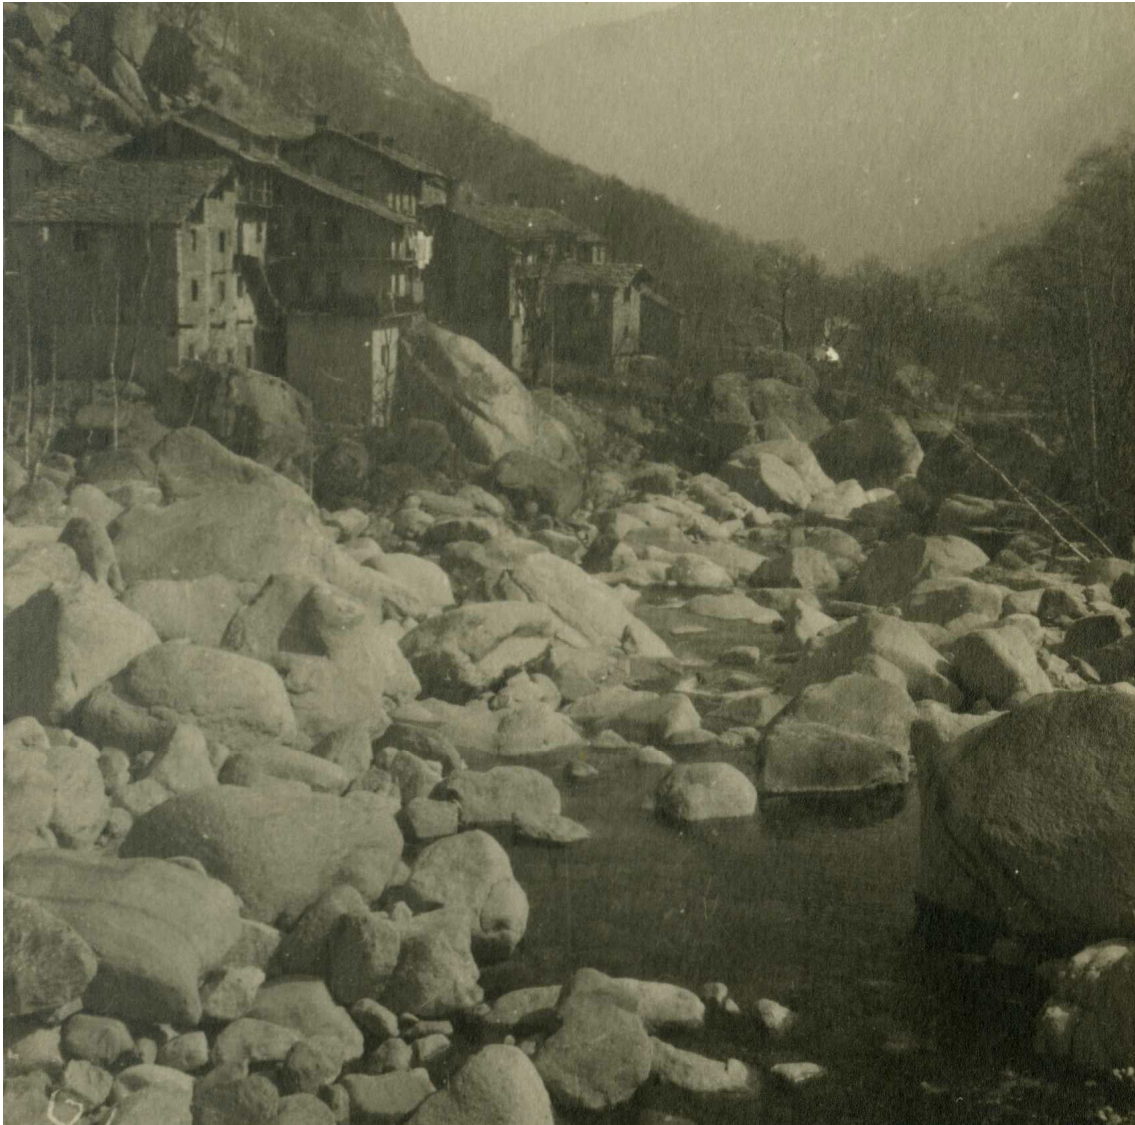
559 Fig. 3

184 The hazard damage database have been generated from old and recent bibliographic sources,
185 newspaper articles, pictures (e.g Fig. 3), unpublished documents of CNR-IRPI and several public
186 archives, included Communes of the Orco valley and from the online archives of Regione
187 Piemonte. A systematic attempt has been made to examine the historical evidence of instabilities
188 (largely from field and aerial photographs) and to verify numerous descriptions of ancient slope
189 failures (many of which date back to the middle of the 17th Century). It includes old nomenclature
190 of stream channels that might have changed in morphology and description of protection works
191 (Fig. 2). To analyze the effects of the events we have exploited the detailed historical research of
192 the CNR-IRPI and other researchers, from documents in national archives, libraries and other public
193 bodies, and correlated them through interviews with local residents and eye-witnesses. A substantial

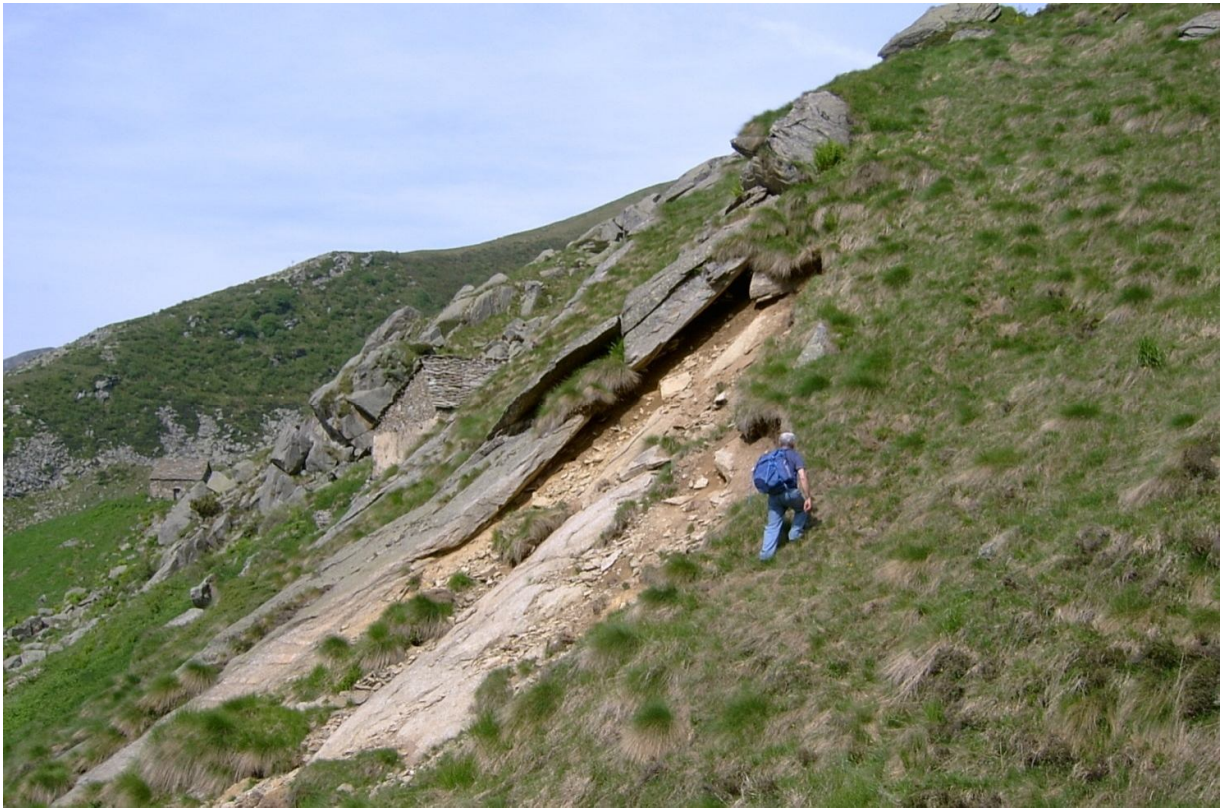
574 Fig. 5

536 **Fig. 5** Right slope of a major catchment in the Orco valley, near the stream head: a rock fall/soil slip
537 process triggered by the extreme rainfall event of October 2000. The matrix-dominated nature of
538 the materials is noteworthy and is connected to weathering products of the bedrock (Photo 11 June
539 2004).

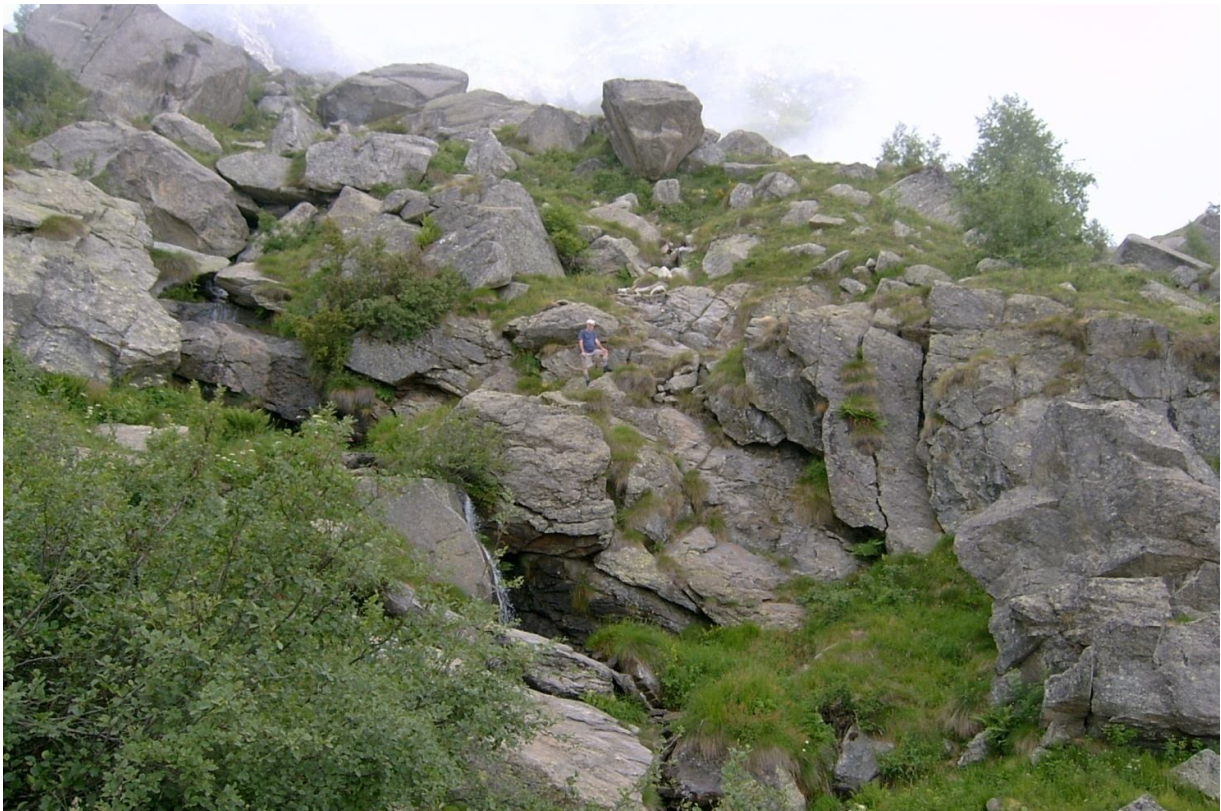
577 Fig. 6

540 **Fig. 6** In a steep-sloping sub-catchment in the upper Orco valley, the right slope, affected by a deep-
541 seated gravitational process, is underlain by disjointed earth blocks and extremely uneven ground
542 surface (Photo 12 July 2004).

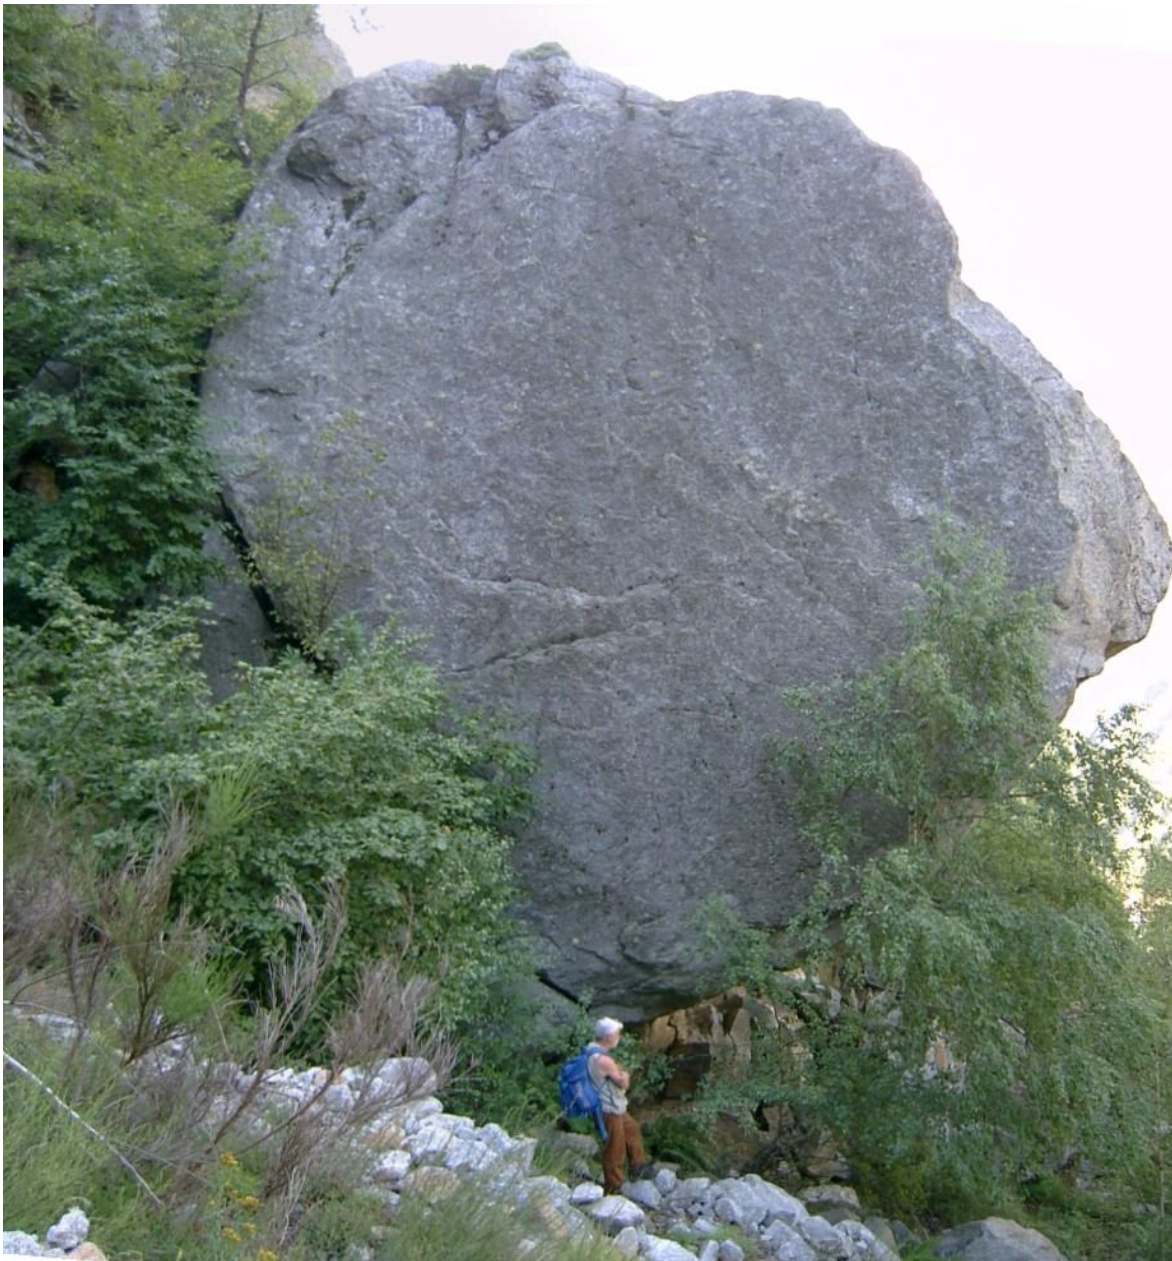
580 Fig. 7

543 **Fig. 7** An example of the huge, disjointed stony blocks outcropping on the left slope of the Orco
544 Valley, behind a settled area few hundreds meters downslope (Photo 21 July 2004).

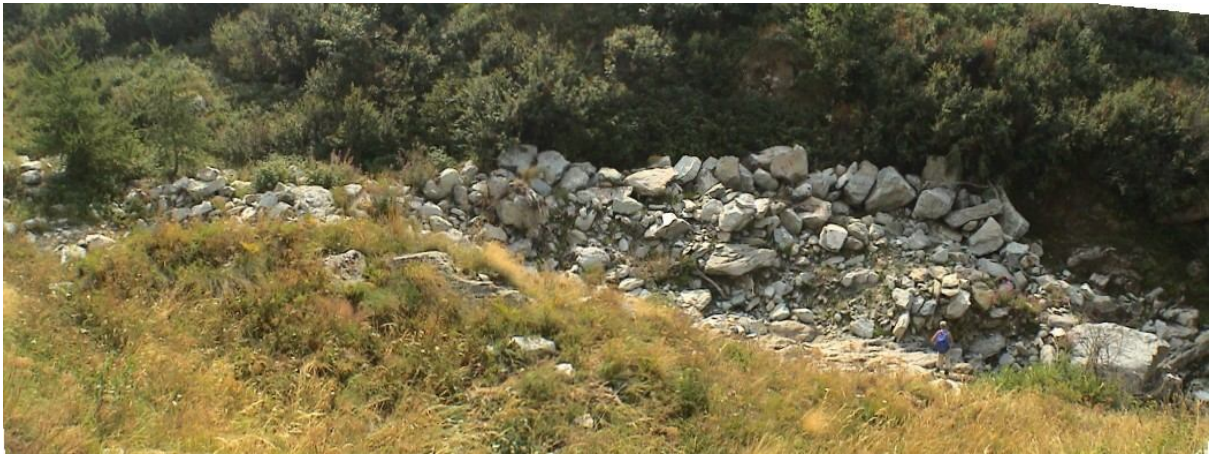
587 Fig. 9

548 **Fig. 9** Residual deposit of a debris flow (October 2000), which shows typical inverse gradation,
549 along a left tributary of the Soana stream (Photo 8 August 2003).

382 This has been sub-divided into three classes (TR1, TR2 and TR3) according to their increasing
383 probability of occurrence. Processes involved are channel overdeepening, bank erosion and
384 especially debris flows; an examples is provided in Fig. 9.
